# Scope of Works for Hazmat Remediation and Demolition

Willyama High School, Broken Hill, NSW, 2880

**Report No.:** 31174 - R02

**Site visit and assessment** - 4<sup>th</sup> June 2024

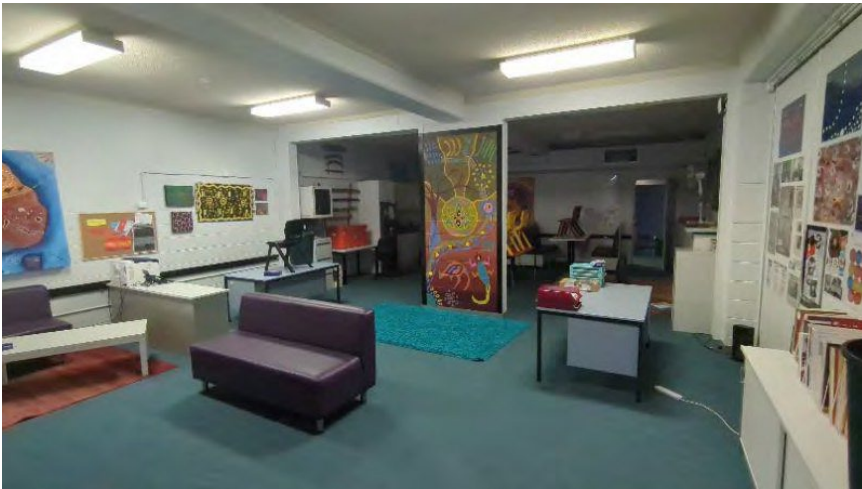
<p data-bbox="337 997 667 1026">B00A-R1W15 - Computer L.S</p>	<p data-bbox="943 495 1253 600">Masonry walls, carpet over concrete and sprayed coating (vermiculite) ceiling.</p>	<p data-bbox="1281 495 1544 674">Sporadic patches of suspected visible mould growth were noted to carpet and porous contents.</p> <p data-bbox="1268 690 1559 756">Refer to index photos 276 - 278</p> <p data-bbox="1349 772 1477 802">Condition 3</p>

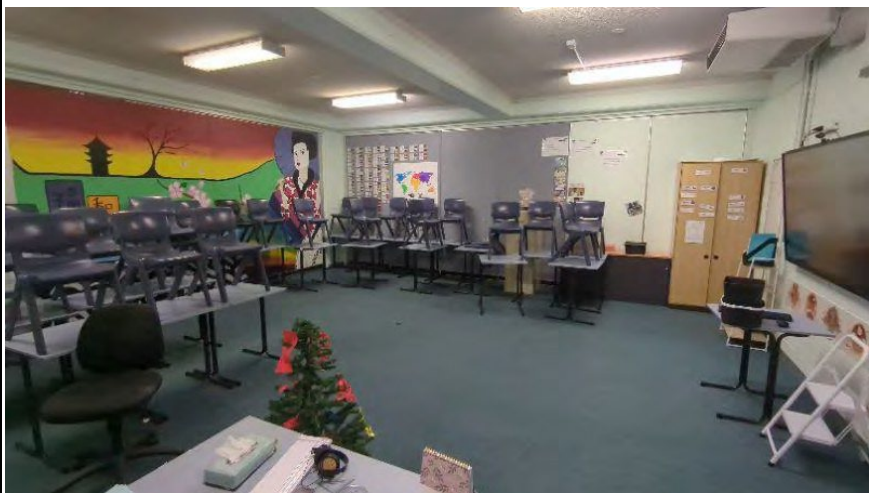
<p>B00A-R1W17 - General L.S</p>	Masonry walls, carpet over concrete and sprayed coating (vermiculite) ceiling.	<p>Suspected visual mould growth was noted to carpet floor and all contents.</p> <p>Refer to index photos 281 - 287</p> <p>Condition 3</p>

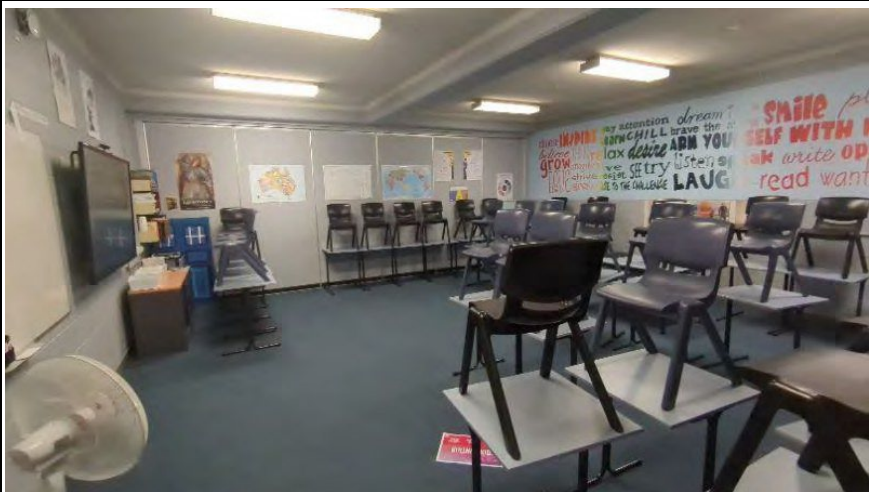
<p>B00A-R1W16 - General L.S</p>	Plasterboard walls, carpet over concrete and sprayed coating (vermiculite) ceiling.	<p>Suspected visual mould growth was noted to carpet floor and chairs.</p> <p>Refer to index photos 288 - 293</p> <p>Condition 3</p>

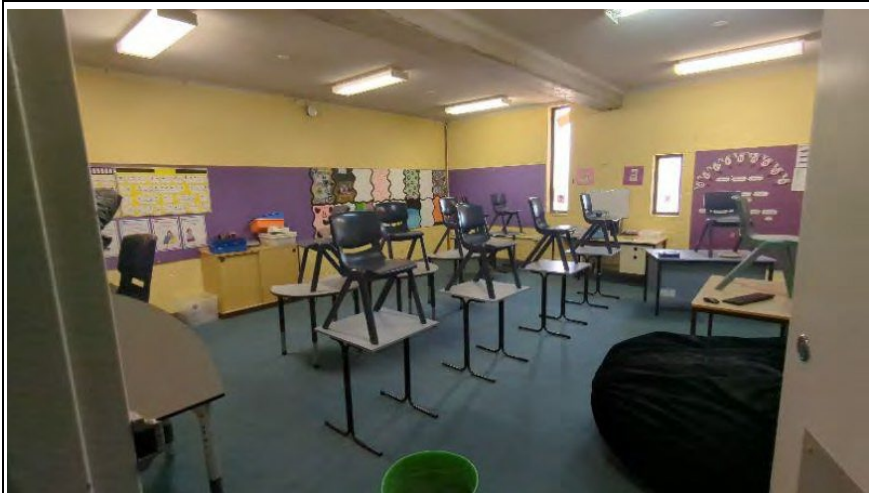
<p>B00A-R1W11 - General L.S</p>	Plasterboard walls, carpet over concrete and sprayed coating (vermiculite) ceiling.	<p>Suspected visual mould growth was noted to carpet, benchtop cupboard and porous contents.</p> <p>Refer to index photos 305 - 307</p> <p>Condition 3</p>

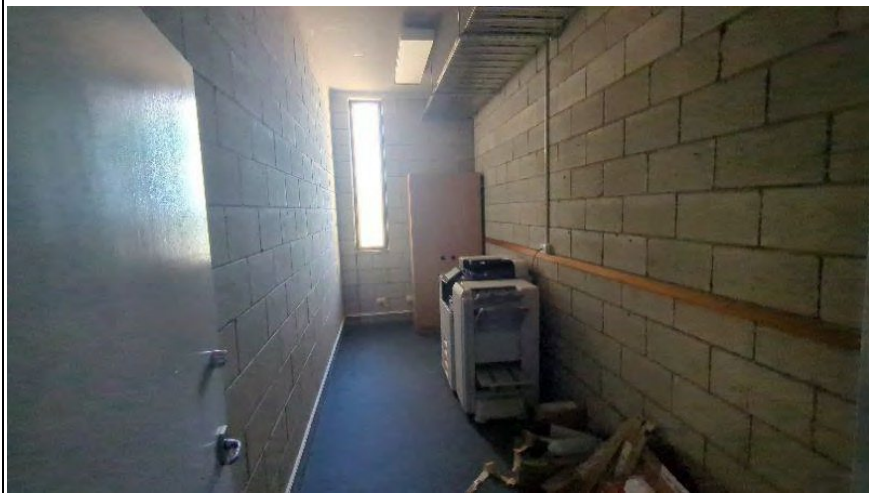
<p>B00A-R1W10 - Storeroom</p>	Masonry walls, carpet over concrete and sprayed coating (vermiculite) ceiling.	<p>No signs of visual mould growth or water damage were noted.</p> <p>Condition 3</p>

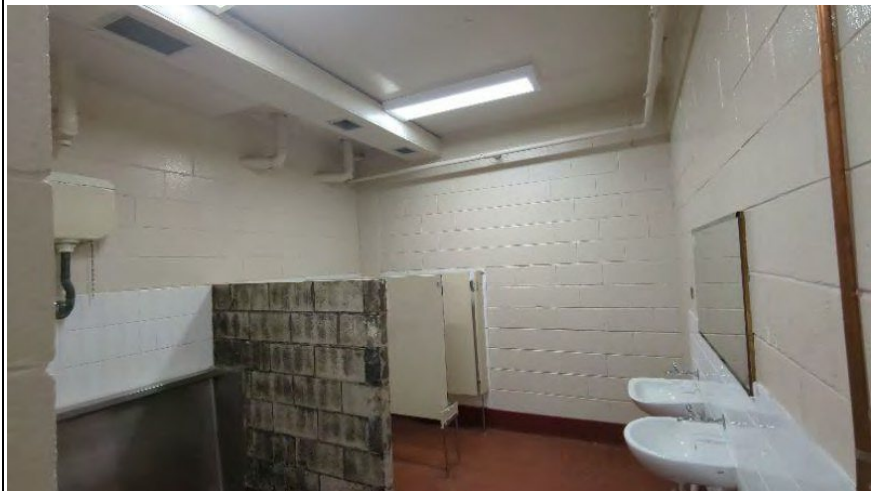
<p>B00A-R1W06 - Boys Toilet</p>	Concrete ceiling, masonry walls and ceramic floor tiles.	<p>No signs of visible mould growth were noted. Evaporative water stains were noted to ceramic floor tiles.</p> <p>Refer to index photos 310 - 311</p> <p>Condition 3</p>

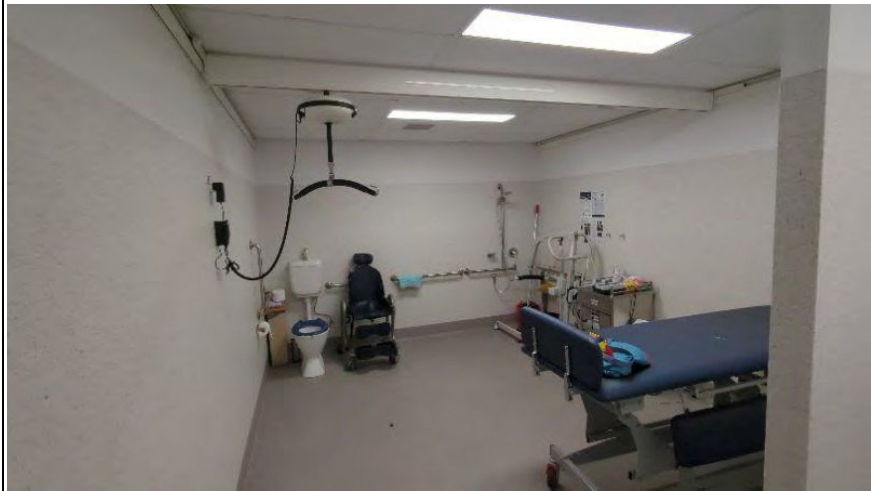
<p>B00A-R1W04 - Staff Toilet</p>	Plasterboard suspended ceiling tiles, plasterboard walls and vinyl floor sheeting.	<p>No signs of visual mould growth or water damage were noted.</p> <p>Condition 3</p>

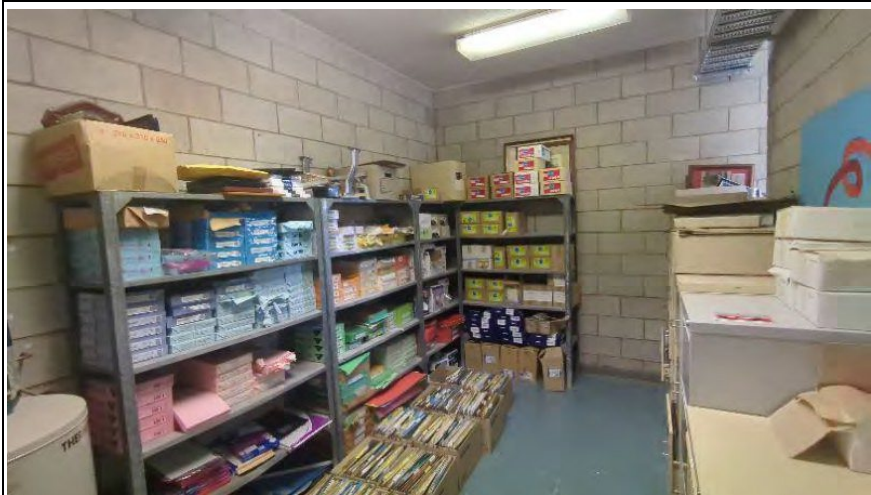
<p>B00A-R1W01 - Staff Study</p>	Masonry walls, vinyl floor sheeting and concrete ceiling.	No signs of visual mould growth or water damage were noted. Condition 3

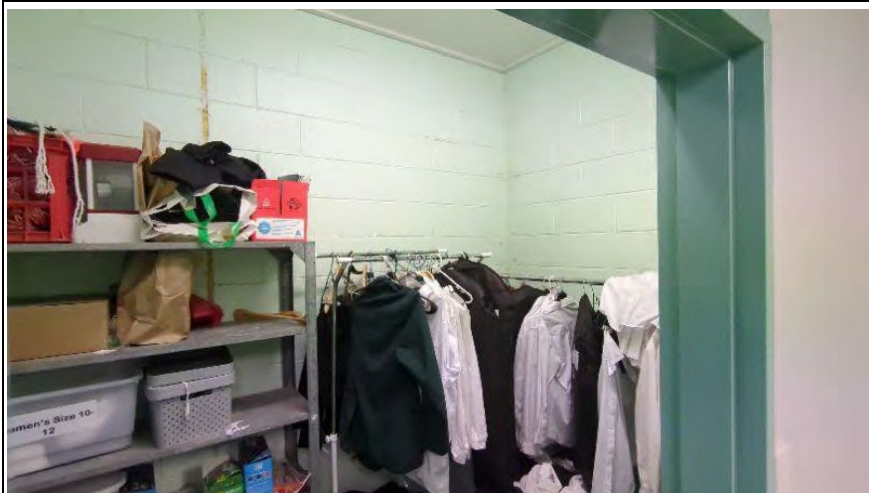
<p>B00A-R2N16 - Uniform Shop</p>	Masonry walls, carpet over concrete and fibre cement ceiling.	No signs of visual mould growth or water damage were noted. Condition 3

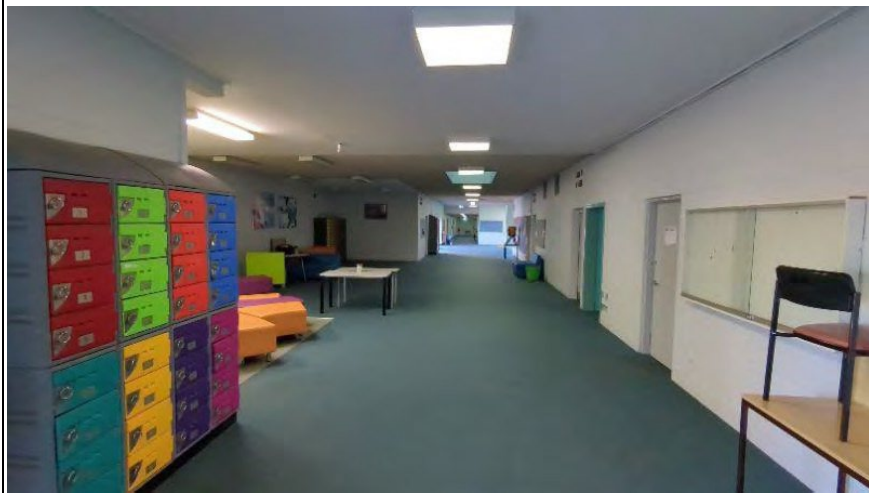
<p>B00A-R2N17 - Movement</p>	Masonry walls, carpet over concrete and plasterboard ceiling.	No signs of visual mould growth or water damage were noted. Refer to index photos 317 - 318 Condition 3

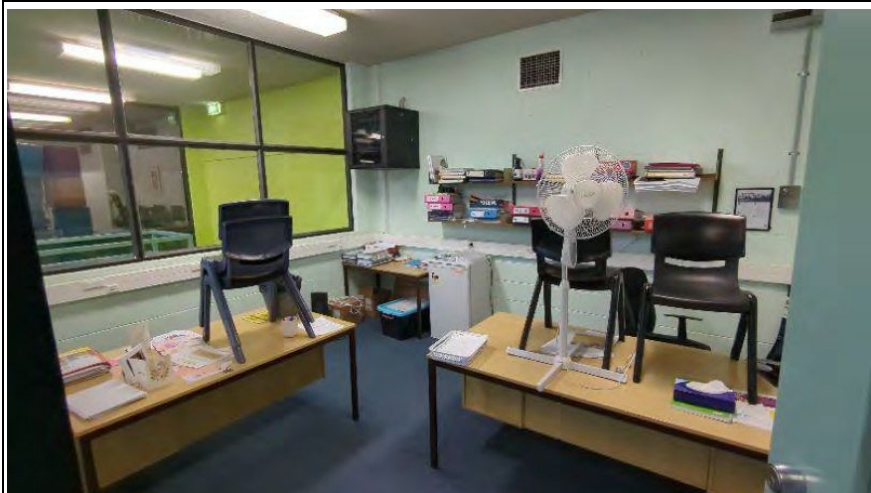
<p>B00A-R2N07 - Workshop</p>	Masonry walls, carpet over concrete and sprayed coating (vermiculite) ceiling.	<p>No signs of visual mould or water damage were noted.</p> <p>Condition 3</p>

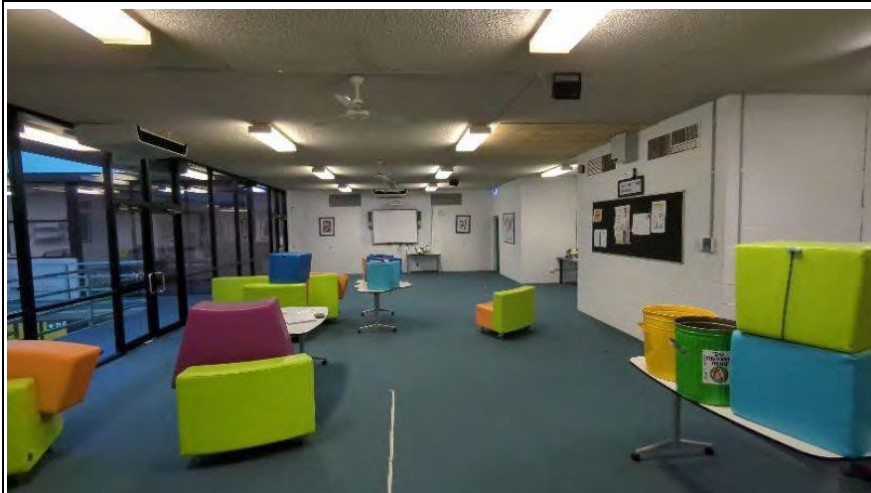
<p>B00A-R2N05 - Library</p>	Plasterboard walls, carpet over concrete and sprayed coating (vermiculite) ceiling.	No signs of visual mould growth or water damage were noted. Condition 3

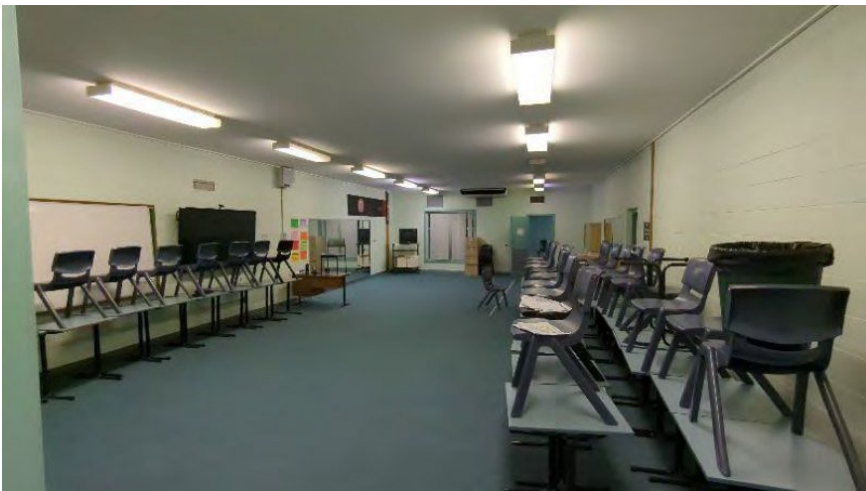
<p>B00A-R2E11 - Staff</p>	Masonry walls, carpet over concrete and plasterboard ceiling.	Suspected visual mould growth was noted to the carpet floor, hardwood desk and porous contents. Condition 3

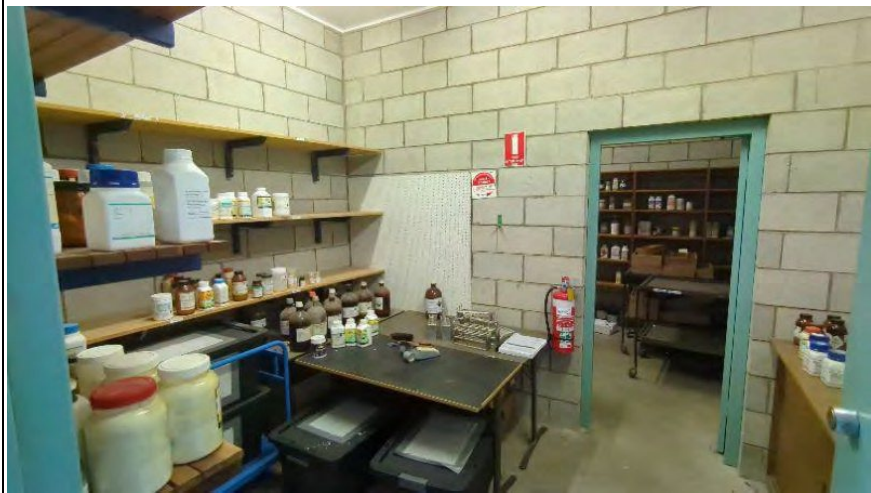
<p>B00A-R2E03 - Lab</p>	Masonry walls, vinyl floor sheeting and sprayed coating (vermiculite) ceiling.	<p>Suspected visual mould growth was noted to the plush in corner tap. No signs of visual mould growth or water damage were noted to building materials.</p> <p>Refer to index photos 327 - 328</p> <p>Condition 3</p>

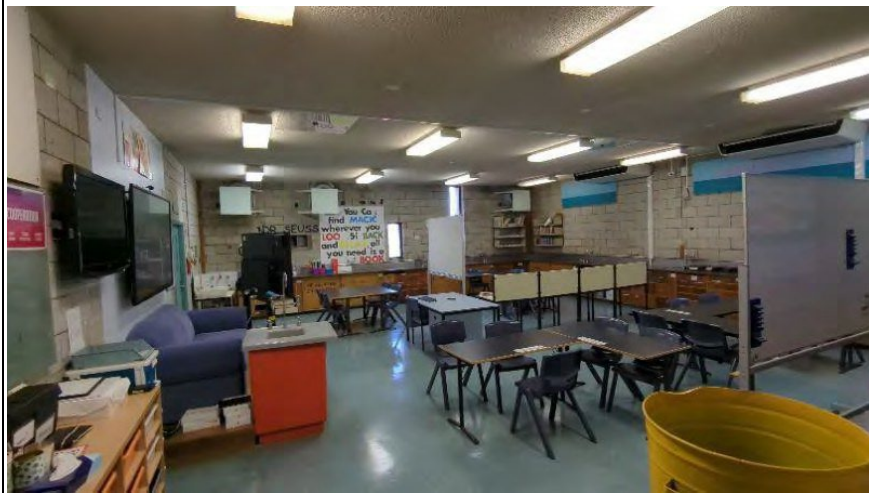
<p>B00A-R2E18 - Lab</p>	Masonry walls, vinyl floor sheeting and sprayed coating (vermiculite) ceiling.	No signs of visual mould growth or water damage were noted. However, staining (likely grease) was present to couch. Refer to index photos 330 - 331 Condition 3

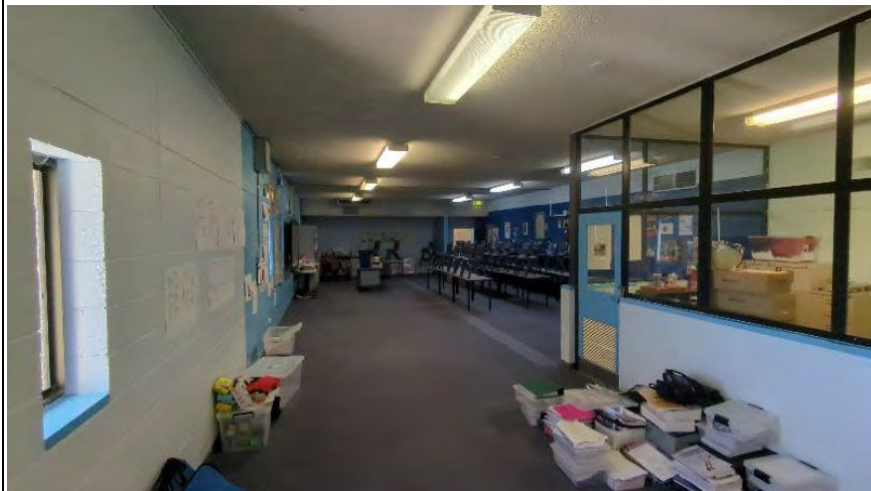
<p>B00A-R2N01 - General L.S</p>	Masonry walls, carpet over concrete and sprayed coating (vermiculite) ceiling.	No signs of visual mould growth were noted. Liquid staining was noted to carpet adjacent to western doorway. Refer to index photos 341 Condition 3

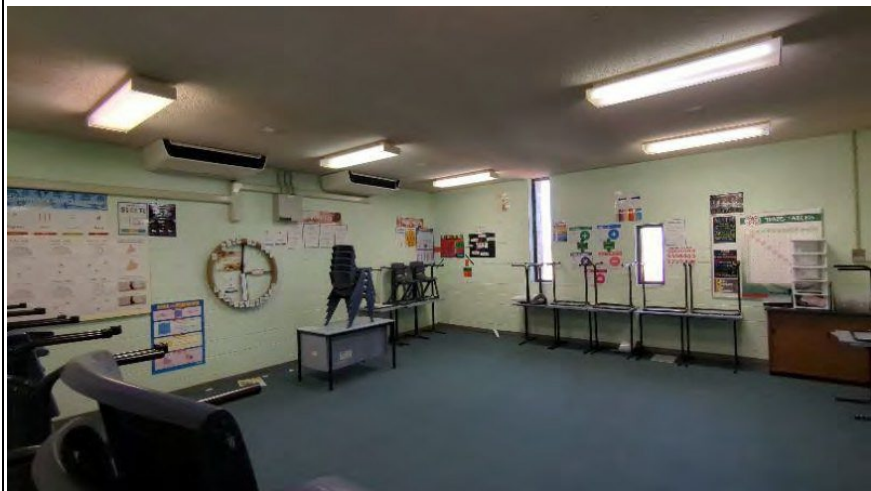
<p>B00A-R2W18 - General L.S</p>	Masonry walls, carpet over concrete and sprayed coating (vermiculite) ceiling.	No signs of visual mould growth were noted. Liquid stains were noted to carpet floor. Condition 3

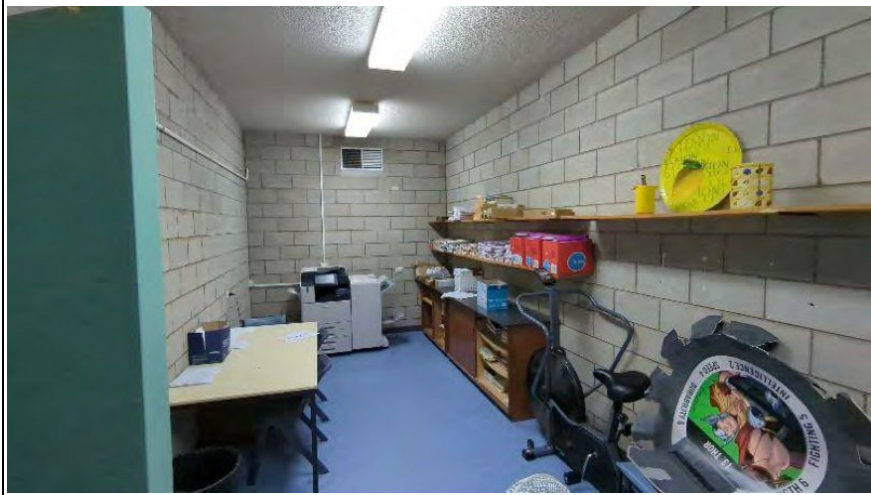
<p>B00A-R2W15 - Staff Study</p>	Masonry walls, carpet over concrete and sprayed coating (vermiculite) ceiling.	<p>Suspected visual mould growth was noted within cabinetry beneath sink.</p> <p>Refer to index photos 342</p> <p>Condition 3</p>

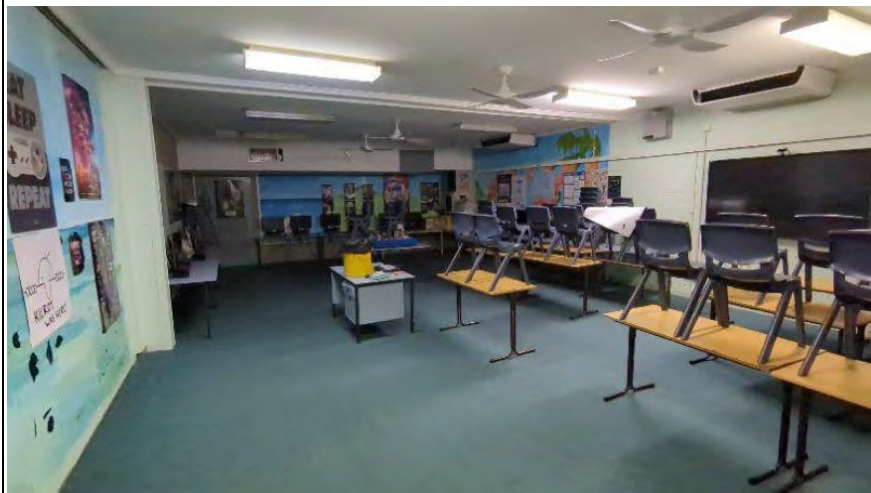
<p>B00A-R2W16 General L.S</p>	Masonry walls, carpet over concrete and sprayed coating (vermiculite) ceiling.	Traces of suspected visual mould growth were noted to carpet. Refer to index photos 344. Condition 3

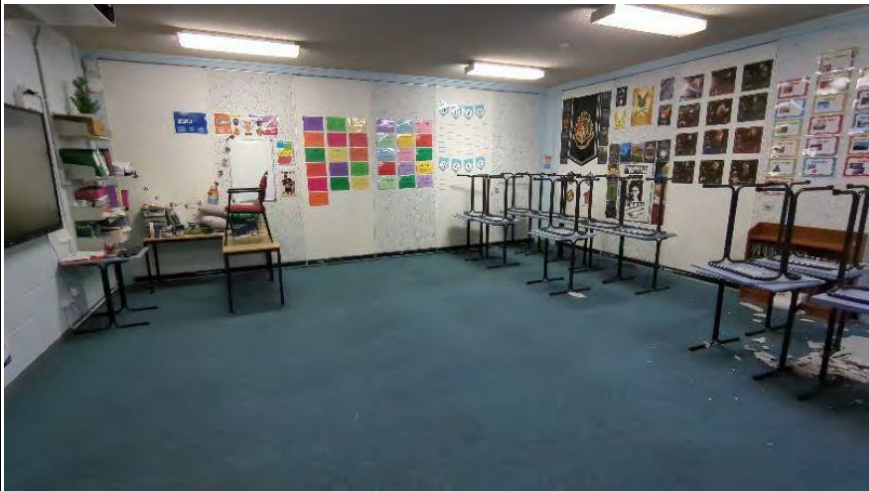
<p>B00A-R2W12 - General L.S</p>	Masonry walls, carpet over concrete and sprayed coating (vermiculite) ceiling.	Suspected visual mould growth was noted to chair and pillow. Refer to index photos 345- 346 Condition 3

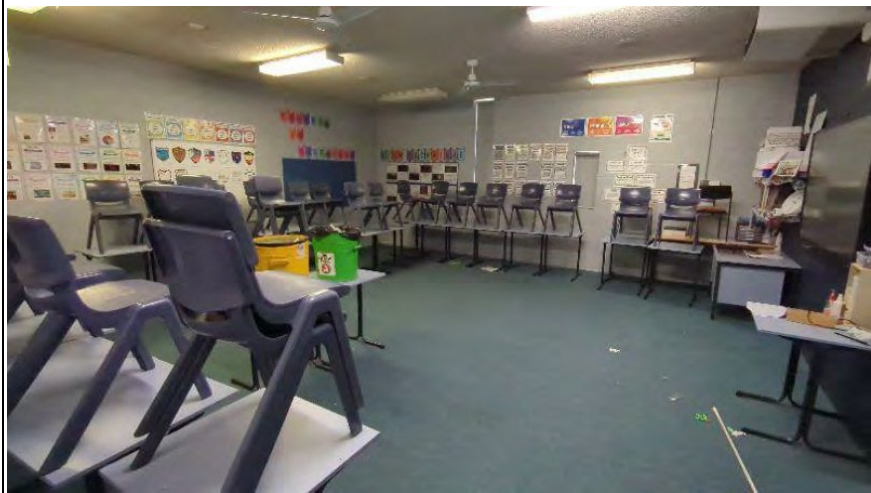
<p>B00A-R2W10 - General L.S</p>	Masonry walls, carpet over concrete and sprayed coating (vermiculite) ceiling.	<p>No signs of visual mould growth were noted. Water damage (in the form of leaching) was noted to ceiling and upper sections of masonry wall. Refer to index photos 347</p> <p>Condition 3</p>

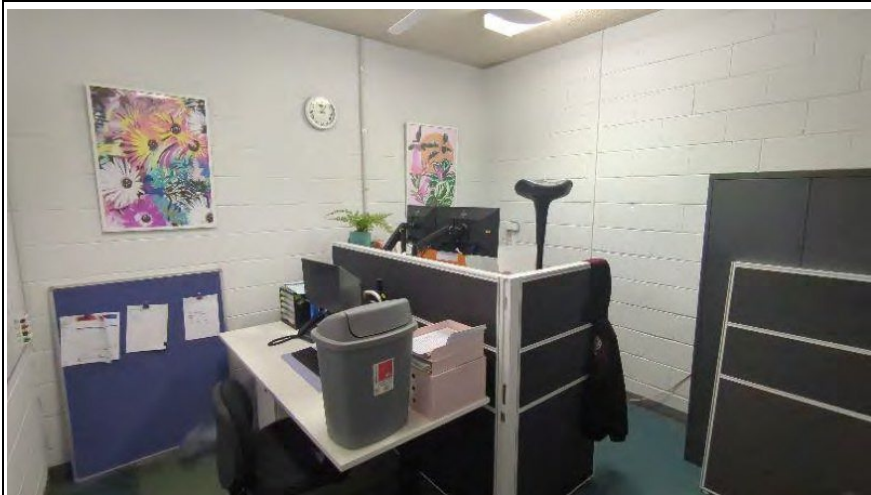
<p>B00A-R1S14 - Clerical</p>	Masonry walls, carpet over concrete and sprayed coating (vermiculite) ceiling.	<p>*Add 'tape-lift' sample results* - Staining Present on seat</p> <p>Refer to index photo 353 Condition 2</p>

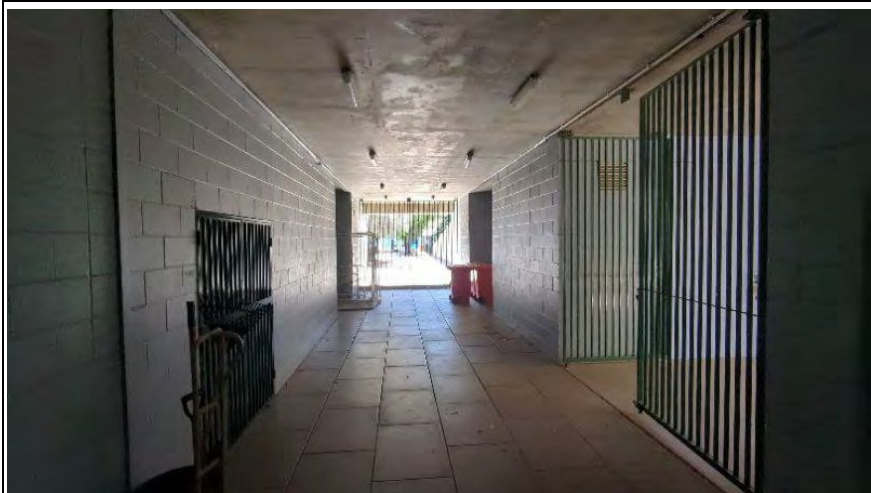
<p>B00A-R0S20 - Movement</p>	Masonry walls, ceramic floor tiles and concrete ceiling.	No signs of visual mould growth or water damage were noted. Condition 2

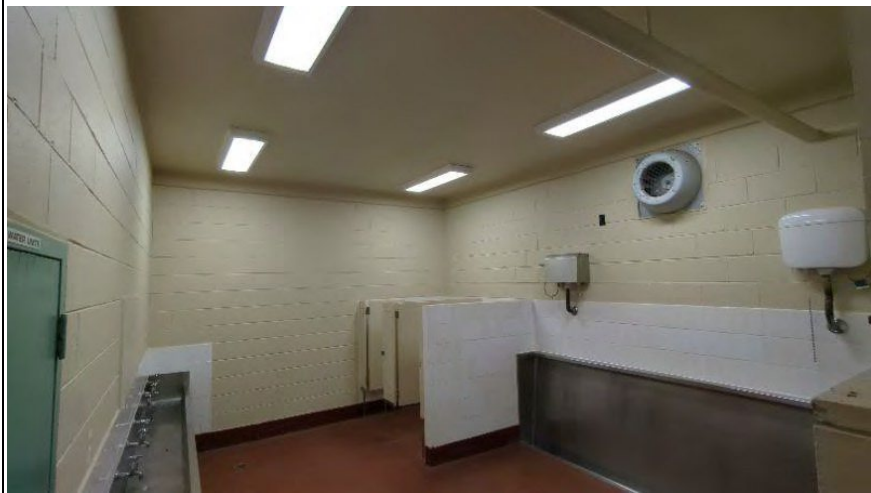
<p>B00A-R0S15 - Boys Toilet</p>	Masonry walls, ceramic floor tiles and concrete ceiling.	No signs of visual mould growth or water damage were noted. Condition 2

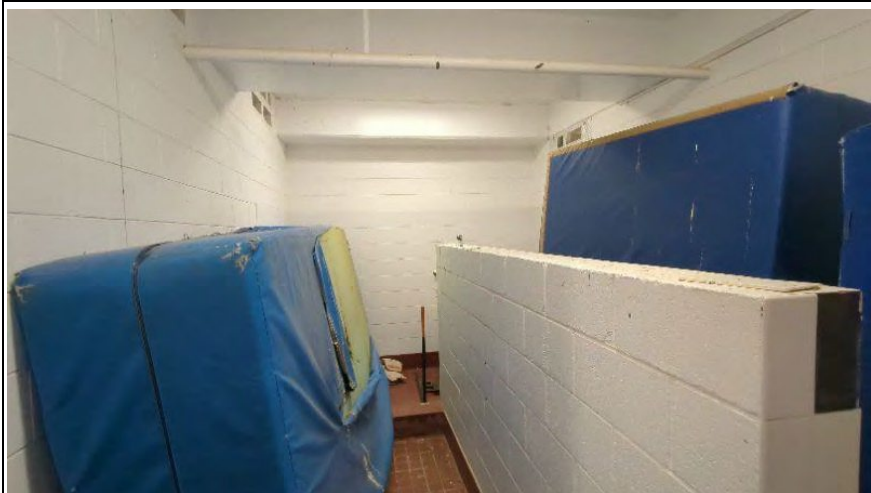
<p>B00A-R0S10 - Showers</p>	Masonry walls, ceramic floor tiles and concrete ceiling.	<p>Suspected visual mould growth was noted to porous contents. Room was in a general state of disarray.</p> <p>Condition 2</p>

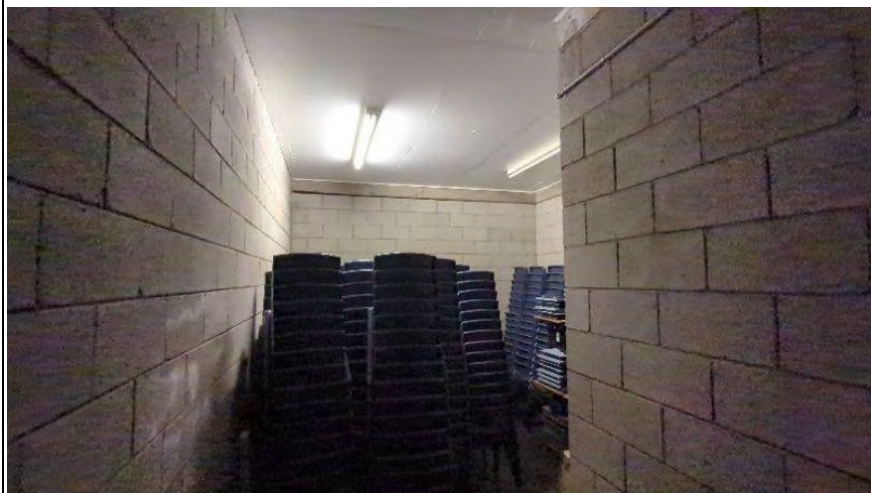
<p>B00A-R0S05 - Equipment Store</p>	Masonry walls, ceramic floor tiles and concrete ceiling.	<p>No signs of visual mould growth were noted. Water ingress (in the form of leaching) was noted to the upper sections of masonry walls. Refer to index photos 360 - 361</p> <p>Condition 2</p>
<p>B00A-R0S04 - Chair Store</p>		<p>No access, keys provided did not open</p> <p>Assumed mould</p>

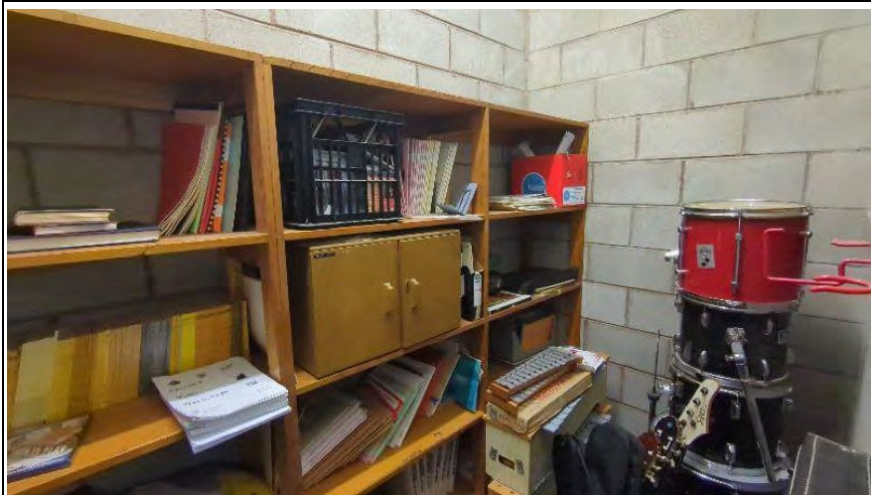
<p>B00A-R0N13 - Music Store</p>	Masonry walls, carpet over concrete and concrete ceiling.	<p>Suspected visual mould growth was noted to the carpet and all contents.</p> <p>Refer to index photos 362 - 363</p> <p>Condition 3</p>

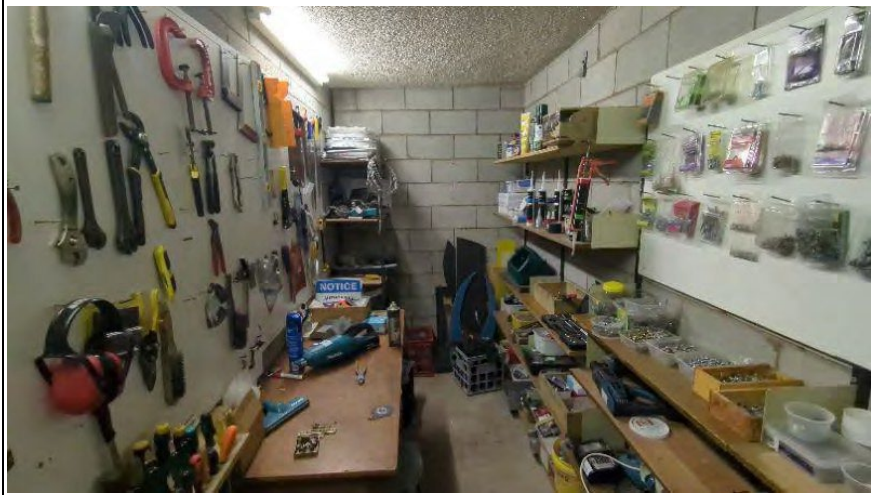
<p>B00A-R0N05 - Maintenance Cupboard</p>	Masonry walls, concrete floor and sprayed coating (vermiculite) ceiling.	<p>Suspected visual mould growth was noted to all contents.</p> <p>Condition 3</p>

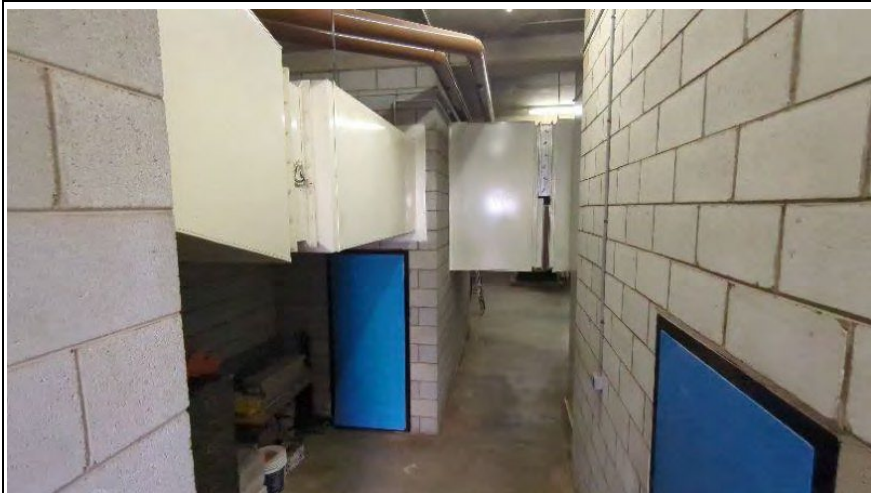
<p>B00A-R0N02 - Plant</p>	Masonry walls, concrete ceiling and concrete floors.	<p>No signs of visual mould growth or water damage were noted.</p> <p>Condition 3</p>

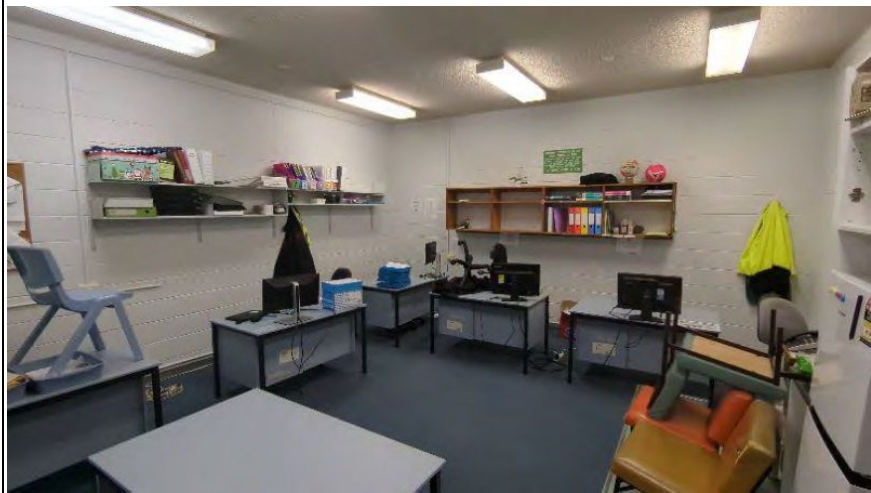
<p>B00A-R1E15 - Staff Study</p>	Masonry walls, carpet over concrete and sprayed coating (vermiculite) ceiling.	<p>Suspected visual mould growth was noted to carpet floor and porous contents.</p> <p>Refer to index photos 364 - 369</p> <p>Condition 3</p>

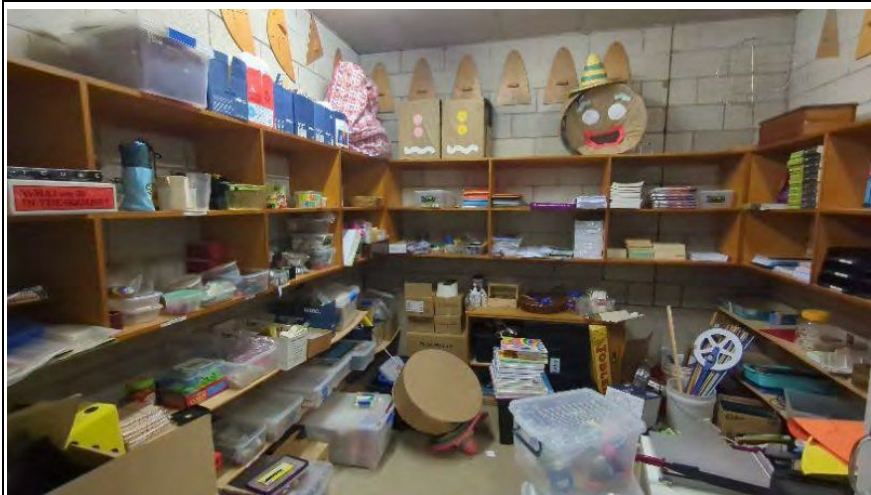
Masonry walls, concrete floor and sprayed coating (vermiculite) ceiling.	No signs of visual mould growth or water damage were noted.  Condition 3
B00A-R1E16 - Math Storeroom

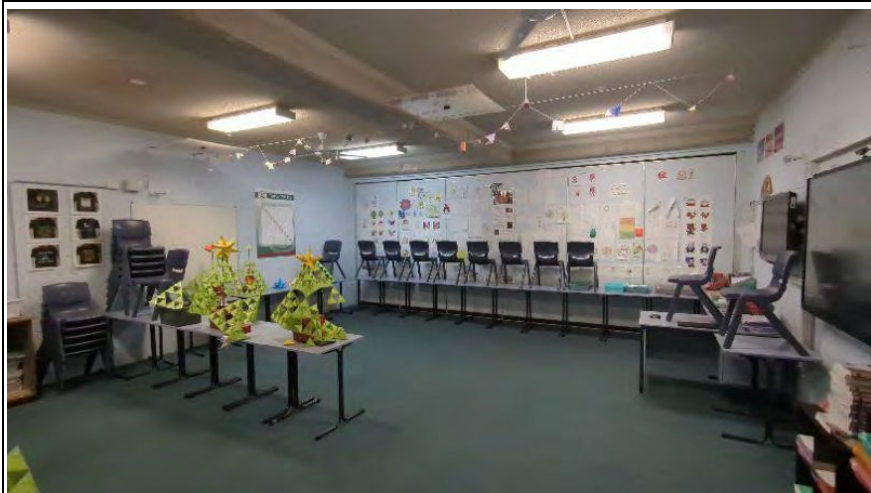
<p>B00A-R1E10 - General L.S</p>	Masonry walls, carpet over concrete and sprayed coating (vermiculite) ceiling.	Suspected visual mould growth was noted to carpet floor. Condition 3
<p>B00A-R2E08 - Music L.S</p>	Masonry walls, carpet over concrete and sprayed coating (vermiculite) ceiling.	No signs of visual mould growth or water damage were noted. Condition 3

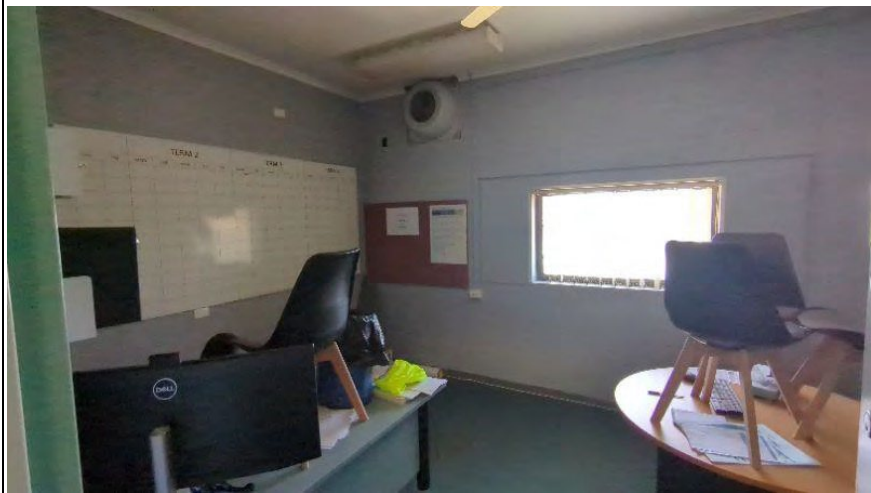
<p>B00A-R2N13 - Staff Study</p>	Masonry walls, carpet over concrete and sprayed coating (vermiculite) ceiling.	Suspected visual mould growth was noted to linoleum skirting. Condition 3

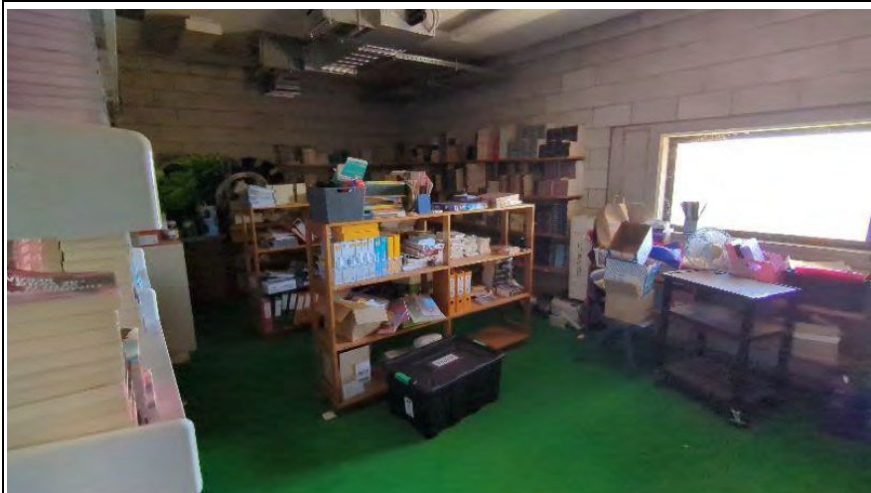
<p>B00A-R2W01 - Store Room</p>	Masonry walls, carpet over concrete and sprayed coating (vermiculite) ceiling.	No signs of visual mould growth or water damage were noted. Condition 3

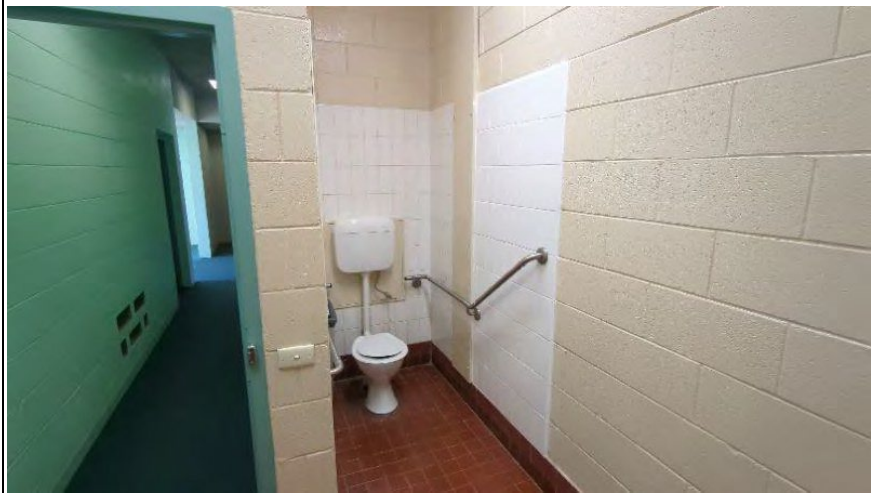
<p>B00A-RW02 - Staff Toilet</p>	Masonry walls, ceramic floor tiles and concrete ceiling.	No signs of visual mould growth or water damage were noted. Condition 3

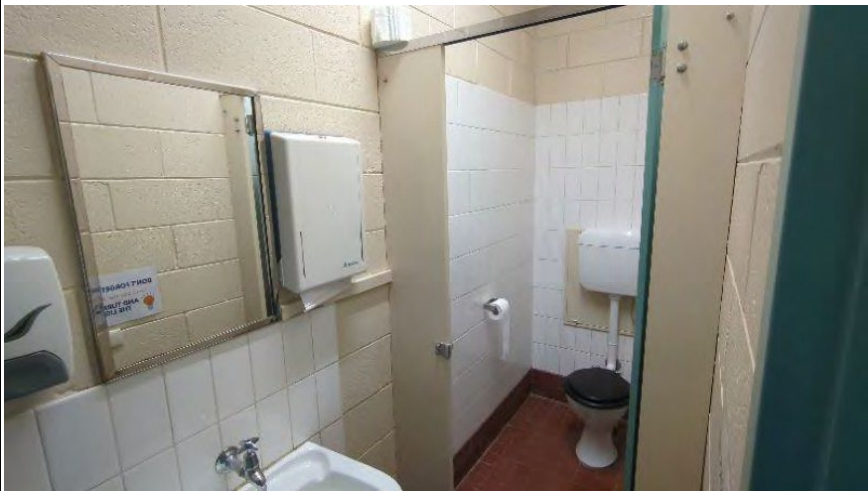
<p>B00A-R2W03 - Staff Toilet</p>	Masonry walls, ceramic floor tiles and concrete ceiling.	No signs of visual mould growth or water damage were noted. Condition 3

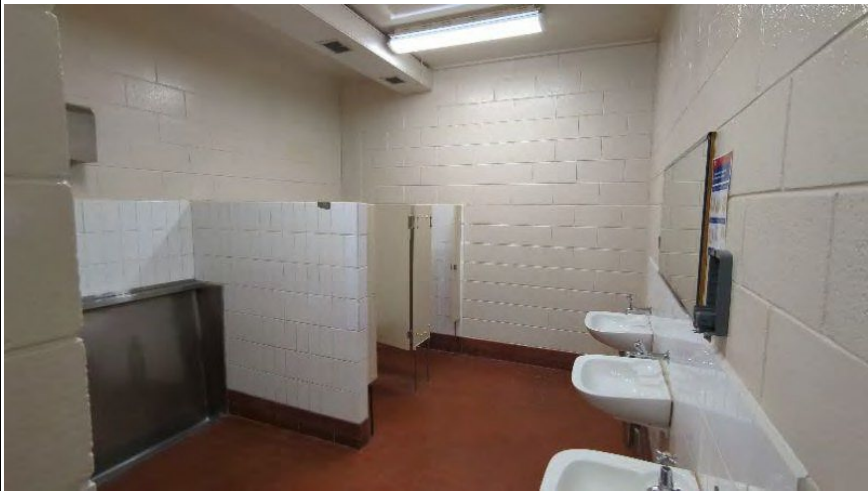
<p>B00A-R2W04 - Boys Toilet</p>	Masonry walls, ceramic floor tiles and concrete ceiling.	No signs of visual mould growth or water damage were noted. Condition 3

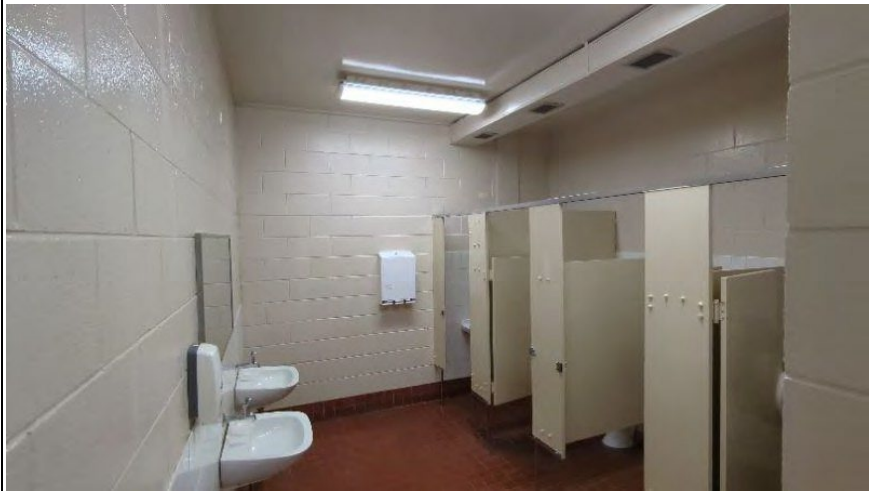
B00A-2W05 - Girls Toilet	Masonry walls, ceramic floor tiles and concrete ceiling.	No signs of visual mould growth or water damage were noted. Condition 3

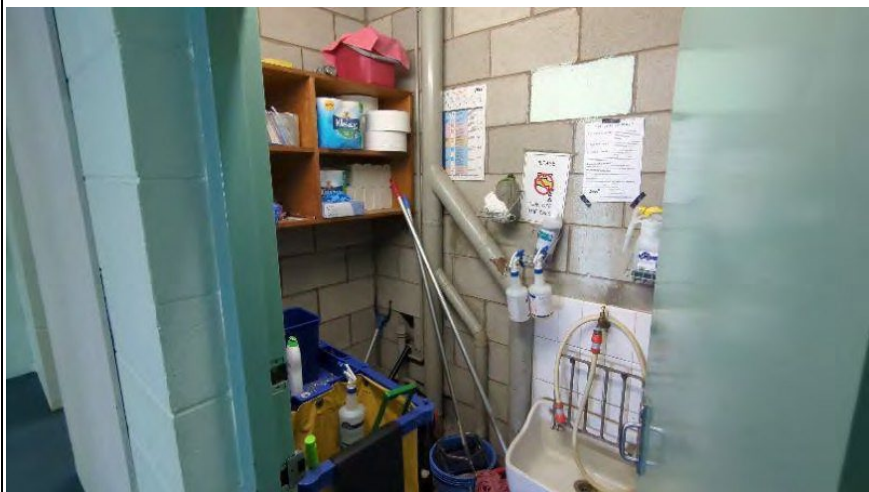
CS-7 Cleaning cupboard	Masonry walls, ceramic floor tiles and concrete ceiling.	Unable to identify room from floor plan. No signs of visual mould growth or water damage were noted. Condition 3
