# Pre-Demolition Hazardous Building Materials Survey – Former Sydney Fish Markets

Infrastructure NSW

JBS&G 64782 | 175,847 (Rev A)

19 May 2026

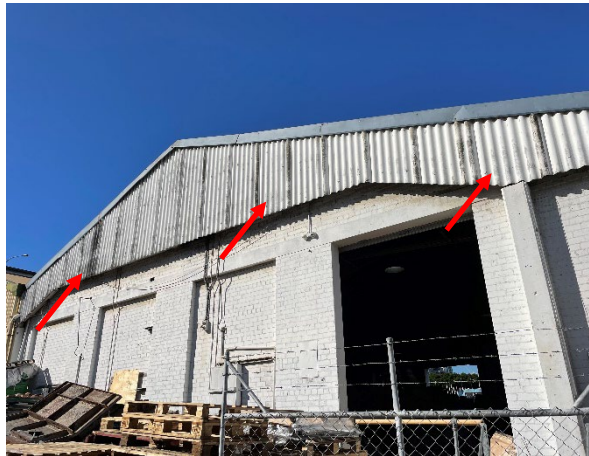
Photo 5: External, Box Recycling Warehouse north gable end – Asbestos containing corrugated fibre cement sheeting

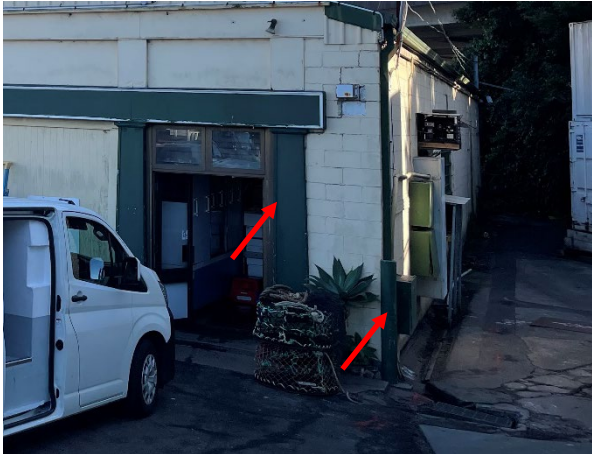
Photo 19: External, Doyle's Warehouse, timber features and traffic bollard – lead based green paint

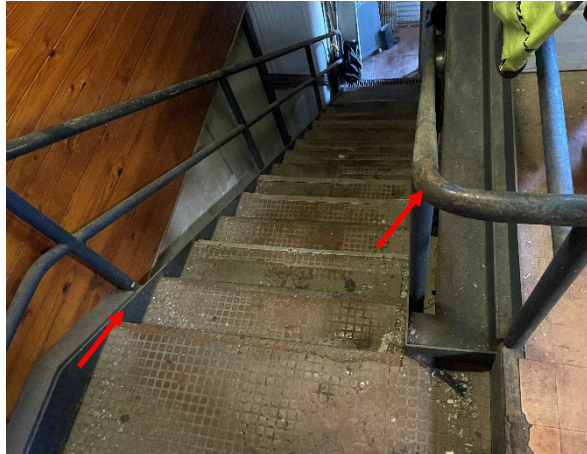
Photo 20: Internal, Doyle's Warehouse, stairwell and handrail – lead based blue paint

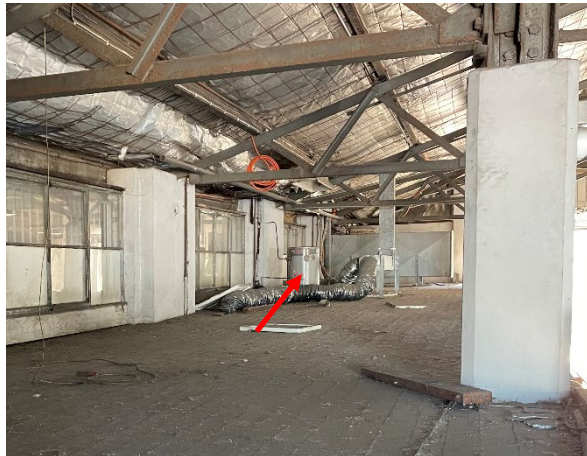
Photo 23: Internal, Box Recycling Warehouse roof to office area, hot water heater – assumed SMF insulation core

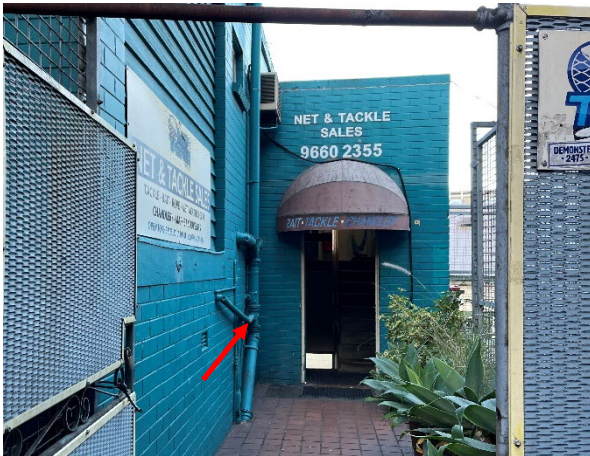
Photo 28: External Net & Tackle, level 1 east entrance, cast iron pipe work – asbestos containing gasket

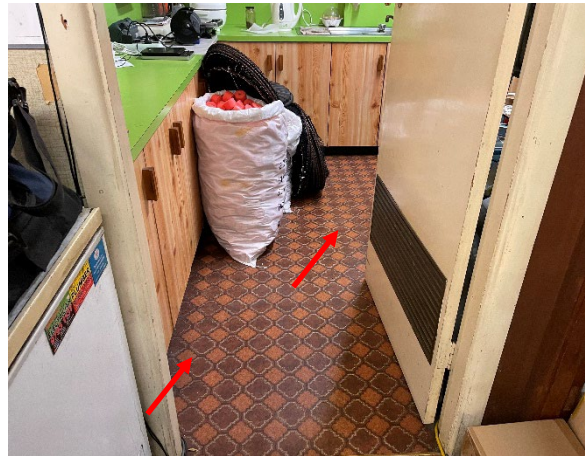
Photo 29: Internal, Net & Tackle level 1, kitchen floor – asbestos-containing fibrous backing to non-asbestos vinyl floor sheeting

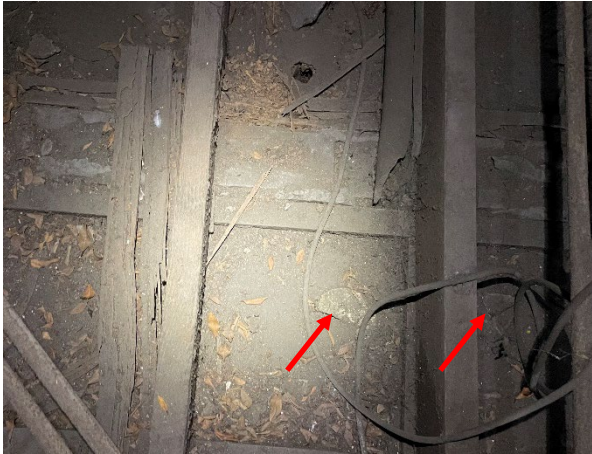
Photo 31: Internal, All Seas, ceiling cavity – asbestos containing corrugated fibre cement sheet debris

- General access to the areas impacted by friable asbestos must remain restricted until such time that the friable asbestos hazards can be removed. These areas include the ceiling cavities to the Doyles Warehouse portion of Building A, the ceiling cavity to the All Seas portion of Building B, and the Substation switchroom to the rear of Building C (refer to **Figure 4**). It is recommended that appropriate asbestos warning signage is installed to the access points to these areas (i.e. doors, ladders, hatches etc.). In the event that access to these areas is required, care should be taken to avoid any activities that may disturb settled dust or asbestos debris and personal protective equipment (PPE) adopted to preclude potential inhalation exposures to dusts. Minimum PPE requirements of P2 half face respirators, disposable coveralls and gloves should be worn by any persons who require to enter these areas.

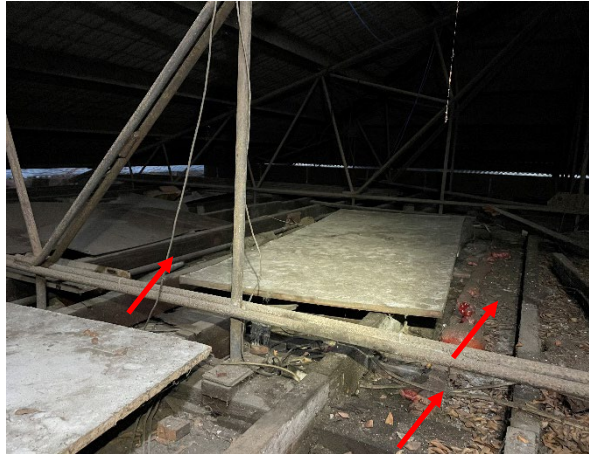
Photo 32: Internal All Seas, ceiling cavity – Friable asbestos and elevated lead concentrations within settled dust

General access to the areas impacted by lead containing dust must remain restricted until such time that the lead containing dust hazards can be removed. These areas include the ceiling cavity to the All Seas portion of Building B, the ceiling cavities to all sections of Building C and the Substation switchroom to the rear of Building C (refer to **Figure 4**). It is recommended that appropriate lead dust warning signage is installed to the access points of these areas (i.e. doors, ladders, hatches etc.). In the event that access to these areas is required, care should be taken to avoid any activities that may disturb settled dust and personal protective equipment (PPE) adopted to preclude potential inhalation exposures to dusts. Minimum PPE requirements of P2 half face respirators, disposable coveralls and gloves should be worn by any persons who require to enter these areas. The lead containing dust will be removed in conjunction with the asbestos removal works as detailed in **Section 5.1.1**. No additional controls are required to manage the identified lead impacted dust.

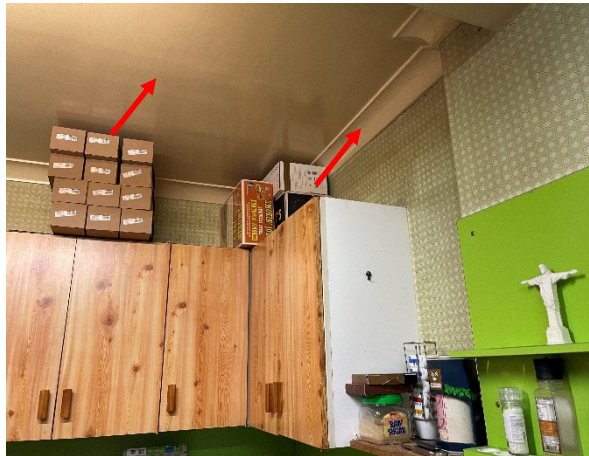
Photo 35: Internal, Net & Tackle, kitchen ceiling – lead based cream paint

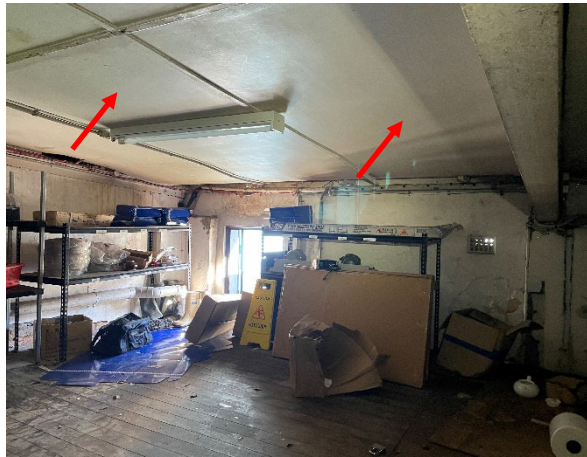
Photo 47: Internal, externally accessed mezzanine level of Sea Emperor, ceiling liner – asbestos containing fibre cement sheet

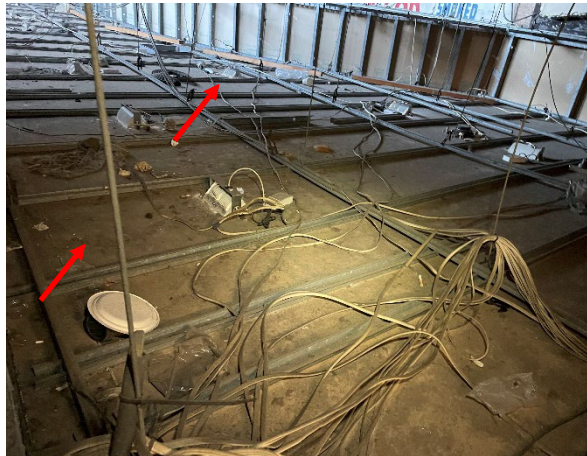
Photo 53: Internal, Salty Squid, ceiling cavity – elevated lead concentrations within settled dust

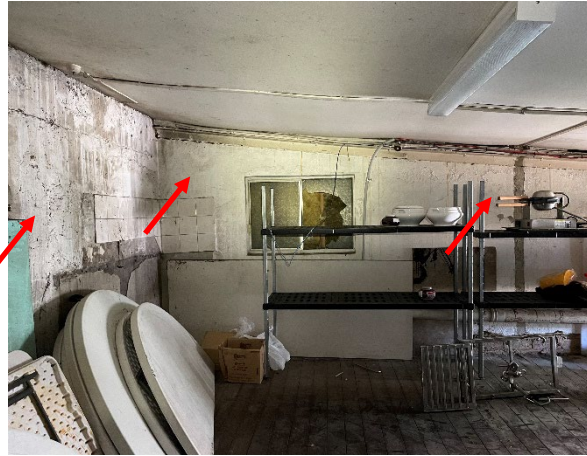
Photo 56: Internal, Sea Emperor mezzanine level, cement rendered brick wall – lead based white paint

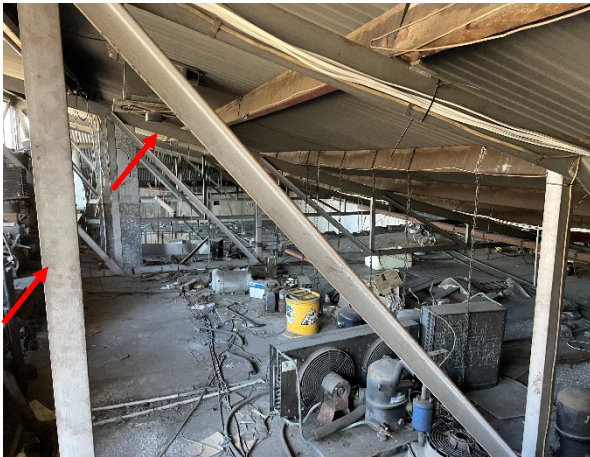
Photo 58: Internal, Get Fish ceiling cavity, meal framework to saw tooth roof – lead based grey paint

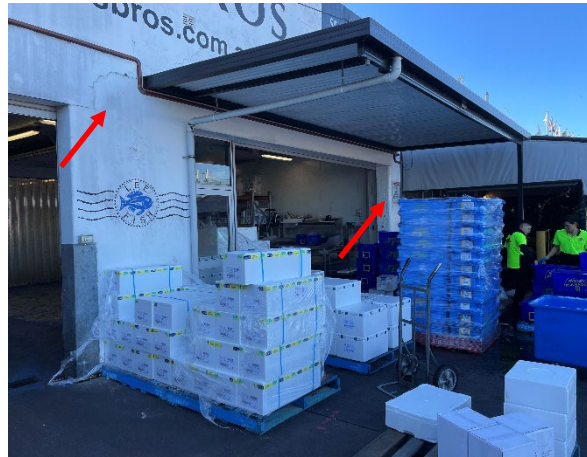
Photo 59: External, Poulos Bros, wall – lead based white paint

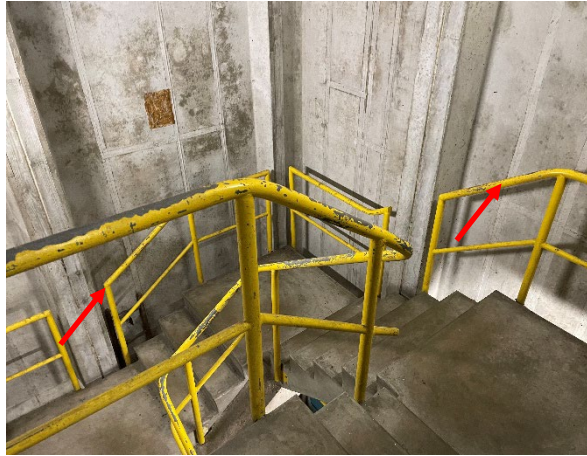
Photo 74: Internal, northeast stairwell, handrail – lead based yellow paint

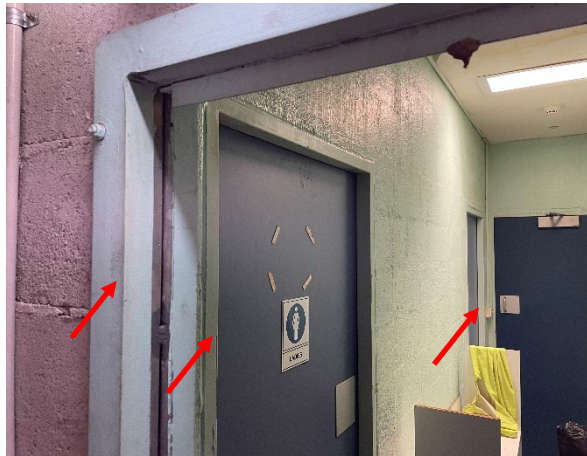
Photo 77: Internal ground level central west, corridor to staff bathrooms and service void for public toilets, door and door frame – lead based blue paint with green overcoat

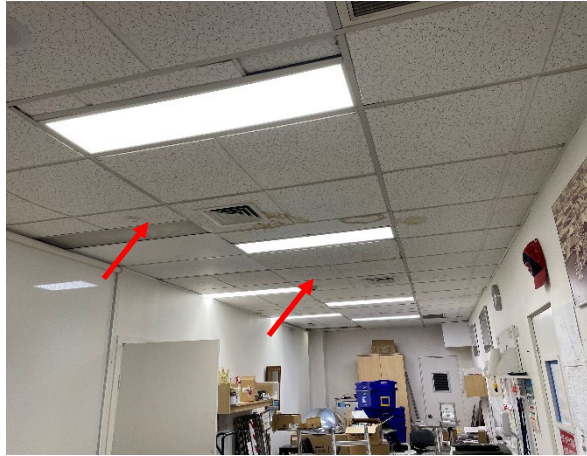
Photo 80: Internal, level 1 ceiling – assumed SMF ceiling tiles

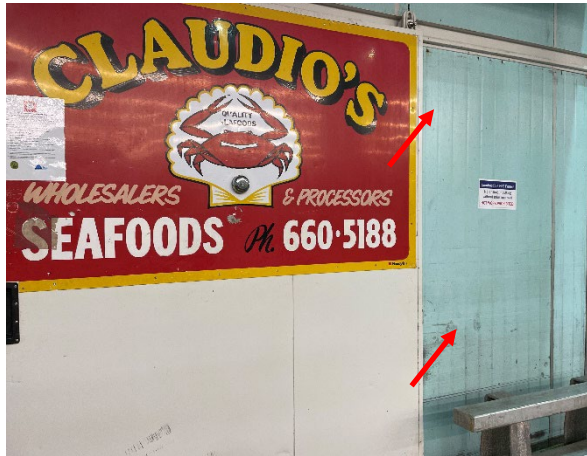
Photo 83: Internal, ground level Claudio's cool room, walls – assumed SMF insulation

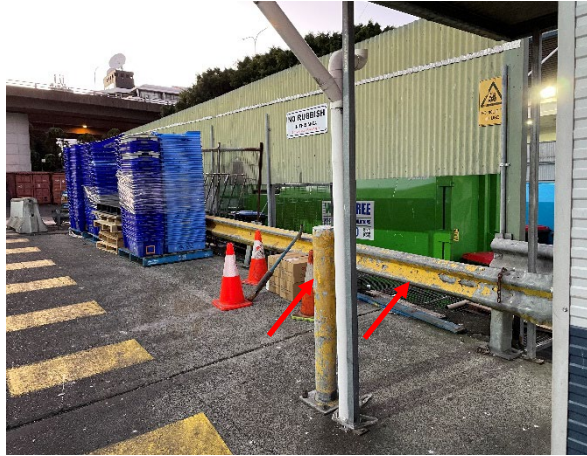
Photo 86: External, traffic bollards and fence – lead based yellow paint

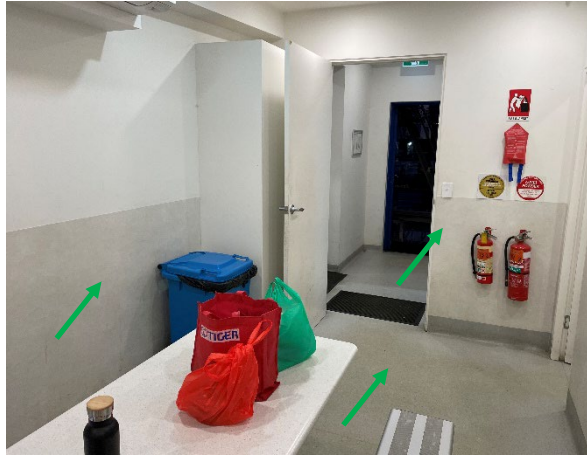
Photo 92: Internal, level 1 lunchroom, walls and floor – non-asbestos containing vinyl sheet

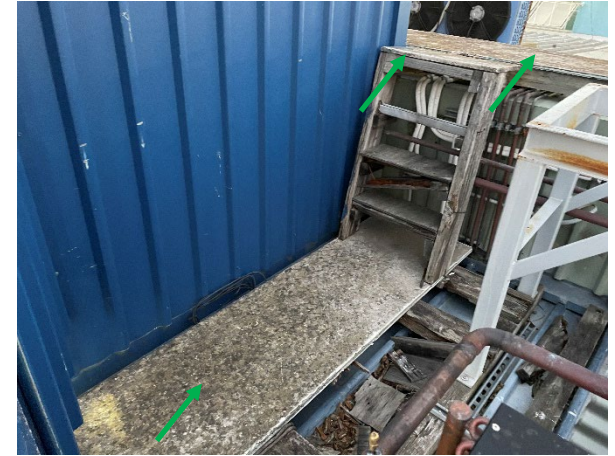
Photo 93: External, level 1 roof access, steps and walkway – non-asbestos containing compressed fibre cement

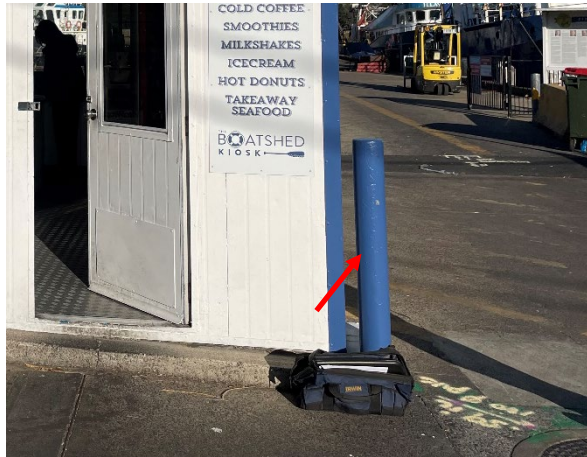
| JBS&G<br>SAMPLE NO. | LOCATION | MATERIAL DESCRIPTION | PHOTO<br>NUMBER | ACCESSIBLE<br>AREA? | FRIABILITY | ANALYTICAL RESULT | MATERIAL<br>CONDITION | APPROX.<br>QUANTITY | ACTION REQUIRED | DATE OF LAST<br>INSPECTION (INCL.<br>COMPANY NAME<br>AND INITIALS) | DATE OF CONTROL<br>ACTION &/OR<br>REMOVAL |
|---|---|---|---|---|---|---|---|---|---|---|---|
| DS-L01 | External – traffic bollards | Blue paint with yellow undercoat | 95 | Yes | - | 1.9% w/w | Good | 1m <sup>2</sup> | Remove loose and flaking paint prior to demolition by an experienced hazardous materials removal contractor in accordance with AS4361.2-2017. Remaining paint well adhered to the building materials may be demolished if care is taken not to spread paint flakes to surrounding areas.<br>Alternatively, remove all paint prior to demolition by an experienced hazardous materials removal contractor in accordance with AS4361.2-2017. | 15/06/2023<br>JBS&G<br>RS & DR | |

Photo 95: External, traffic bollards – lead based blue paint with yellow undercoat

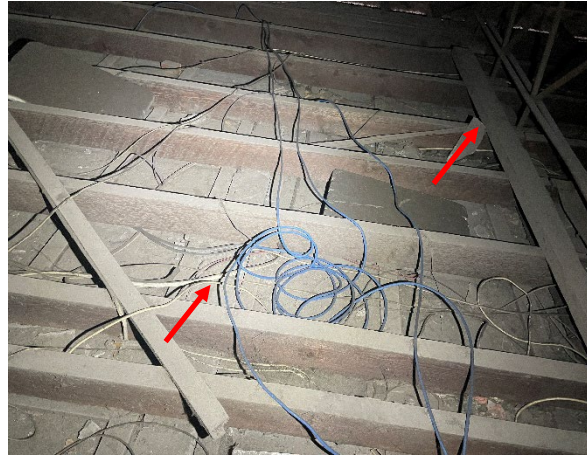
Photo 104: Internal, Doyles Warehouse, ceiling cavity – asbestos containing dust and asbestos containing fibre cement sheeting debris

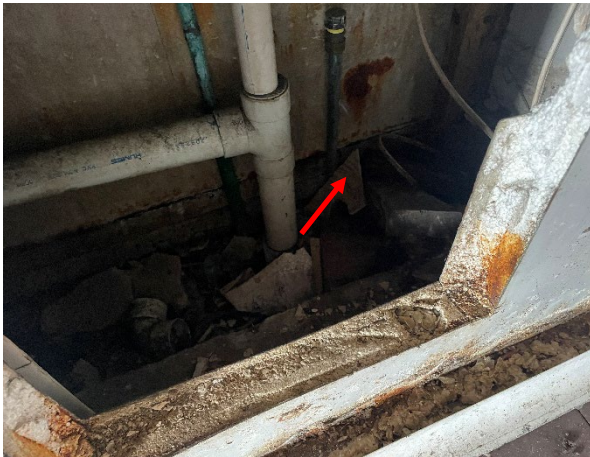
Photo 106: Doyles Warehouse, internal, ground level, central south cool room, wall cavity – asbestos containing fibre cement debris

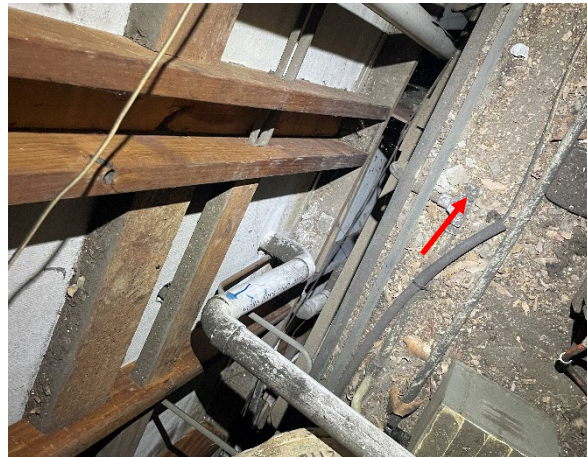
Photo 107: Doyles Warehouse, internal, level 1, wall cavity behind bathroom – asbestos containing fibre cement debris

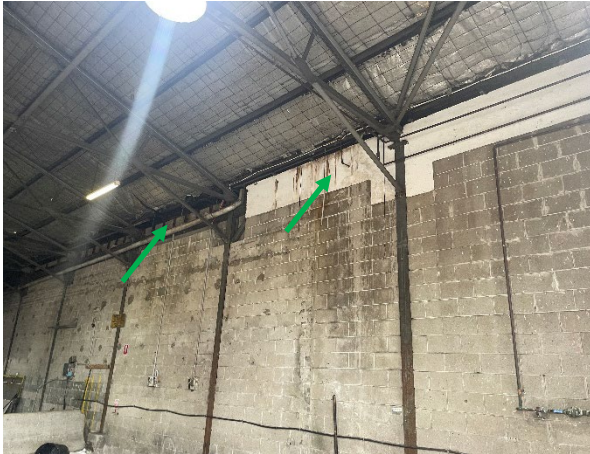
Photo 109: Internal, between Box Recycling Warehouse and Doyles Warehouse – infill panel to the Besser block wall and gutter – non-asbestos containing cement

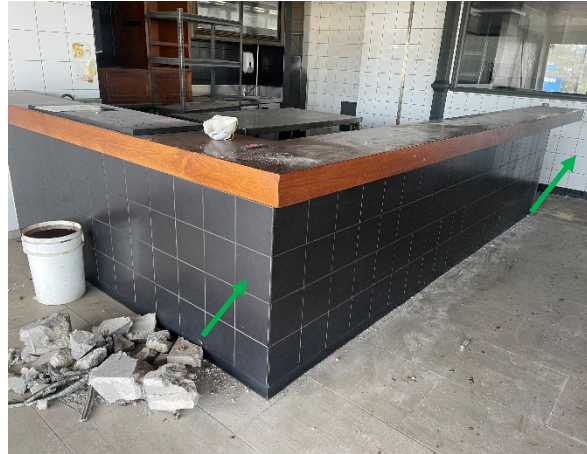
Photo 110: Vic's Meats, internal, ground floor, bar area, behind black and white tiled walls – non-asbestos containing fibre cement sheeting

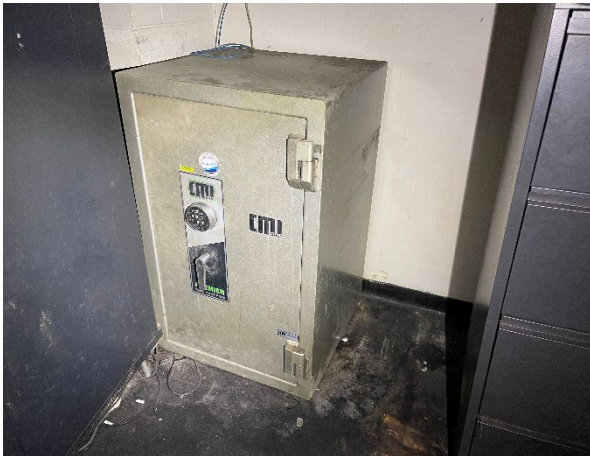
Photo 112: Vic's Meats, internal, ground floor, office area, safe – no access to safe interior at time of inspection. Potential asbestos containing insulation may be present within

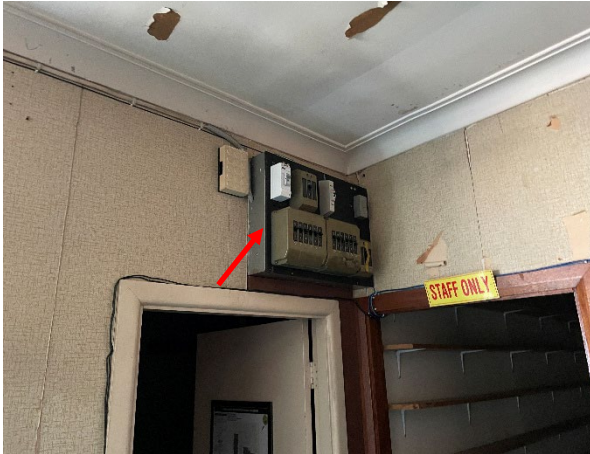
Photo 115: Net and Tackle, internal, level 1, above door to kitchen – asbestos containing electrical backing board

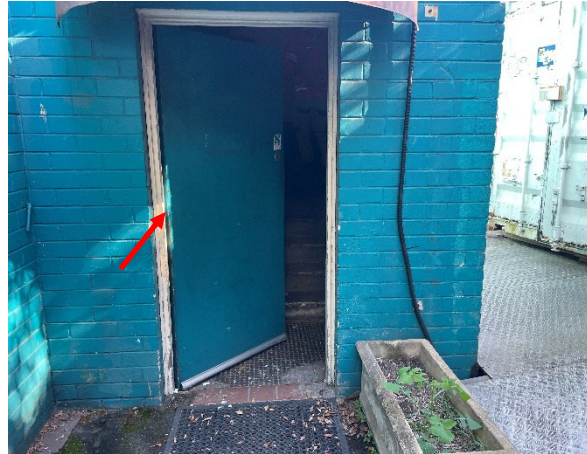
Photo 116: Net and Tackle, external, door frames – lead based cream paint

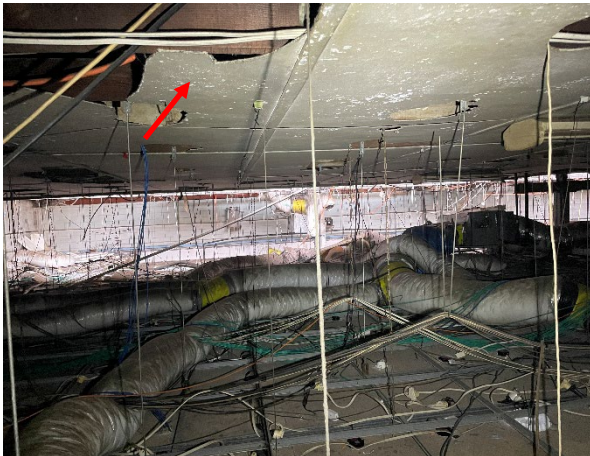
Photo 118: Get Fish, internal, above lining to ground floor, ceiling lining – asbestos containing fibre cement sheeting

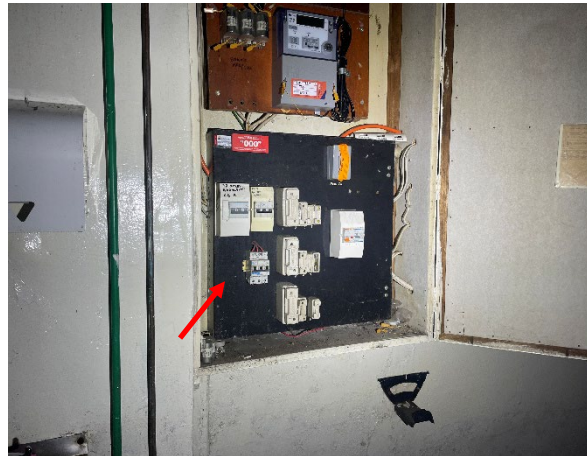
Photo 119: Poulos Bros, internal, ground level, west main room – asbestos containing electrical backing board

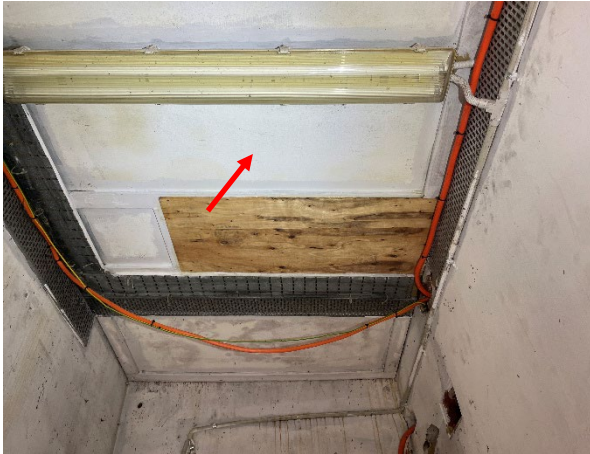
Photo 121: Substation, switchroom, internal, ceiling lining – asbestos containing fibre cement sheeting

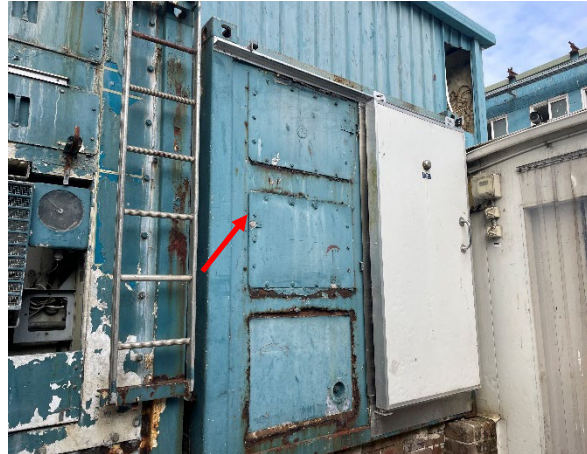
Photo 122: Get Fish, exterior, eastern area, shipping container – lead based blue paint

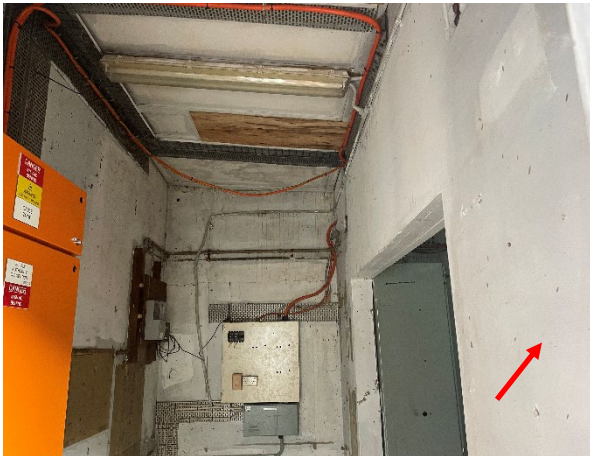
Photo 124: Substation, switchroom, walls throughout – lead based white paint

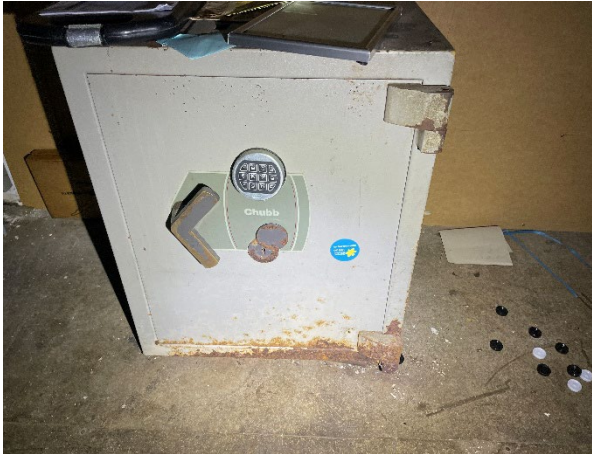
Photo 133: Claudios Seafoods, internal, level 1, storeroom area, safe – no access to safe interior at time of inspection. Potential asbestos containing insulation may be present within
