## **Sundowner Snowmaking & Associated Works Thredbo NSW**

Geotechnical Investigation

Our ref: 6653-G1  
6 October 2021

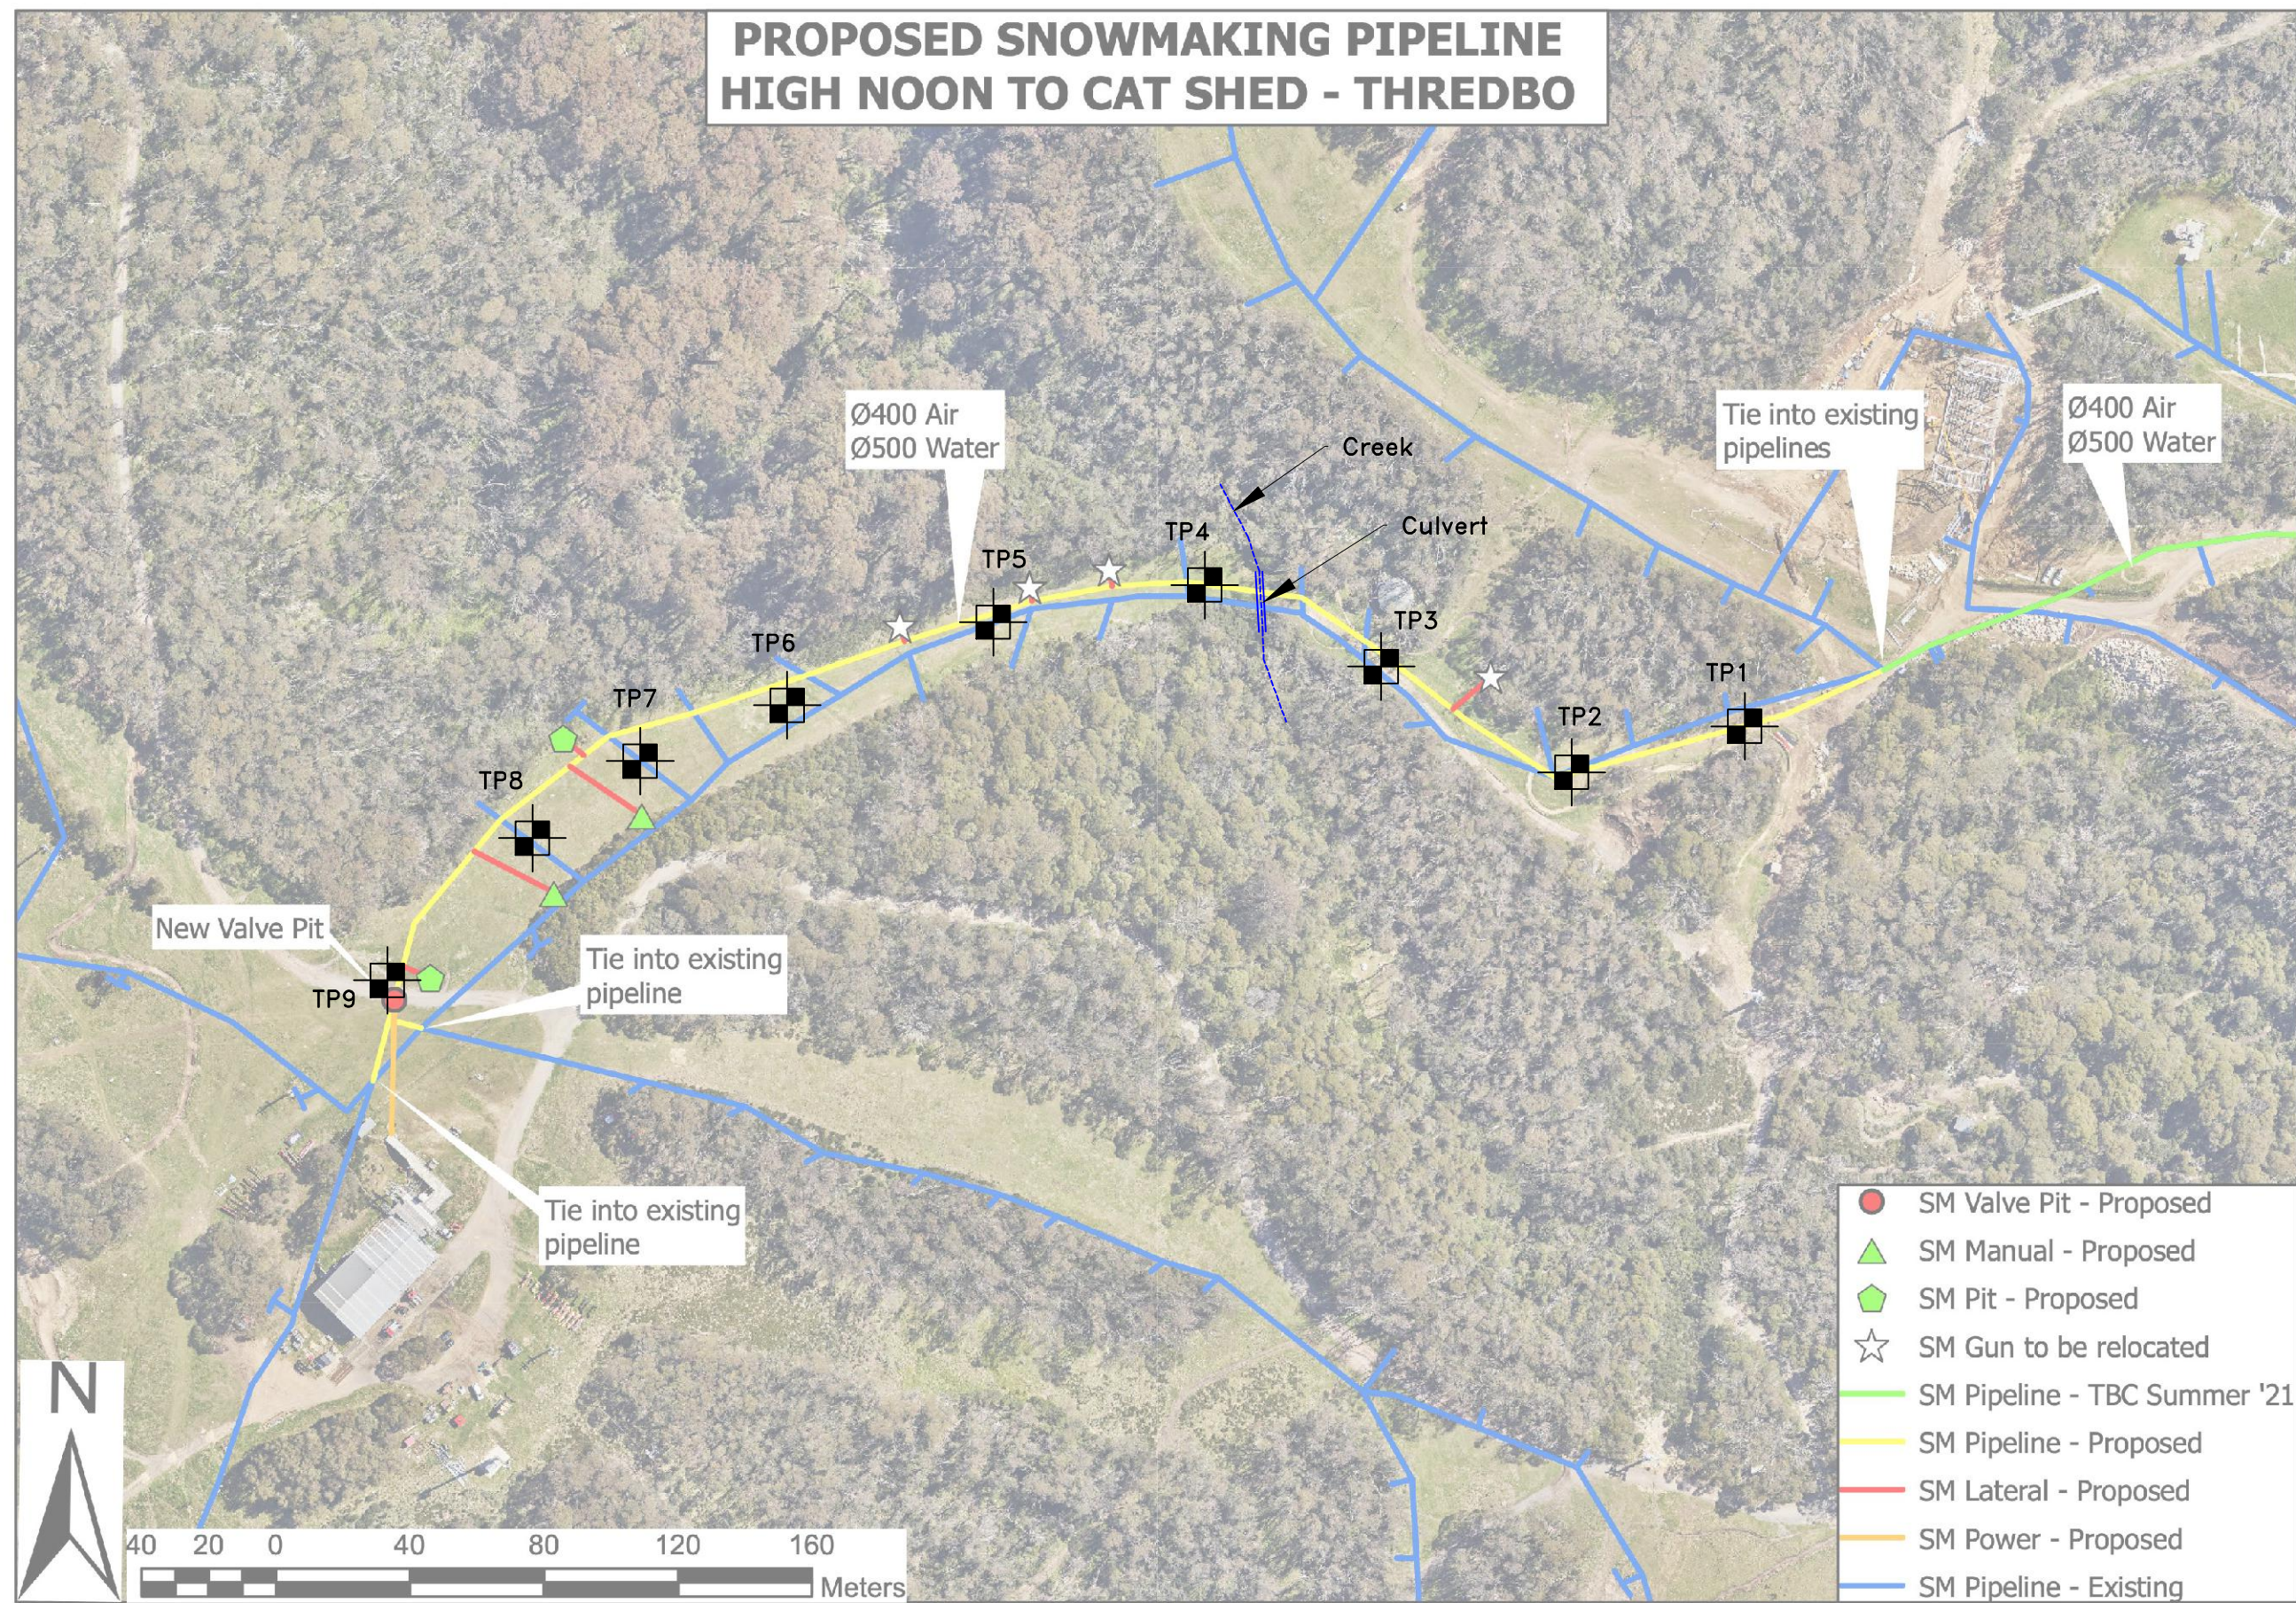
drawn: MAB	job no.: 6653
date: 2.10.2021	
checked: MAB	fig: 2
scale: 1:2,000 A3	issue: A

The test locations are shown in the attached Figure 3 and were set out by our Senior Principal Geotechnical Engineer relative to existing site features.

Source: Kosciuszko Thredbo Pty Ltd.  
Test pit locations approximate only,  
subject to detail survey.
