# Coastal Management Advice: 68 - 86 River Road, Shoalhaven Heads

WRL TR 2021/24, February 2022

By M J Blacka

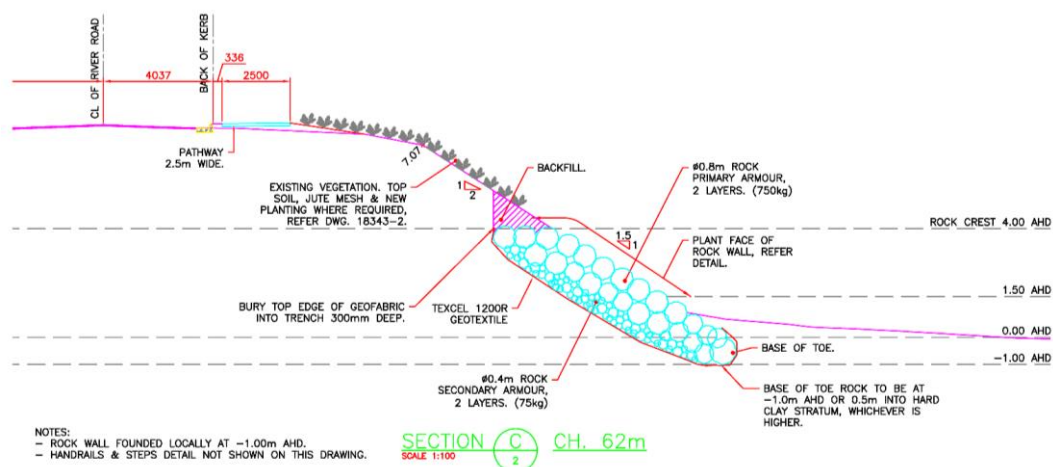
**Figure 3.1 Typical cross section of revetment detailed design  
(extracted from Magryn drawing 18343 Rev0)**

Magryn were engaged to complete the detailed design of the foreshore management works. A typical cross section for their detailed revetment design is shown in Figure 3.1, with the design consisting of:

- A revetment slope of 1V:1.5H extending from -1 m AHD to +4 m AHD
- Two layers of armour stone with median stone mass ( $M_{50}$ ) of 750 kg, overlaying a double layer of secondary armour with median stone mass ( $M_{50}$ ) of 75 kg
- Geotextile underlayer.

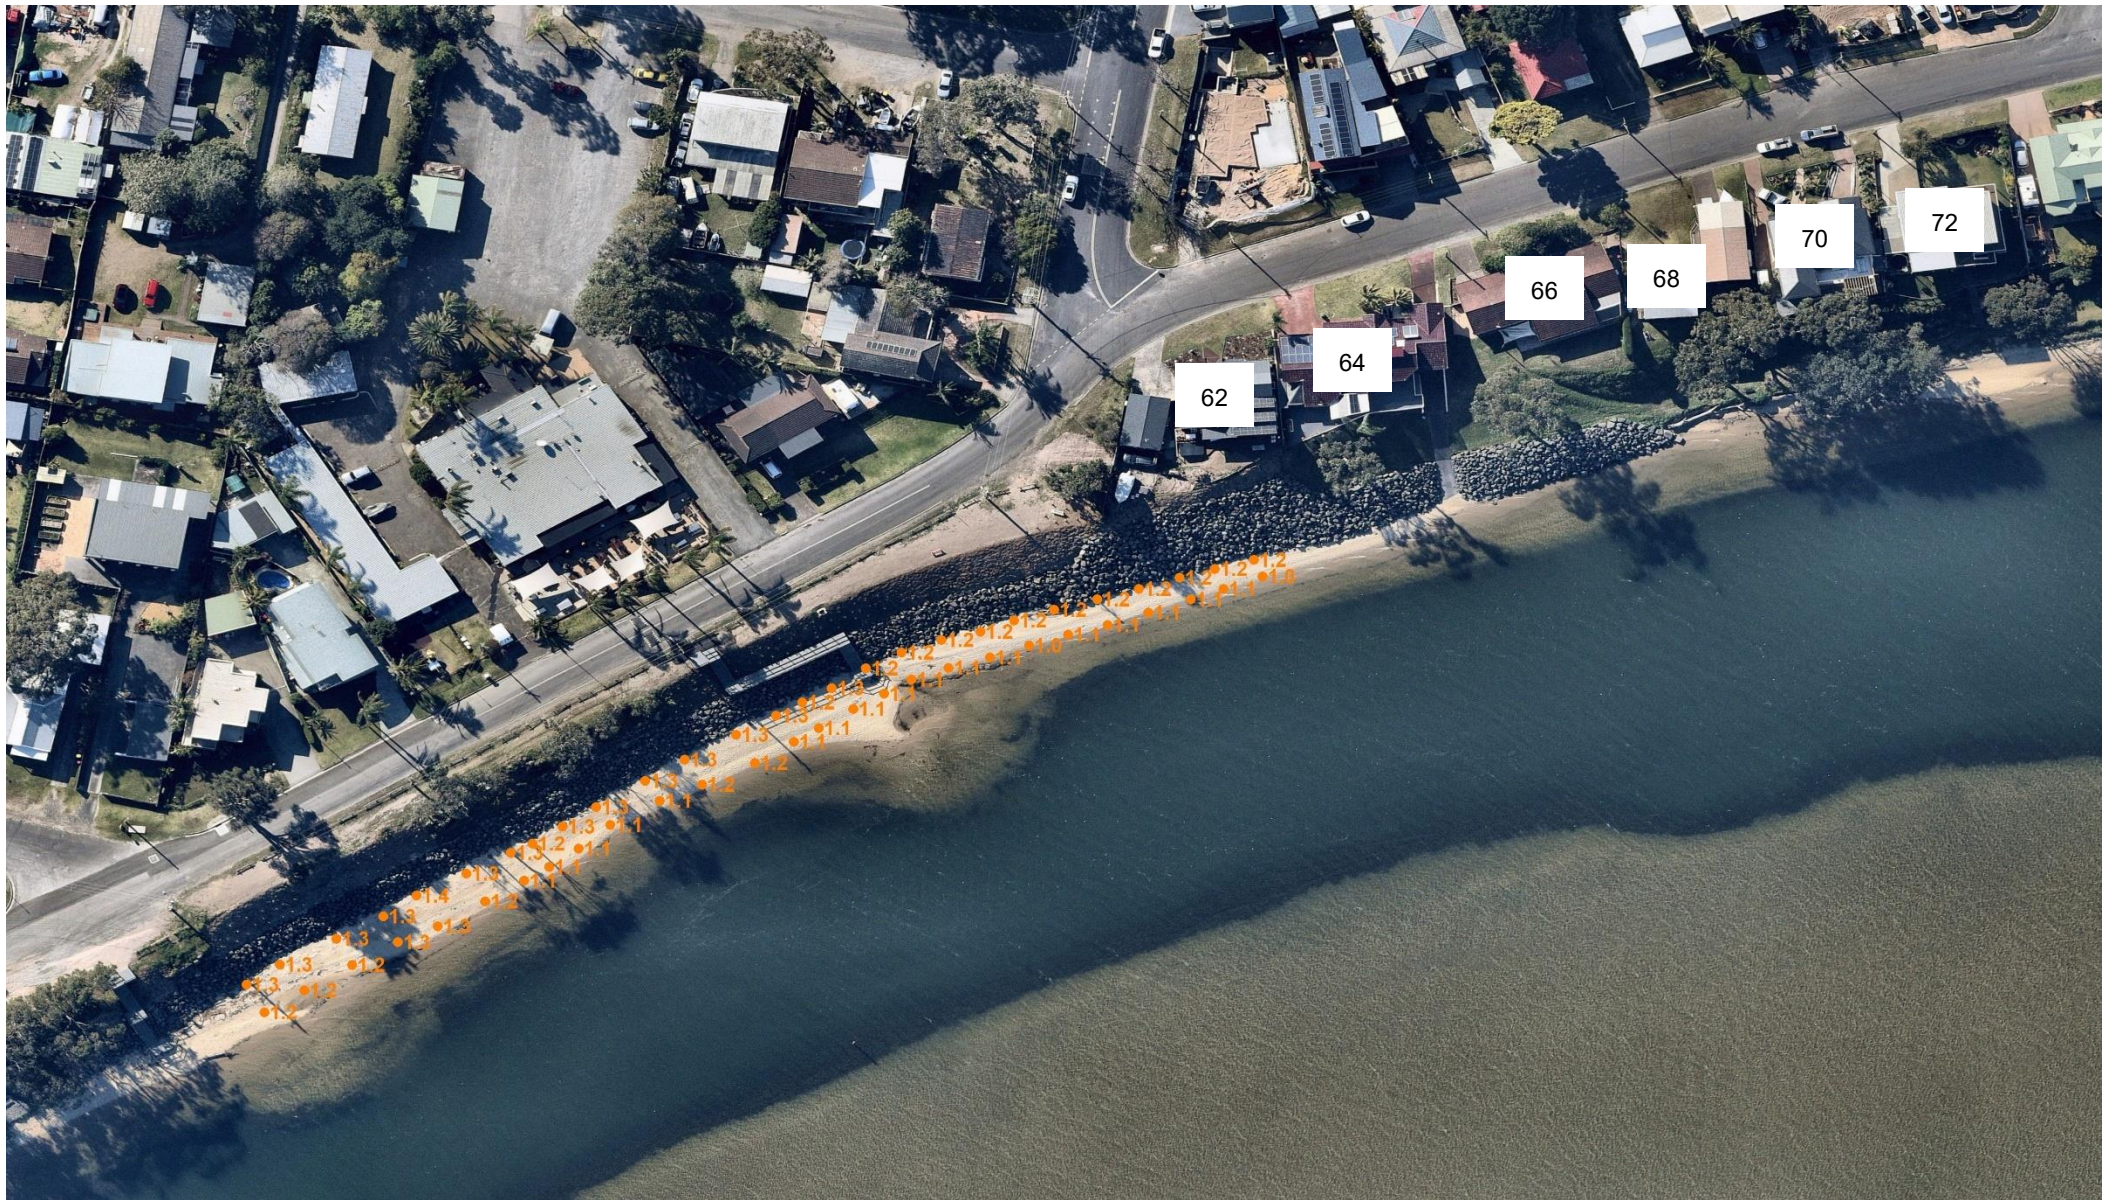
**Figure 3.15 Measured beach nourishment levels (m AHD) from “As Constructed Survey”  
(Levels extracted from from MGN Civil drawing PR149216-4a.dwg; Image: Nearmap 30/07/2021)**

Figure 3.15 shows the beach elevation levels collected during a post construction survey by MGN Civil (drawing PR149216-4a), with the levels provided as “As Constructed Sand Nourishment”. The measured beach nourishment levels are noted to not cover the full extent of the revetment. As noted in our observations, the beach in front of the eastern end of the revetment was notably lower than areas in front of the central and western sections of the revetment. This was a result of nourishment sand not being placed at the eastern end, due to a lack of available sand for the contractor (SCC, personal communication).

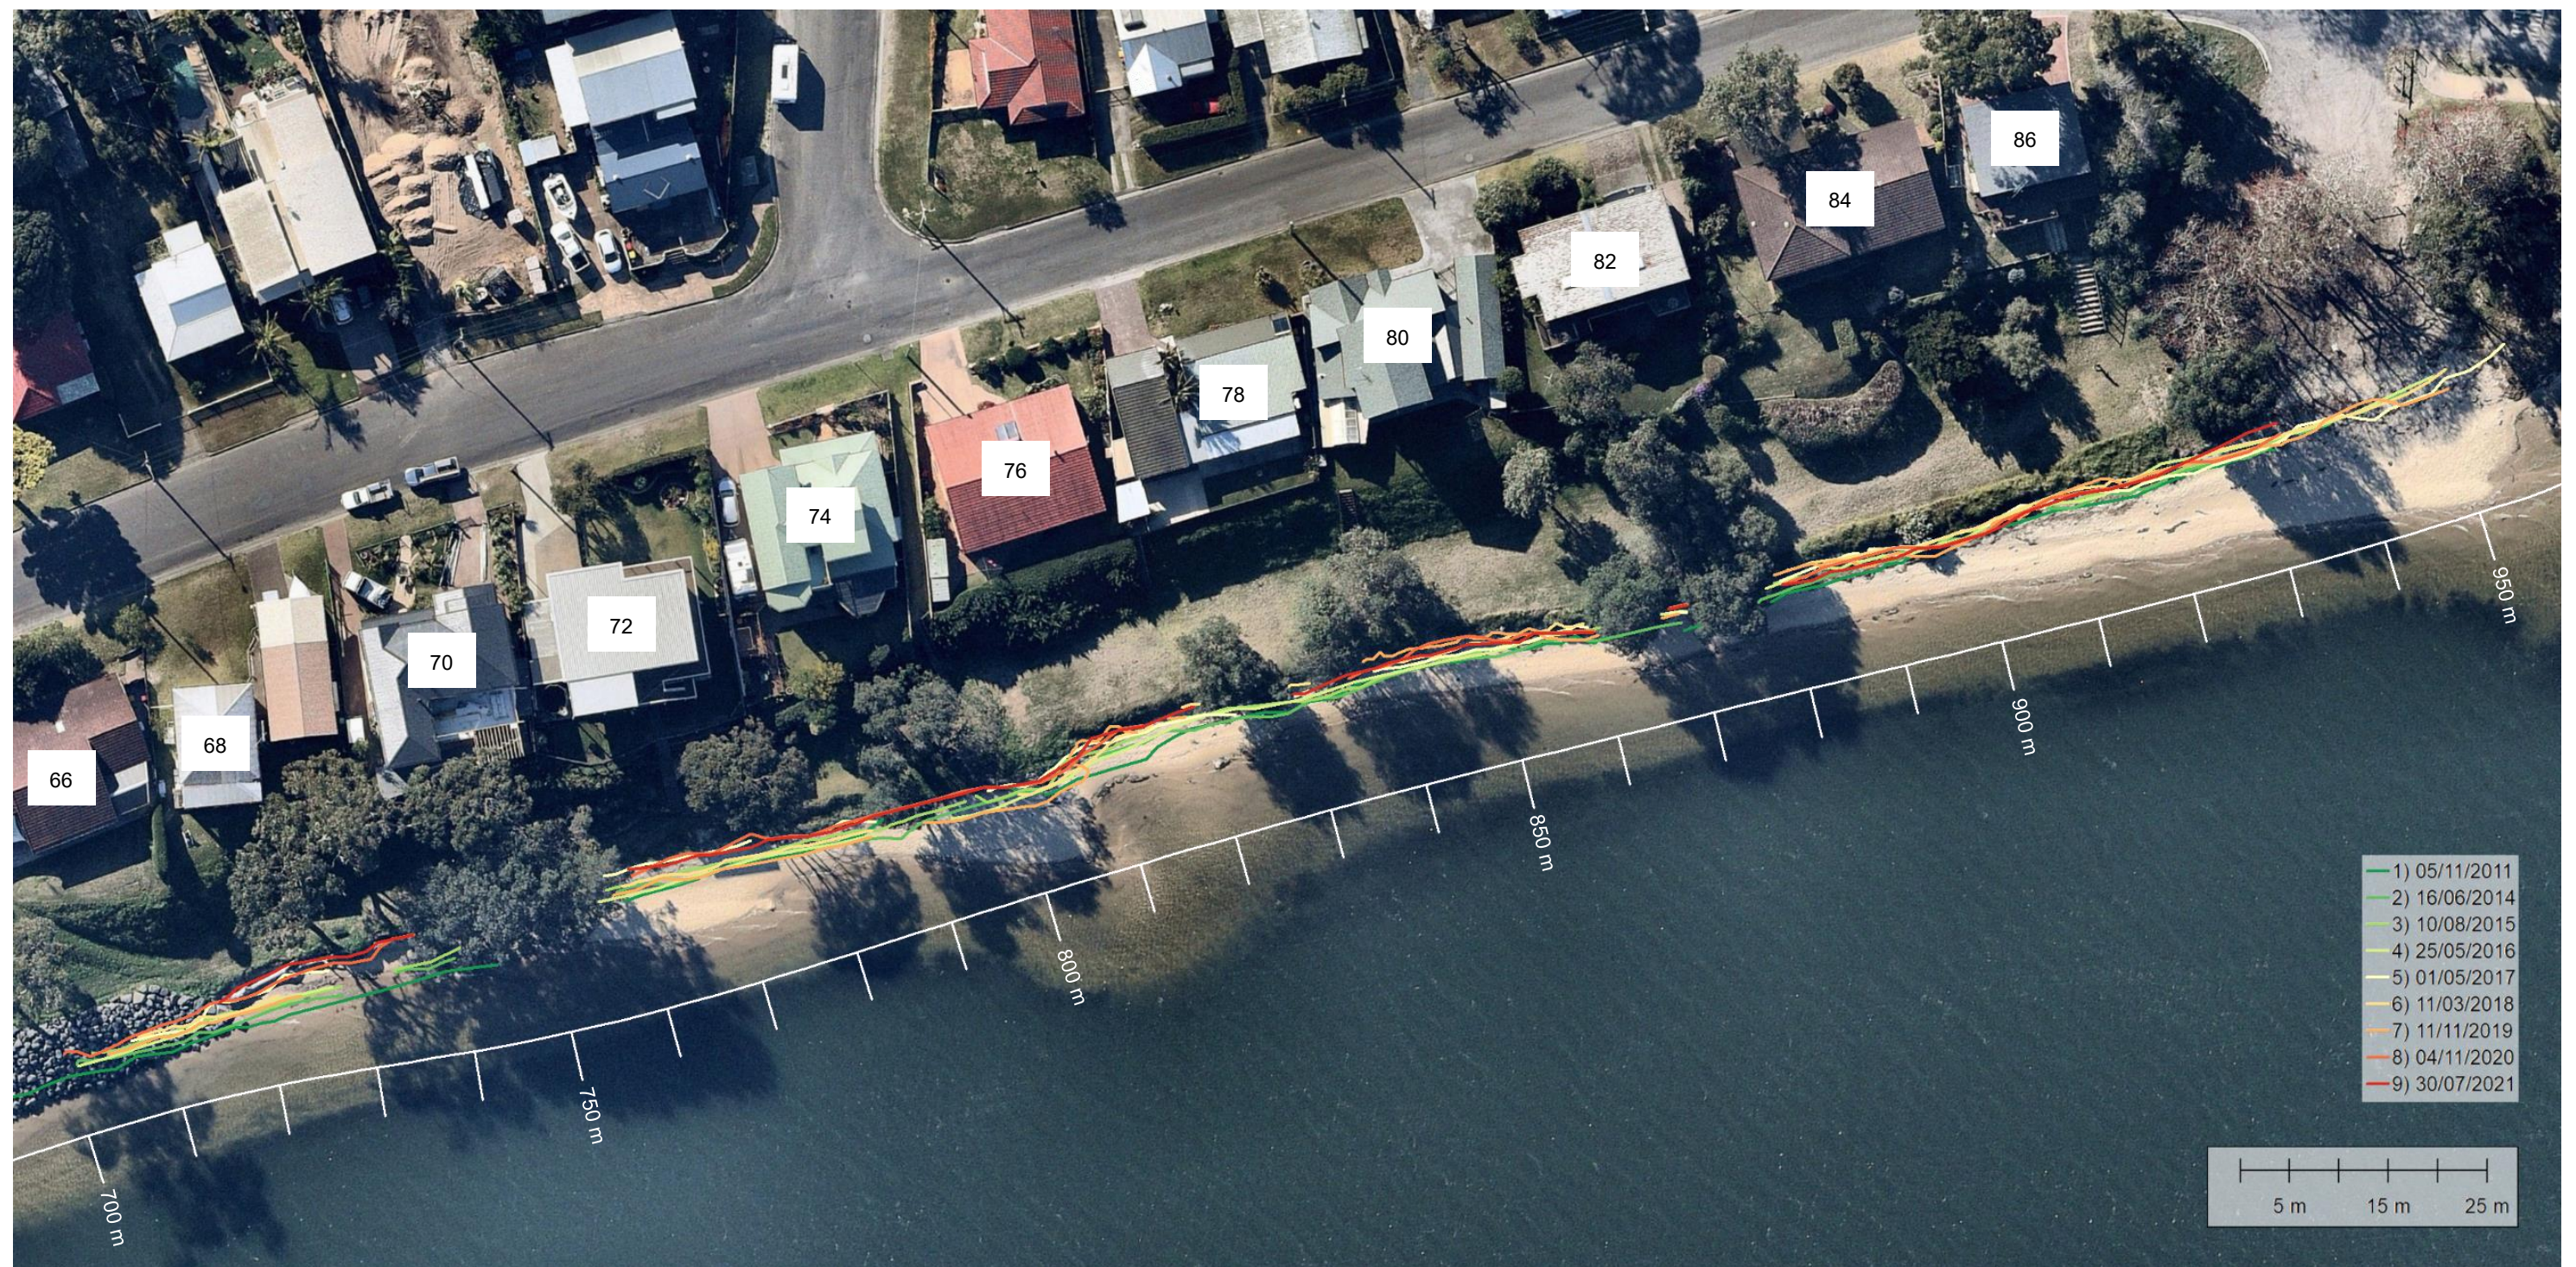
**Figure 4.8 Mapping of the position of the bank toe at the back of the beach (2011 to 2021)**  
**(Background Image, Nearmap 30/07/2021)**

Figure 4.8 shows the mapping for the toe of the bank between 2011 and 2021. For clarity, these time periods are further broken down into sub-sets of time in Figure 4.9, Figure 4.10 and Figure 4.11. A number of important pieces of information can be ascertained from the bank toe mapping:

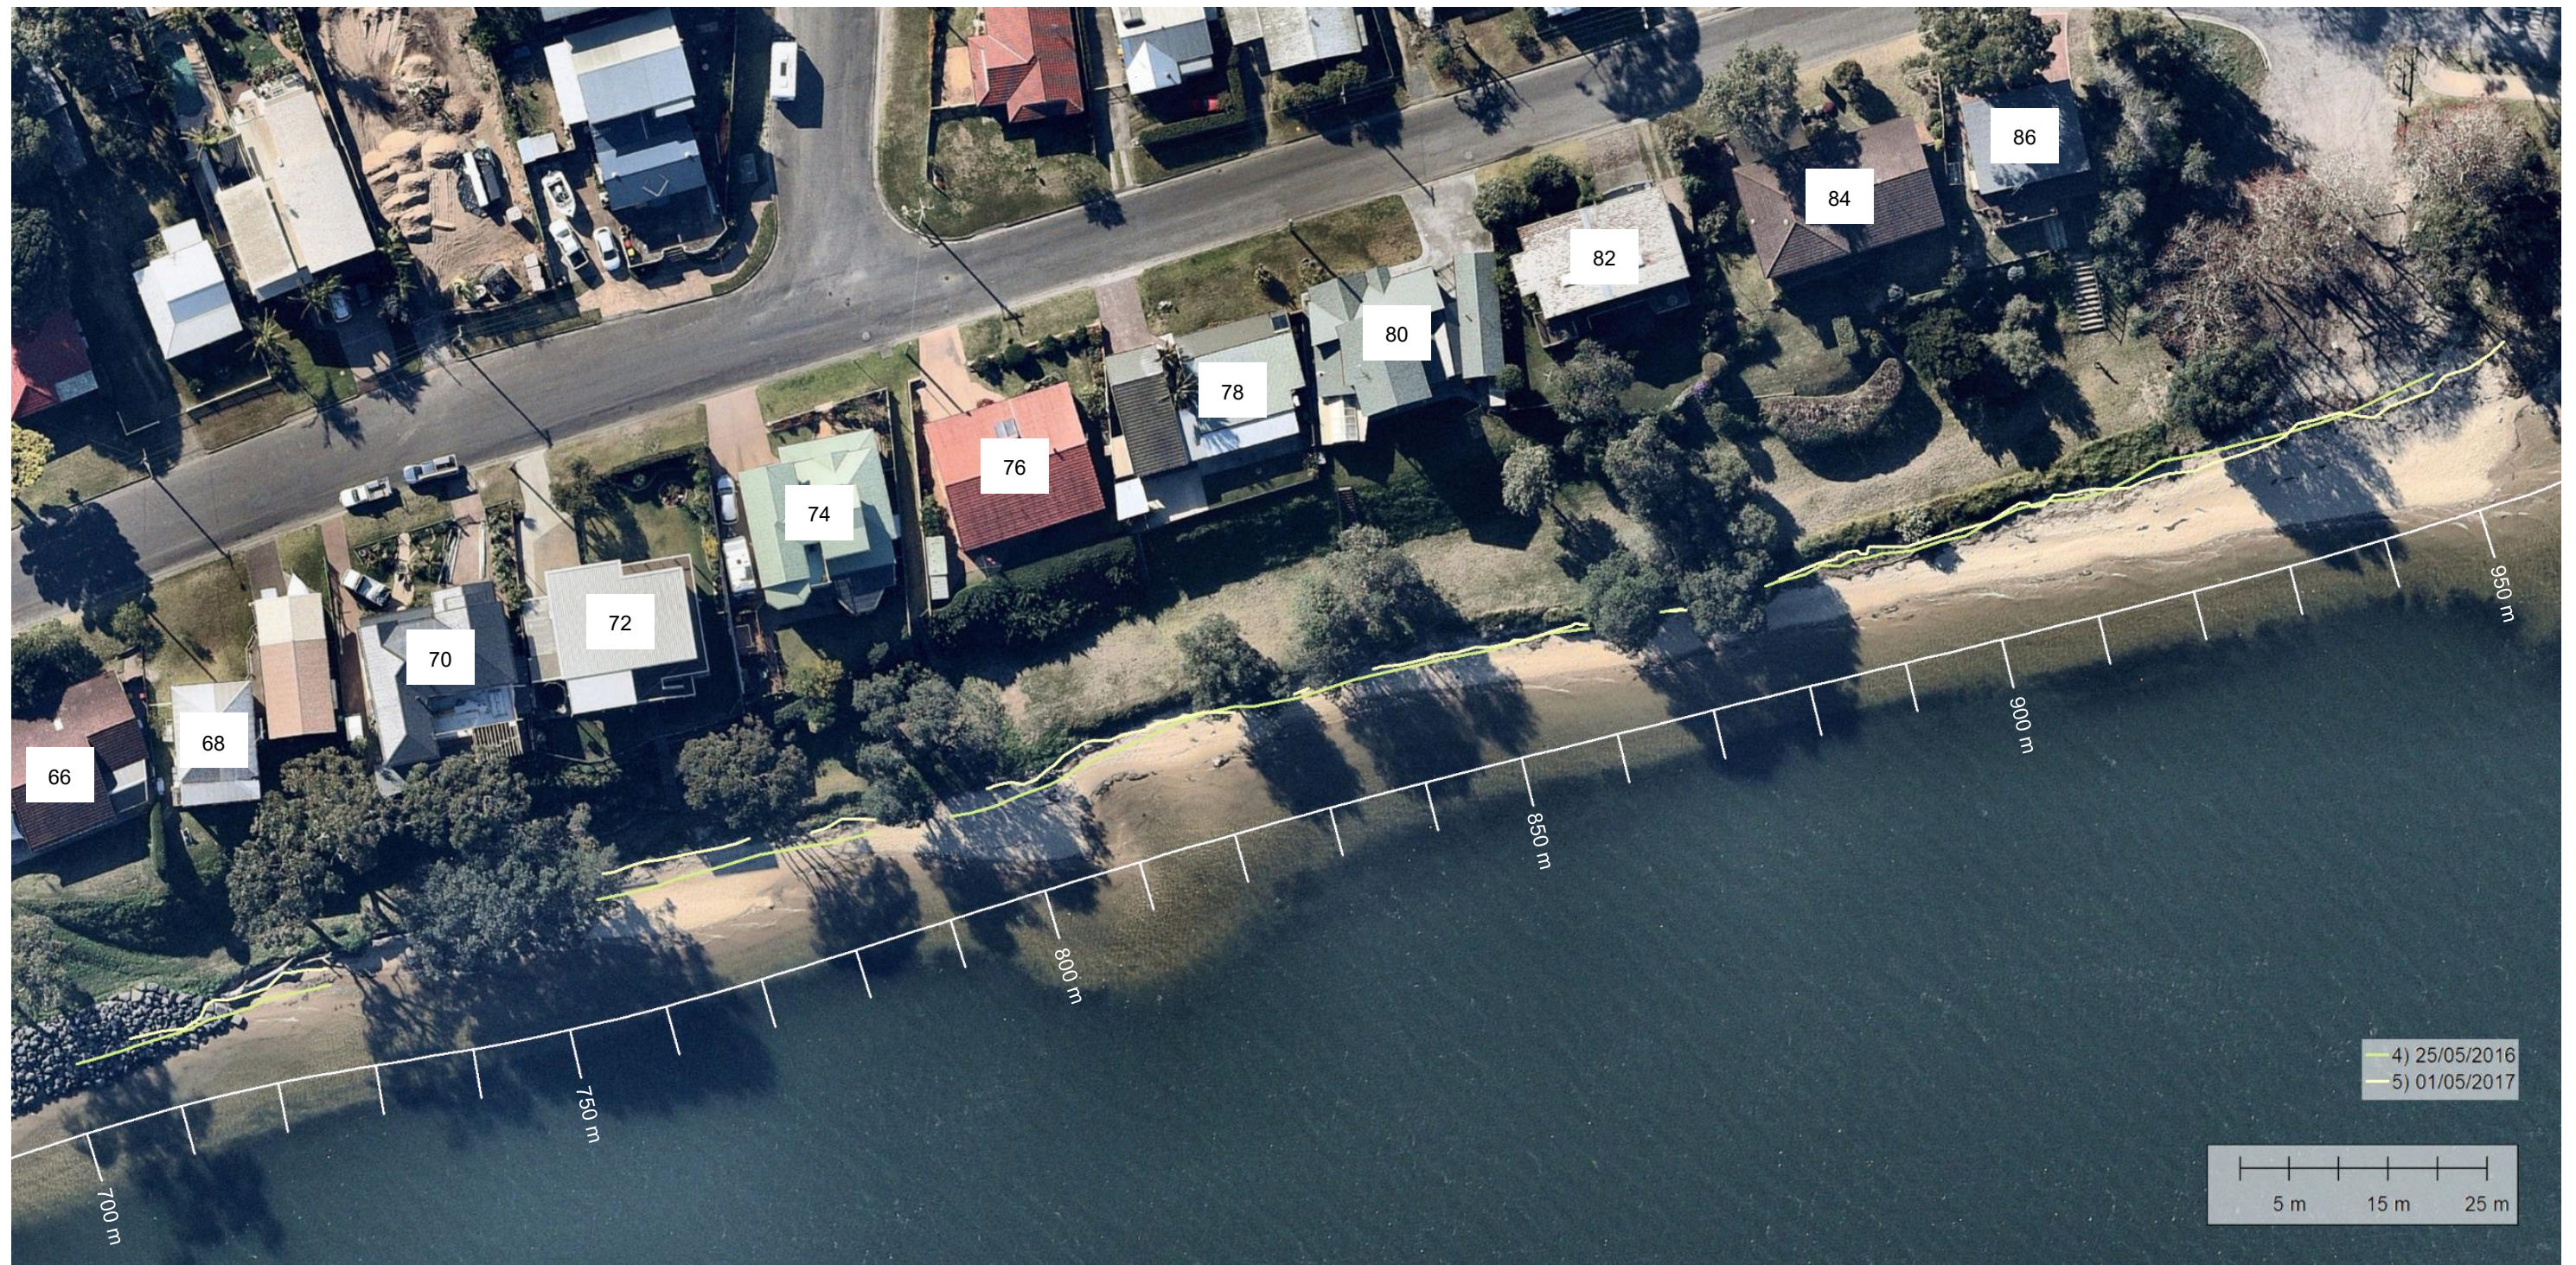
**Figure 4.9 Mapping of the position of the bank toe before and after 2016 storms**  
**(Background Image, Nearmap 30/07/2021)**

- The erosion in the 2016 period is apparent (compare 2016 and 2017 lines in Figure 4.9) with the toe of the bank retreating approximately 2 m at the western end (Ch 720 to 750 m) and 0.5 m at the eastern end (Ch 750 to 950 m) during this period

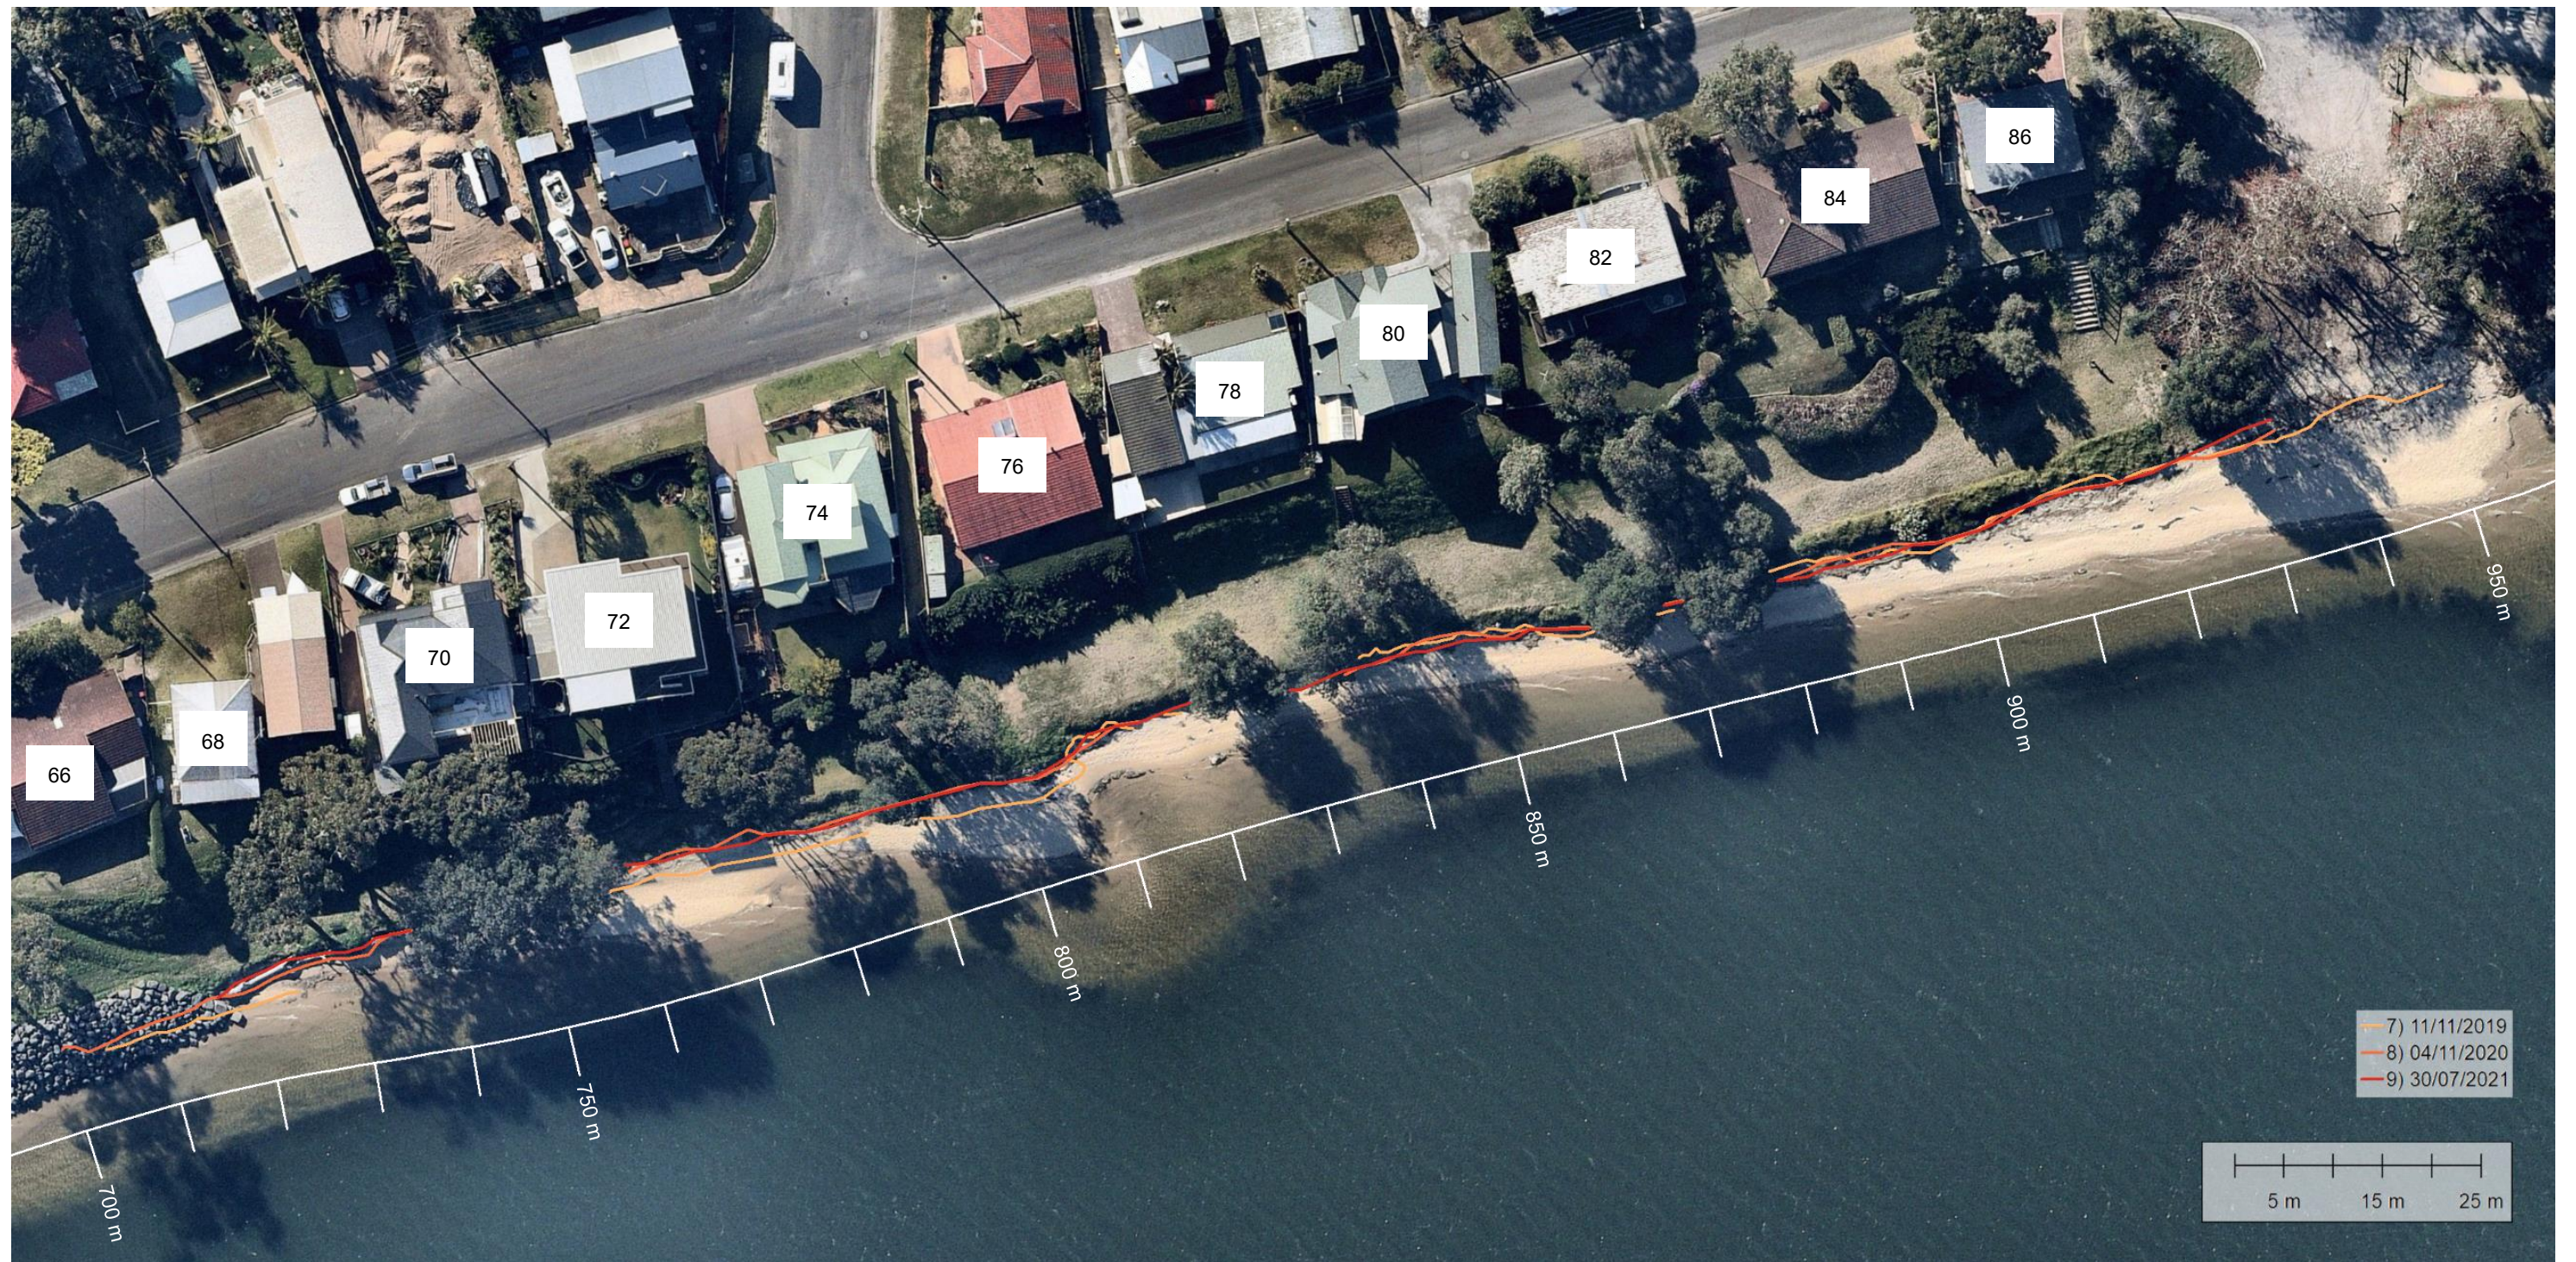
**Figure 4.11 Mapping of the recent position of the bank toe between 2019 and 2021**  
**(Background Image, Nearmap 30/07/2021)**

- The toe of the bank accreted (or shifted towards the channel through bank slope adjustment) between 2016 and 2019 as shown in Figure 4.10
- The toe of the bank eroded in 2020 and 2021 (Figure 4.11), such that the toe alignment is now

- There has been minimal change to the bank toe since November 2020 (Figure 4.11).

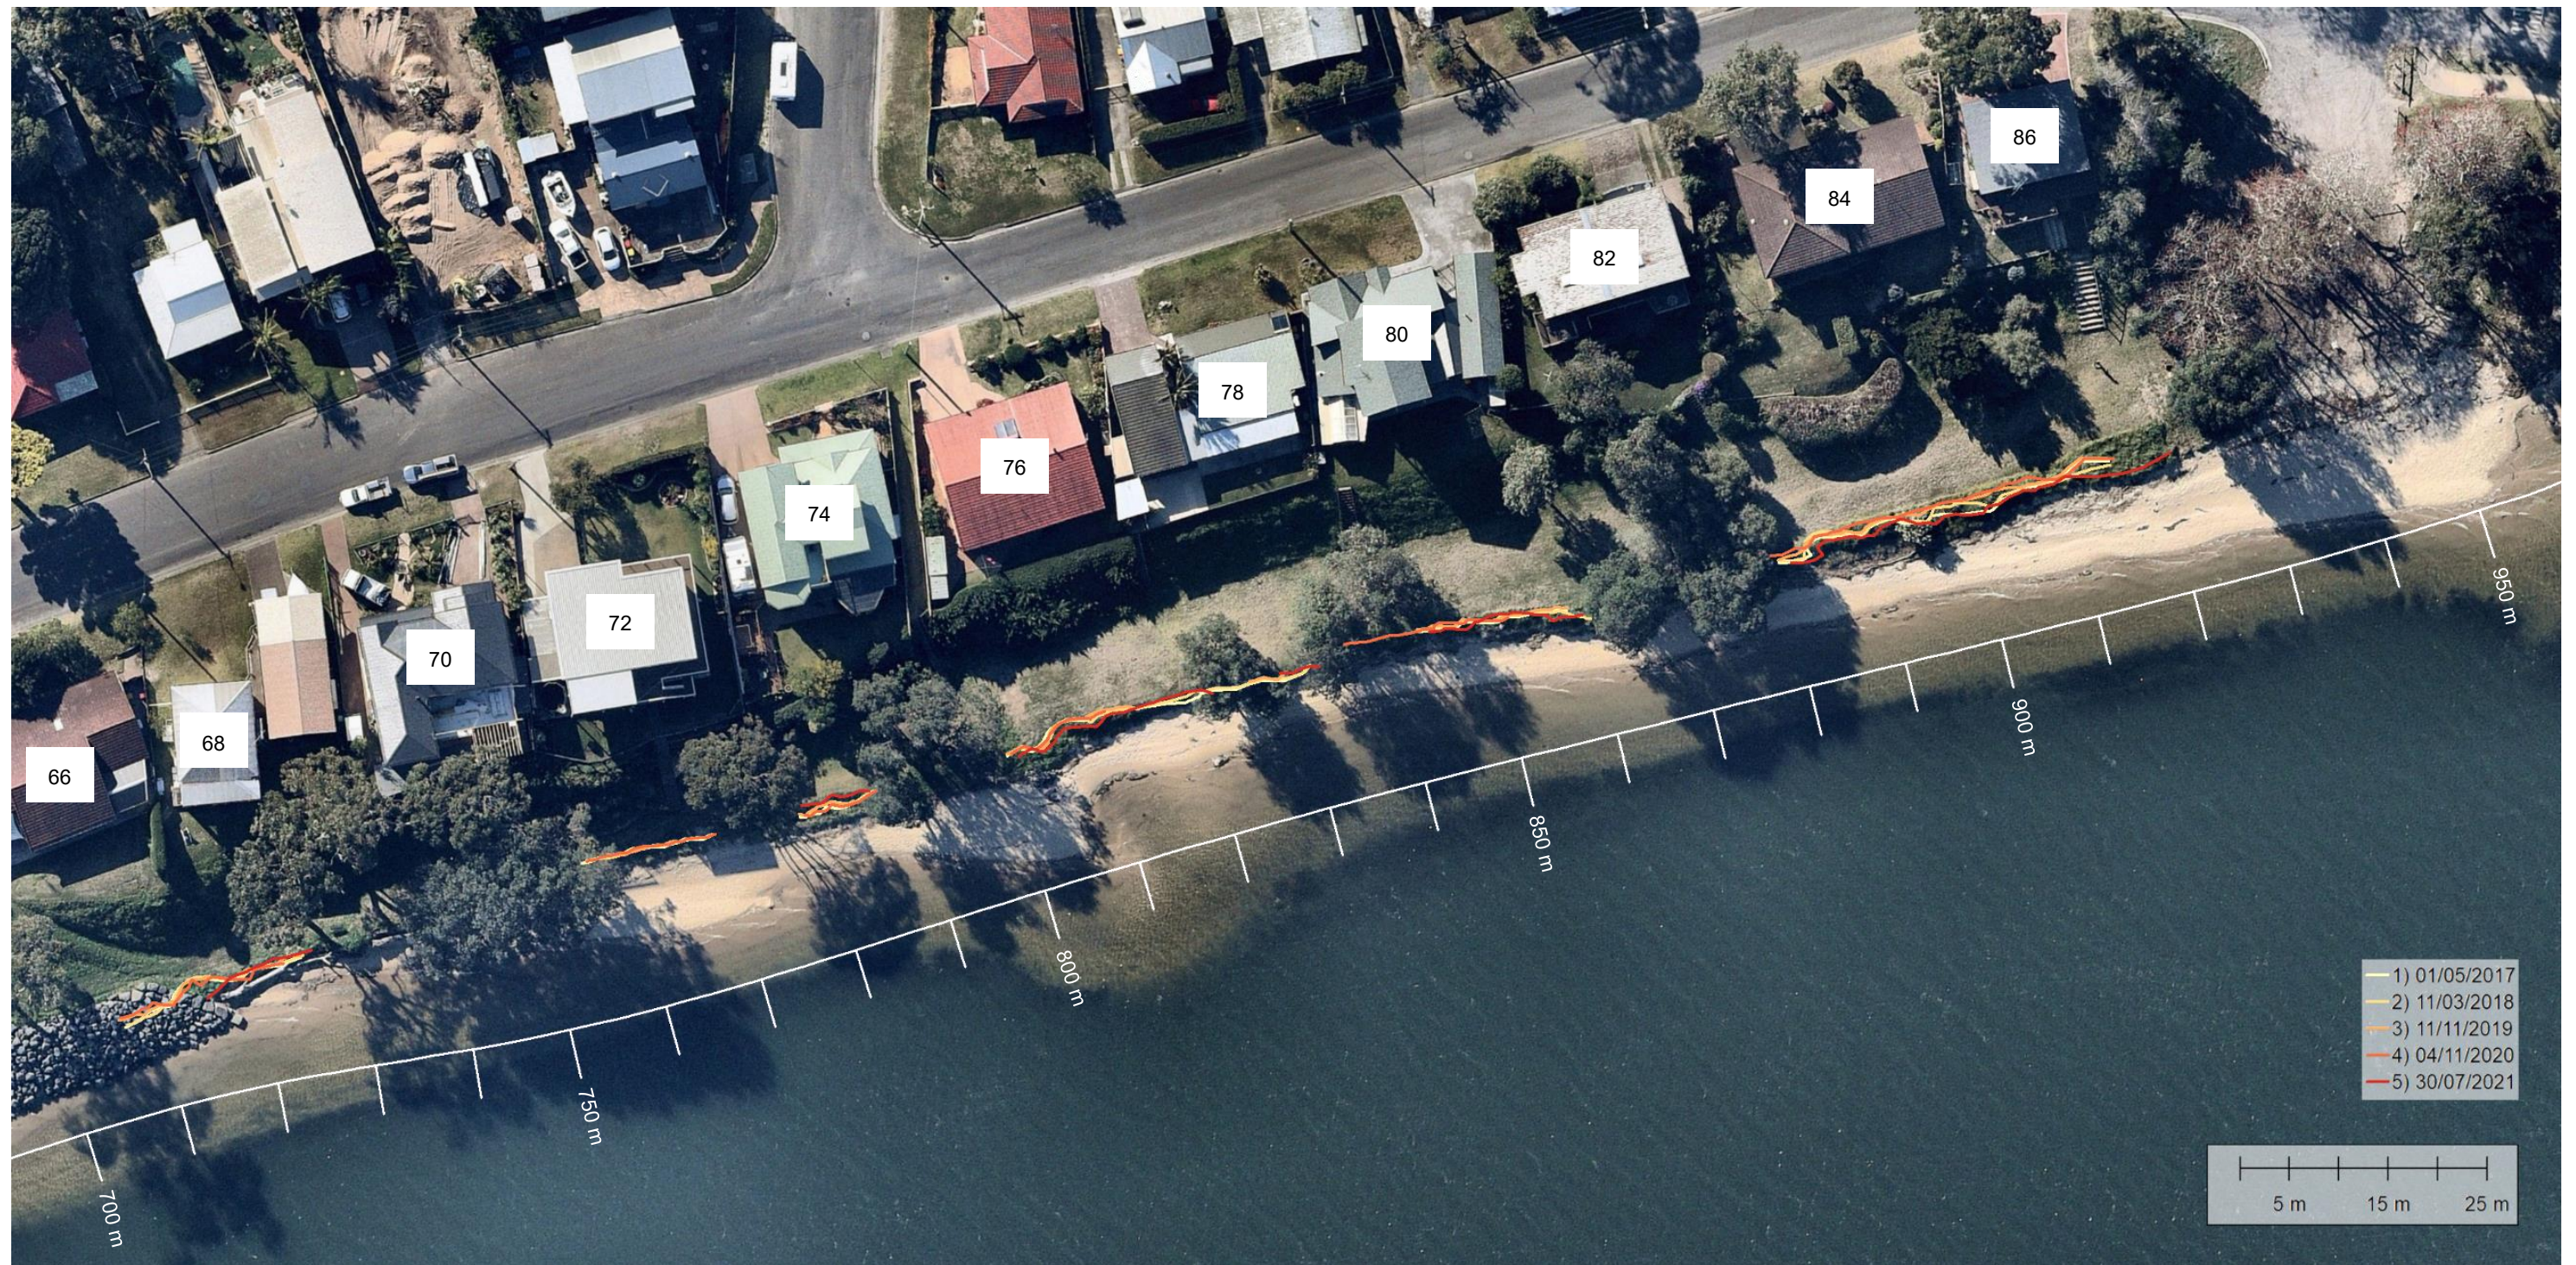
Figure 4.12 Mapping of the position of the bank top at the back of the beach (2017 to 2021)  
(Background Image, Nearmap 30/07/2021)

Figure 4.12 shows the mapping for the top of the bank between 2016 and 2021. From this mapping it can be concluded that:

- Between Ch 720 m and Ch 860 m, there has been no discernible change in position of the top of the bank at the back of the beach since the erosion events of 2016 (within the accuracy of the mapping method)
- East of Ch 860 m, it would appear from the mapping that the top of the bank has pro-graded, though this may be an artifact of changes in vegetation at the top of the bank that have occurred between aerial images.

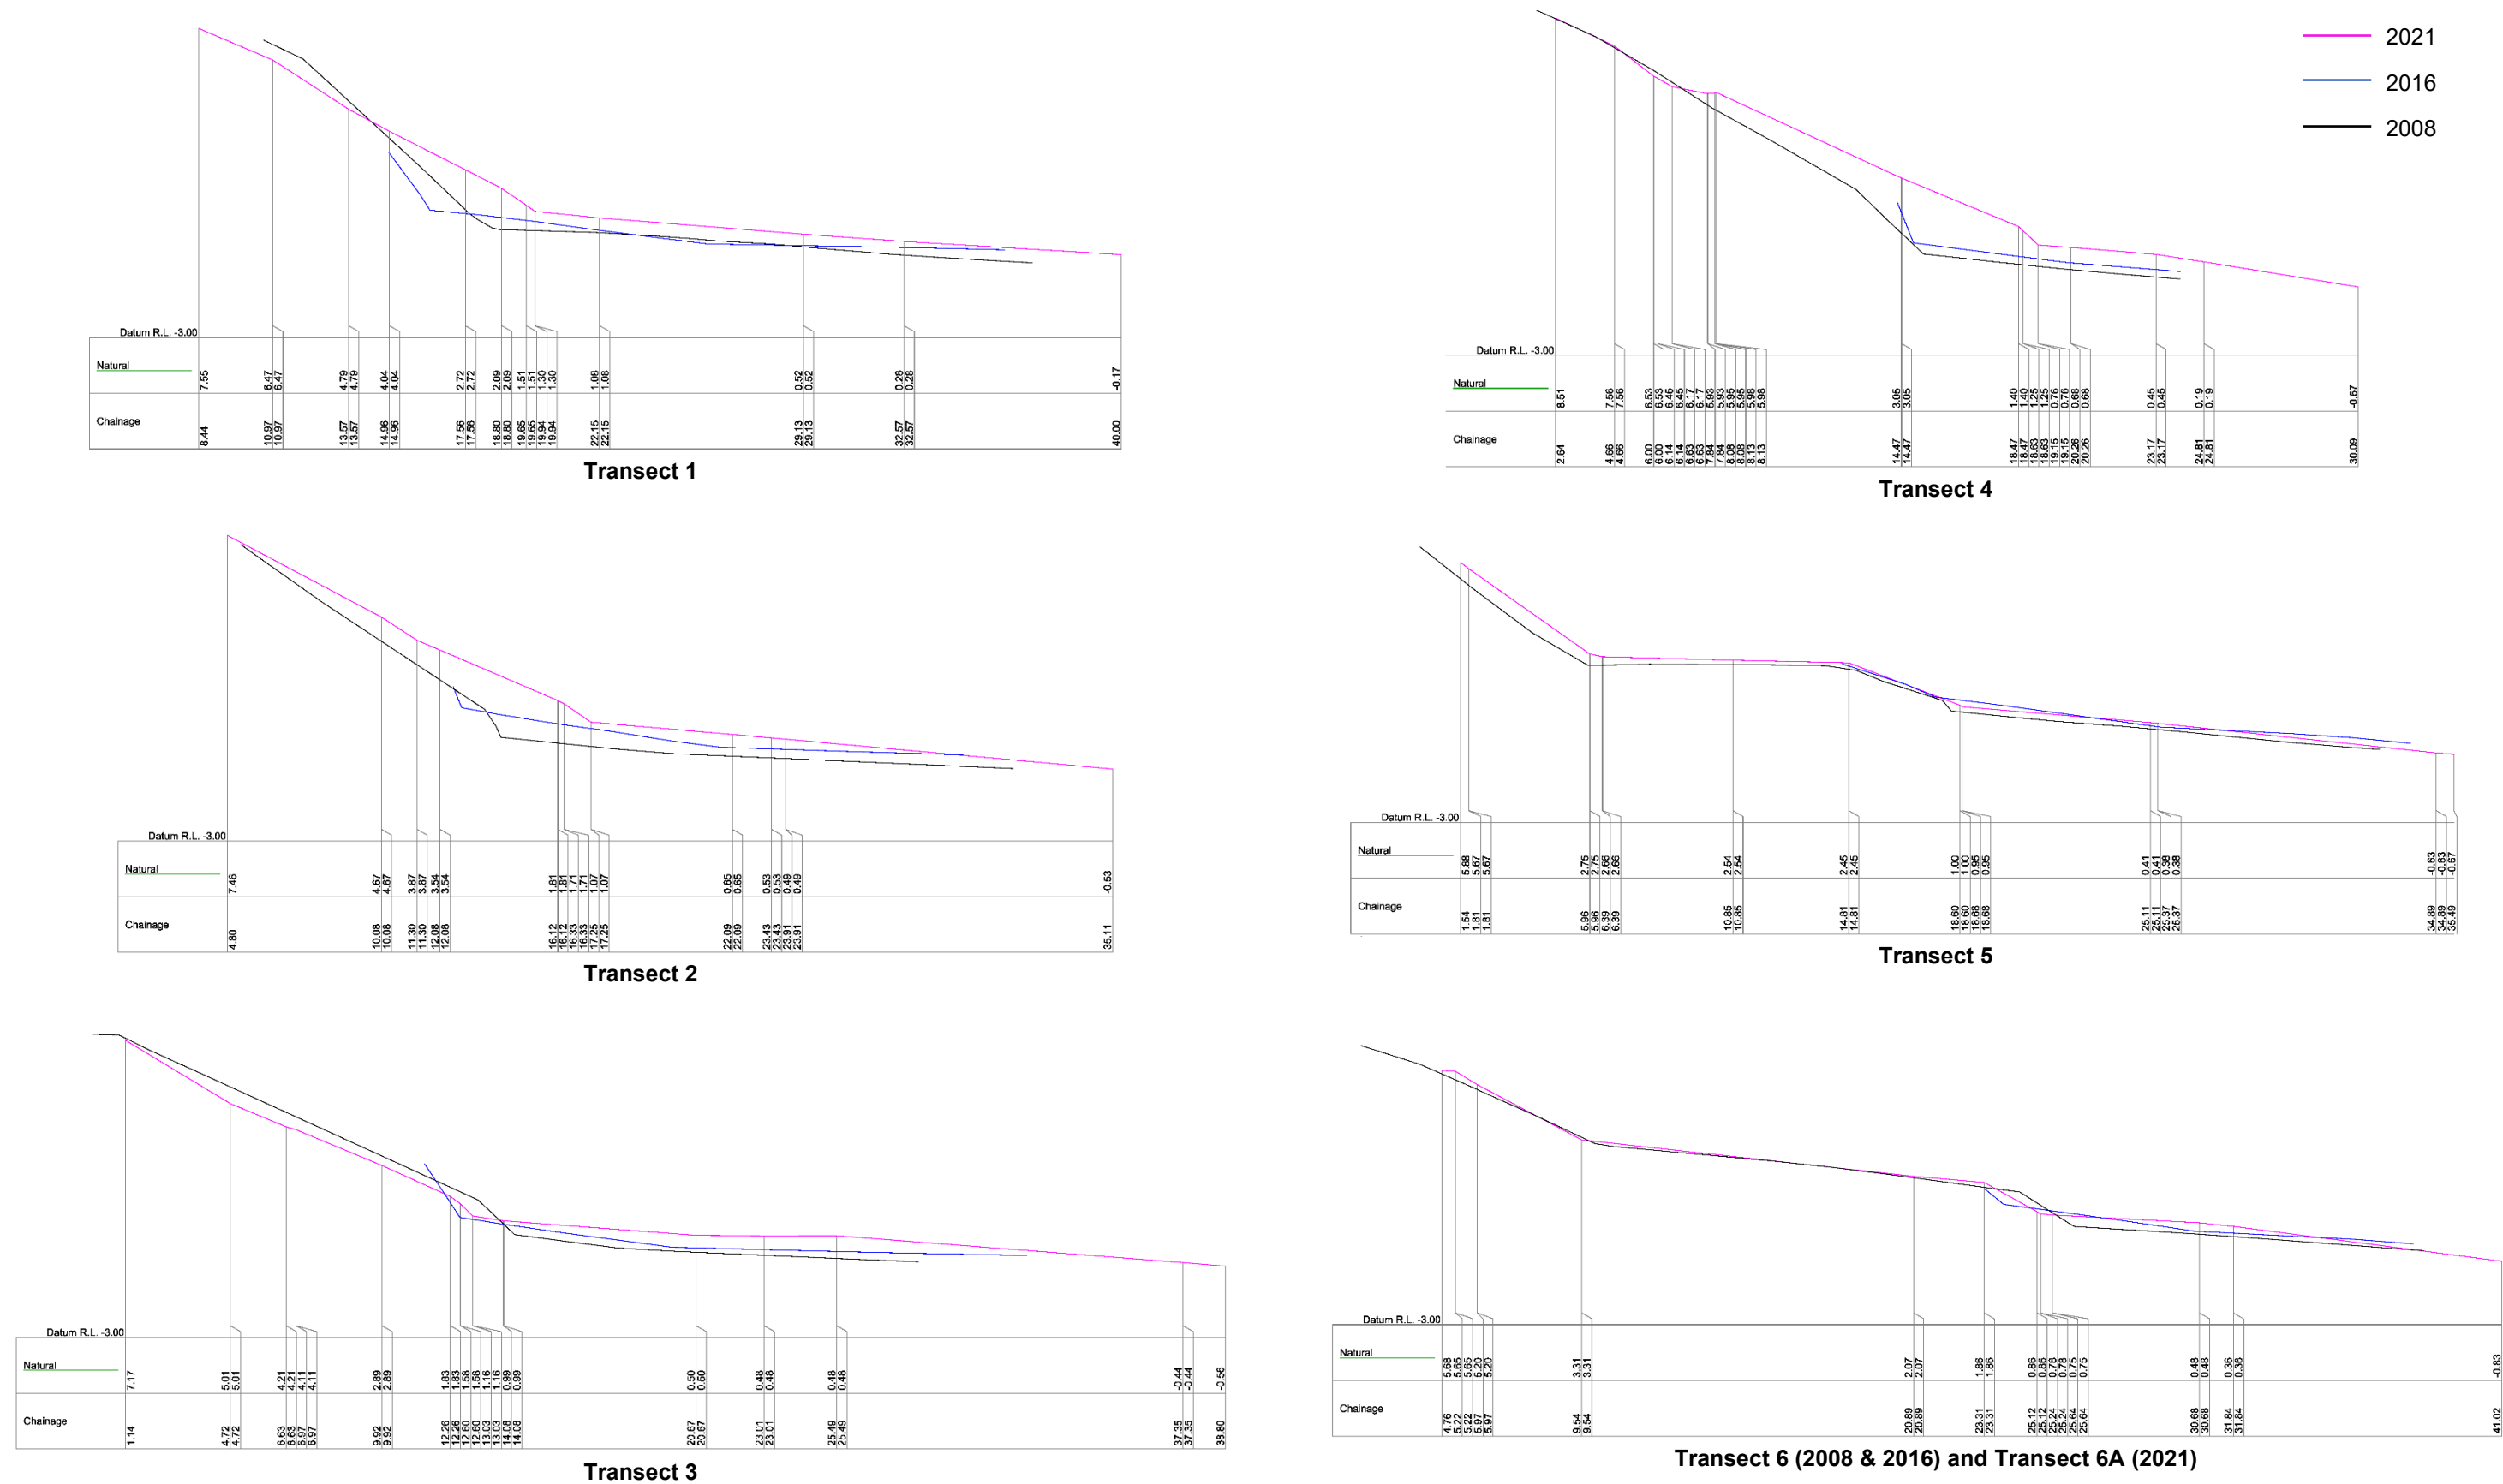
Figure 4.14 Foreshore survey profile comparison for August 2008, June 2016 and October 2021

Council collected cross shore profile surveys for specific transects of the River Road foreshore in August 2008, June 2016 and October 2021. The locations of the six survey transects are presented in Figure 4.13, while the survey profiles themselves are presented in Figure 4.14. Transect 4 passes through the rock revetment towards its eastern end, and clearly shows the position of the revetment surface (2021 survey line) sitting approximately 4 m towards the estuary channel relative to the natural pre-construction profile (2016), as noted in previous sections of this report. The 2021 survey also confirms that the beach level at the toe of the revetment at its eastern end (Transect 4), is approximately 0.7 m AHD, which is 0.4 m lower than the beach at the toe of the revetment sections further west (Transects 2 and 3).

In considering the un-protected section of foreshore captured in Transects 5 and 6/6A, the survey data indicates that there has been negligible change in the position of the beach or bank at the rear of the beach between the 2008, 2016 and 2021 surveys. This data further supports our field observations and measurements from aerial imagery.
