# Coastal Management Advice: 68 - 86 River Road, Shoalhaven Heads

WRL TR 2021/24, February 2022

By M J Blacka

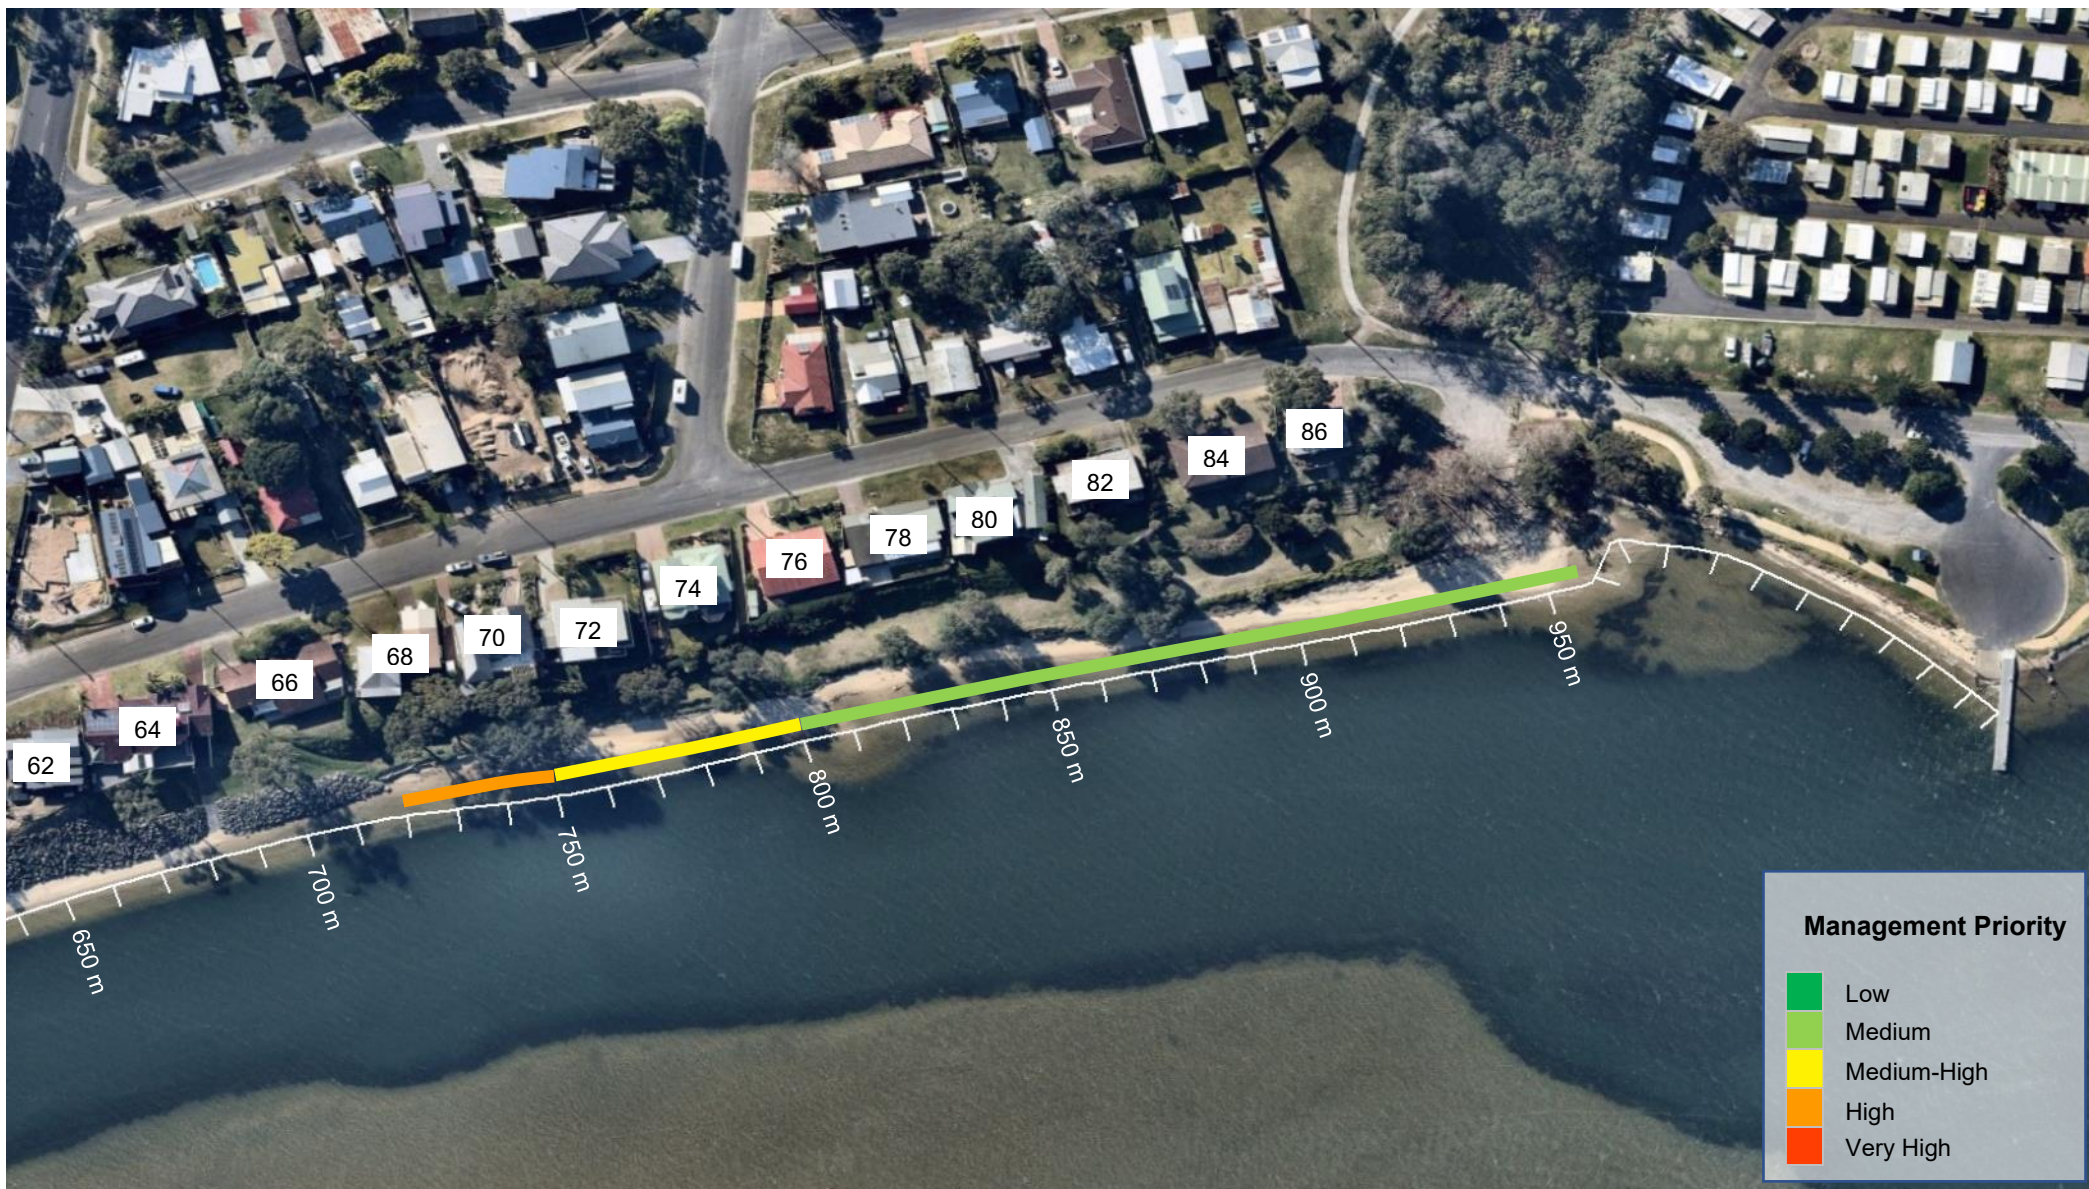
**Figure 4.16 Study area and updated 2021 management priority**

Table 4.1 and Figure 4.16 provide an updated prioritisation of management response for the study area covered within this report.

<b>Foreshore zone</b>	<b>Description</b>	<b>Management priority</b>
Ch 720 - 750 m	Immediately east of the revetment end, and seaward of properties 66 to 70 River Road	High
Ch 750 - 800 m	Seaward of properties 72 to 74 River Road	Medium-High
Ch 800 - 950 m	East from 76 River Road	Medium

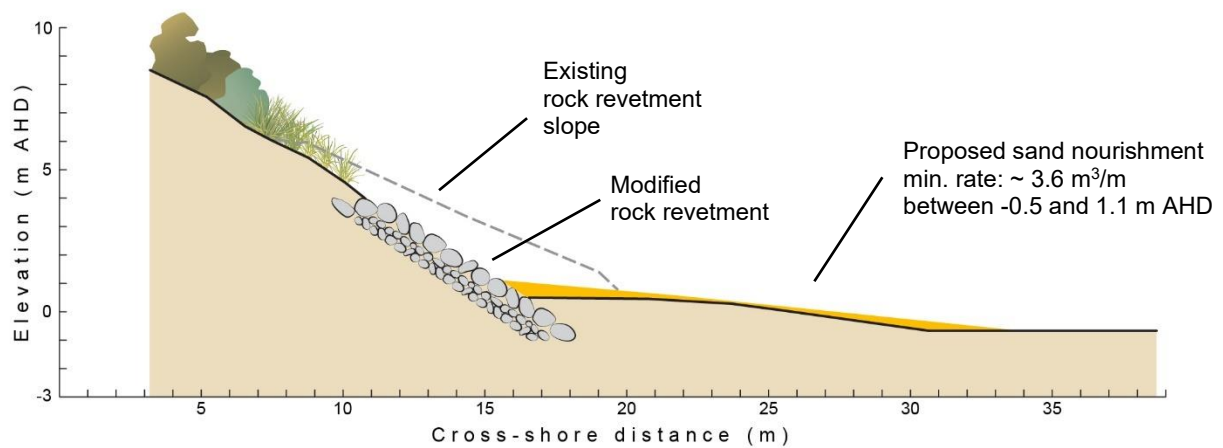
- Nourishment Zone A, Ch 600 to 680 m (Figure 5.10)
  - Central-eastern section of revetment
  - Though immediate nourishment of this area is not necessary for recreational purposes, it would provide a sand buffer for future storm events
- Nourishment Zone B, Ch 680 to 720 m (Figure 5.11)
  - Eastern section of revetment in front of numbers 64-66 River Road

**Figure 5.11 Nourishment design Zone B, Ch 680 to 720 m**

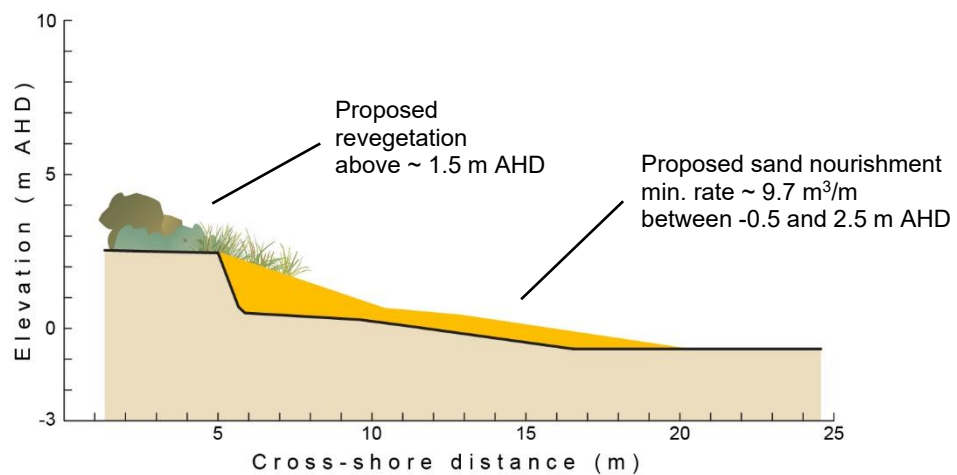
- Nourishment Zone C, Ch 720 to 800 m (Figure 5.12)
  - Un-protected stretch of beach east of the revetment end, in front of numbers 68-74 River Road
  - The beach in this area is currently lower than desirable, with swash impacting the toe of the erosion scarp during periods of high tide. The erosion is worst at the immediate end of the revetment, and reduces further to the east. Nourishment here is required to offset the un-recovered beach volume losses experienced in the 2016 storms and since the construction of the revetment, including protection of remaining mature trees.

**Figure 5.12 Nourishment design Zone C, Ch 720 to 800 m**
