2 Burley Road Padstow 2211

Predevelopment Tree Assessment Report

Date: 10/08/2022

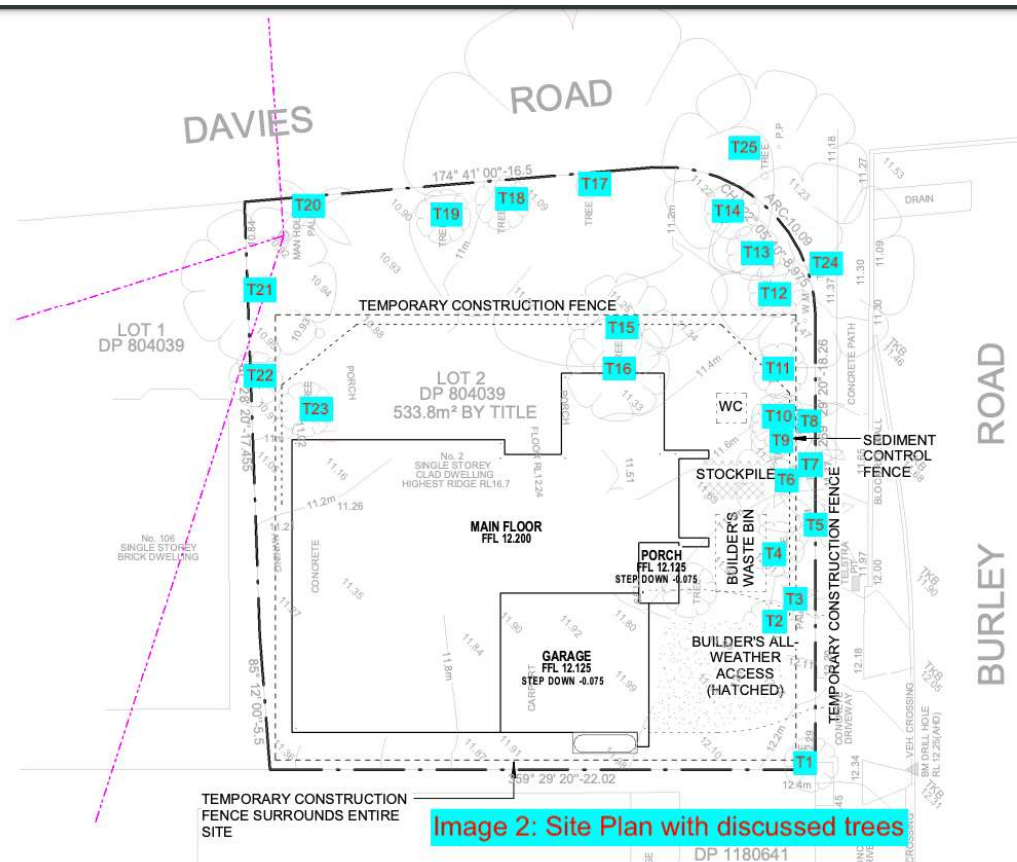
The trees have been located on the supplied Site plan and numbered. This plan is for illustrative purposes only and it should not be used for directly scaling measurement. Refer (Image 2 & Appendix I).
