Hazardous Materials Survey

7A Racecourse Road, West Gosford NSW

Report No. A1292_HMS_140524

Date: 17 May 2024

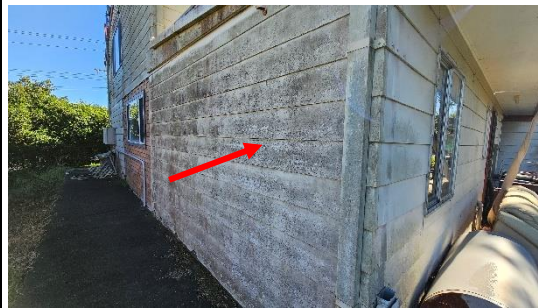
Low Risk R3	The material is in fair condition. In its current state this material does not pose an immediate health risk to Site users unless disturbed.			Remove by Class B Licensed Asbestos Removalist prior to renovation or demolition works

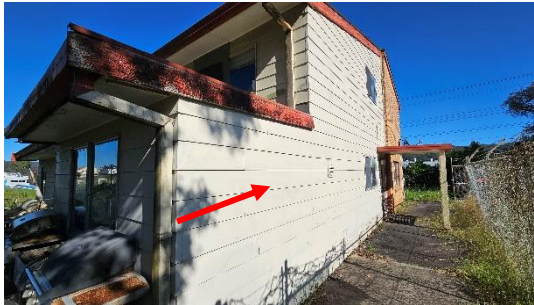
N/A	The paint is in fair condition. This material does not pose a health risk to Site users.			-

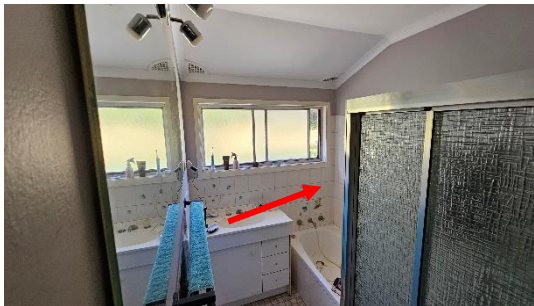
N/A	The material is in good condition. This material does not pose a health risk to Site users.			-			
Location - Description		Hazardous Material	Condition	Quantity	Sample ID	Labelled / Signage	Photo(s)
Laundry – Interior – ground floor – north-east laundry – wall linings – fibre cement sheet		No asbestos detected	Good No damage	-	11222.07/AS12	N/A

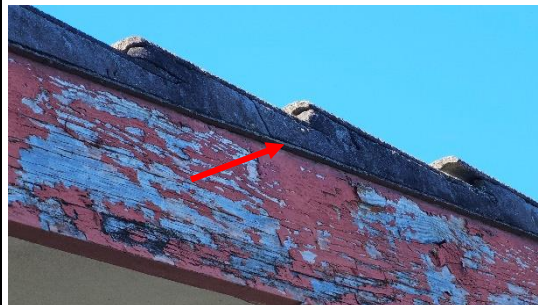
Low Risk R3	The material is in fair condition. In its current state this material does not pose an immediate health risk to Site users unless disturbed.			Remove by Class B Licensed Asbestos Removalist prior to renovation or demolition works			
Location - Description		Hazardous Material	Condition	Quantity	Sample ID	Labelled / Signage	Photo(s)
Garage – Exterior – ground surface – southern aspect – asbestos cement sheet debris		Chrysotile (non-friable)	Fair Weathered and damaged	~1 m ²	Same as 11222.07/AS16	No

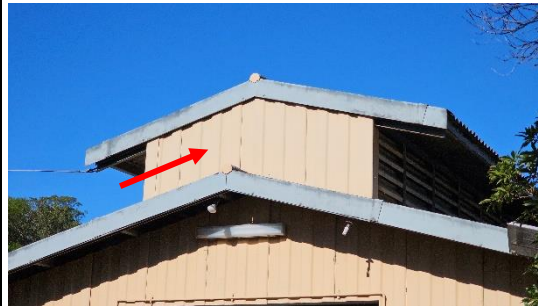
Minimal Risk R4	The material is in good condition. In its current state this material does not pose an immediate health risk to Site users unless disturbed.			Remove by Class B Licensed Asbestos Removalist prior to renovation or demolition works			
Location - Description		Hazardous Material	Condition	Quantity	Sample ID	Labelled / Signage	Photo(s)
Stables – Exterior – roofing – corrugated asbestos cement sheet		Chrysotile & Amosite Asbestos (non-friable)	Poor Heavily weathered	~350 m²	24-My0039208	No

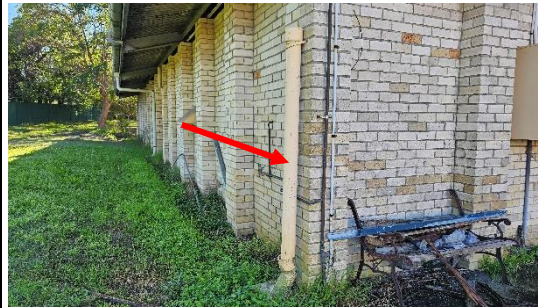
Moderate Risk R2	The material is in poor condition. In its current state this material does pose an immediate health risk to Site users if disturbed.			Remove by Class B Licensed Asbestos Removalist before further disturbance			
Location - Description		Hazardous Material	Condition	Quantity	Sample ID	Labelled / Signage	Photo(s)
Stables – Exterior – ground surface – southwestern aspect – loose asbestos fibre in soil		Chrysotile & Amosite Asbestos (friable)	Poor Exposed	~ 16 m²	11222.07/AS10	No

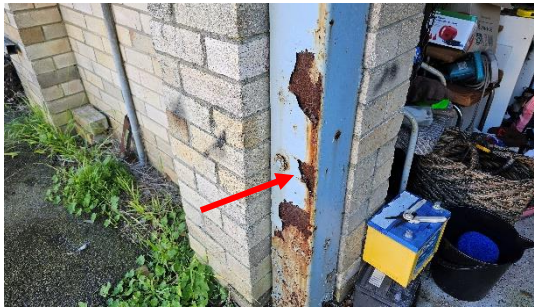
N/A	The paint is in poor condition with severe flaking and weathering.			Material should be handled with care and paint encapsulated or removed according to guidelines			
Location - Description		Hazardous Material	Condition	Quantity	Sample ID	Labelled / Signage	Photo(s)
Stables - Exterior – all aspects – cream paint		Lead Paint 0.46%	Good No flaking	-	Pb2	N/A

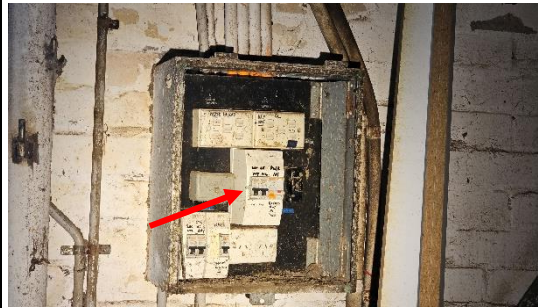
Low Risk R3	The material is in fair condition. In its current state this material does not pose an immediate health risk to Site users unless disturbed.			Remove by Class B Licensed Asbestos Removalist prior to renovation or demolition works			
Location - Description		Hazardous Material	Condition	Quantity	Sample ID	Labelled / Signage	Photo(s)
Stables – Interior – southern wall – asbestos electrical distribution backing board		Assumed (non-friable)	Fair	~<0.25 m²	-	No

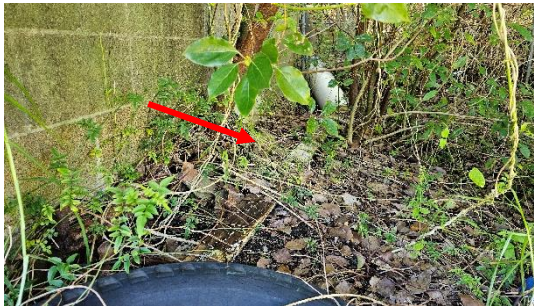
Moderate Risk R2	The material is in poor condition. In its current state this material does pose an immediate health risk to Site users if disturbed.			Remove by Class B Licensed Asbestos Removalist before further disturbance			
Location - Description		Hazardous Material	Condition	Quantity	Sample ID	Labelled / Signage	Photo(s)
North Stables – Exterior – ground surface – northern aspect –asbestos cement sheet debris		Chrysotile & Amosite Asbestos (non-friable)	Poor Exposed	~ <1 m ²	Same as 24-My0039209	No
