The Dog on the Tucker Box Redevelopment Tree Inventory

August 2023
Ref. 23/452.

Trees on The Dog on the Tucker Box Site, Five Mile, via Gundagai.

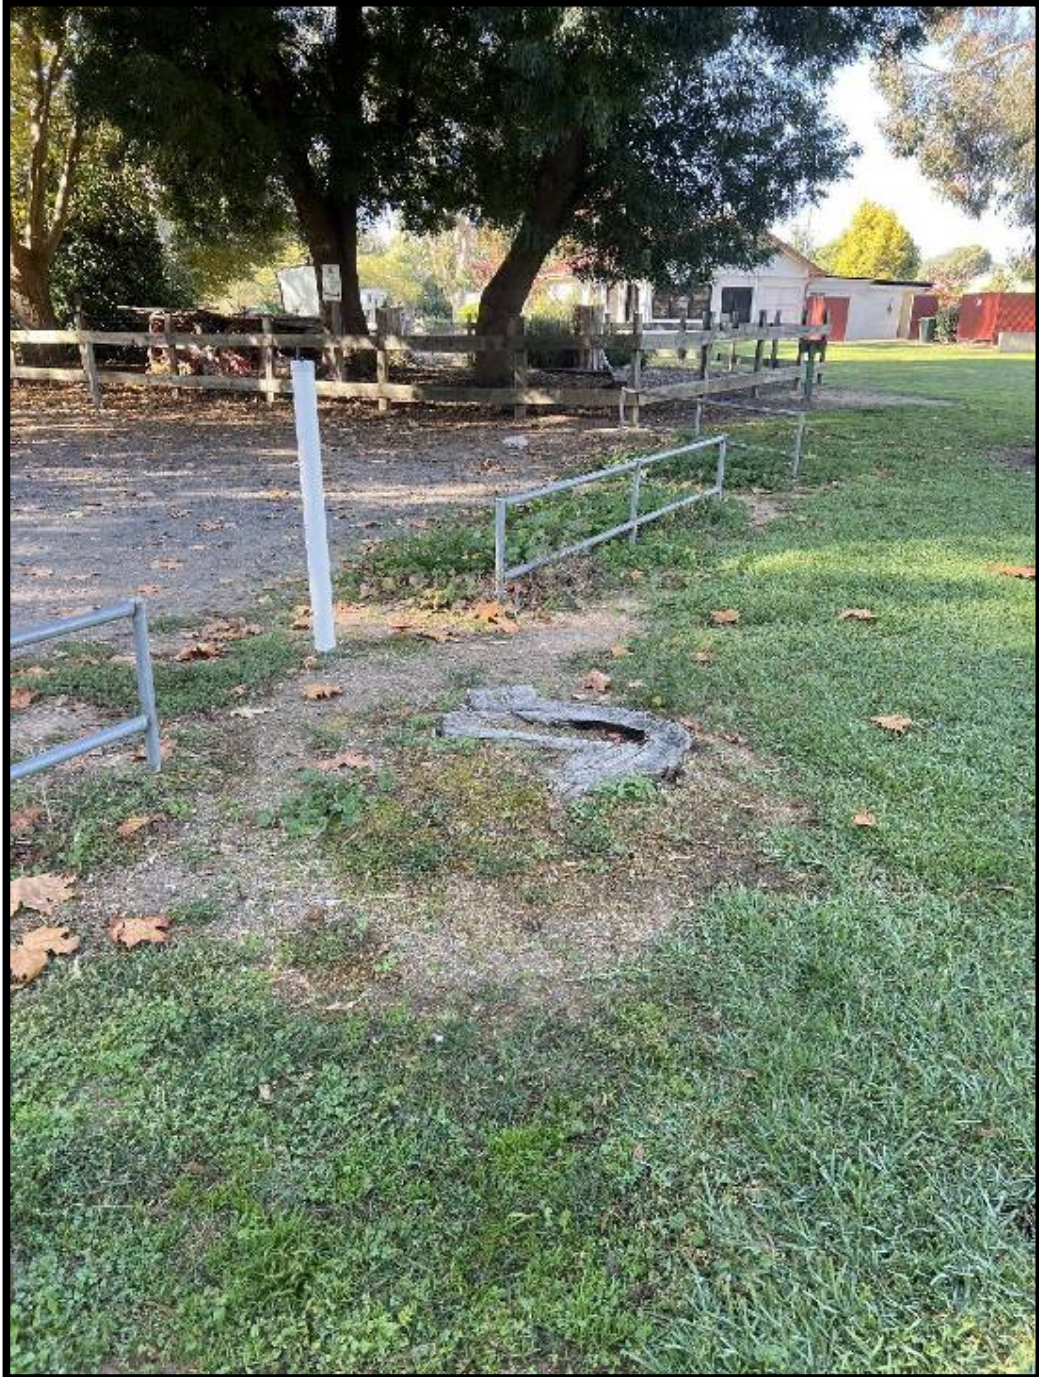
Tree No. 1

Tree Reference No. (Refer to Appendices B & C)	Scientific Name	Common Name	Height (m)	DBH (cm)	Condition (Refer to Section 3)	Notes
1	Tree removed					Tree removed - ground level stump
2	<i>Corymbia maculata</i>	Spotted Gum	20	65	Good	High crown; some small diameter deadwood
3	<i>Corymbia maculata</i>	Spotted Gum	6	50	Poor	Very poor condition; two stems, bifurcated at base, mostly dead; only live tissue epicormic shoots from base.
4	<i>Eucalyptus mannifera</i>	Brittle Gum	14	65	Good	Large lower NW lateral pruned off.
5	<i>Platanus X hispanica</i>	Plane Tree	15	100	Fair	Deadwood & hangers in crown (to about 100mm dia.)
6	<i>Eucalyptus cinerea;</i>	Argyle Apple	12	40	Poor	Sparse crown, probably attributable to surrounding ground compaction; lower laterals (long) removed.
7	<i>Eucalyptus mannifera</i>	Brittle Gum	18	60	Fair	High crown & deadwood to 150mm diameter; prior limb failures to 250mm diameter

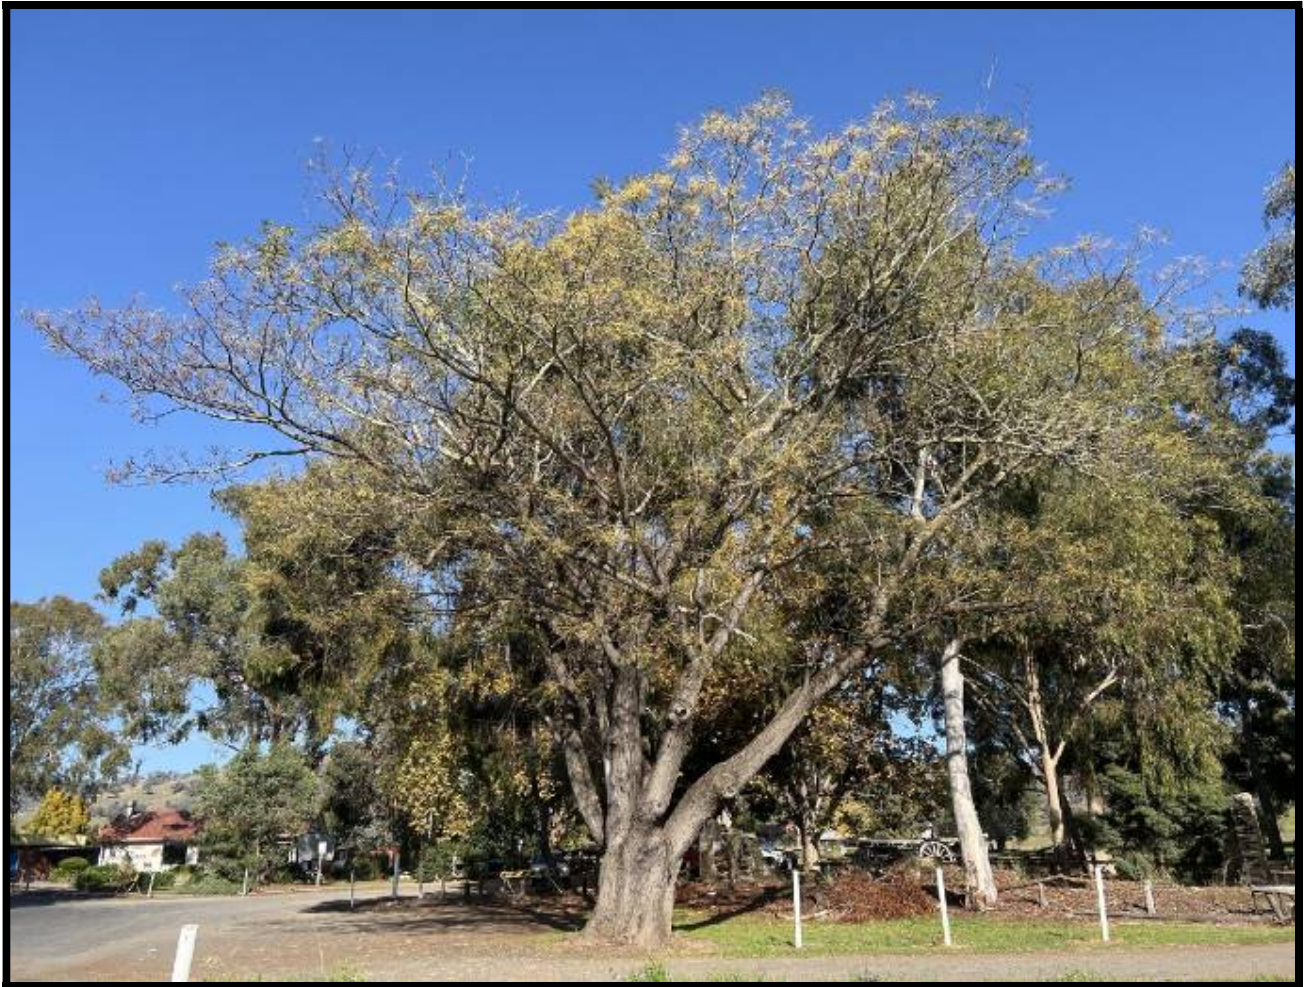
Tree No. 9

8	<i>Eucalyptus mannifera</i>	Brittle Gum	18	50	Fair	Similar to Tree 7, also Cockie damage high on stem
9	<i>Melia azederach</i>	White Cedar	12	100	Fair	Large tree, has previously had major laterals shortened (for vehicle clearance) especially N & E of crown; deadwood high in crown & perimeter dieback; current season defoliation by sawfly larvae
10	<i>Eucalyptus sideroxylon</i>	Mugga Ironbark	15	40	Fair	High crown with SW leaders (over lawn / picnic tables) shortened; basal water shoots (E & N) from root pruning(?); extensive mistletoe infestation of crown
11	<i>Corymbia citriodora</i>	Lemon-scented Gum	18	50	Fair	High (& sparse) crown with perimeter (small diameter) deadwood and prior limb failures to 150mm; crown density probably attributable to surrounding ground compaction / pavement.
12	<i>Platanus X hispanica</i>	Plane Tree	15	70	Good	Deadwood, to about 100mm diameter, throughout crown.

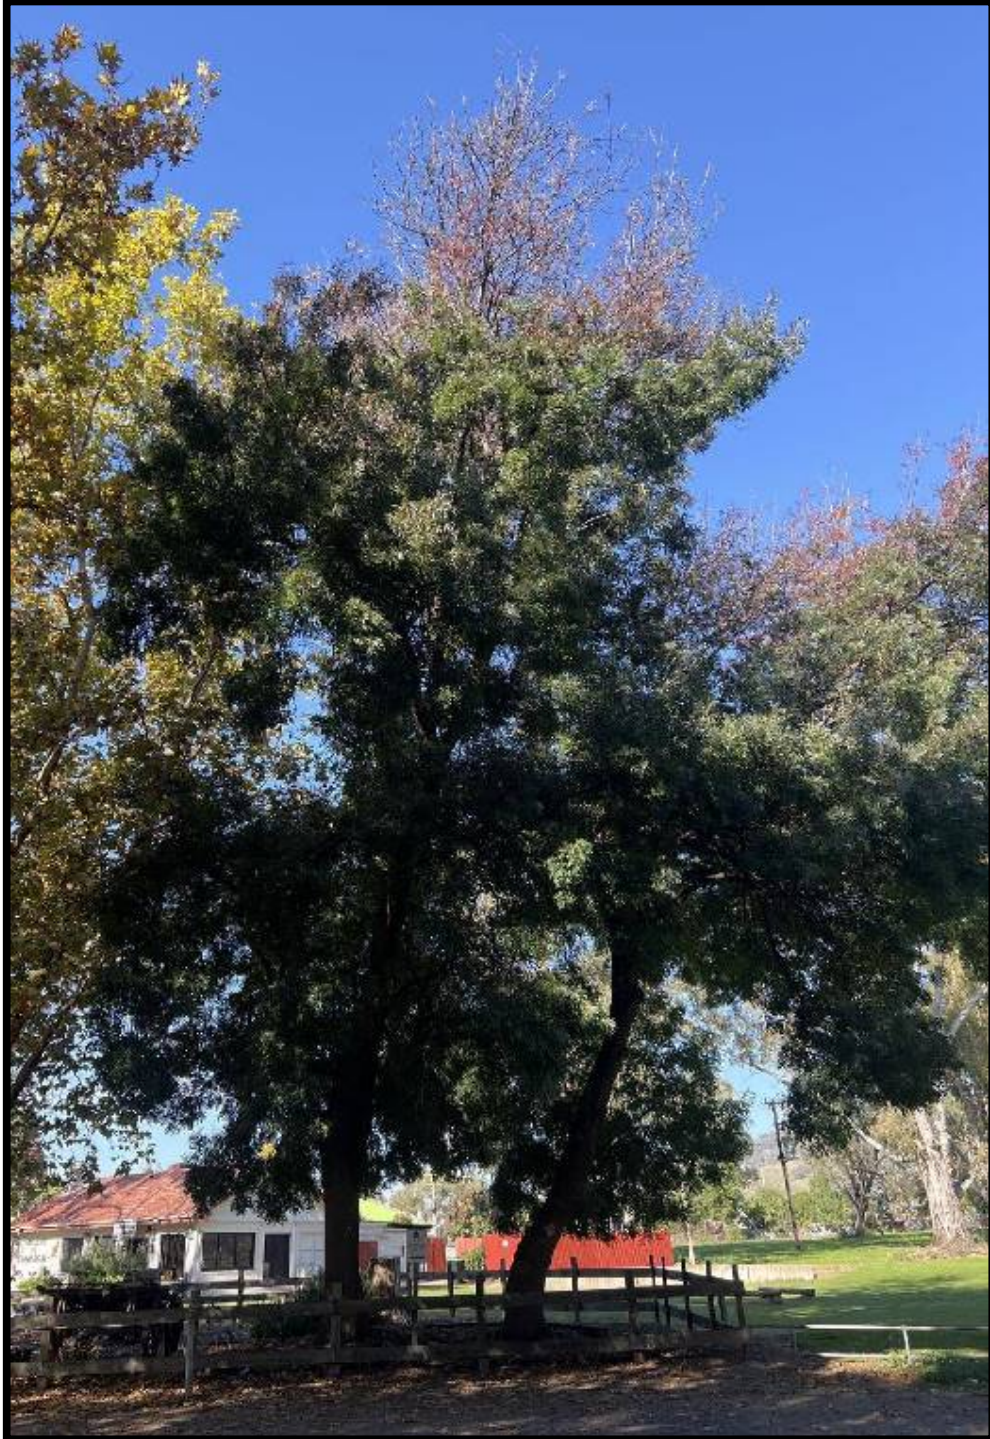
Tree No. 13

13	<i>Fraxinus</i> Raywood	Claret Ash	15	55	Fair	Upright crown, biased to N & W, due to competition from adjacent Plane Tree; apical dieback of leaders at top of canopy
14	<i>Fraxinus</i> Raywood	Claret Ash	12	45	Good	Stem lean & major crown bias to W, due to competition from neighbouring trees (both extant and removed); lift pruning has removed major lower laterals (to about 10m)
15	<i>Corymbia citriodora</i>	Lemon-scented Gum	10	65	Fair	Main leader previously lopped at 4m; Fair condition, due to species resistance to decay.
16	Tree removed	(probably) Blue Gum				Coppicing stump (probably Blue Gum)

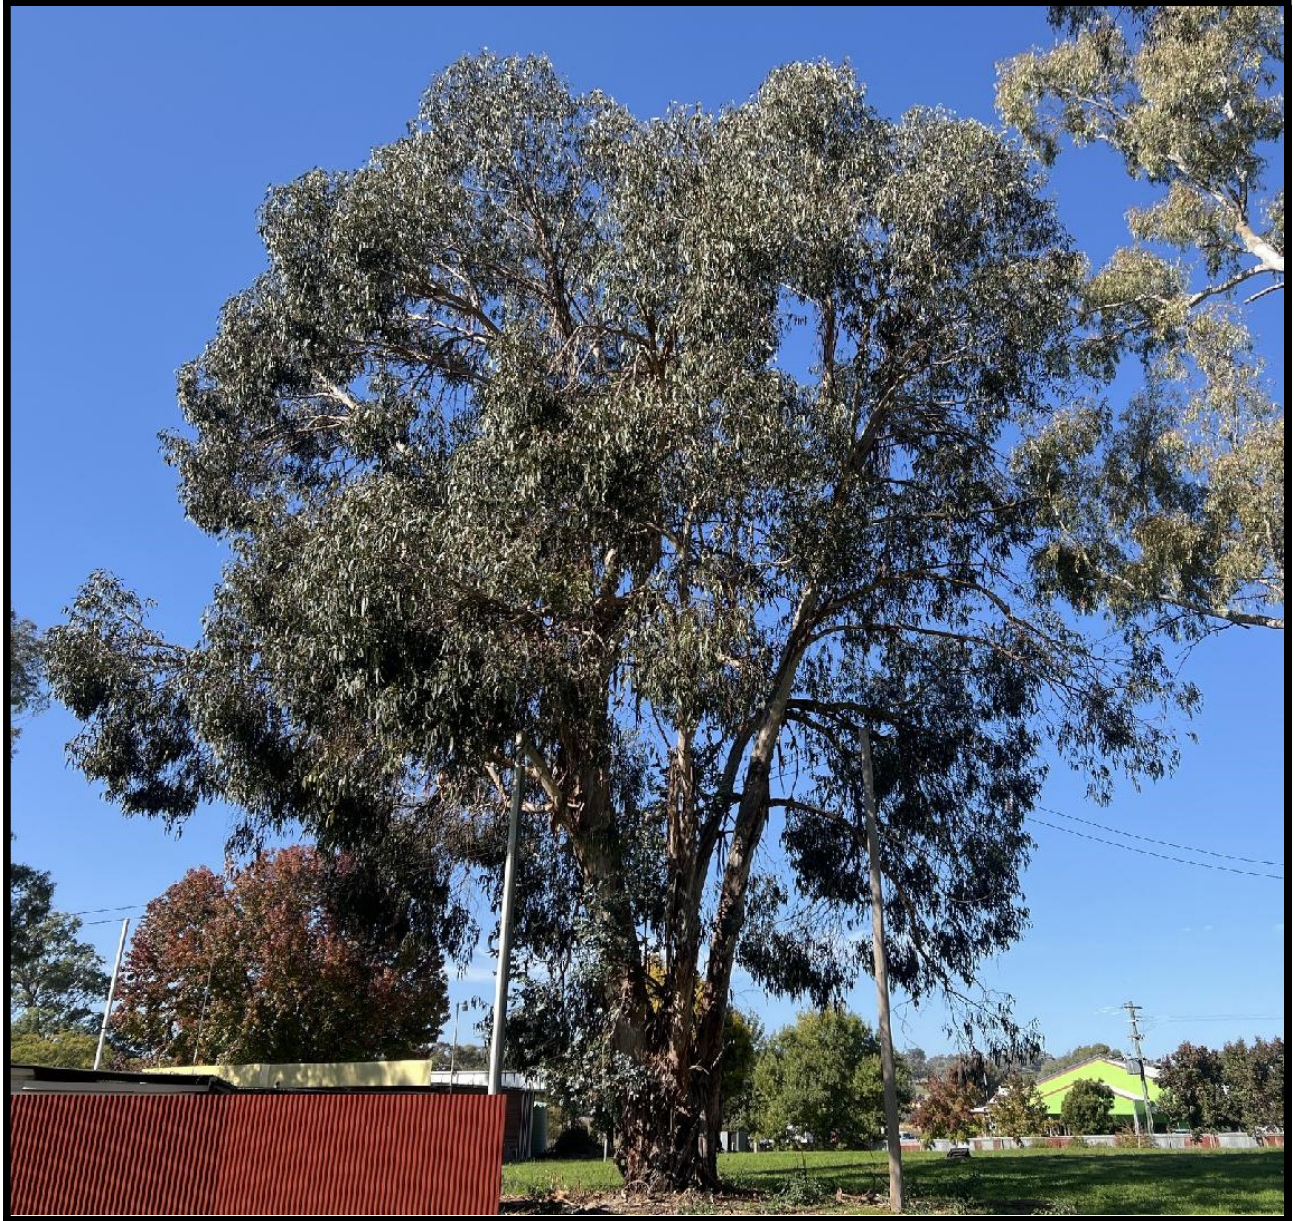
Tree No. 17

17	<i>Eucalyptus bicostata</i>	Blue Gum	25	150	Good	Very large basal bole that forks into major (NE) leader & three other secondary leaders (to NW, W & S); upper crown density a little thin & some epicormic juvenile foliage in lower crown; surrounded by current services infrastructure of electricity service line & septic system.
18	<i>Eucalyptus camaldulensis</i>	River Red Gum	30	140	Fair	Very large; multiple prior failures, some >300mm dia.; leader & lower laterals to N pruned off
19	<i>Corymbia citriodora</i>	Lemon-scented Gum	18	70	Fair	Surrounded by hard pavement; small diameter (<50mm) deadwood throughout crown.
20	<i>Liquidambar styraciflua</i>	Liquidamber	15	65	Poor	Large tree with basal wound (1.5m long, 400-500mm across) & decay SE side, probably originates from removal of lower lateral branch (for signage); long term stability of tree compromised as stem failure a possibility - Remove tree.

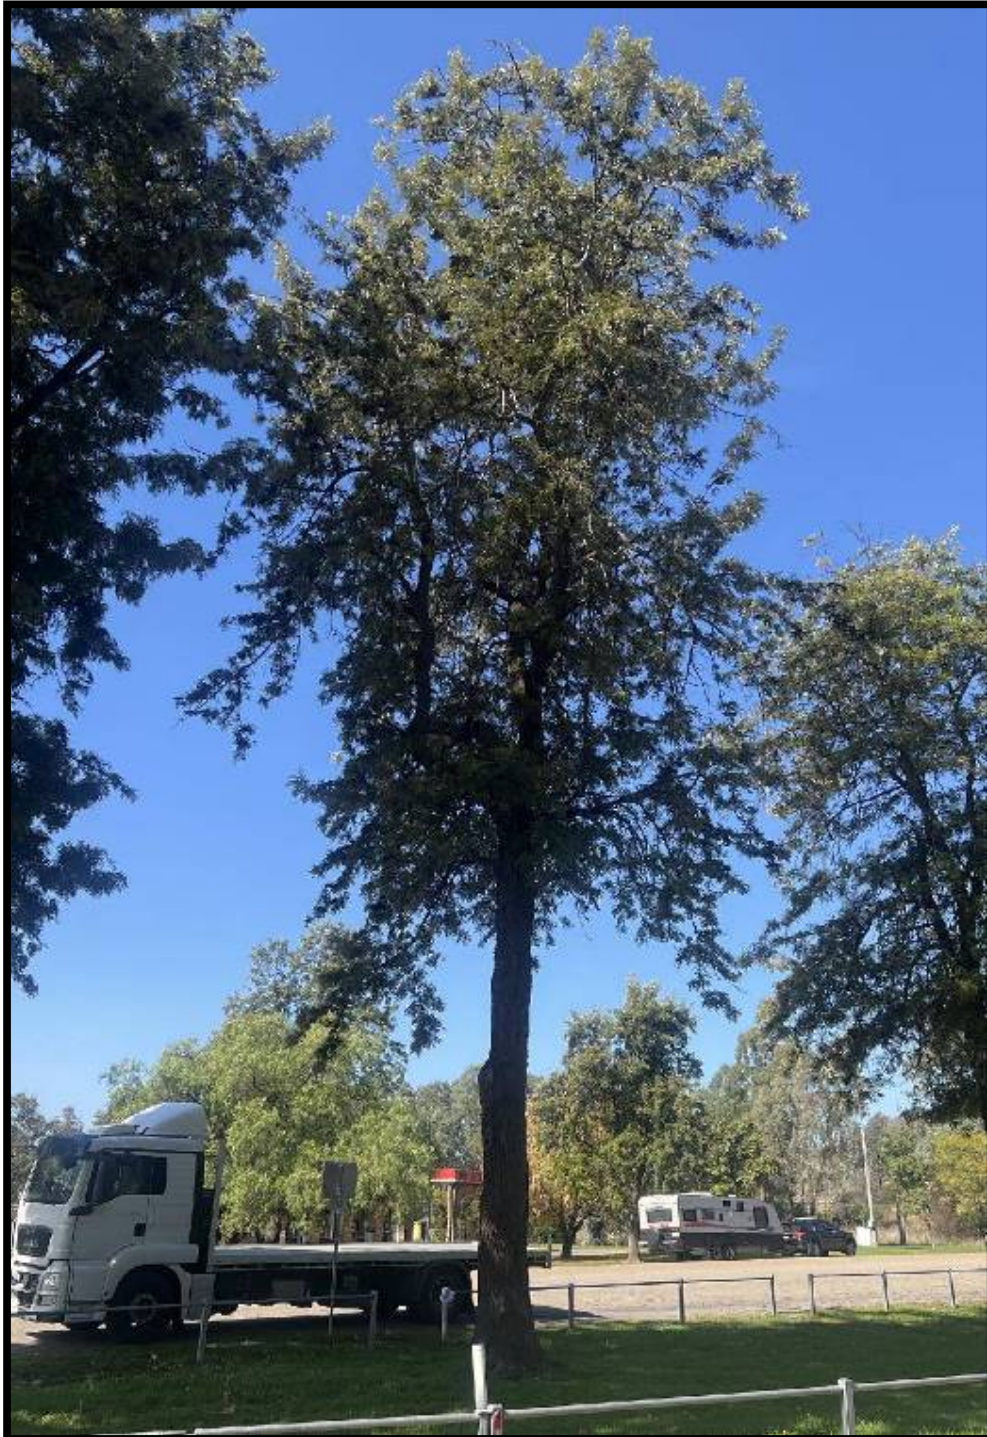
Tree No. 27

27	<i>Grevillea robusta</i>	Silky Oak	14	40	Good	High crown & condition and features as other Silky Oaks (Nos. 23, 24, 26 & 28)
28	<i>Grevillea robusta</i>	Silky Oak	15	70	Good	Largest and most vigorous of Silky Oak avenue; small basal opening & cavity, E side; internal deadwood as other Silky Oaks, though perimeter dieback not prevalent.
29	<i>Grevillea robusta</i>	Silky Oak	12	30	Fair	
30	<i>Brachychiton populneus</i>	Kurrajong	10	50	Fair

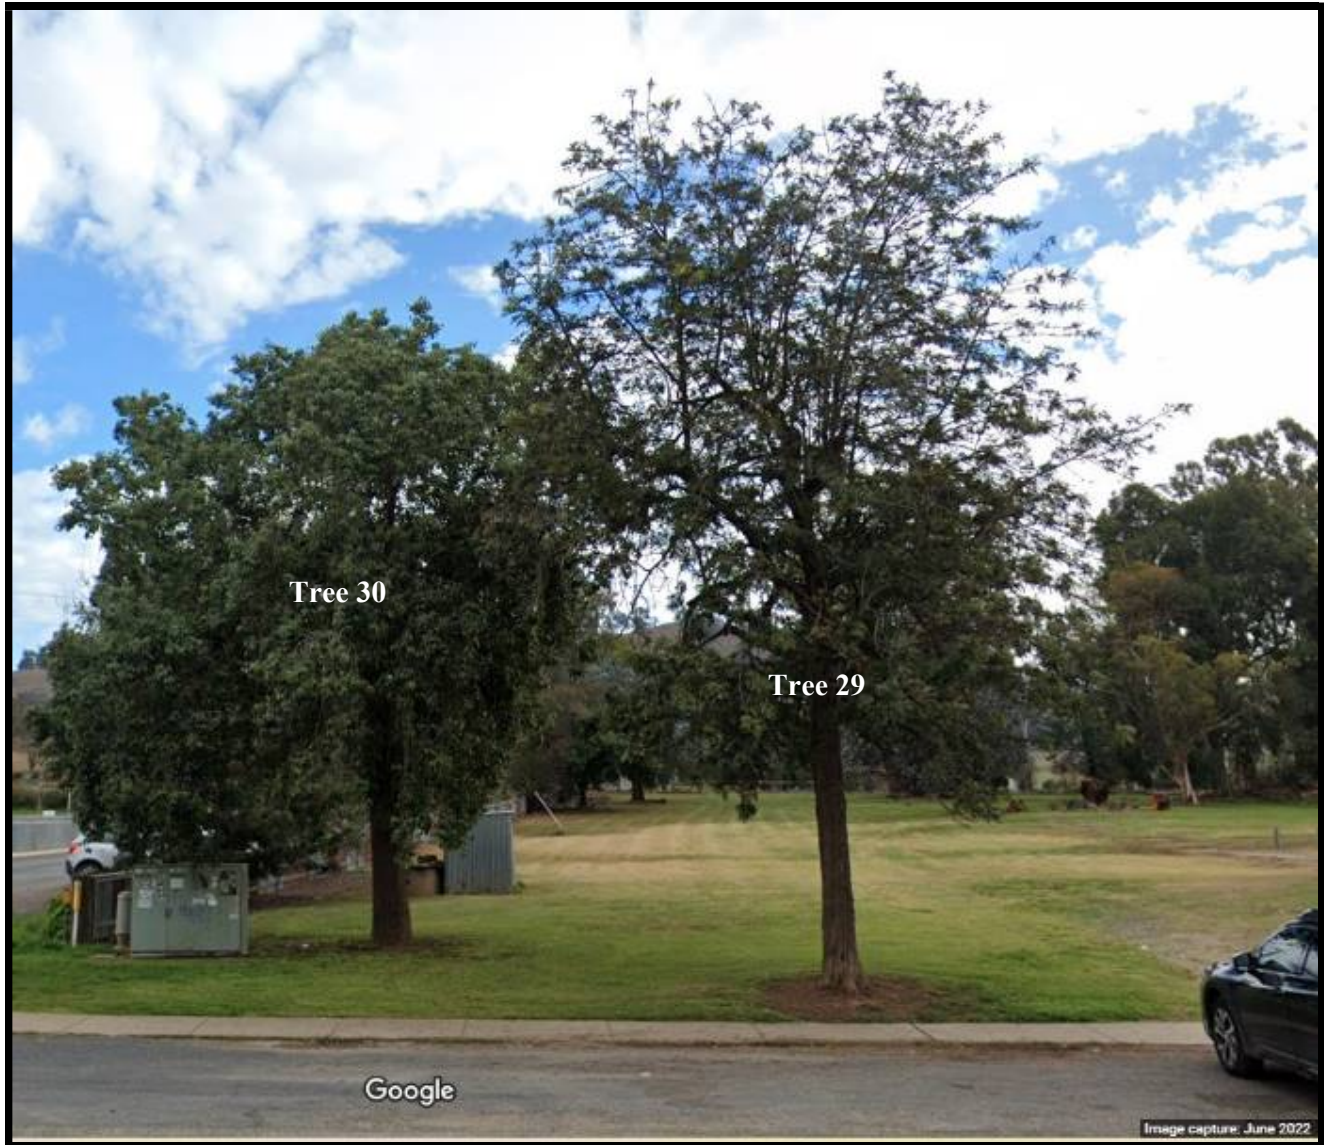
Tree Nos. 29 and 30

Tree 29 (**Right**) and Tree 30 (**Left**), June 2022.
