**SEASONED TREE
CONSULTING**

**ARBORICULTURAL IMPACT
ASSESSMENT REPORT**

Prepared for
Gary Carli c/o DMPS

Site address
**8 Dawn Fraser Avenue,
Sydney Olympic Park**

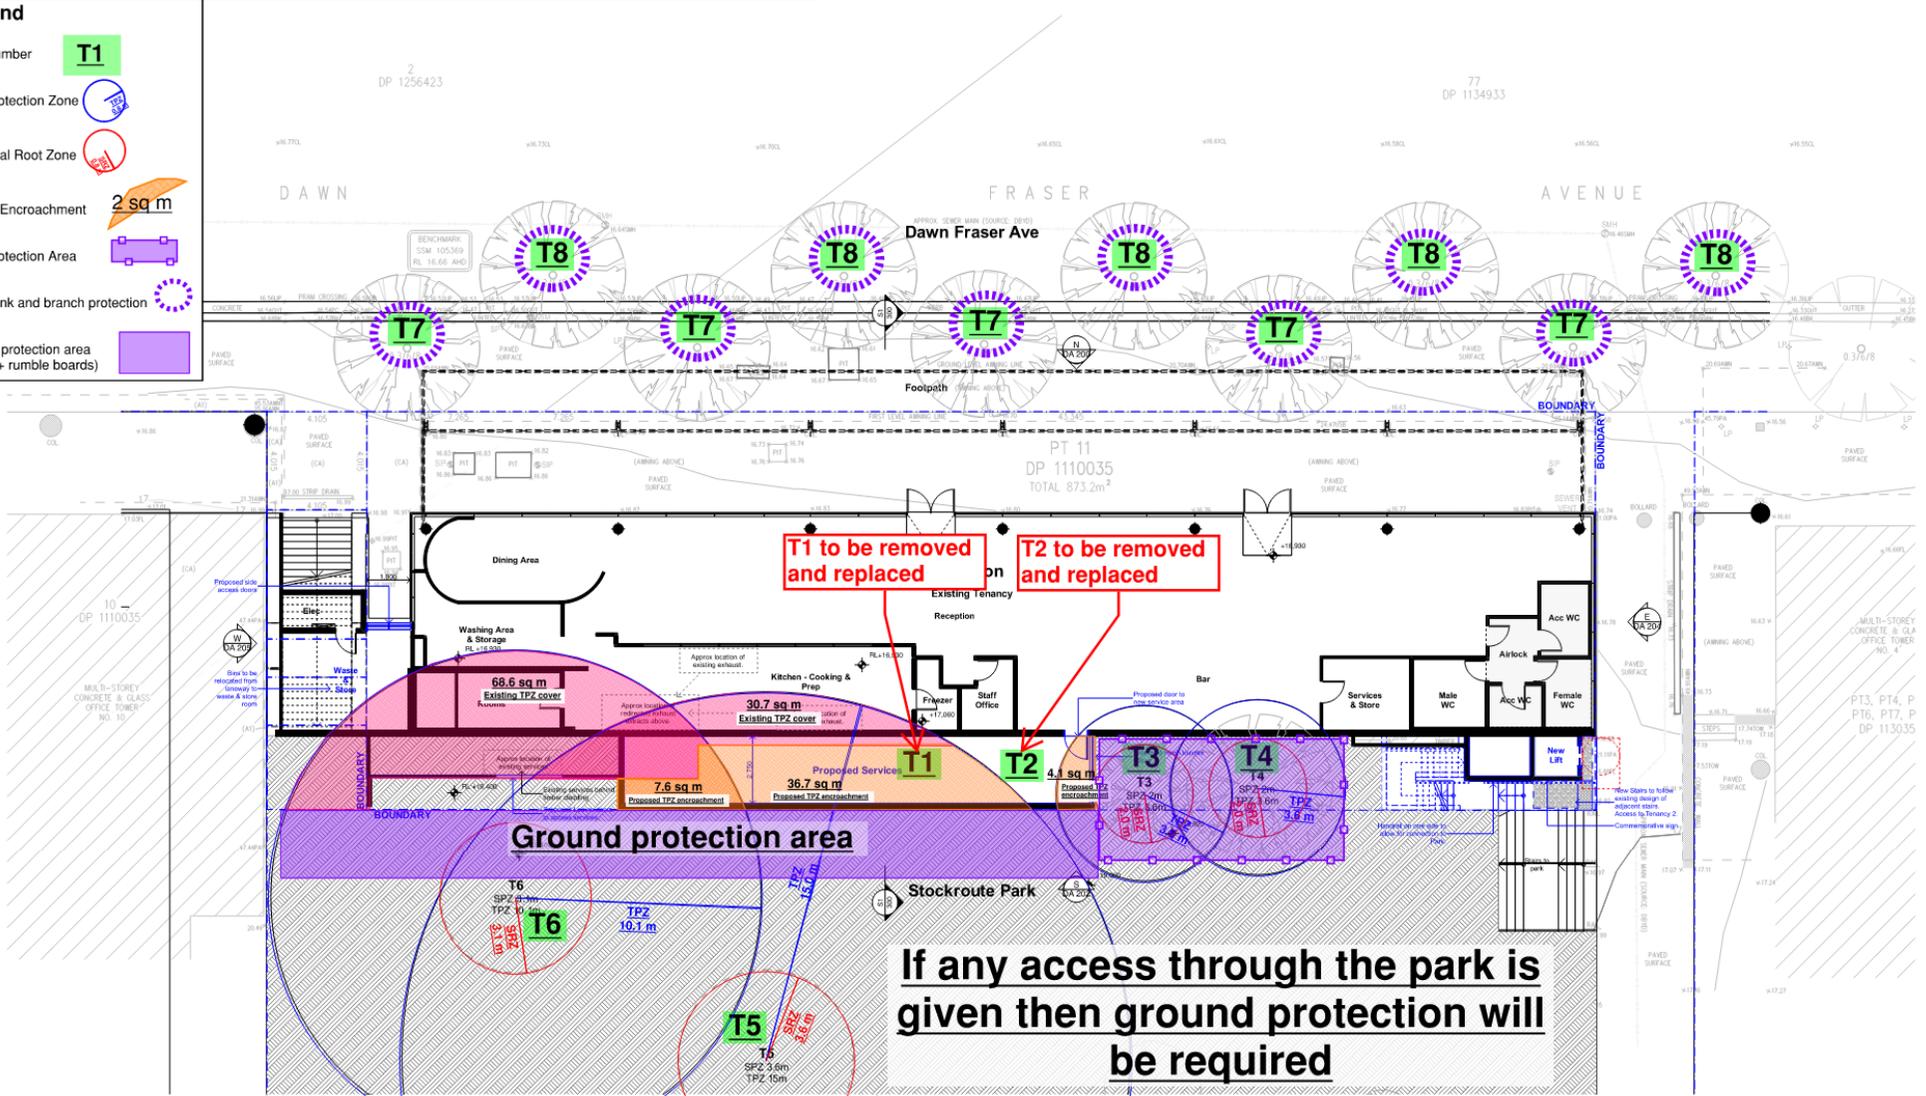
Proposed Site Plan and Tree Protection Plan

If any access through the park is given then ground protection will be required
