Proposed Demolition of Sonnblick Lodge

Kosciuszko
Thredbo Pty Ltd

10 Bobuck Lane,
Thredbo, NSW

Proposed Demolition of Sonnblick Lodge **10 Bobuck Lane, Thredbo, NSW** *Geotechnical Investigation & Landslide Risk Assessment*

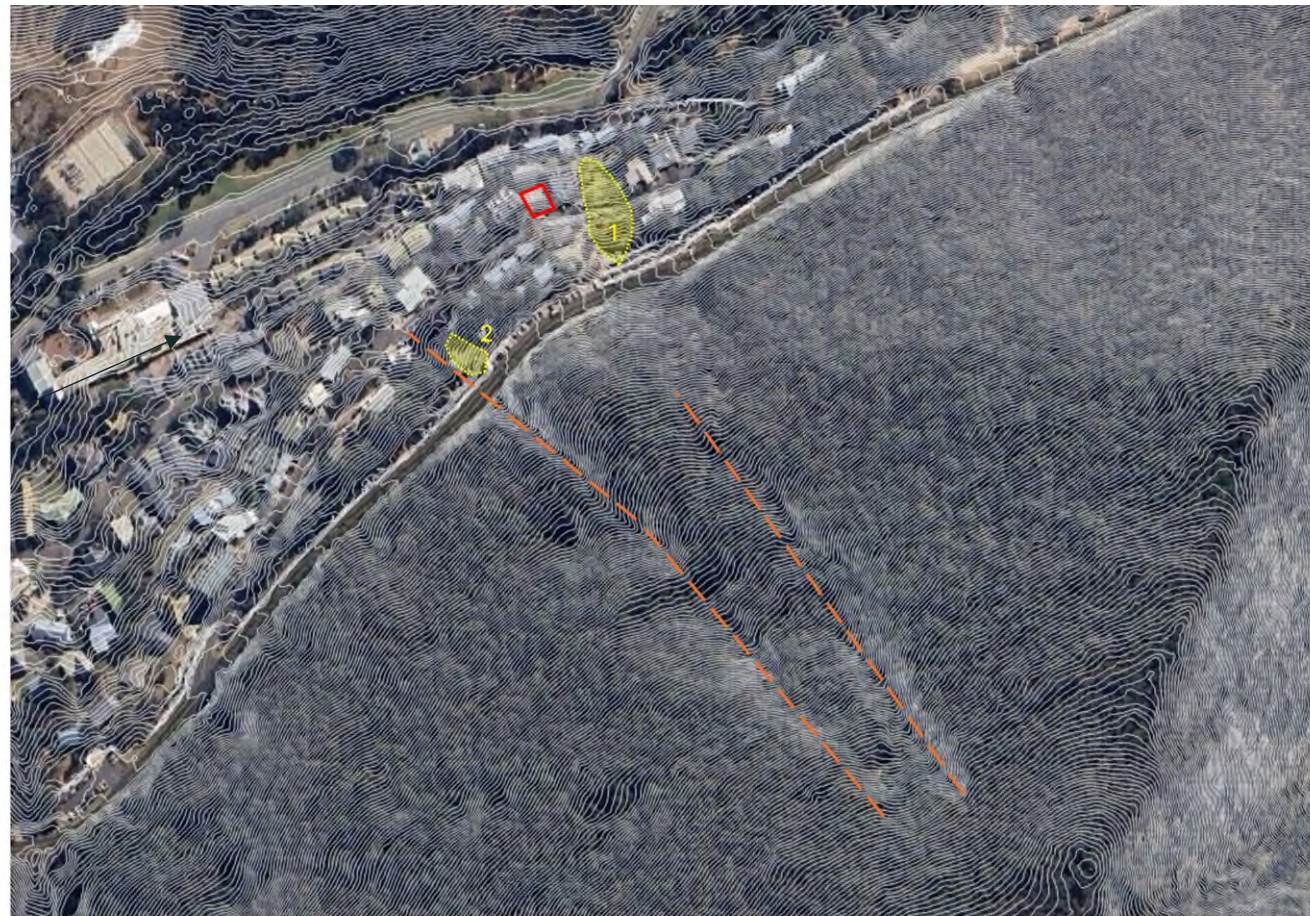
FIGURE 4: CONTOUR MAP WITH SITE LOCATION

Figure 4 shows the landslides that we were able to locate. The figure illustrates that the most destructive and repeated failures (1964/ Winterhaus and 1997/Carynia) occurred in the intersection of the Alpine Way with two distinctive in the relief creek gullies. The gullies serve as intermittent watercourses or drainage lines. The position of the Sonnblick Lodge is between these two gullies, which would decrease the likelihood of that failure.

Previous large-volume landslides:
 - 1 – Carinya Lodge July 1997
 - 2 – Winterhaus Lodge
