# **Hazardous Chemicals Assessment**

**Blakebrook Public School**

3 August 2023

Project Ref: 754-SYDGE319200-1

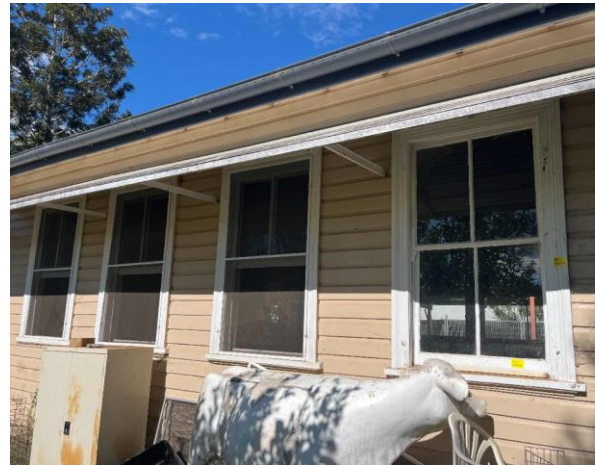
Line ID 2: External, Building A, Throughout, Wooden Framed Windows, Window Caulking - No Asbestos Detected

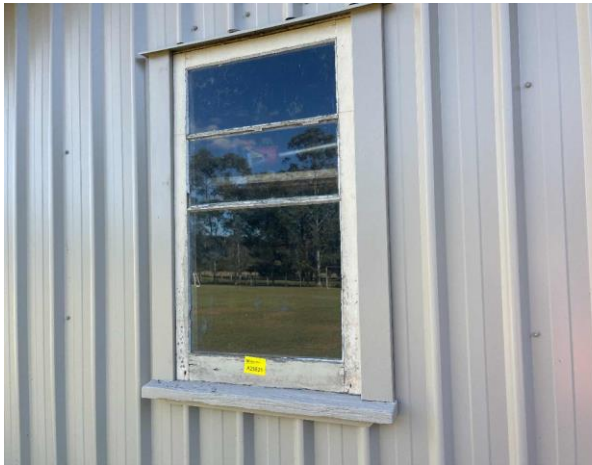
Line ID 3: External, Building D, Eastern Wall, Wooden Framed Window, Window Caulking - No Asbestos Detected

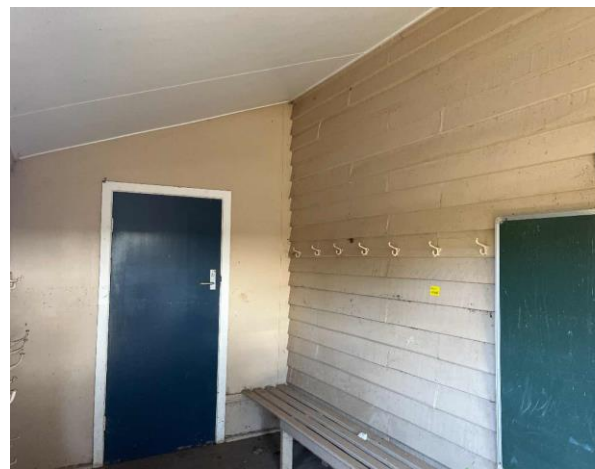
Line ID 6: External, Building E, Throughout, Walls, Beige Paint - No Asbestos Detected

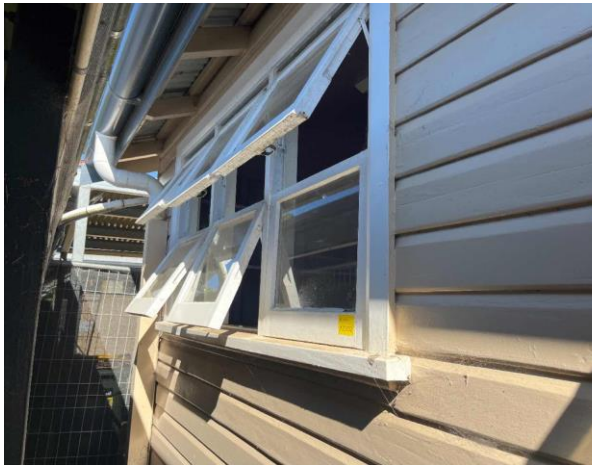
Line ID 7: External, Building E, Throughout, Wooden Windows, Window Caulking - No Asbestos Detected

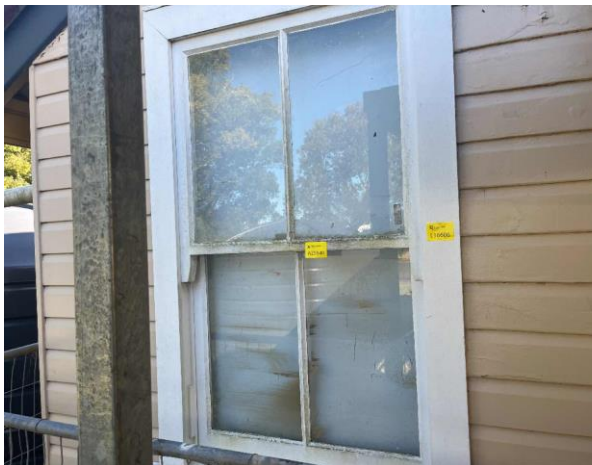
Line ID 9: External, Building F, South Side, Window Frame, Window Caulking - No Asbestos Detected

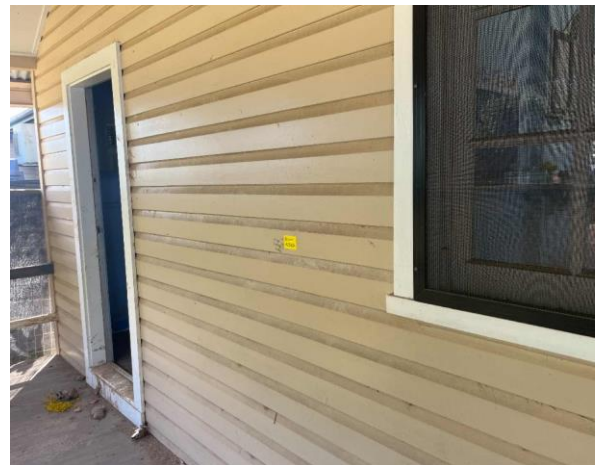
Line ID 10: External, Building F, Throughout, Walls, Cream Paint - No Asbestos Detected

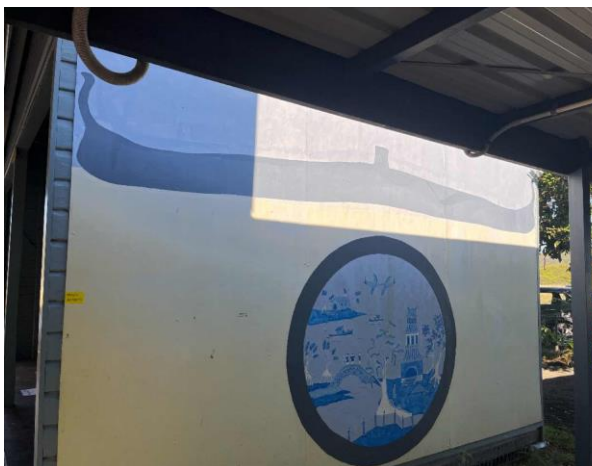
Line ID 11: External, Building G, Throughout, Wall, Fibre Cement Sheet - No Asbestos Detected

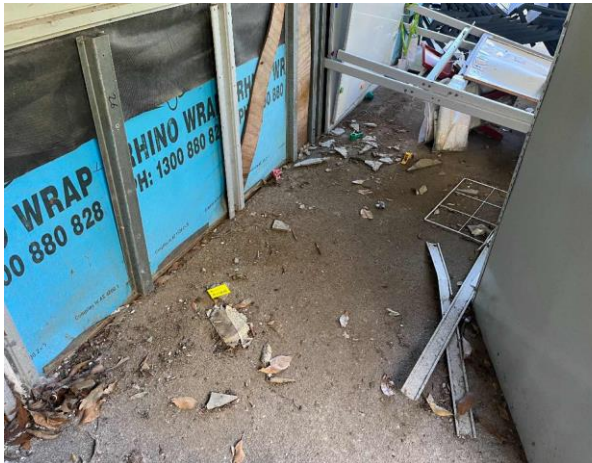
Line ID 13: External, Building I, Throughout, Debris, Compressed Cement Sheet - No Asbestos Detected

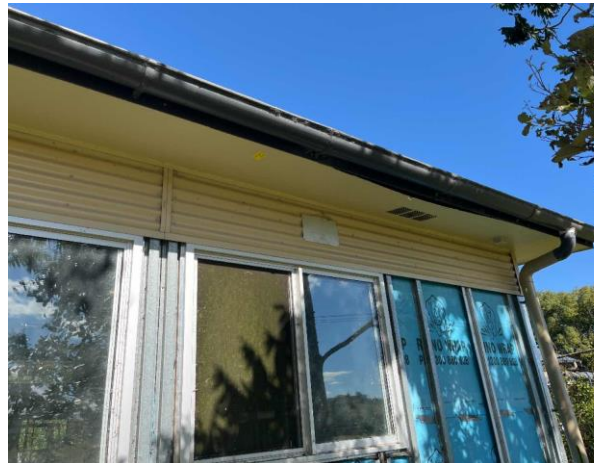
Line ID 14: External, Building I, Throughout, Eaves, Fibre Cement Sheet - No Asbestos Detected

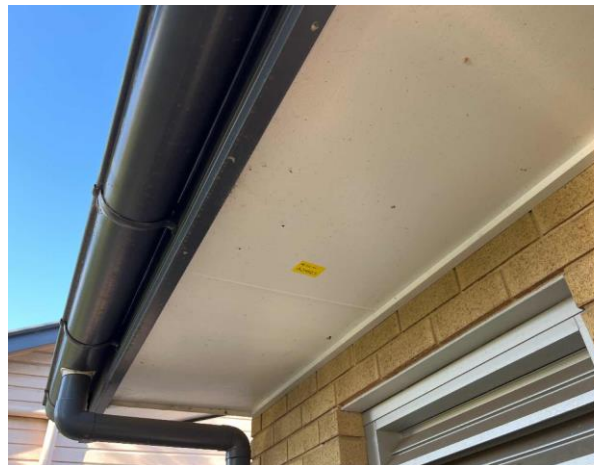
Line ID 16: External, Building J, Throughout, Eaves, Fibre Cement Sheet - No Asbestos Detected

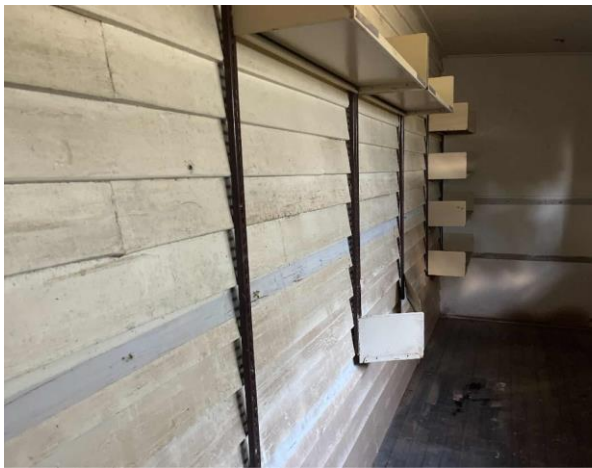
Line ID 24: Internal, Building E, Western Room, Walls, Beige Paint - No Asbestos Detected

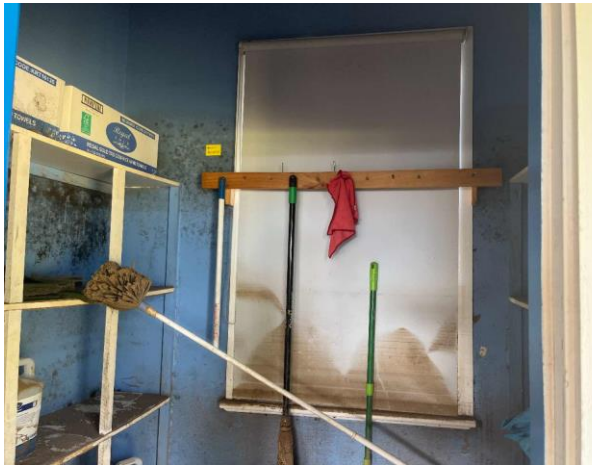
Line ID 28: Internal, Building F, Southwest Storeroom, Walls, Compressed Cement Sheet - No Asbestos Detected

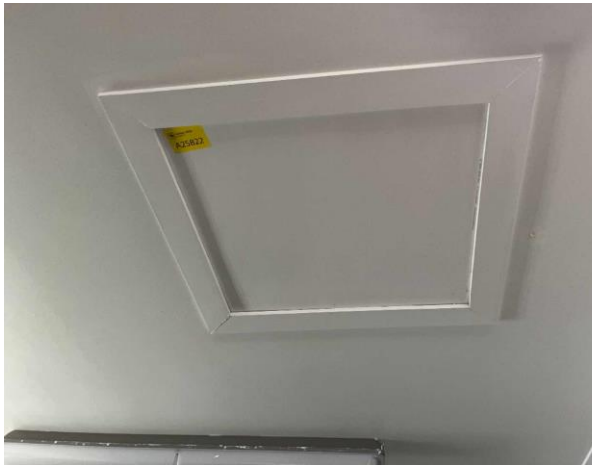
Line ID 31: Internal, Building J, Boys Toilet, Man Hole Cover, Fibre Cement Sheet - No Asbestos Detected

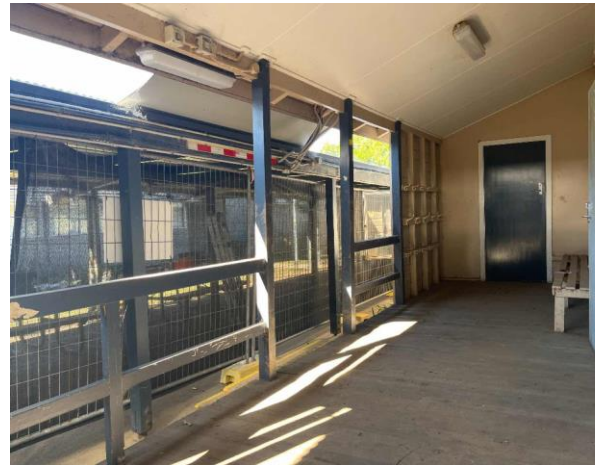
Line ID 36: External, Building E, Throughout, Posts, Railings and Doors, Blue (Dark) Paint - Lead Detected (0.009% w/w)

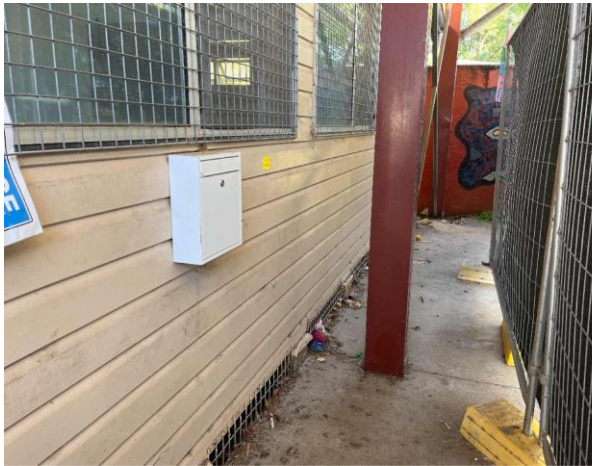
Line ID 37: External, Building E, Throughout, Walls, Beige Paint - Lead Detected (0.04% w/w)

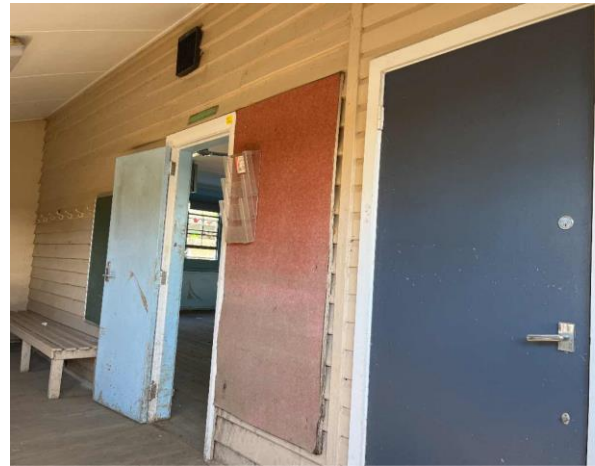
Line ID 38: External, Building E, Throughout, Windows and Door Frames, White Paint - Lead Detected (0.03% w/w)

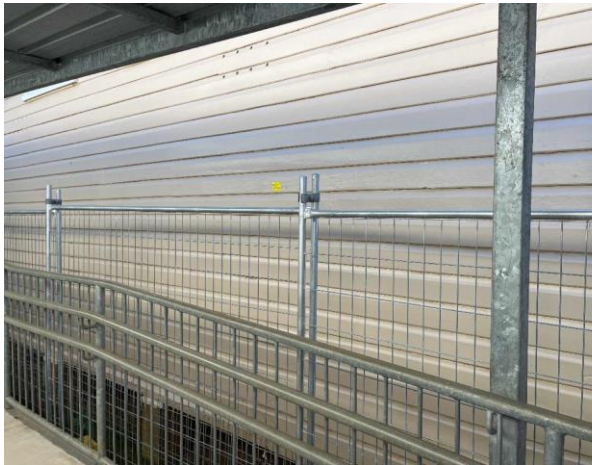
Line ID 41: External, Building F, Throughout, Walls, Beige Paint - Lead Detected (0.065% w/w)

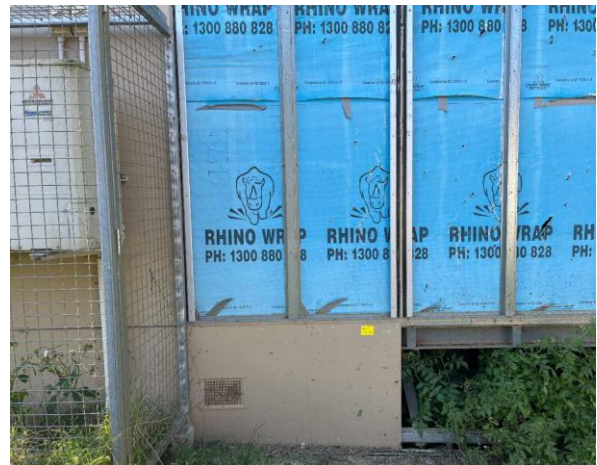
Line ID 44: External, Building I, Throughout, Walls, Beige Paint - Lead Detected (<0.005% w/w)

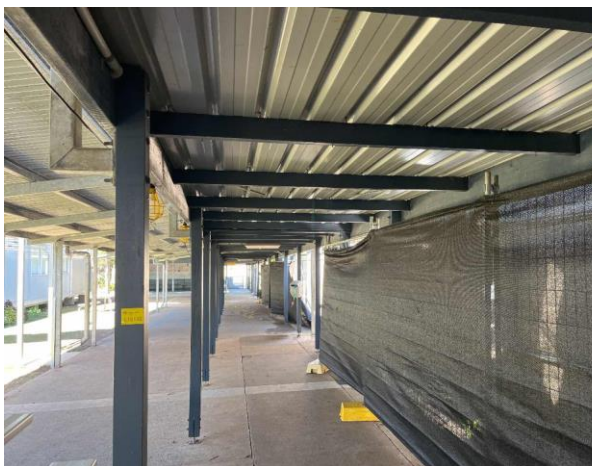
Line ID 45: External, Walkways, Throughout, Timber to Cover, Blue (Dark) Paint - Lead Detected (<0.005% w/w)

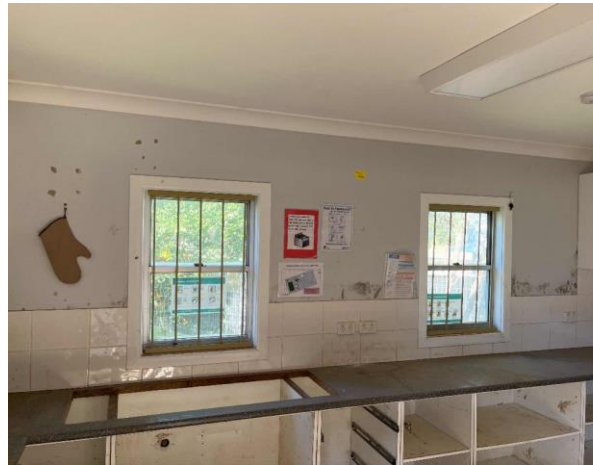
Line ID 48: Internal, Building C, Throughout, Walls, Blue Paint - Lead Detected (<0.005% w/w)

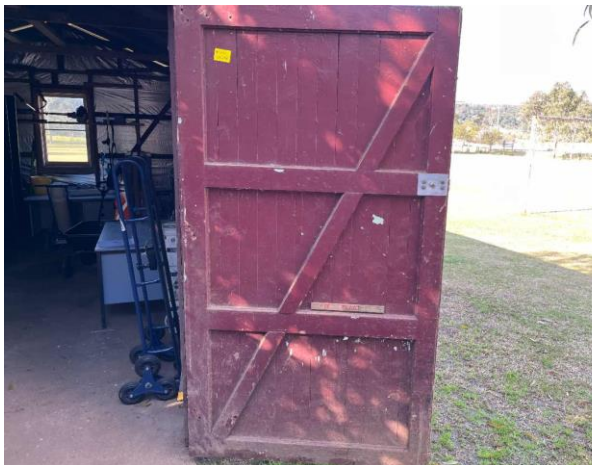
Line ID 49: Internal, Building D, Western Wall, Double Doors, Red (Dark) Paint - Lead Detected (0.054% w/w)

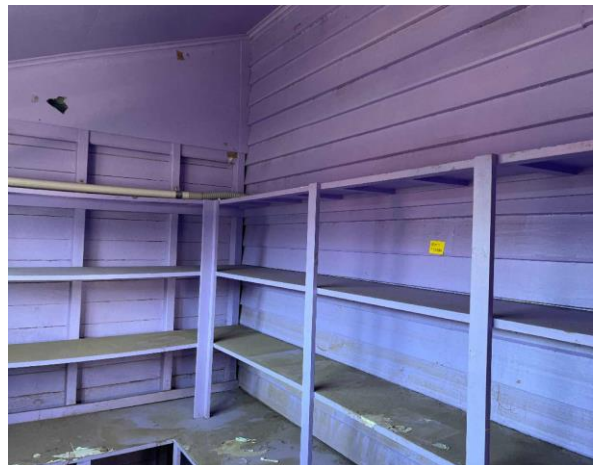
Line ID 51: Internal, Building E, South Eastern Storeroom, Walls and Ceiling, Purple Paint - Lead Detected (0.02% w/w)

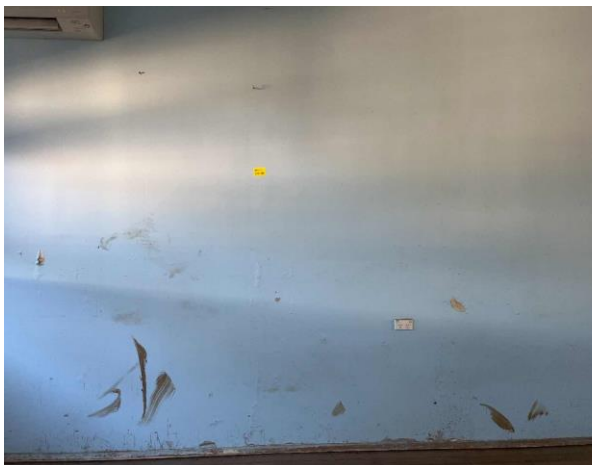
Line ID 52: Internal, Building E, Throughout, Walls, Blue (Light) Paint - Lead Detected (0.086% w/w)

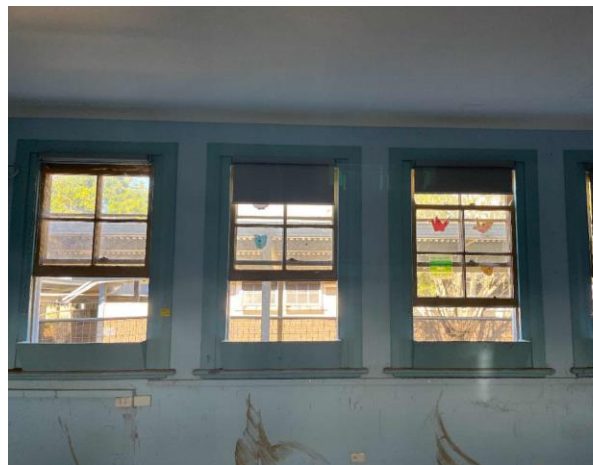
Line ID 53: Internal, Building E, Throughout, Window Frames, Blue Paint - Lead Detected (0.089% w/w)

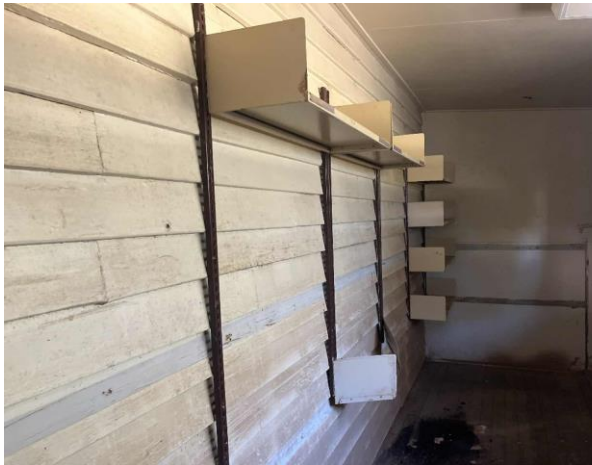
Line ID 54: Internal, Building E, Western Room, Eastern Wall, Beige Paint - Lead Detected (0.04% w/w)

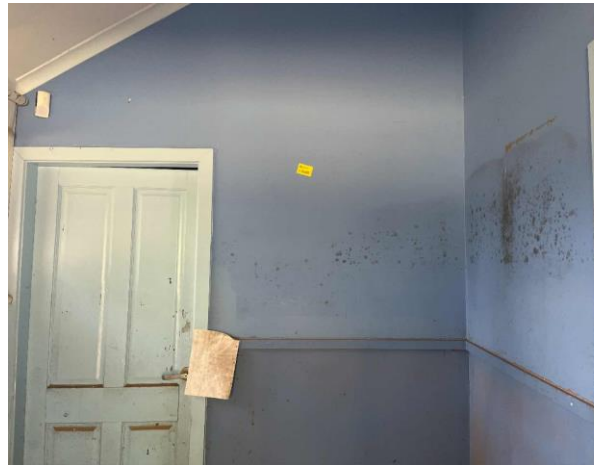
Line ID 55: Internal, Building F, North West Room, Walls, Blue (Dark) Paint - Lead Detected (<0.005% w/w)

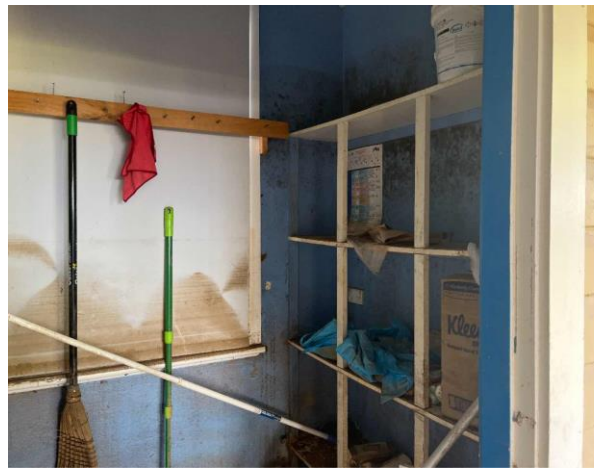
Line ID 57: Internal, Building F, Southwest Storeroom, Walls, Blue (Dark) Paint - Lead Detected (<0.005% w/w)

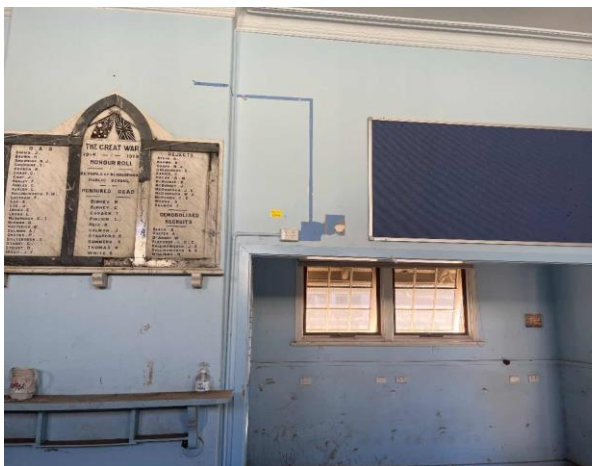
Line ID 58: Internal, Building F, Throughout, Walls, Light Blue Paint - Lead Detected (0.082% w/w)

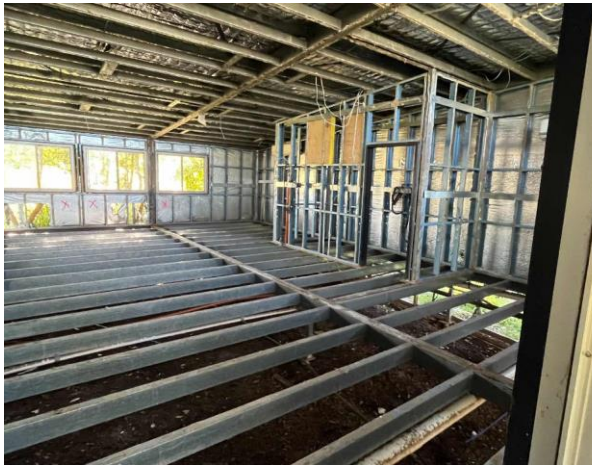
Line ID 66: Internal, Building I, Throughout, Walls and Ceiling, Sarking Insulation - Suspected SMF

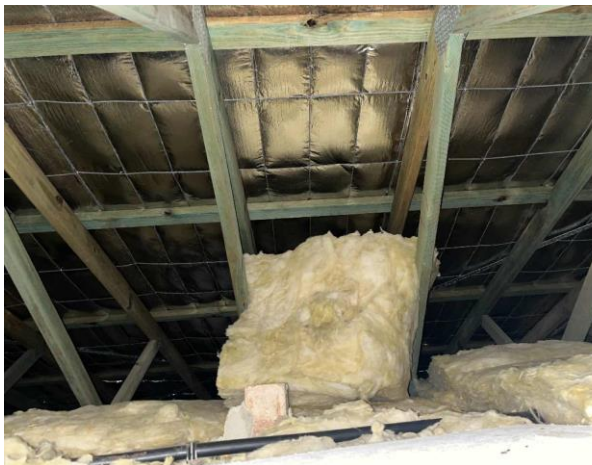
Line ID 68: Internal, Building J, Throughout, Ceiling Void, Sarking - Suspected SMF

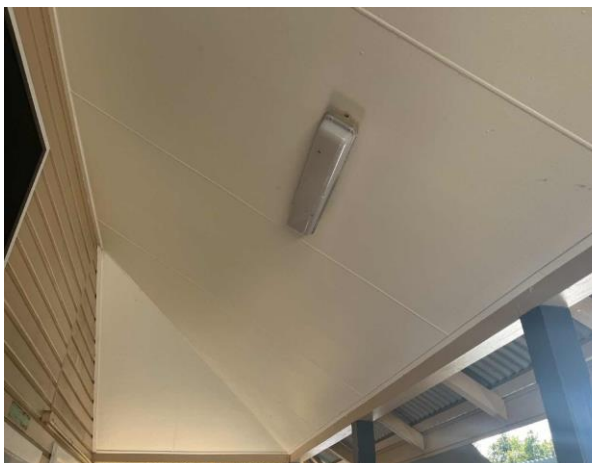
Line ID 70: External, Building F, East and West Verandah, Lights, Capacitor(s) - Non PCB Material

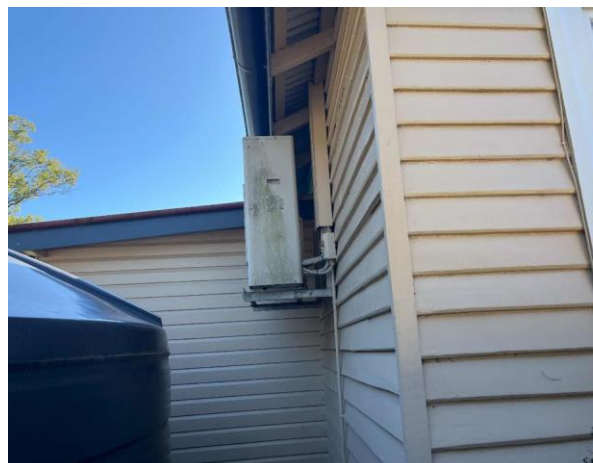
Line ID 71: External, Building E, Western Side, Daikin Air Conditioning unit, R410A Hydrofluorocarbon (HFC) - Non ODS Refrigerant

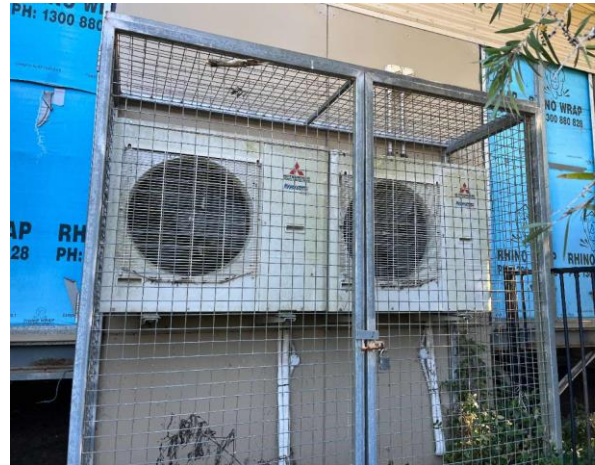
Line ID 73: External, Building I, Eastern and Western Sides, Mitsubishi Air Conditioning Units, R410A Hydrofluorocarbon (HFC) - Non ODS Refrigerant

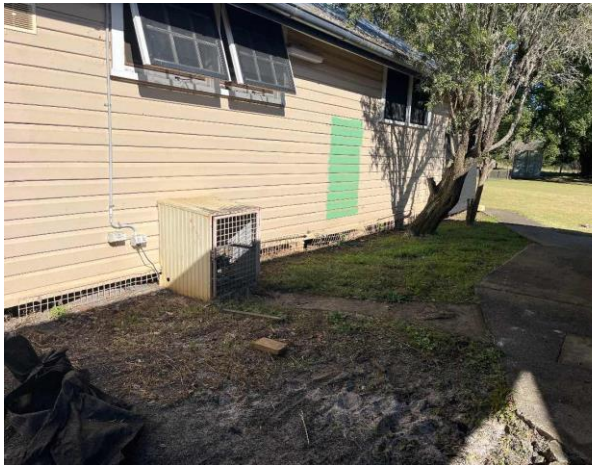
Line ID 74: External, Building F, Subfloor – No Access

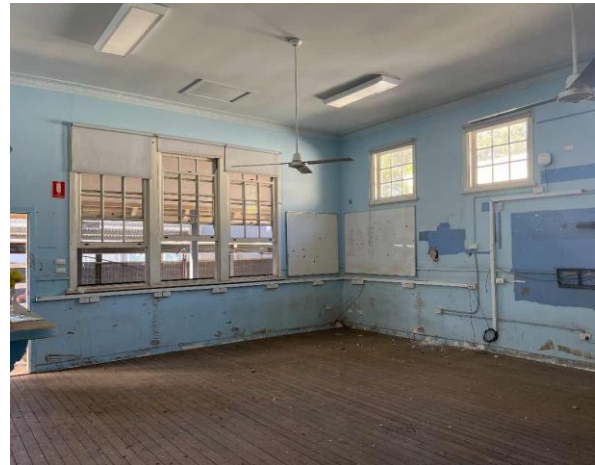
Line ID 76: Internal, Building F, Ceiling Void – No Access
