Arboricultural Impact Assessment

14 Victory Street, Belmore
NSW, 2192
3/-/DP347819
16/02/2024

Temporal Tree Management Pty Ltd.

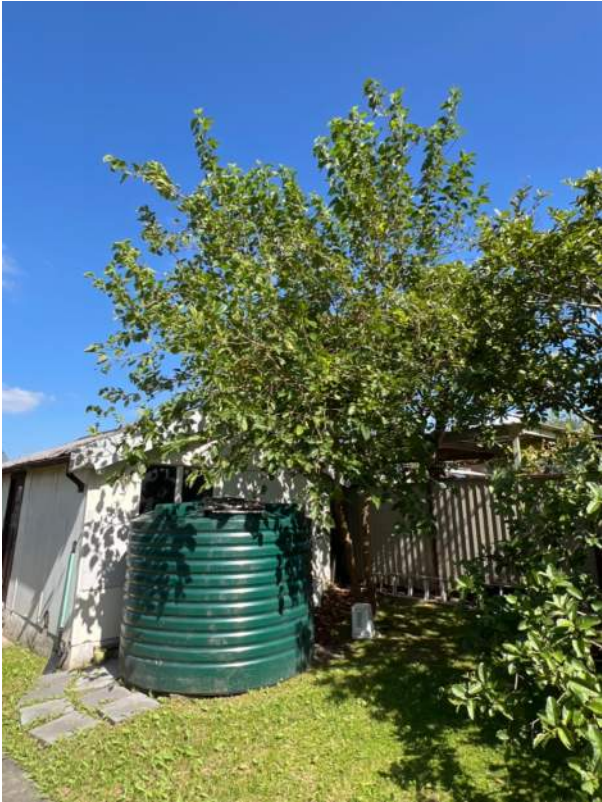
Guava Primary ID #1055889

4	Morus alba	Mulberry	Semi mature	7	4	14	20	Good	Fair	Medium	Low	Low	2.0	1.7	Maturing tree of low species value observed to be in mostly good condition. Stem becomes codominant at ground level.
5	Psidium guajava	Guava	Mature	3	4	15	22	Good	Fair	Medium	Low	Low	2.0	1.8	Small specimen of low species value.
6	Mangifera indica	Mango	Mature	6	3	20	25	Good	Poor	Medium	High	Moderate	2.4	1.8	Smaller tree positioned 0.5 metres outside western boundary within neighbouring property. External ownership renders tree of High retention value. Canopy has been lopped. Poor canopy structure underpinned trees reduced ULE estimate.
7	Mangifera indica	Mango	Mature	6	4	20	25	Good	Poor	Medium	High	Moderate	2.4	1.8	Smaller tree positioned 0.5 metres outside western boundary within neighbouring property. External ownership renders tree of High retention value. Canopy has been lopped. Poor canopy structure underpinned trees reduced ULE estimate.

Trees 2 and 14 will require removal to facilitate the proposed design plan. It is also recommended that Trees 4, 5, 8, 9, 10, 11 and 12, which were determined to be of Low retention value, are removed and replaced as part of the proposed development. Trees 4, 5, 8, 9, 10, 11, 12 and 14 are exempt from the protection controls outlined in *Chapter 2.3 'Tree Management' of the Canterbury Bankstown DCP (2023)* due to their small size or potential invasiveness. These eight trees may therefore be removed without prior consent from the Canterbury-Bankstown Tree Management Officer. Tree 2 is protected under *Chapter 2.3 'Tree Management' of the Canterbury Bankstown DCP (2023)*. Prior consent from Canterbury-Bankstown Council must be obtained prior to commencement of any removal works for Tree 2.
