# Arlberg Ski Lodge - Proposed Extension

## Geotechnical Investigation Report

Arlberg Ski Club Limited

11 April 2024

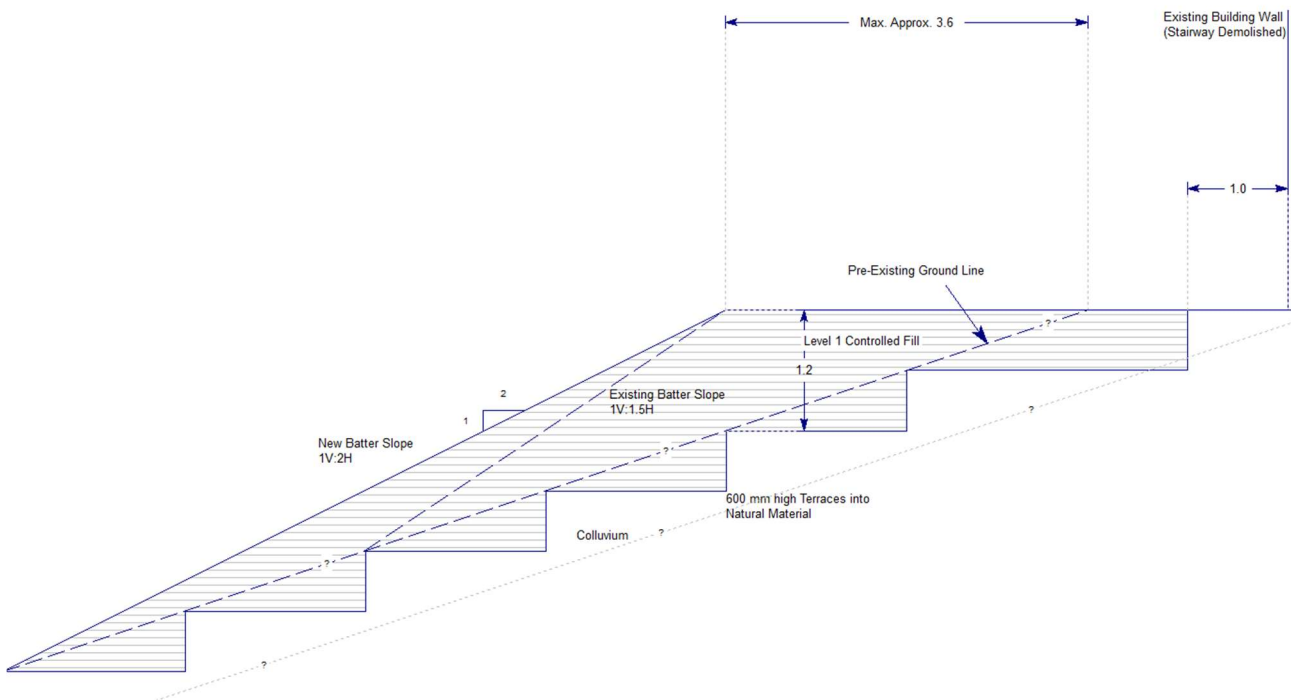
Plate 24 – Conceptual Sketch of Controlled Fill Replacement for Support of the Extension.

It is possible that minor import of fill may be required should the number of cobbles screened out be significant, and due to the recommended controlled fill batter of 1V:2H. Selected material may be used for this purpose, however, the proposed source of material and type of material should be vetted with the project geotechnical consultant prior to use. Material with a CBR of at least 5% and shrink-swell index of less than 1% (or CBR swell of 0.5% or less) is recommended.

For the controlled fill replacement as described above, a site reactivity of up to 40 mm (similar to Class M per AS2870-2011) may be adopted for seasonal moisture changes.

As an alternative to the use of bored pile footing, the existing fill could be reworked and recompacted to form an Engineered Fill platform on which raft/spread footing could then be formed. To do this it is recommended that the existing fill be removed to the level of colluvial soil, and then screened for reuse as controlled filling under Level 1 conditions.,.

The filled area and batters should be provided with suitable vegetation and be made to drain appropriately to prevent future erosion.
