Arboricultural Impact Assessment report

Site address
20 Selwyn Street, Mayfield East NSW 2304

Prepared for property owners
JBC Family Nominees Pty Ltd

24 July 2024

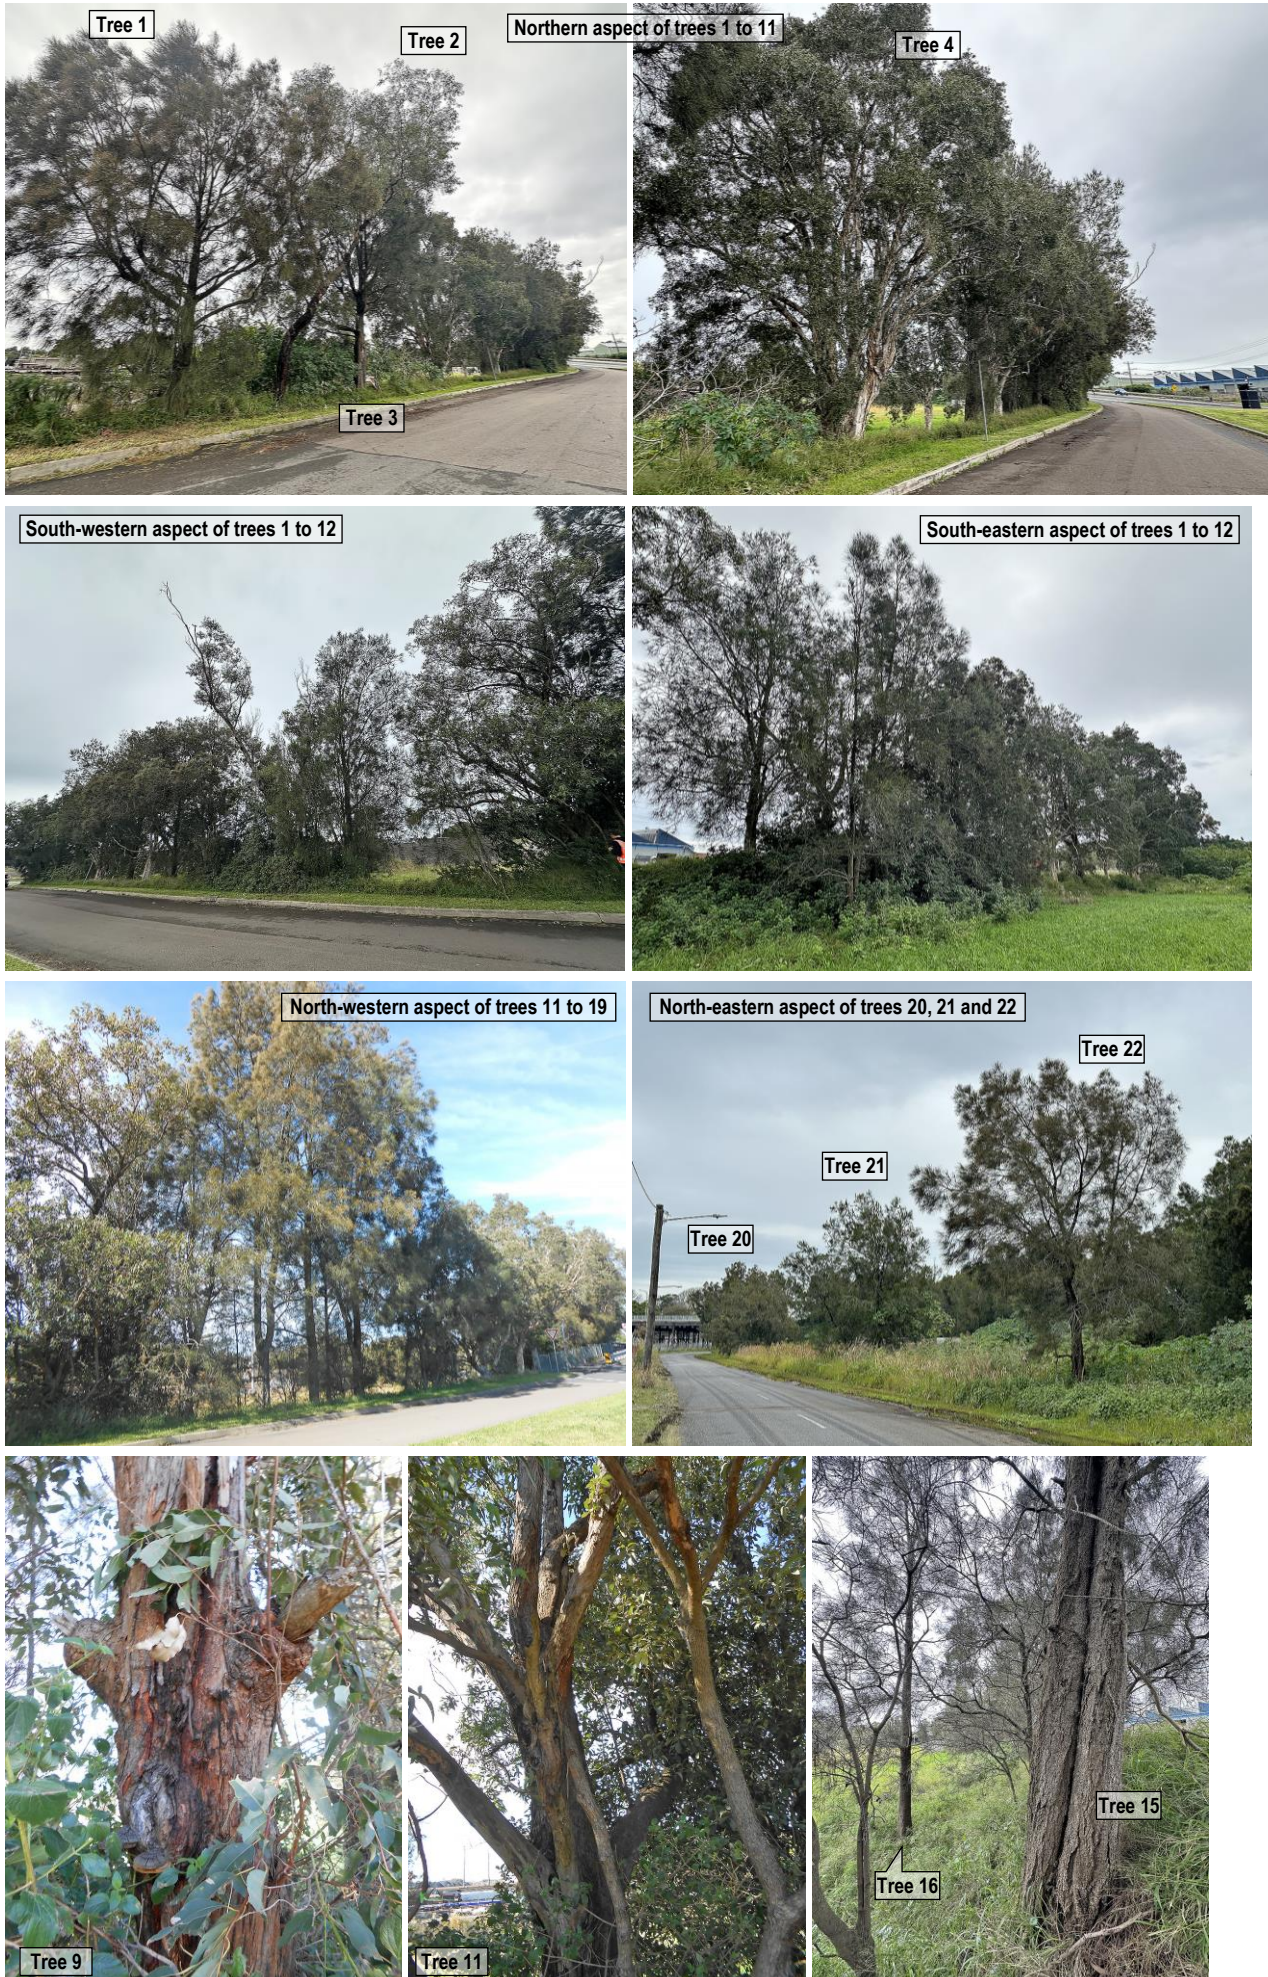
- 9.3. **Tree 3** had experienced a failure of its west scaffold branch, which remains on the ground alongside to its south. This has damaged the trunk and resulted in development of a small cavity which attributes to its average condition. The tree is relatively low in height with good basal flare indicating that it may recover from this failure without loss of stability. The tree has a moderate average crown size of 64m² and is of high retention value.

- 9.4. **Tree 4** is the largest and most prominent tree assessed. The one enveloping scaffold branch may eventually anastomise but would otherwise be end-weighted or removed to avoid buffeting damage to the trunk. It has a stout trunk with a low centre of gravity, no structural issues, and is in good health with normal vigour. This tree is long term sustainable, in good health qualifying for a high retention value and high landscape significance.

- 9.5. **Tree 5** has a rib formation at its main branching junction. This rib has formed because of included bark. The thickness of the rib suggests adaptive wood has reinforced this area to reduce failure potential of one or the other of its structural branches. This is a mature tree with a large average crown size of 89m². It is in overall good condition and has long term sustainability.

- 9.7. **Tree 7** is a mature tree with good form. It appears in poor health, vigour and in fair condition because of its lack of foliage cover contributing to low photosynthesis. However, branching is balanced, and it has a moderate average crown size of 55m² contributing to its high retention value.
