# Arborist Impact Assessment

Proposed Manufactured Home Estate  
Lot 100 DP1286524 & Lot 11 DP615229  
40-80 & 82 Chapmans Road Tuncurry, NSW

**9 December 2024**

**AEP Ref: 3295**

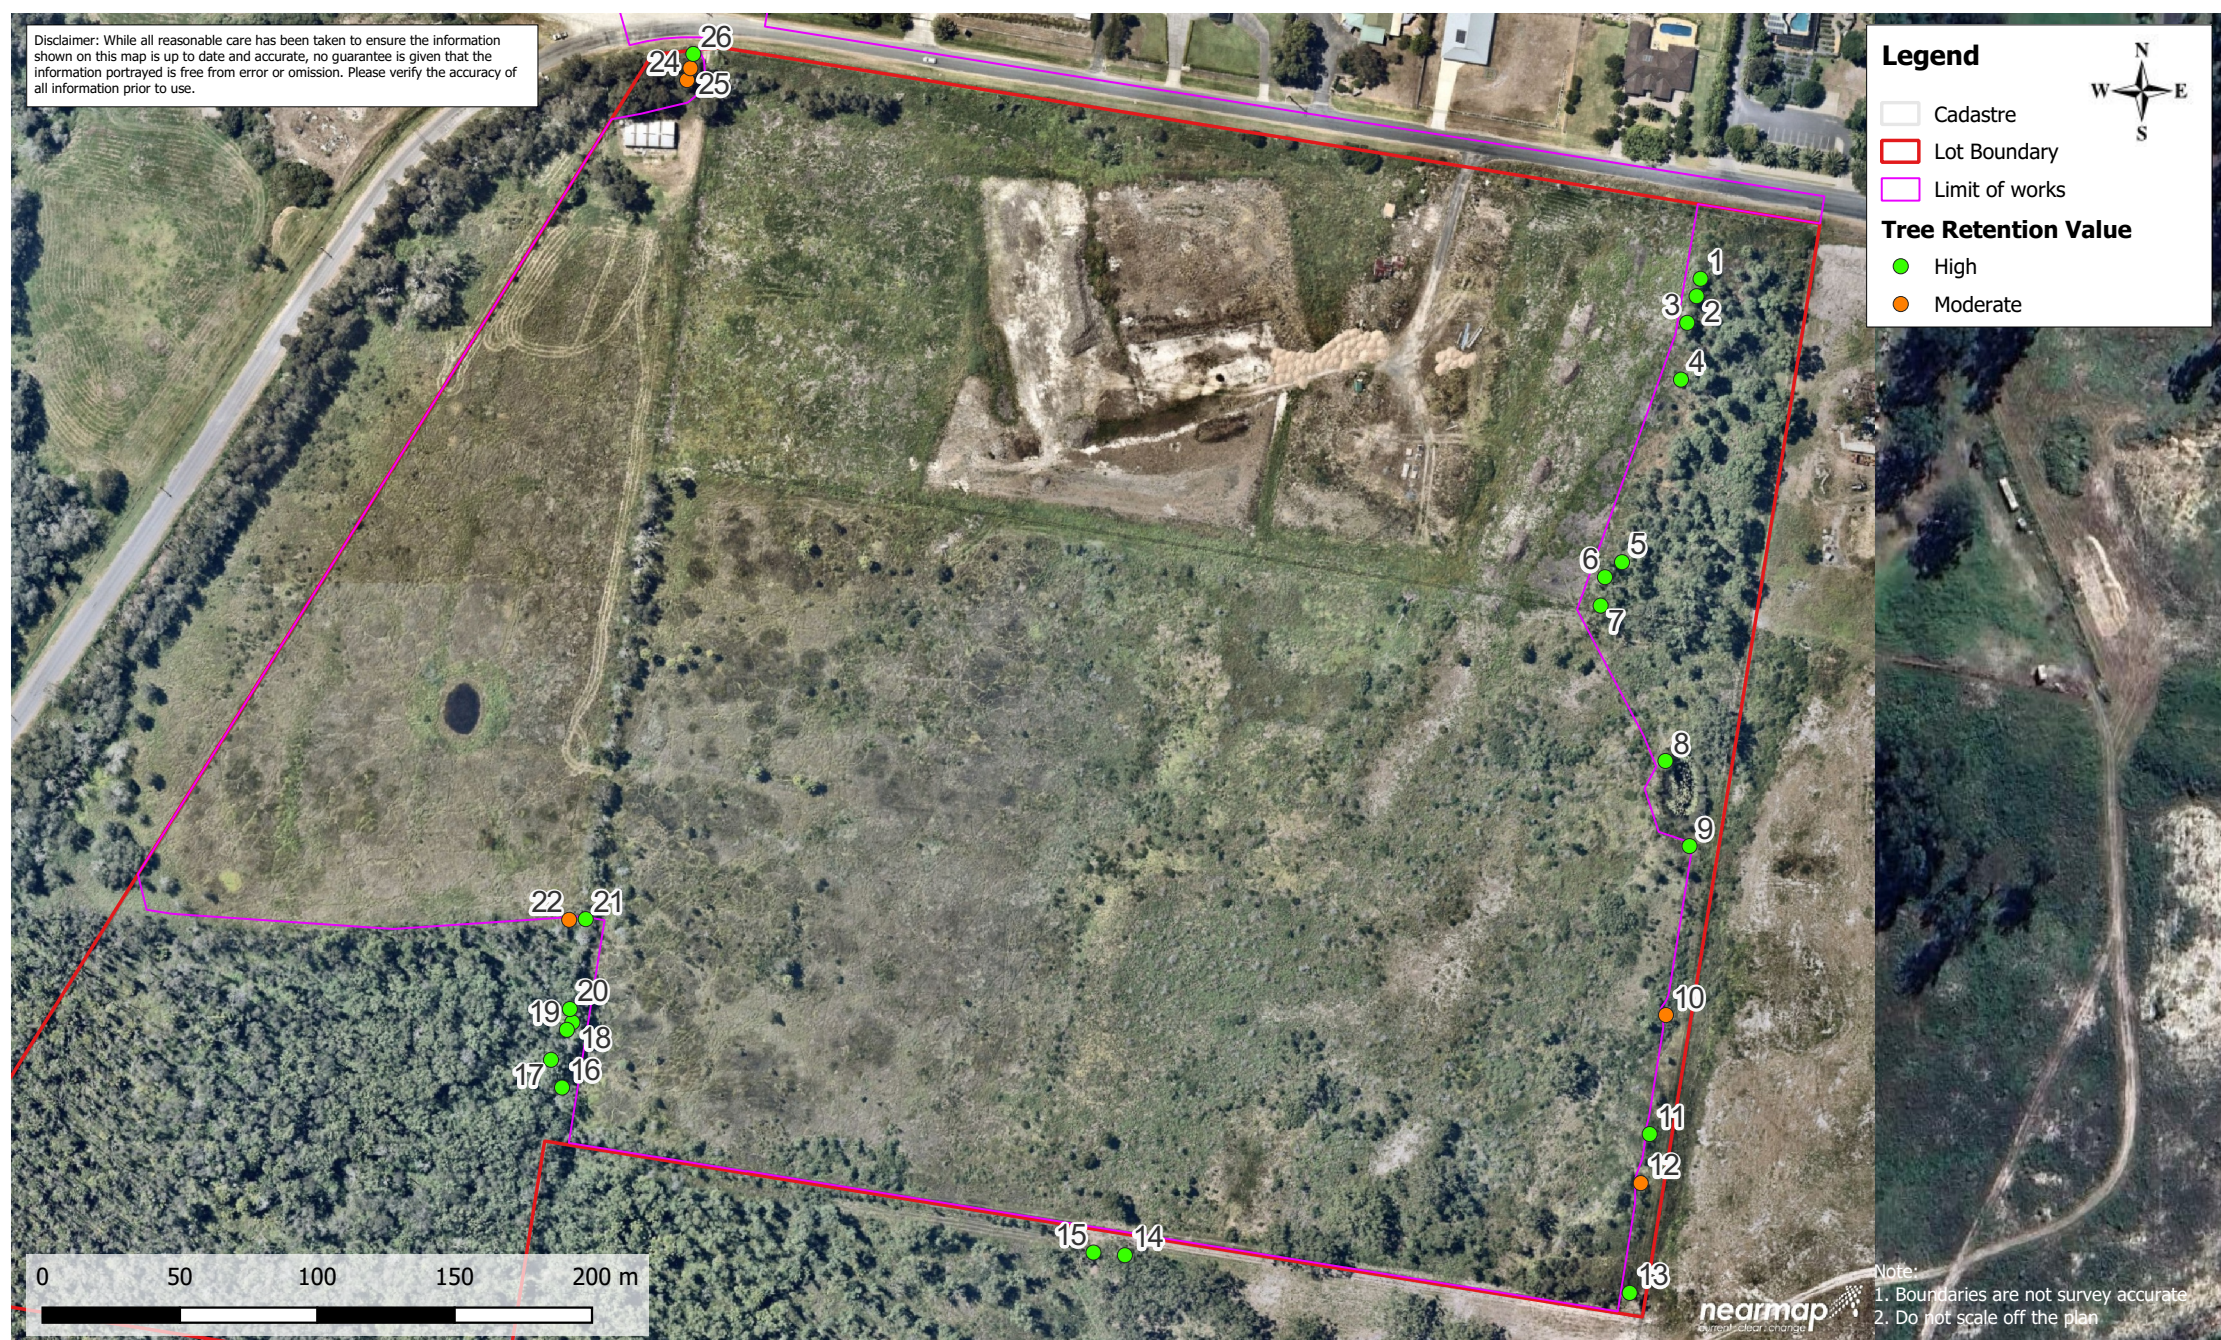
Figure 3 - Tree Locations

A total of 26 trees identified within the site and neighbouring properties were assessed. Clusters of emerging trees were evaluated. Observations were made for each assessed tree (**Appendix A**). Tree locations are shown in **Figures 3**.
