STRUCTURAL

Engineering Report

34 Lostock School Road, Lostock

25 October 2024

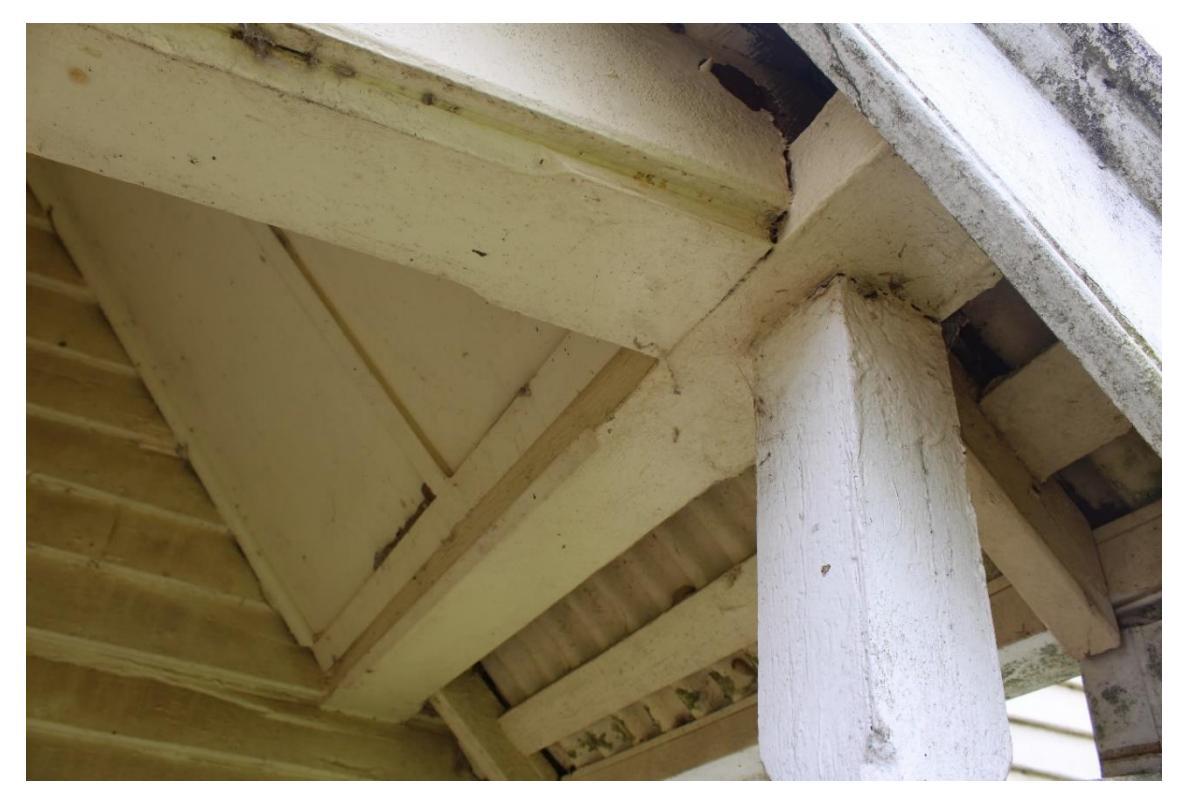
Figure 10

Many of the piers were unable to be inspected due to limited subfloor space, however the condition of those able to be viewed appeared poor with cracking to the timber and general degradation. The piers appear to have sunk up to 300mm in varying locations across the site (refer Figures 10 and 36).

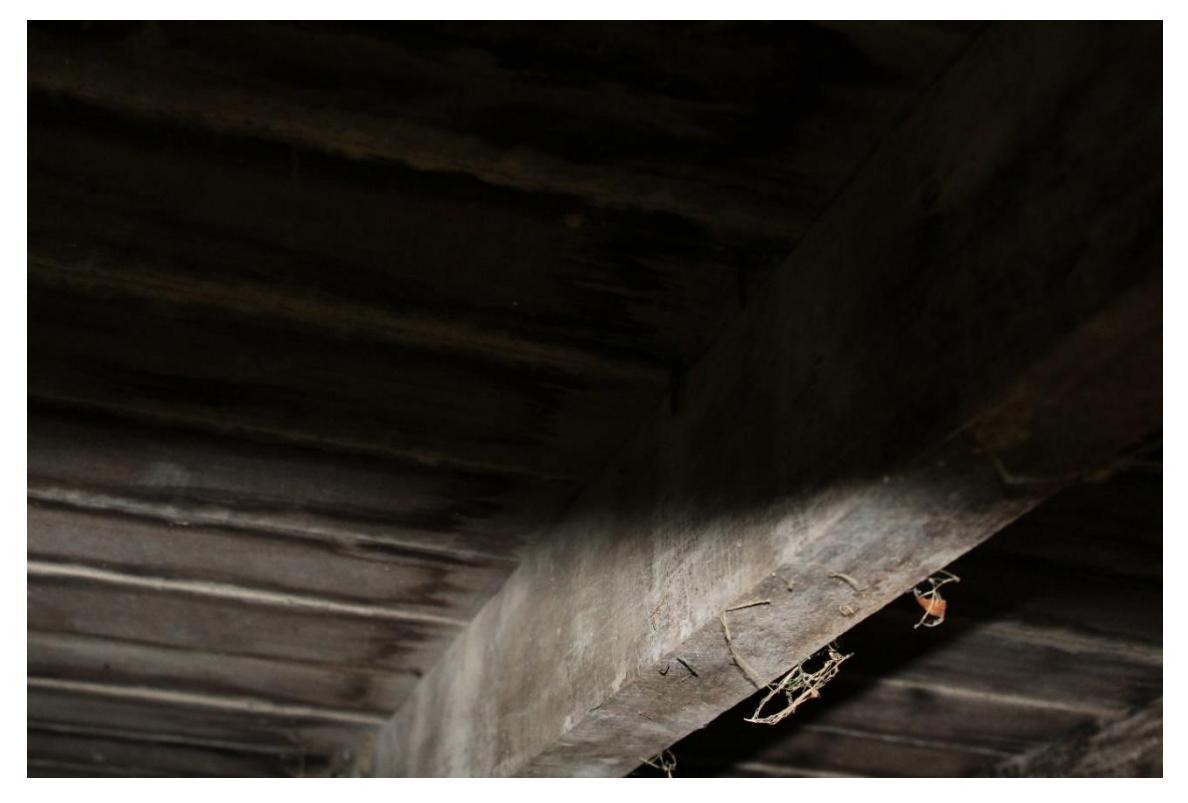
Figure 16

- **Subfloor ventilation:** The settlement of the piers has resulted in the weather boards being in contact with the ground (see photos 4 and 36). This has reduced any subfloor ventilation, evidenced by the damp noted. Damp subfloor we know is likely to result in mould and mildew growth, pest infestation and wood rot to the structure. See photos (14, 15, 16, 26 and 29) for evidence of water ingress.
