**RE: Proposed Dwelling**  
**16B The Saddle, Tallwoods Village (Lot 2 DP1279242)**  
**Geotechnical Assessment**

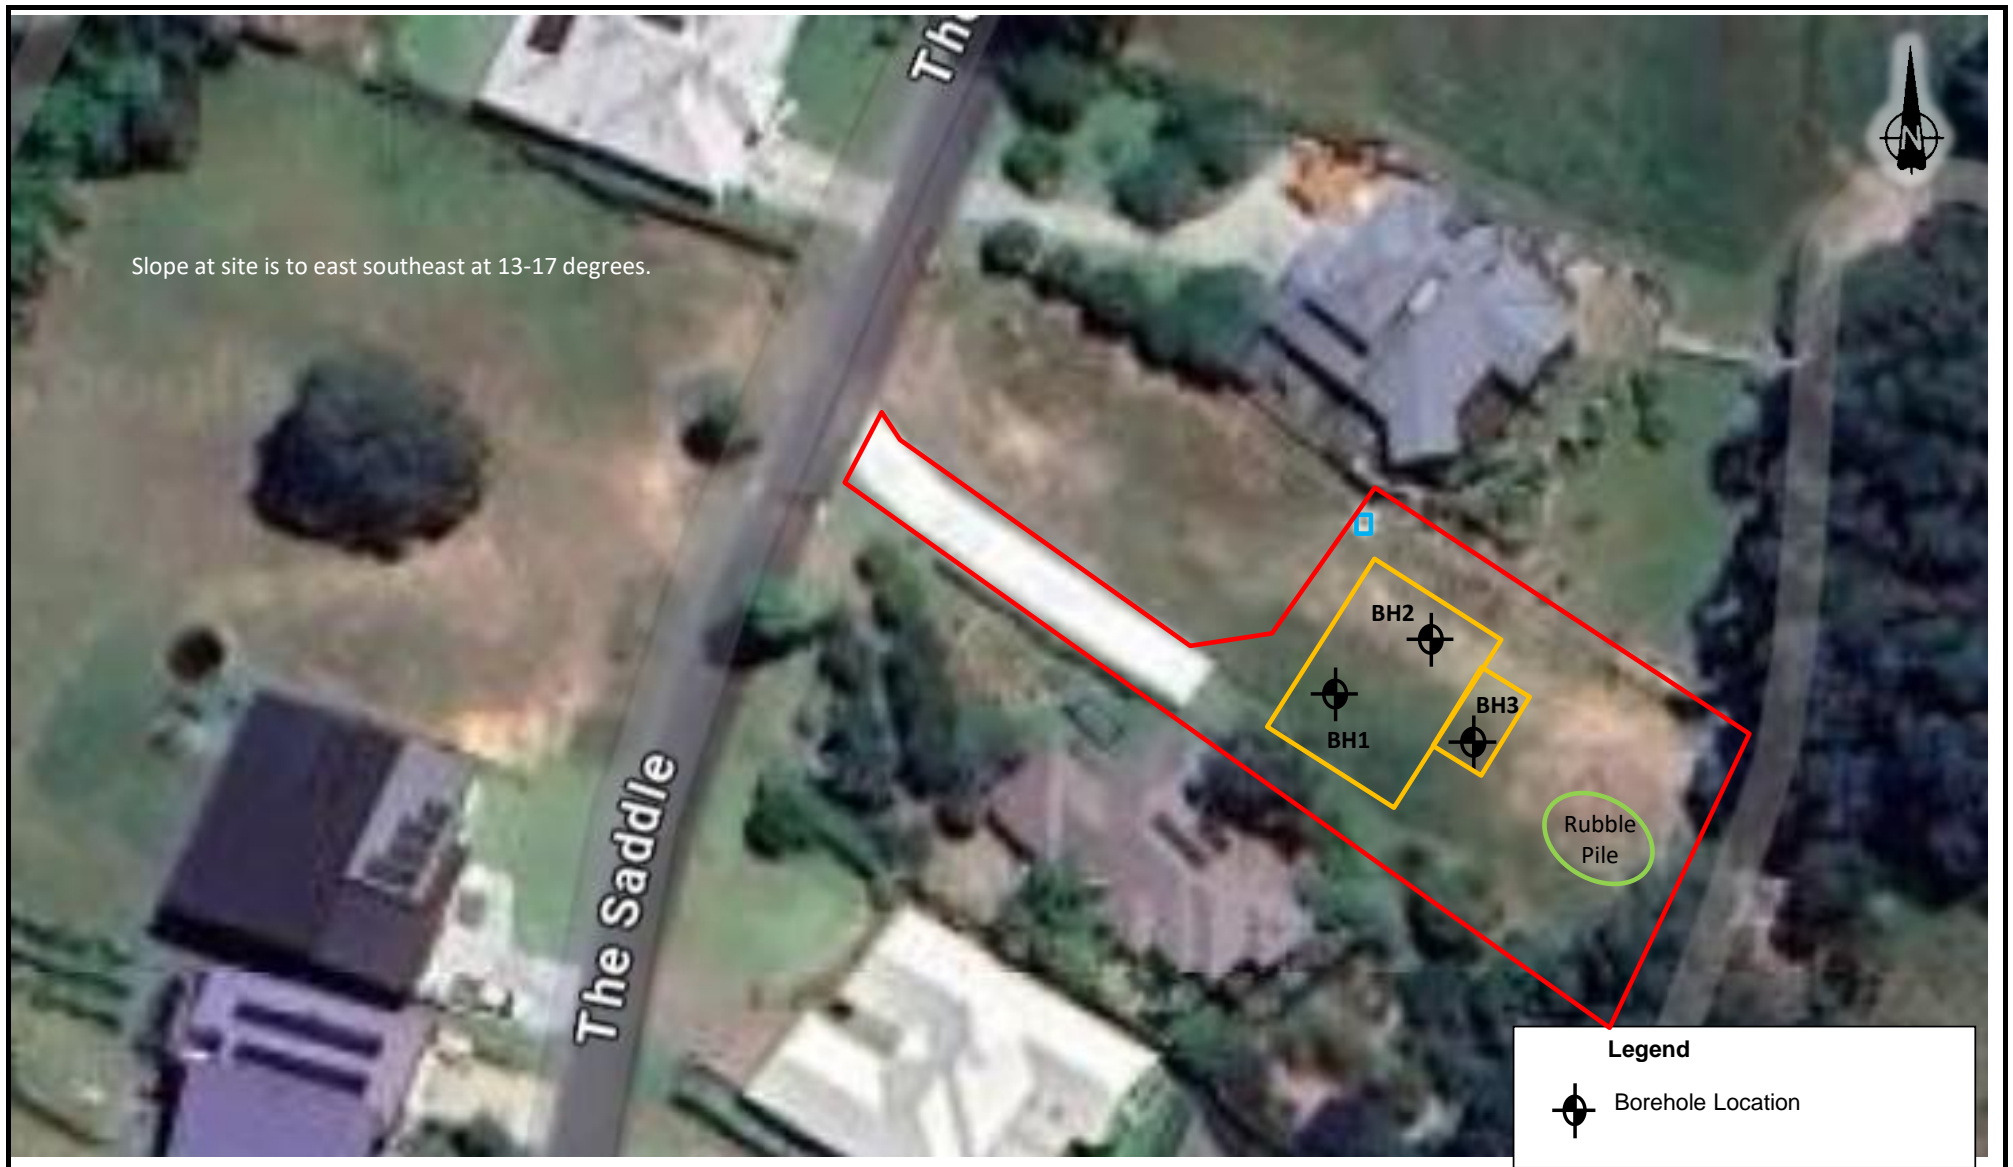
<b>REGIONAL GEOTECHNICAL SOLUTIONS</b>	<b>Client</b>	Jason McKinley	Job No.	RGS03697.1
	<b>Project:</b>	Proposed Dwelling	Drawn By:	JD
		16B The Saddle, Tallwoods Village	Date:	31-Mar-25
	<b>Title:</b>	Borehole Location Plan	Drawing No.	<b>Figure 1</b>

Engineering logs of the boreholes are attached. Test locations are shown on the attached Figure 1.
