Murray River Adventure Trail  
Arboricultural impact assessment report

23037 mrat0524\_AIA

19 July 2024

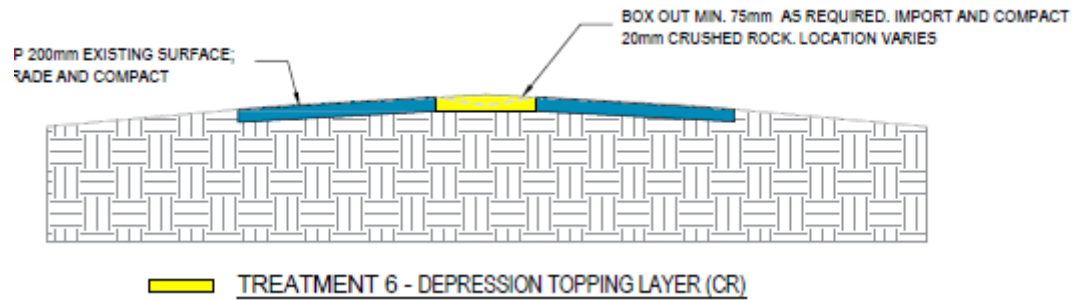
*Our most impactful works relate to the rectification of soft spots or repairs of rutting along these sections. Where removal / ripping and recompacting of unsuitable ground would go to a depth of 200mm below existing surface.*

*These areas are localised to areas of poor / damaged subgrade.*

*Then crushed rock would be placed on top.*
