## Geotechnical Assessment

# Proposed Residential Development 460 Kolodong Road, Taree NSW

Report Ref: G1246-SCFP-001-Rev0

10 September 2025

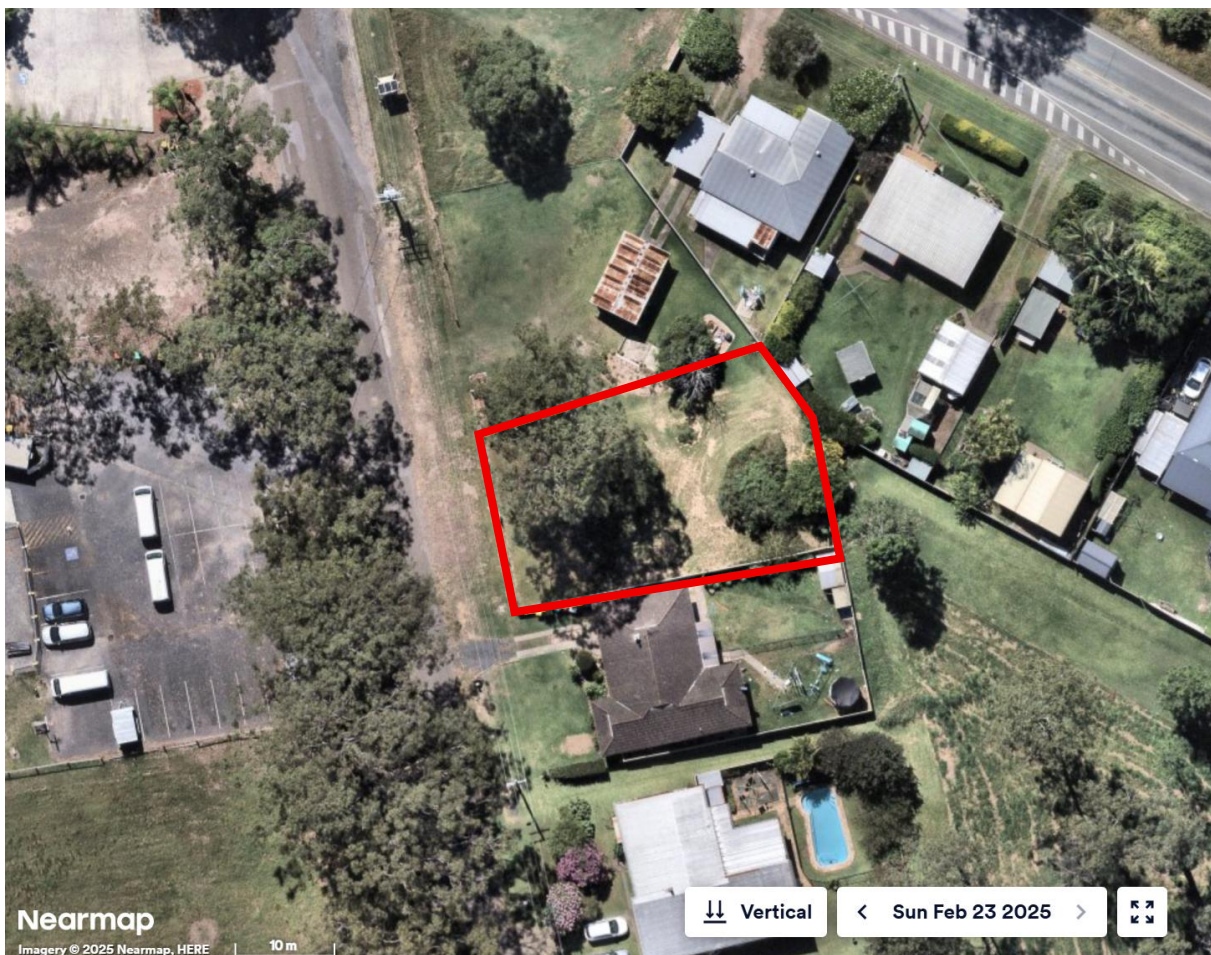
Figure 1: Aerial image obtained from ‘Nearmap’ depicting site and site boundaries

At the time of inspection, the site had been largely cleared, presenting as grassed ground with scattered regrowth vegetation. The central and eastern portions of the block contained immature shrubs and small trees, while several mature eucalypts (up to ~25 m in height) remain within the influence of the proposed building footprint along the frontage. These trees represent both a visual feature and a geotechnical consideration in relation to soil moisture variability.

Surface drainage occurs via overland sheet flow directed downslope to the northeast, supplemented by infiltration into the sandy topsoils. There was no evidence of concentrated erosion or water ponding across the lot. Given the surrounding drainage framework, the site forms part of a subdued slope element that integrates with the broader undulating ridge terrain.

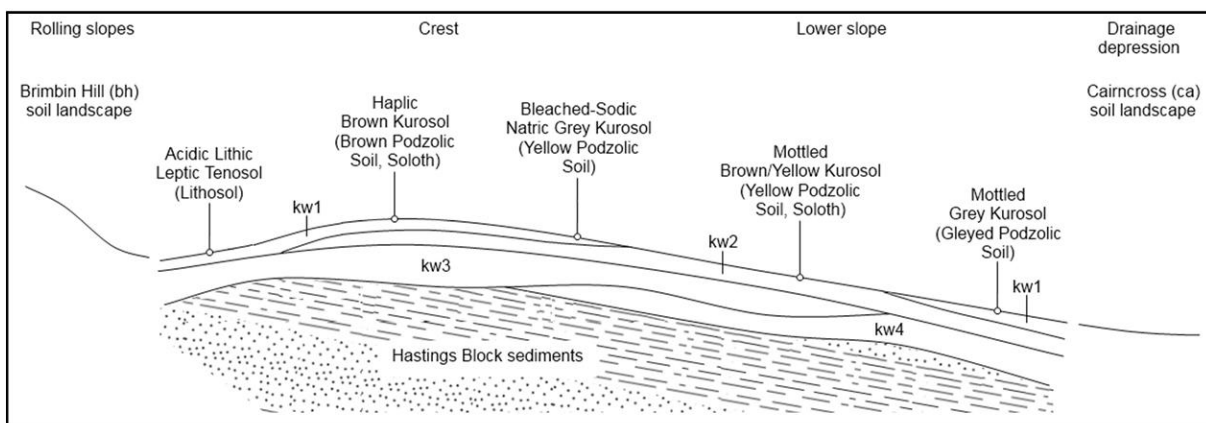
**Figure 6: Kew Colluvial Landscape (eSPADE)**

Reference to published soil landscape mapping (eSPADE), indicates that the site is underlain by the Kew Colluvial Landscape, characterised by undulating rises on Devonian and Carboniferous sediments of the Hastings Block in the Kempsey–Myall Low Hills, and soils comprised of shallow to moderately deep, imperfectly drained Yellow Kurosols on crests, and moderately deep to deep, poorly drained Mottled Yellow Kurosols downslope.

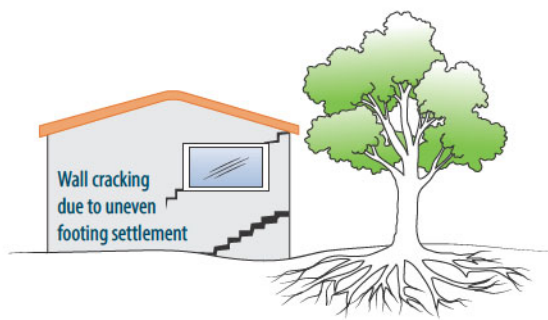
**FIGURE 1** Trees can cause shrinkage and damage.

- ▶ Roots in the vicinity of footings will absorb much of the moisture in the foundation soil, causing shrinkage or subsidence.
