## **Hazardous Building Materials (HAZMAT) Report**

**Former Shoalhaven Anglican School**

**17 Croobyar Milton NSW**

**Project 89390.08**

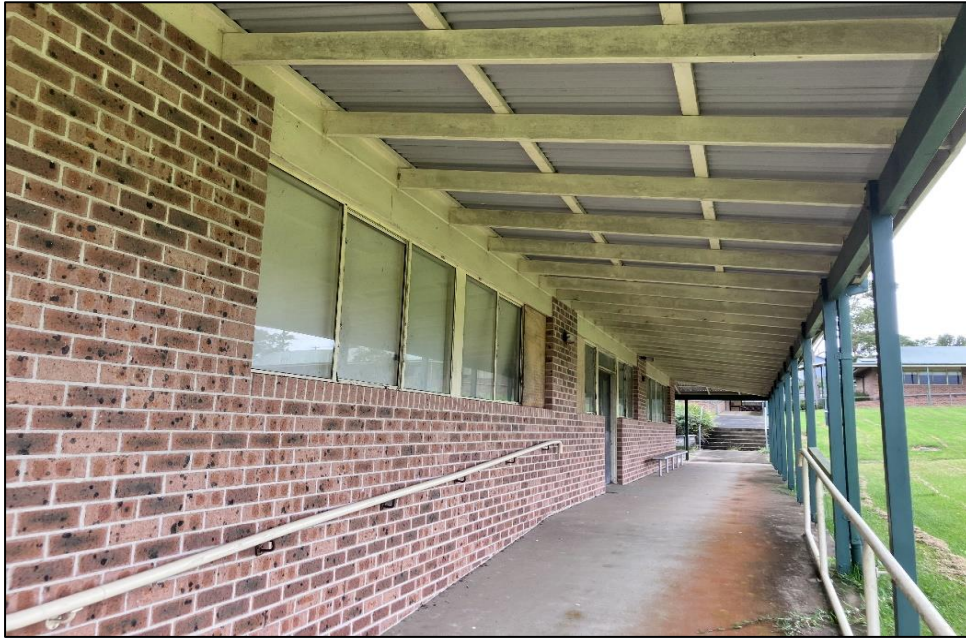
Photograph 3: B00A, exterior, lower level, walls generally, weatherboard linings, suspected non-asbestos.

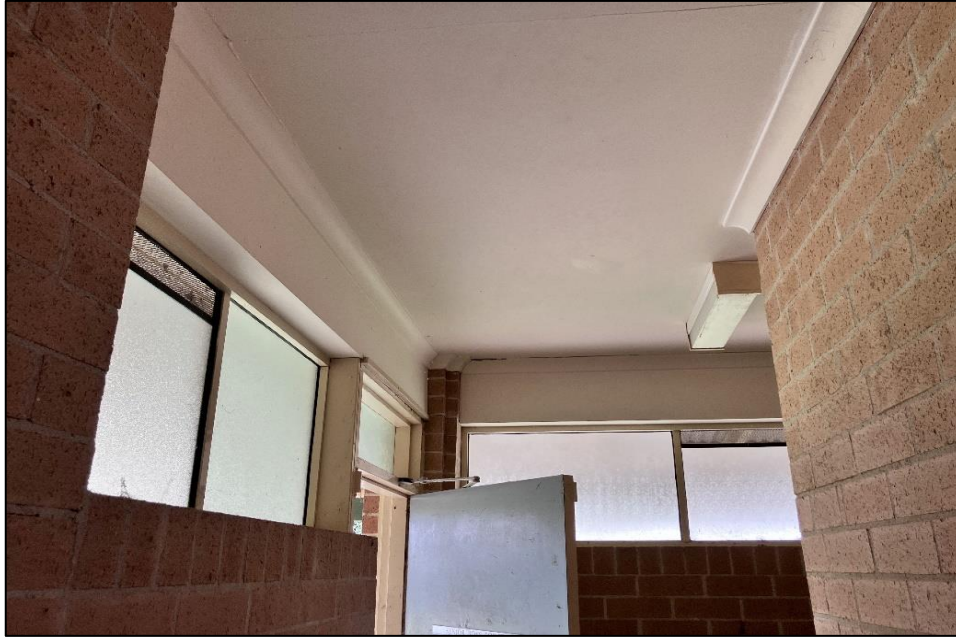
Photograph 5: B00A, AR0018 / 19, wall infill and ceiling linings, fibre cement sheeting, no asbestos suspected and/or detected by analysis.

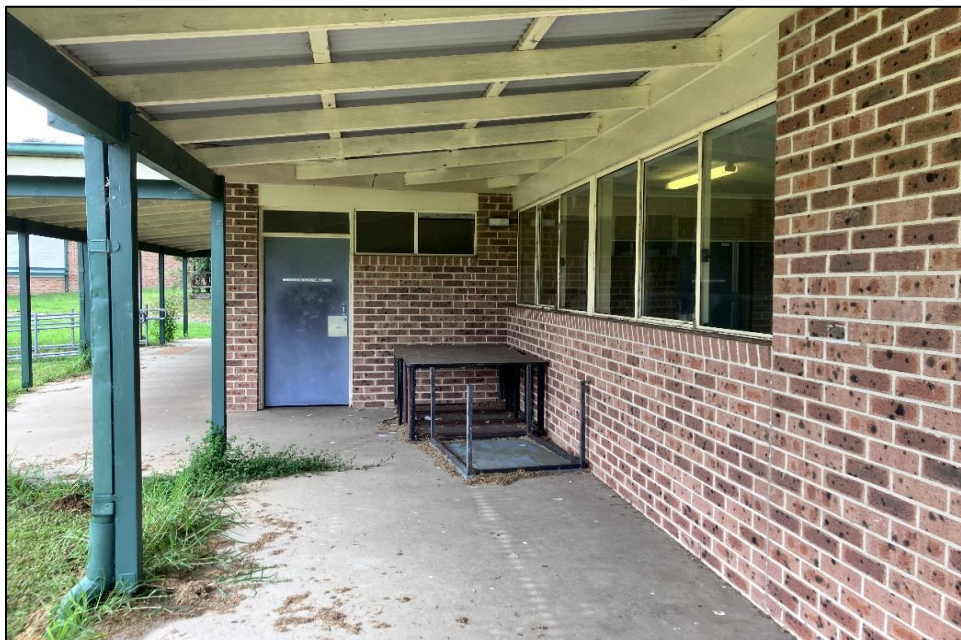
Photograph 8: B00A, exterior, north façade, timberwork, cream and green paints.

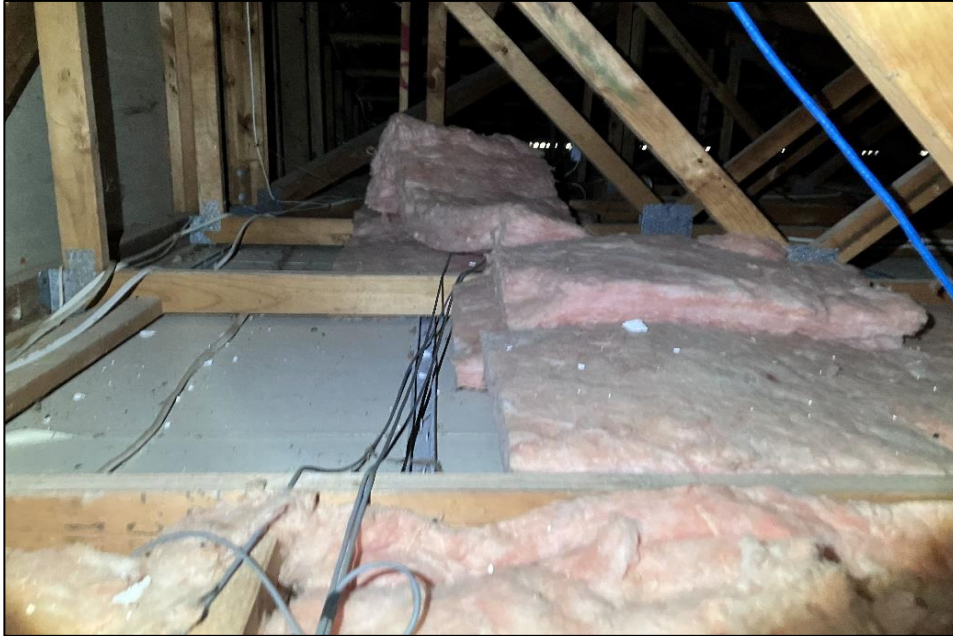
Photograph 9: B00A, ceiling cavity, settled dust / debris (elevated lead concentration detected) and insulation to top of ceiling (SMF).

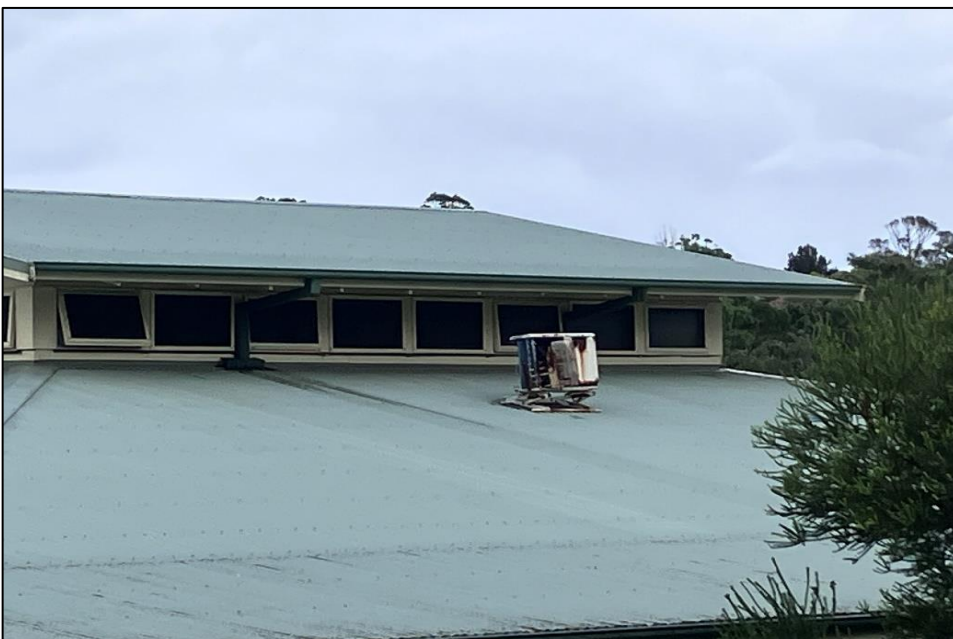
Photograph 13: B00A, exterior, roof, airconditioning unit(s), unidentified, inaccessible.

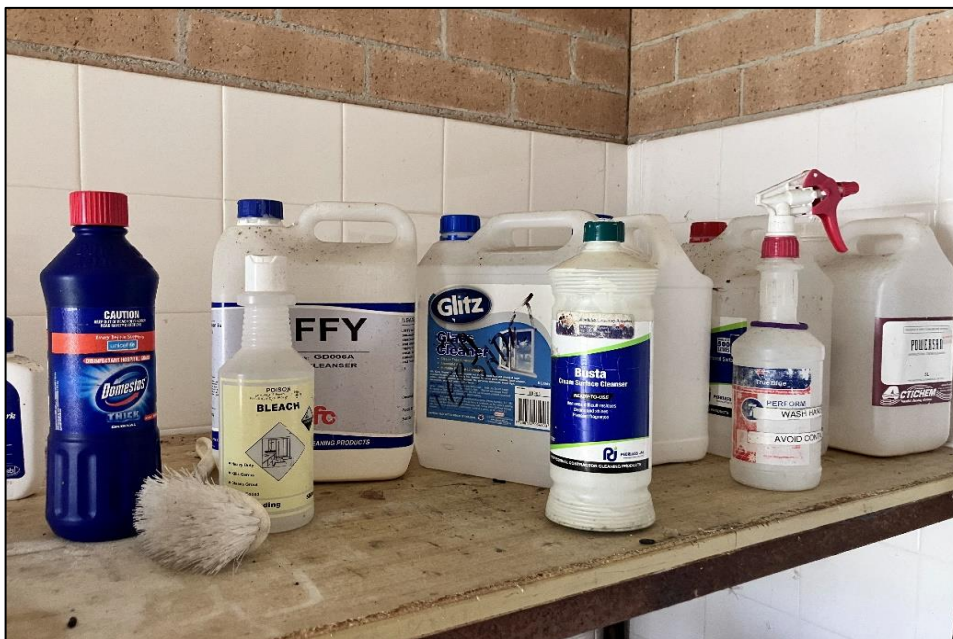
Photograph 15: B00A, AR0017, throughout, various empty chemical containers.

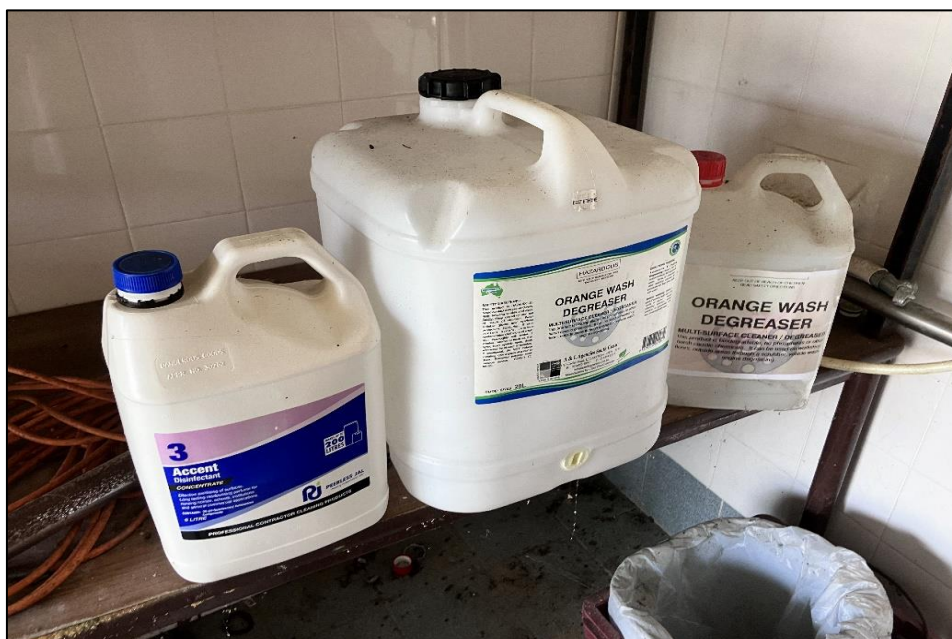
Photograph 16: B00A, AR0017, throughout, various empty chemical containers.

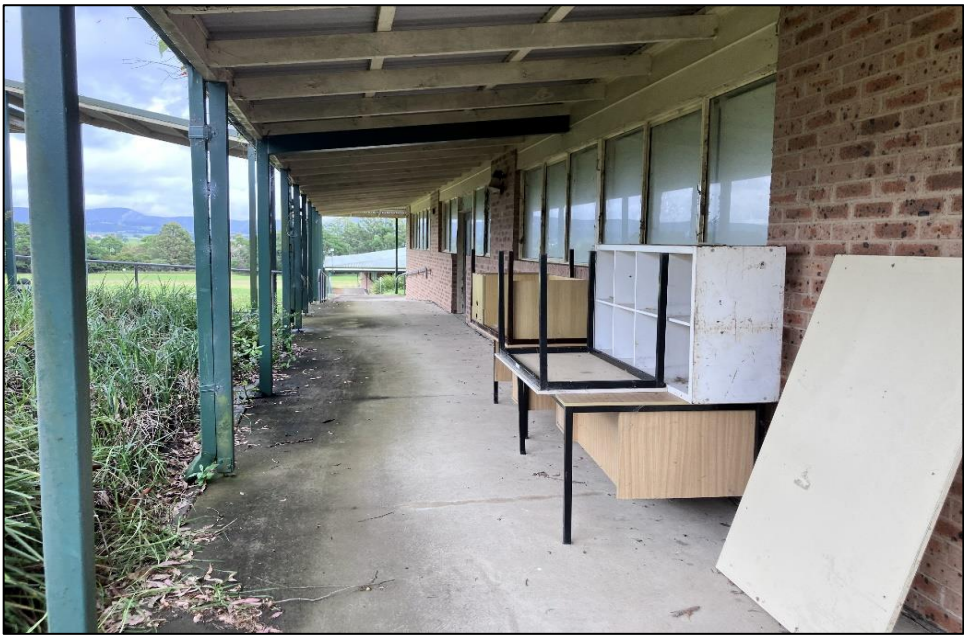
Photograph 2: B00B, exterior, lower level, walls generally, weatherboard linings, suspected non-asbestos.

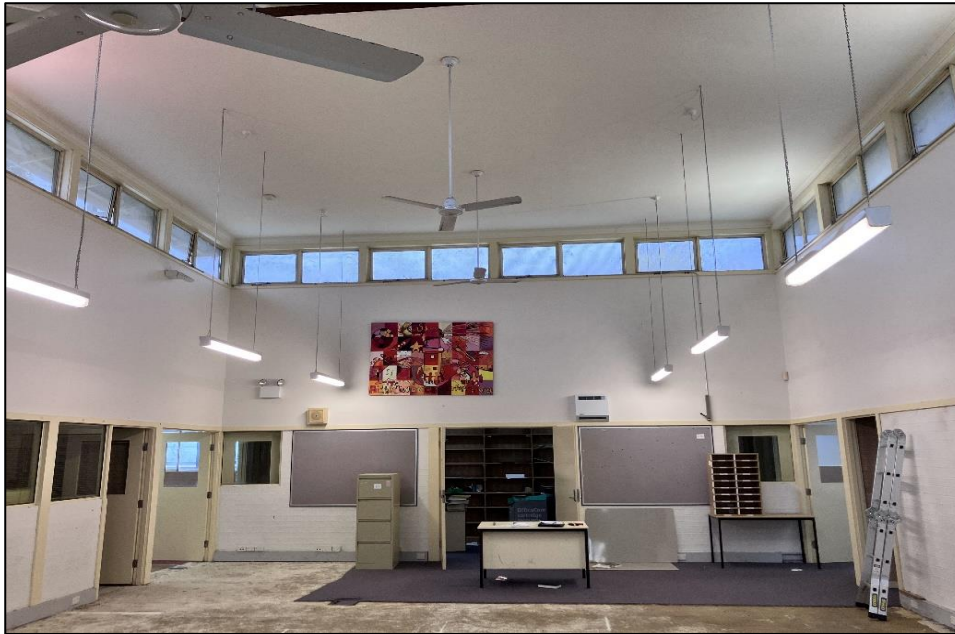
Photograph 5: B00B, BR0009, upper ceiling, suspected plaster product, suspected non-asbestos.

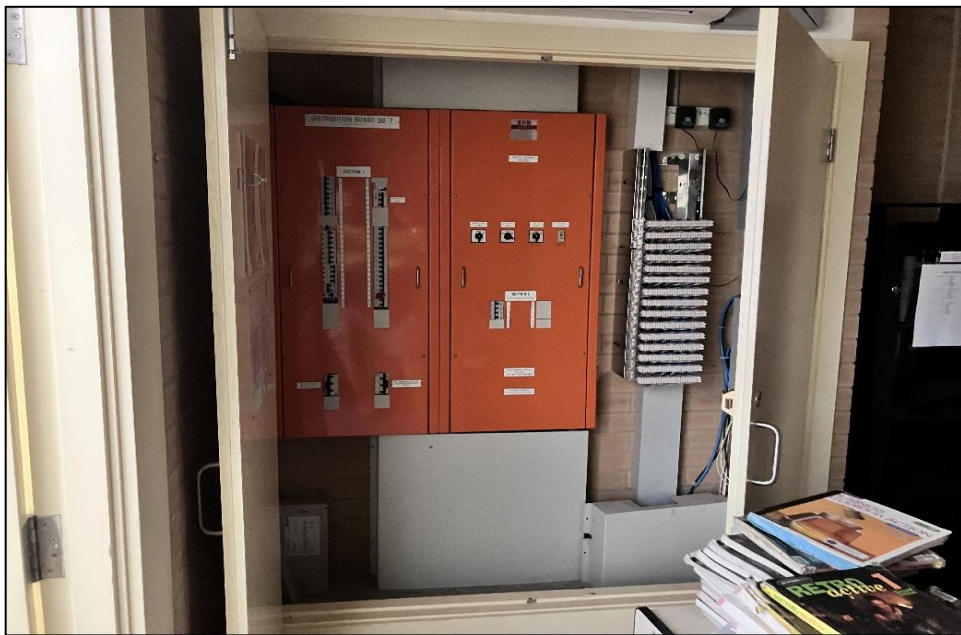
Photograph 6: B00B, BR0015, interior of electrical panel(s), materials in general, suspected non-asbestos.

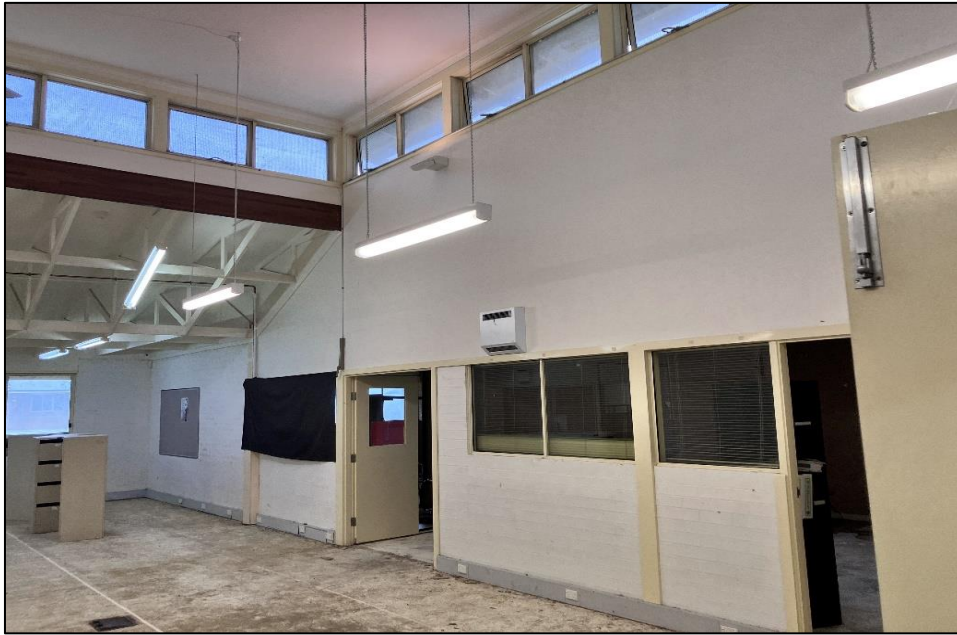
Photograph 7: B00B, BR0009, brick wall (white paint) and door frame (cream paint).

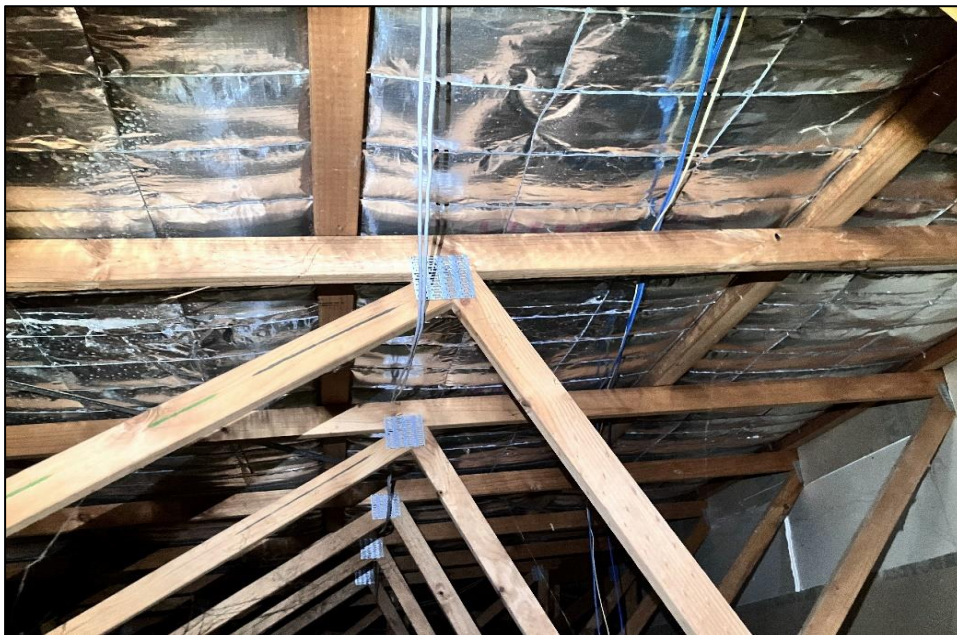
Photograph 9: B00B, rooms and areas in general, ceiling cavity, underside of roof, insulation, SMF identified visually.

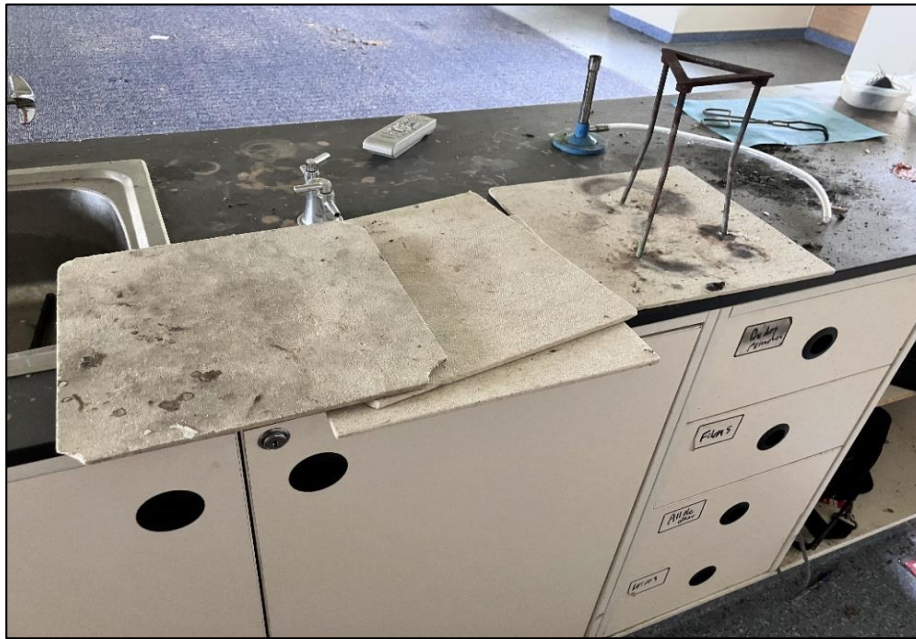
Photograph 3: B00C, CR0003, selected heat insulation pads, fibre cement product, no asbestos detected by analysis.

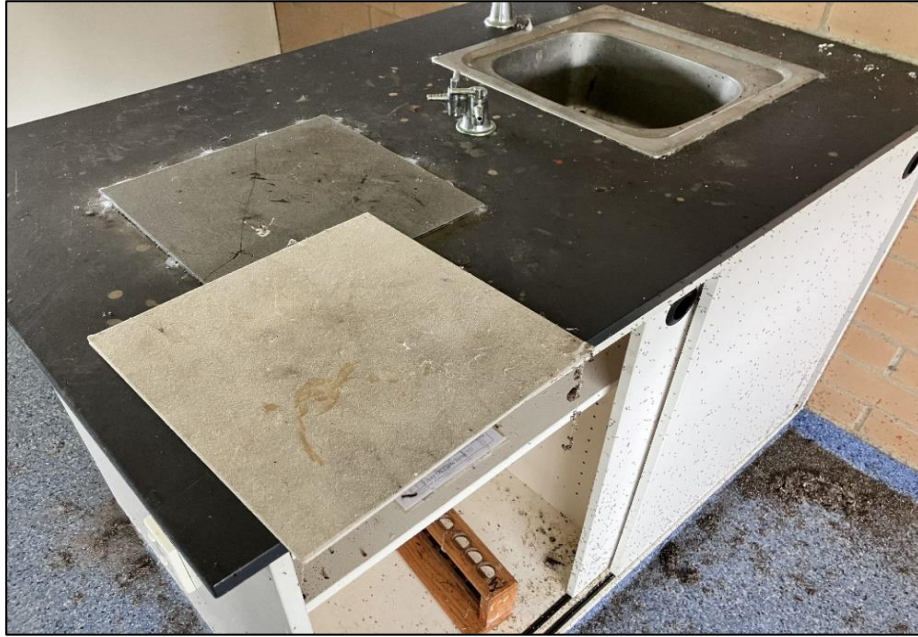
Photograph 5: B00C, interior generally, heat insulation pads generally, fibre cement product, suspected non-asbestos.

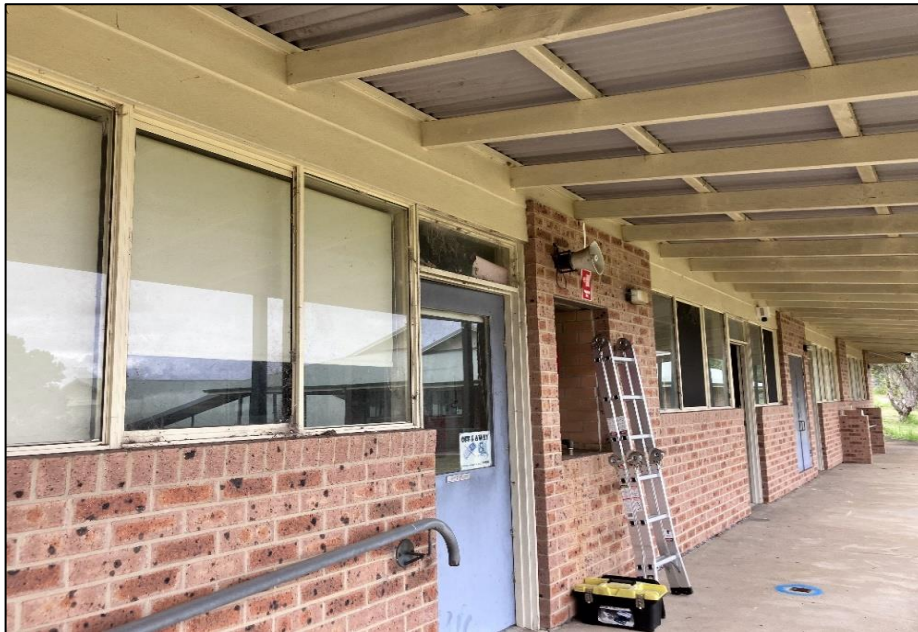
Photograph 6: B00C, exterior, ground level, western façade, door, grey paint.

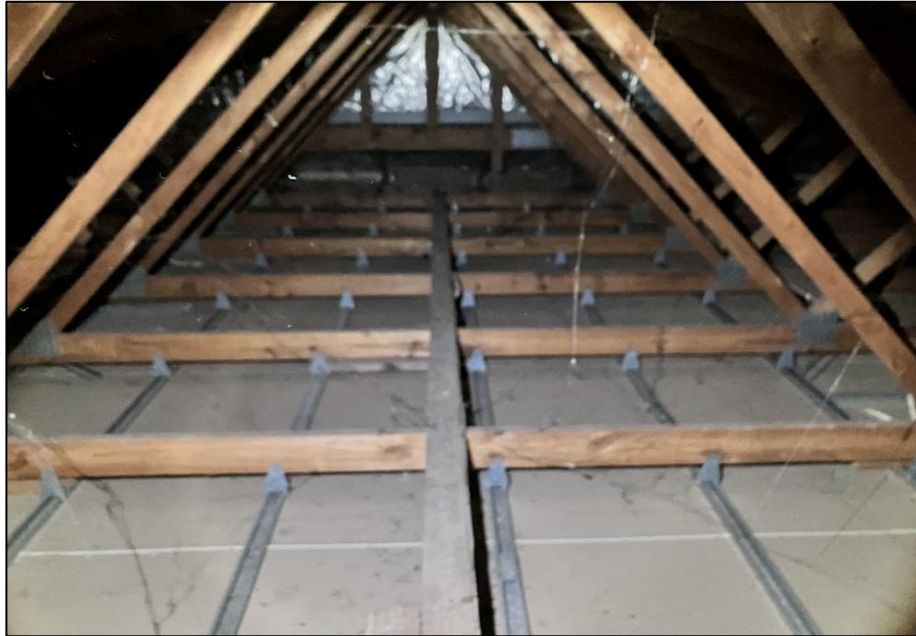
Photograph 7: B00C, interior, ceiling cavity, settled dust / debris, elevated lead concentration detected.

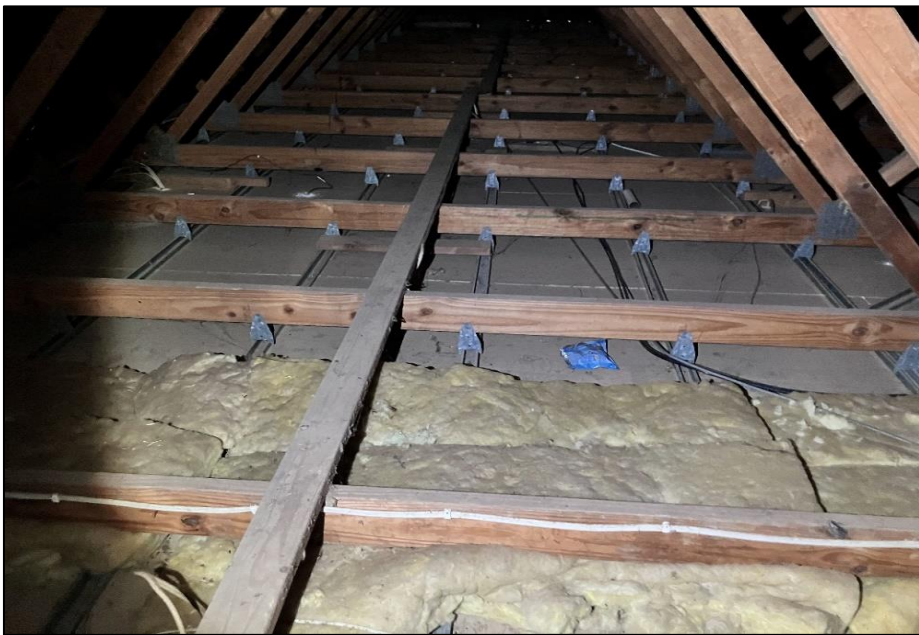
Photograph 8: B00C, rooms and areas in general, ceiling cavity, top of ceiling, insulation, SMF identified visually.

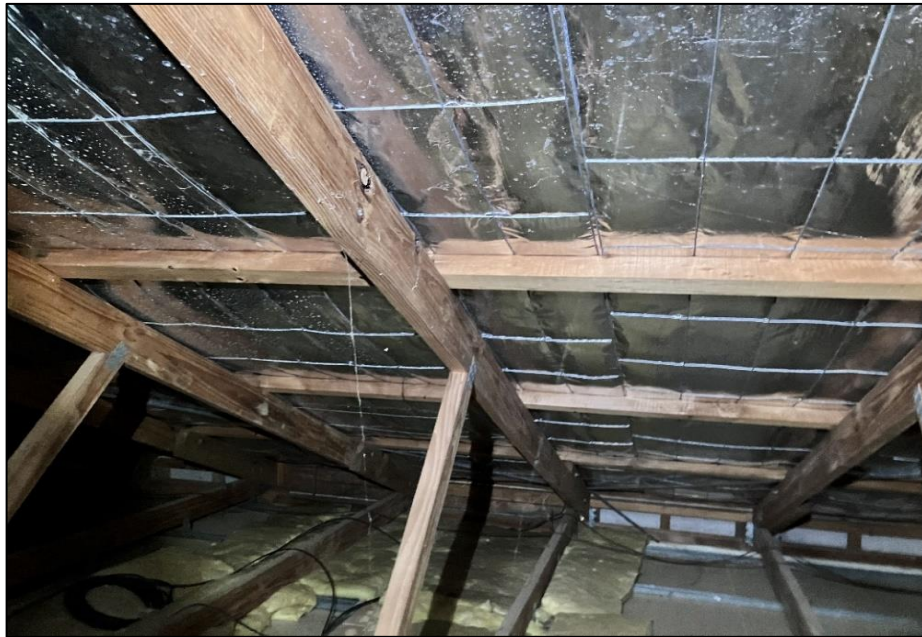
Photograph 9: B00C, rooms and areas in general, ceiling cavity, underside of roof, insulation, SMF identified visually.

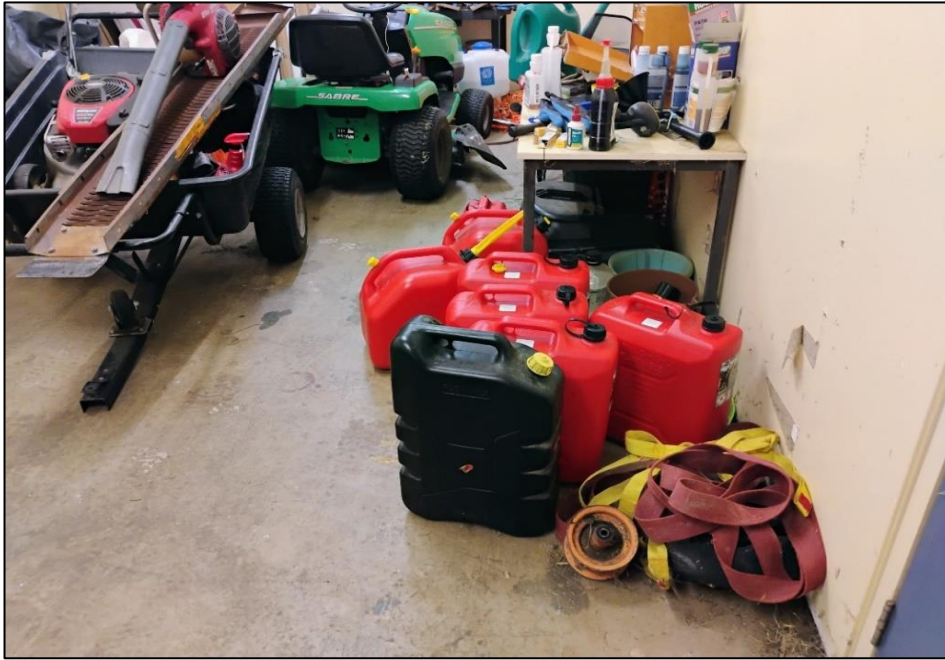
Photograph 9: B00D, DR0007, throughout, various chemical products including fuels, oils, herbicides, paints and various other products.

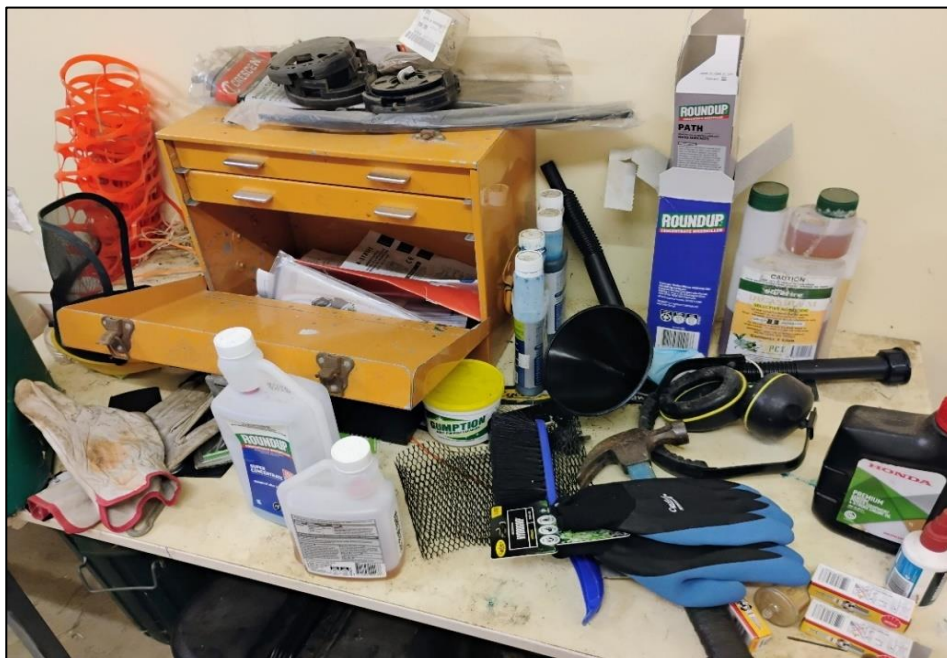
Photograph 10: B00D, DR0007, throughout, various chemical products including fuels, oils, herbicides, paints and various other products.

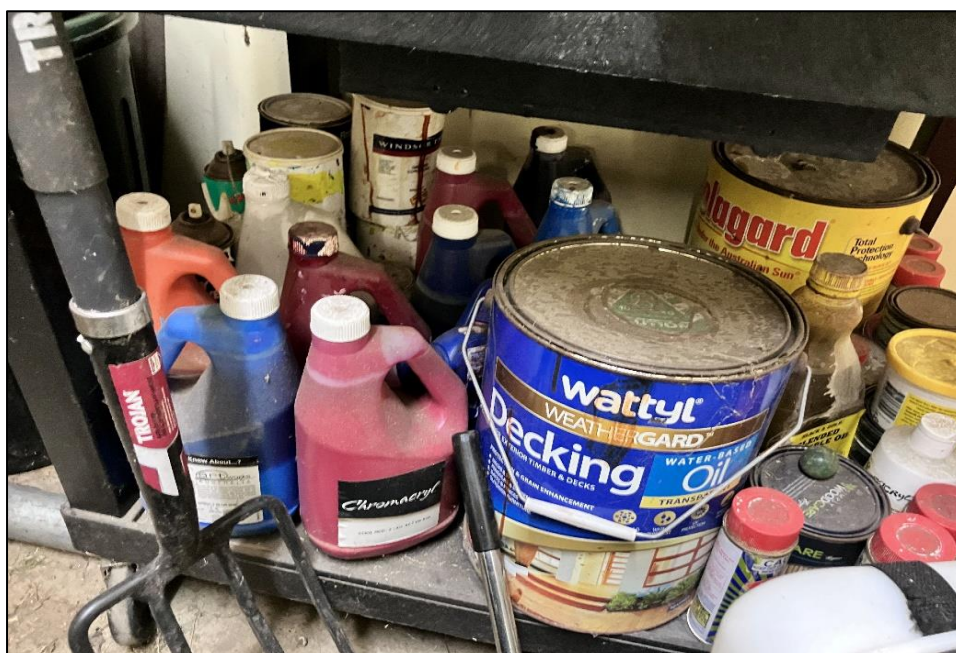
Photograph 14: B00D, DR0007, throughout, various chemical products including fuels, oils, herbicides, paints and various other products.

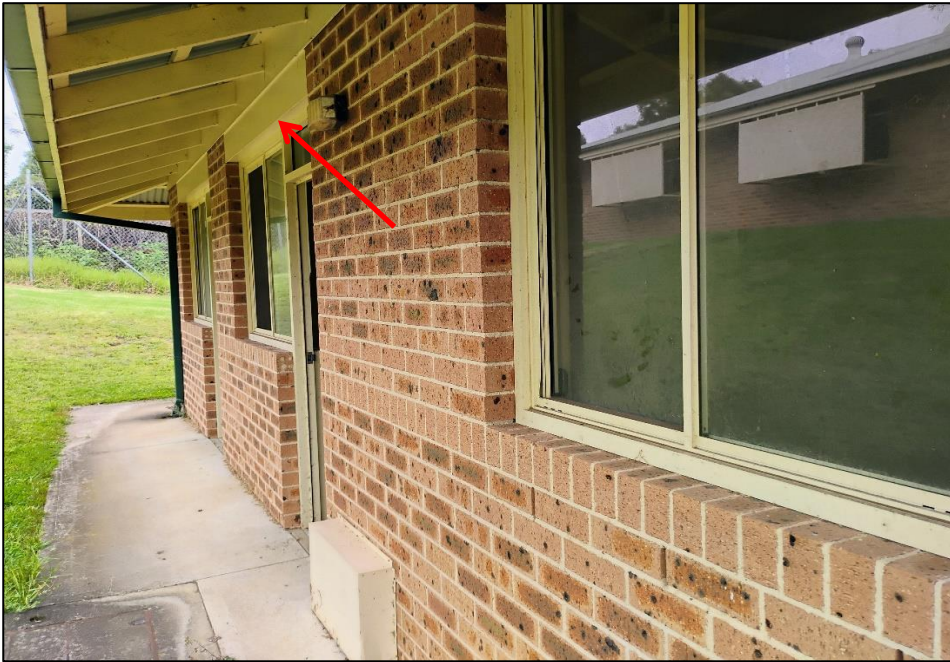
Photograph 3: B00E, exterior, typical wall, headlining, fibre cement sheeting, no asbestos detected by analysis.

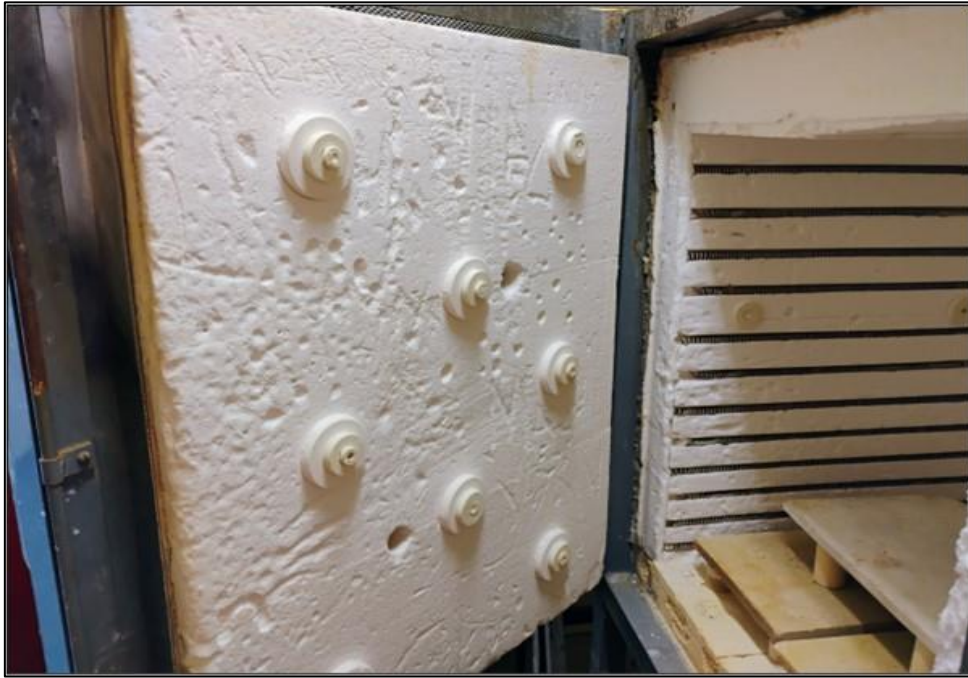
Photograph 7: B00E, interior, ER0016, pottery kiln, bulk insulation, no asbestos detected by analysis (SMF detected).

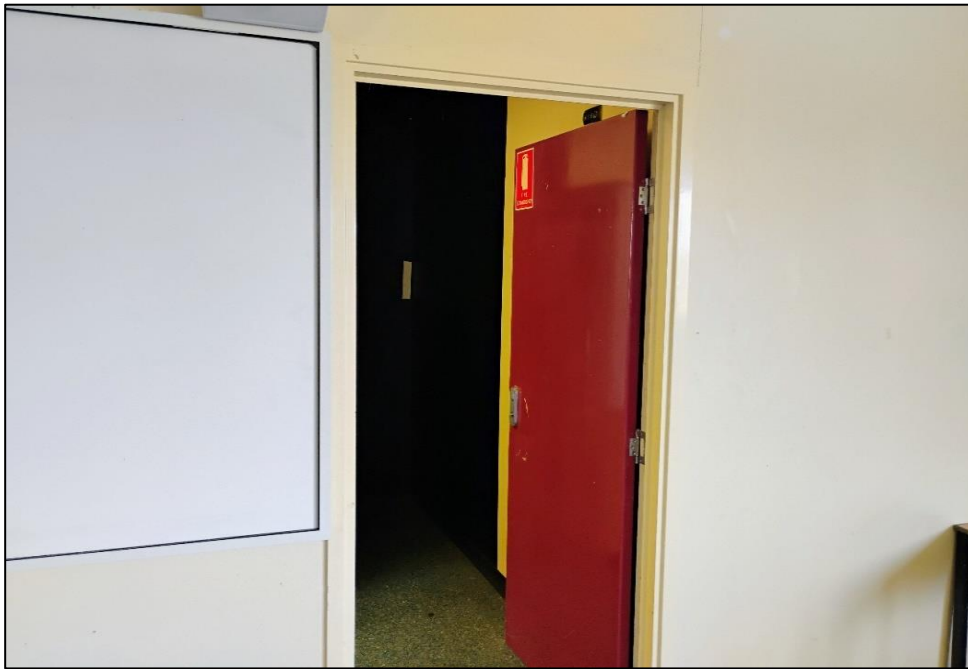
Photograph 8: B00E, ER0009, wall (cream paint) and ER0010 wall (black paint).

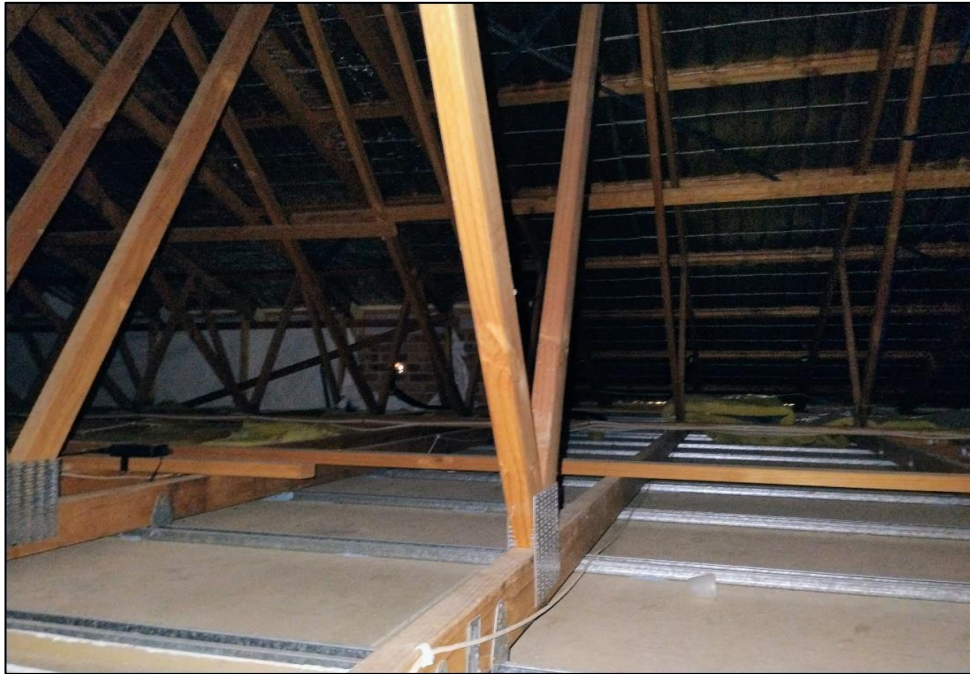
Photograph 9: B00E, ER0012, ceiling cavity, settled dust / debris, elevated lead concentration not identified.

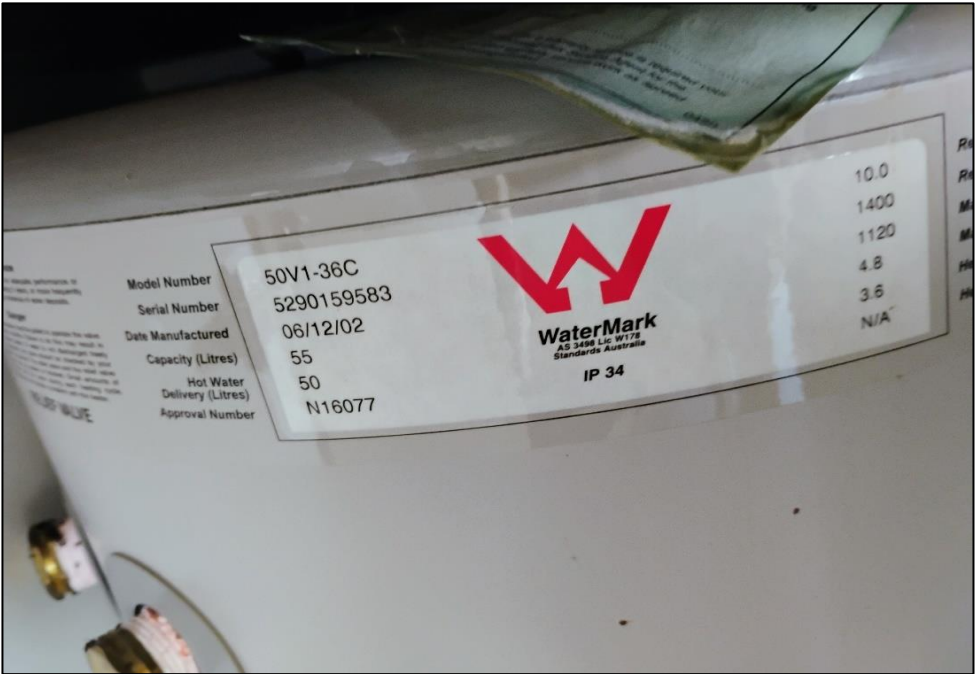
Photograph 11: B00E, ER0024, WaterMark hot water unit (circa 2002), insulation, SMF (suspected).

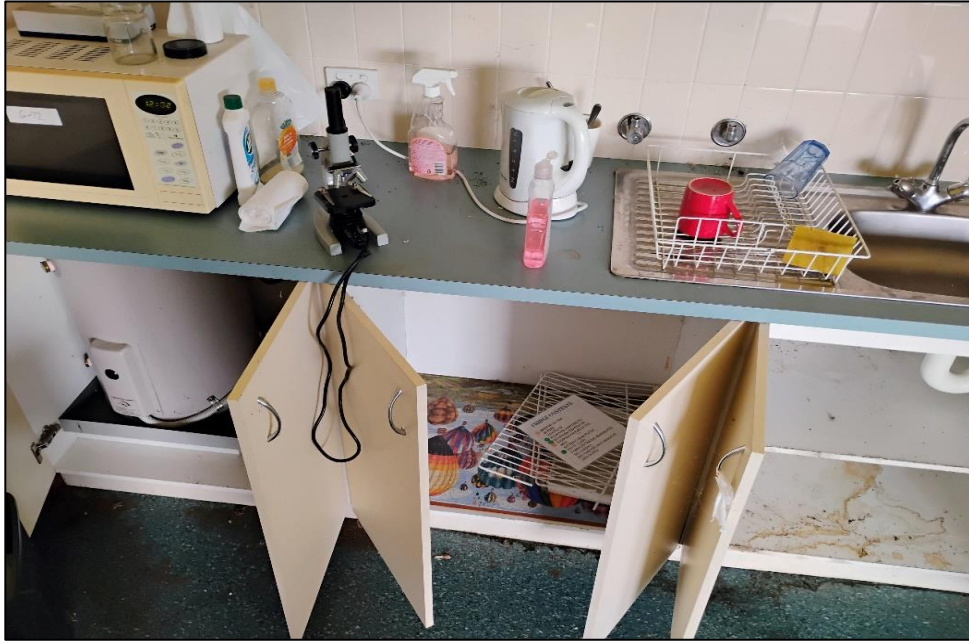
Photograph 13: B00E, ER0024, kitchen benches etc., Domestic cleaning products.

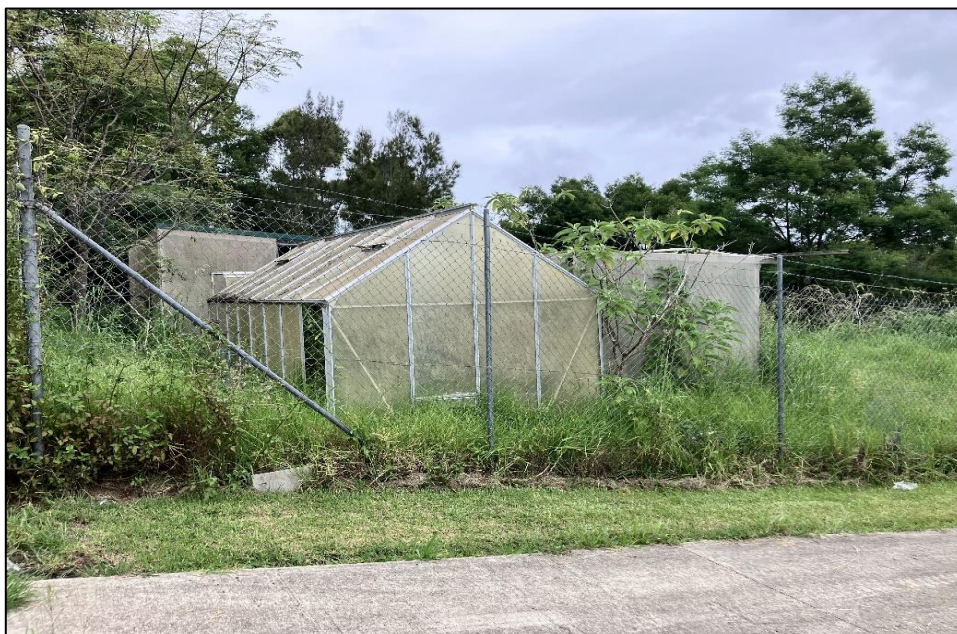
Photograph 3: B00F, inaccessible inside security (barbed wire) fencing.

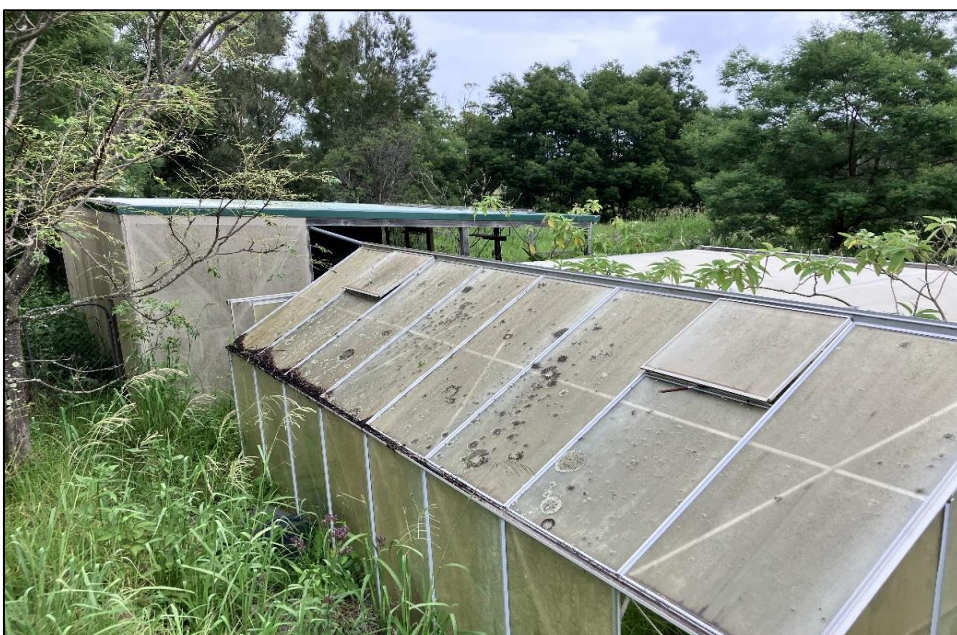
Photograph 4: B00F, view from top of ladder overlooking security fence.

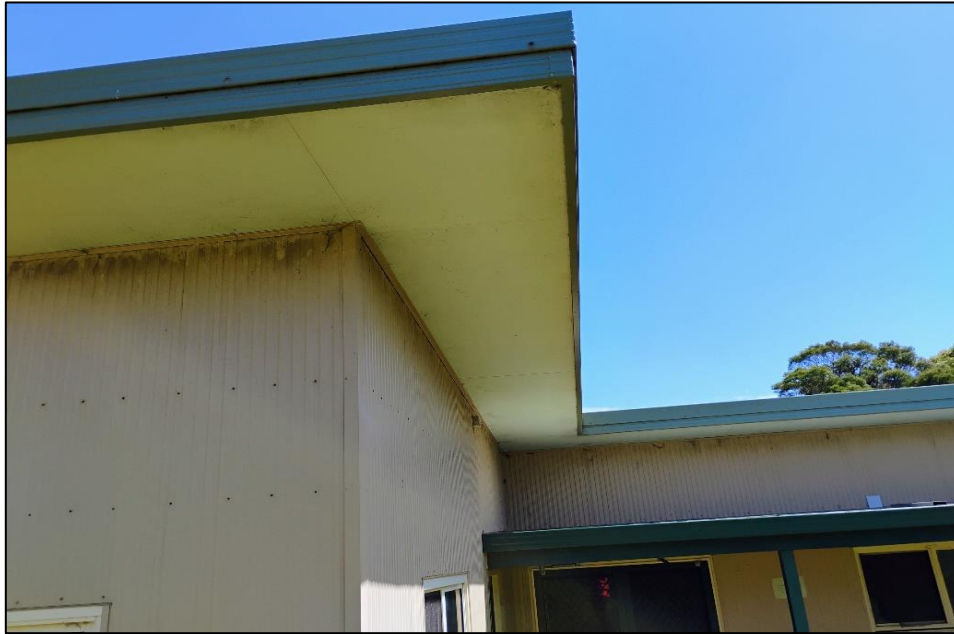
Photograph 1: B00H, exterior, southeastern façade, eave lining, fibre cement sheeting, no asbestos detected by analysis.

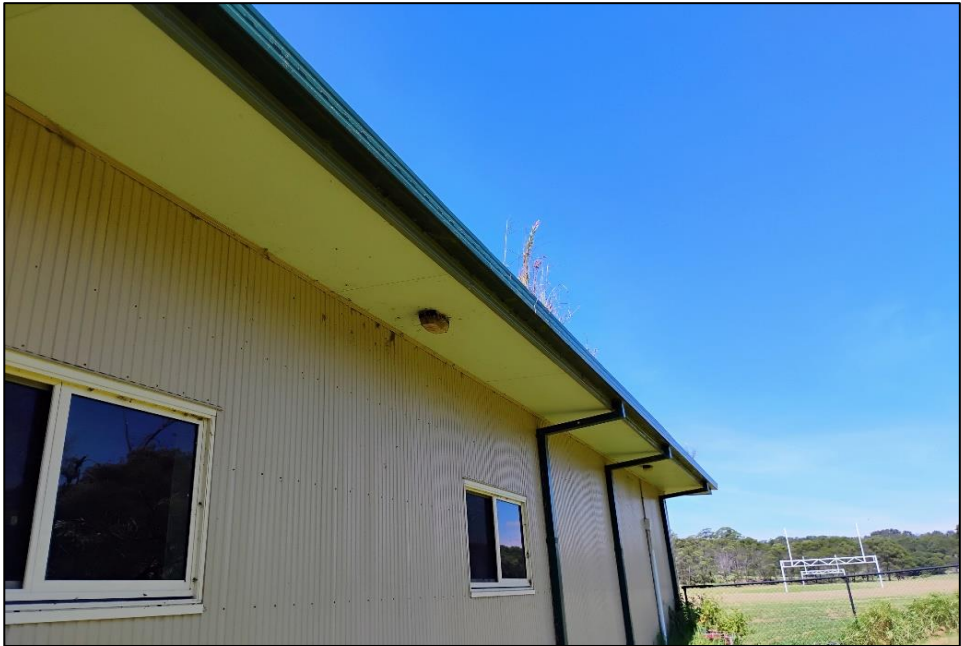
Photograph 3: B00H, exterior generally, eave linings, fibre cement sheeting, suspected non-asbestos.

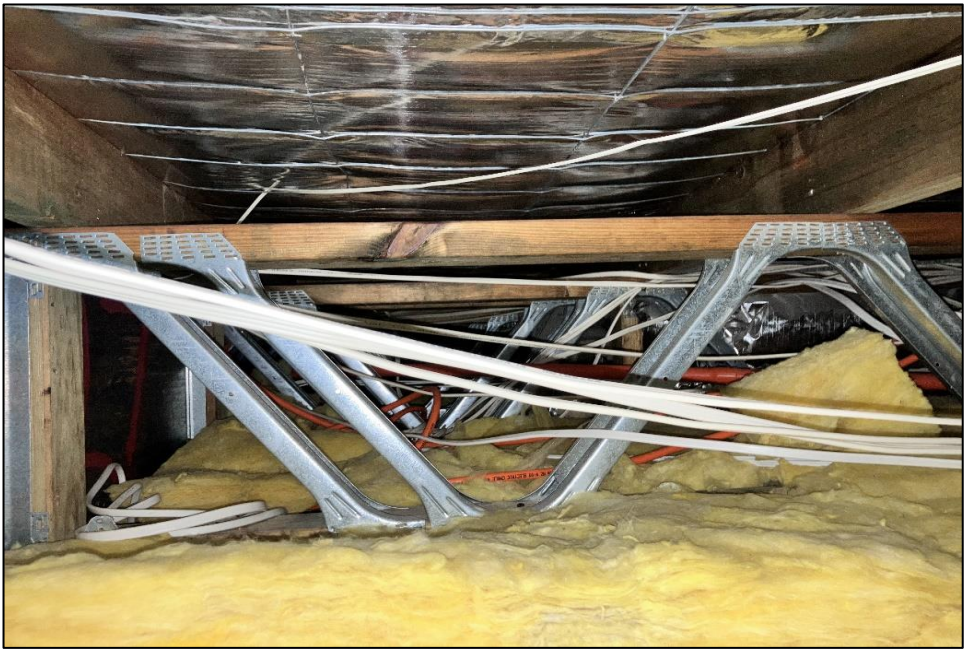
Photograph 4: B00H, rooms and areas in general, ceiling cavity, underside of roof, bulk insulation, SMF identified visually.

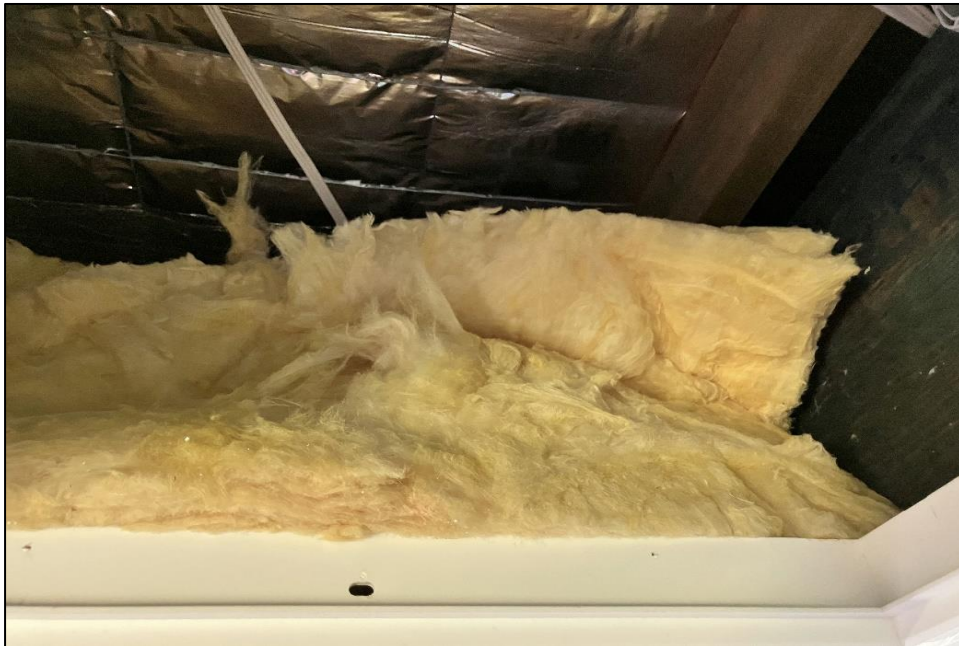
Photograph 5: B00H, rooms and areas in general, ceiling cavity, top of ceiling, bulk insulation, SMF identified visually.

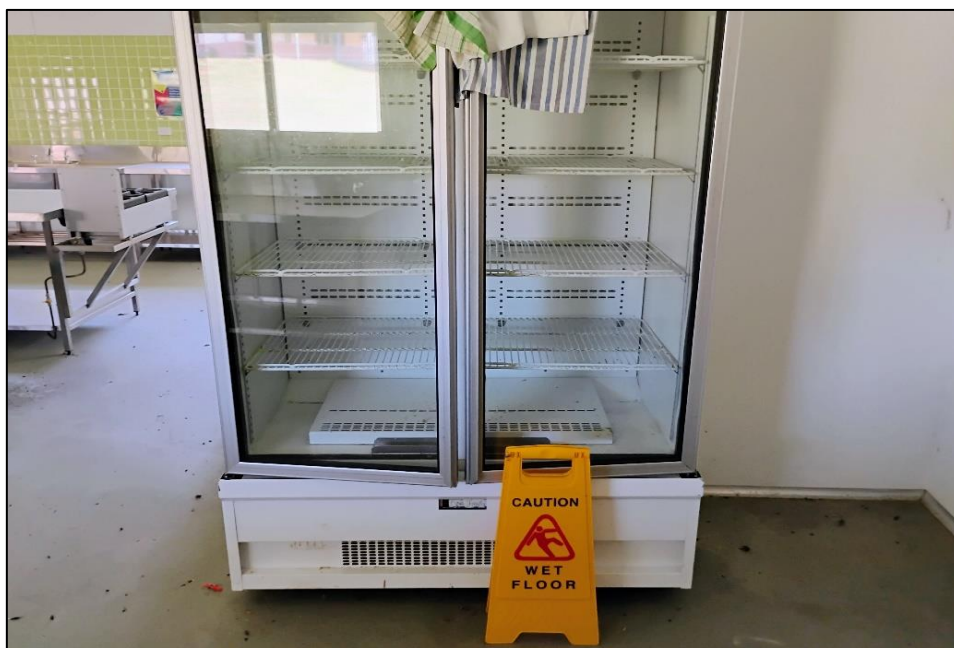
| Building | Room / Area | Item | Refrigerant | Quantity (kg) | Material Status | Photo No. | Summary Comment/Recommendation |
|---|---|---|---|---|---|---|---|
| B00H | HR0004 | refrigerated display unit | unconfirmed | unconfirmed | nil ODS suspected | 7 | <p>Compliance plates not readily identified. Take appropriate steps to identify the refrigerant(s) used.</p> <p>Maintain plant / equipment in good condition to avoid refrigerant leakage.</p> <p>Phase-out ODS in accordance with the Montreal Protocol and Ozone Protection and Synthetic Greenhouse Gas Management legislation</p> <p>Recover ODS during maintenance and decommissioning. Do not vent ODS to atmosphere.</p> |

Photograph 7: B00H, HR0004, refrigerated display unit, unconfirmed, nil ODS suspected.

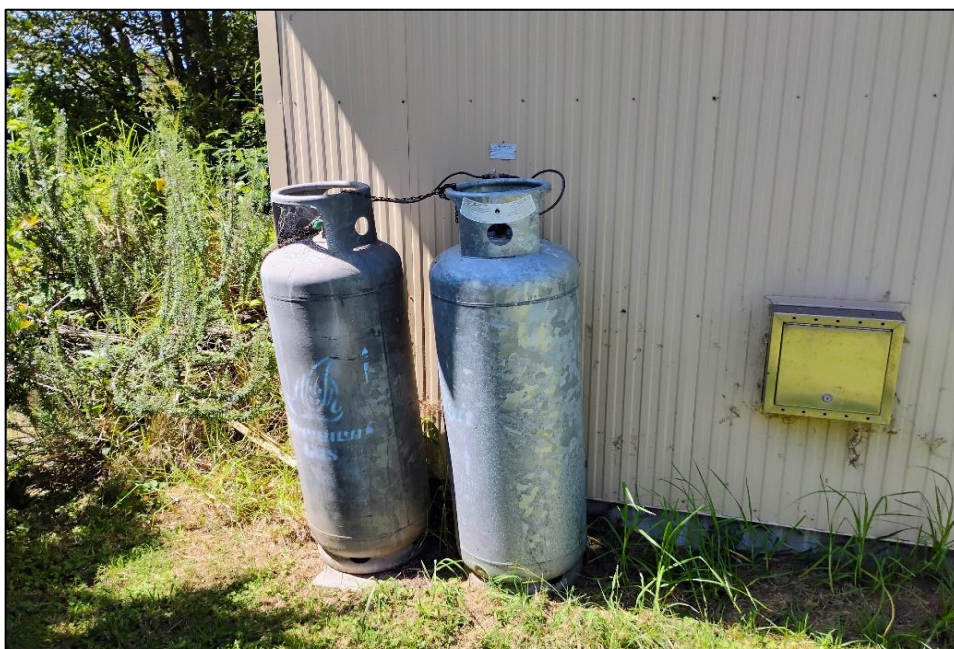
Photograph 8: B00H, exterior, designated LPG storage , LPG tanks (x2).
