## **Hazardous Building Materials (HAZMAT) Report**

**Former Shoalhaven Anglican School**

**17 Croobyar Milton NSW**

**Project 89390.08**

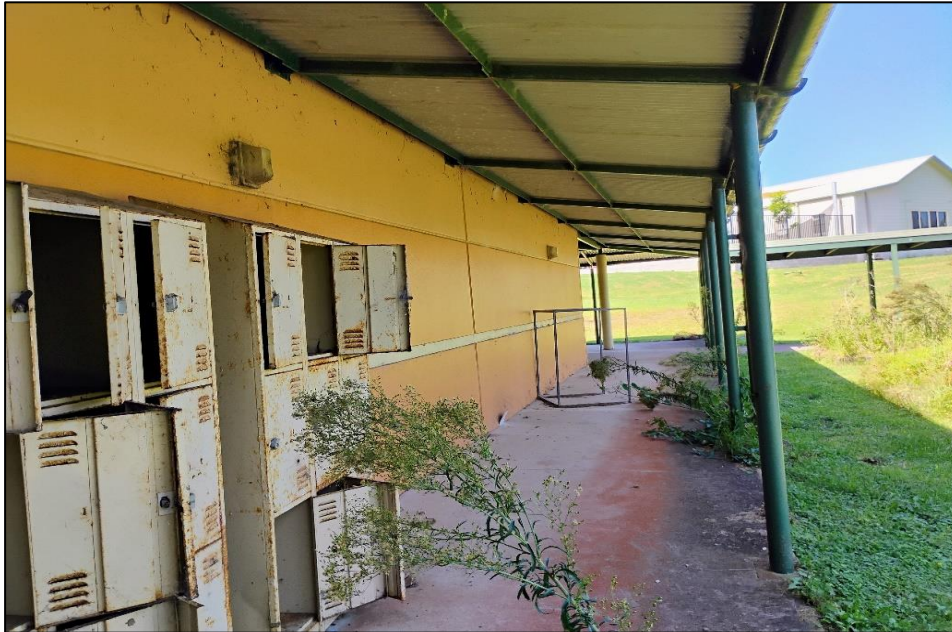
Photograph 3: B00I, exterior, southern façade, wall (orange paint) and awning support post (green paint).

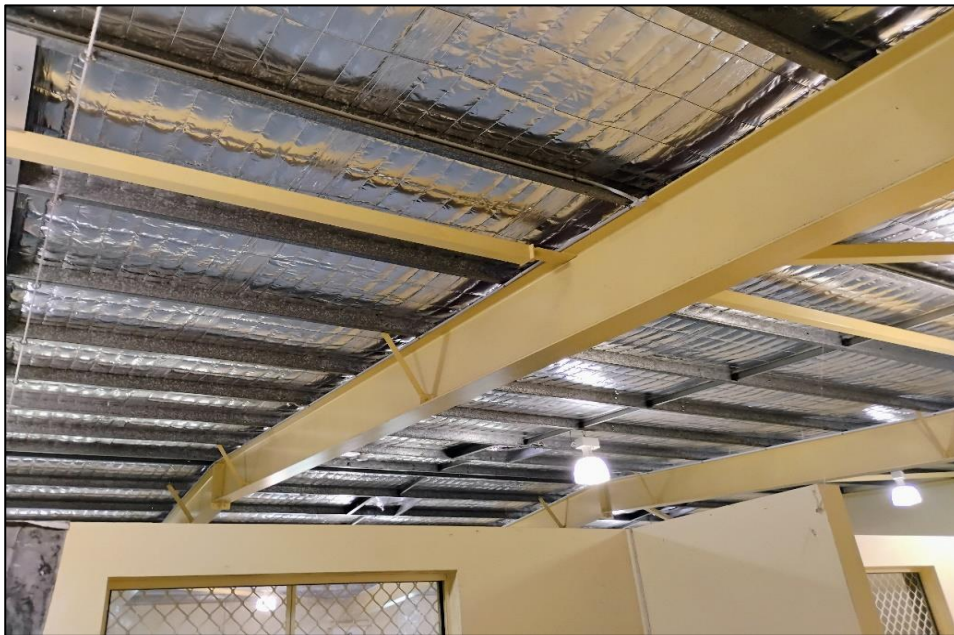
Photograph 5: B00I, interior, roof framework, steel beam, pale yellow paint.

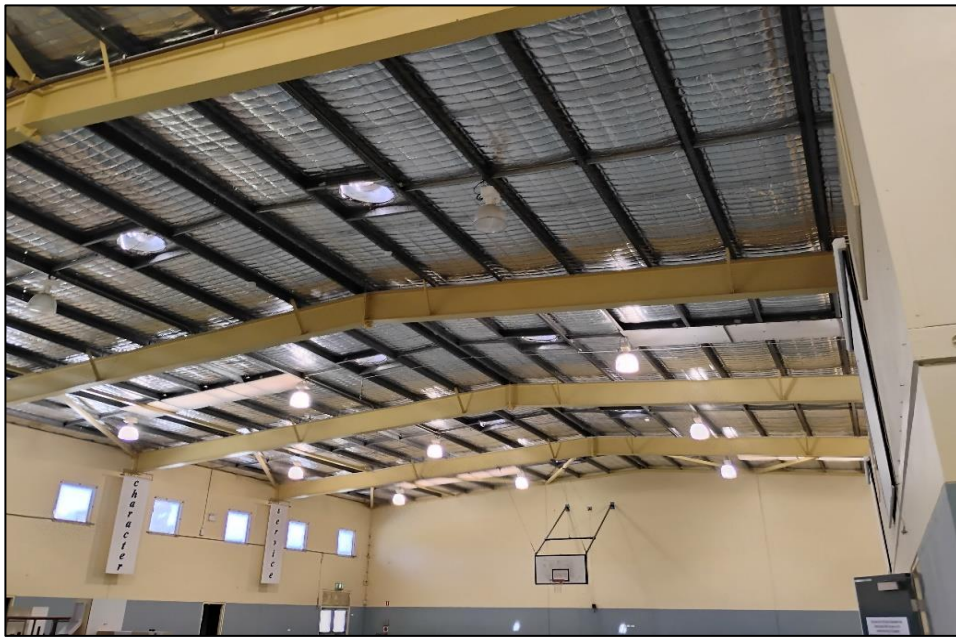
Photograph 7: B00I, interior, underside of roof, bulk insulation, SMF (suspected).

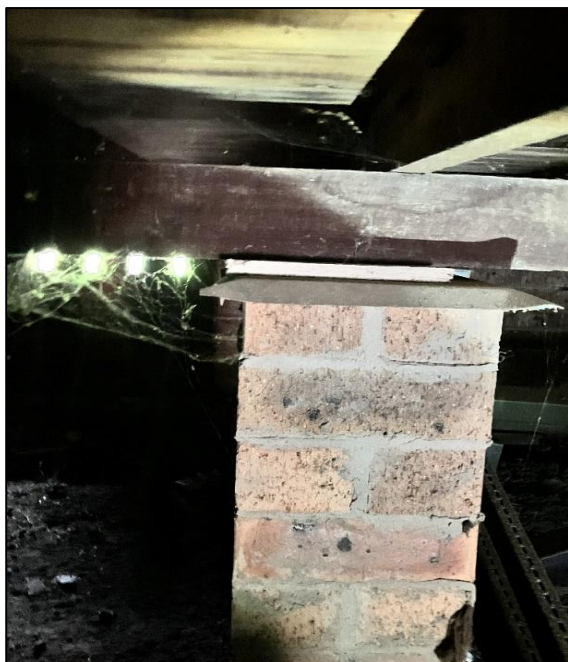
Photograph 3: B00P, sub-floor area, packing material, fibre cement sheeting, no asbestos detected by analysis.

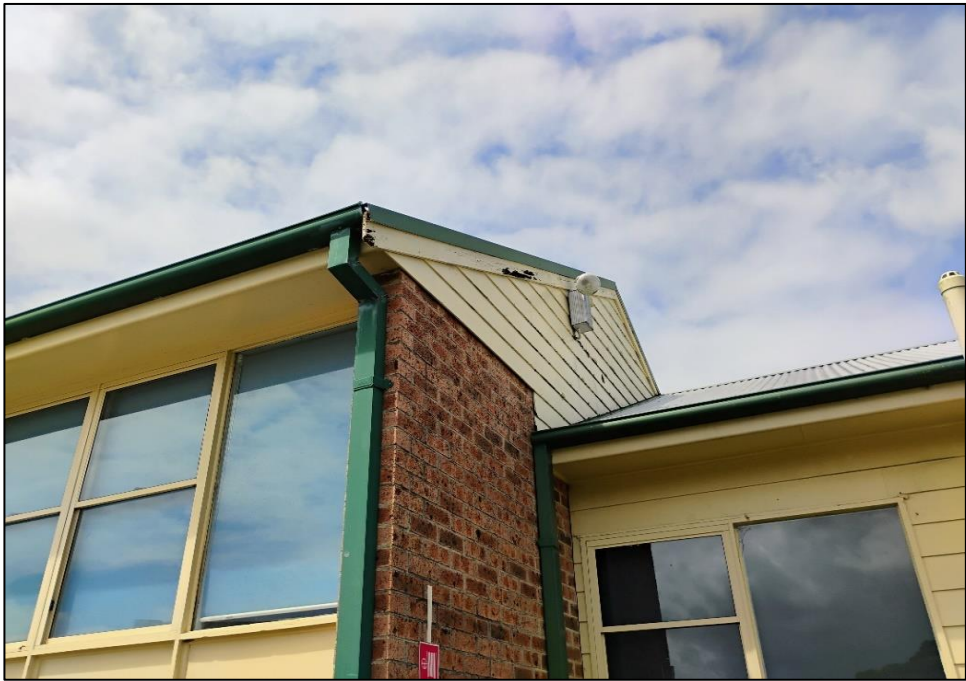
Photograph 2: B00Q, exterior, eave and gable lining, fibre cement sheeting, no asbestos detected by analysis.

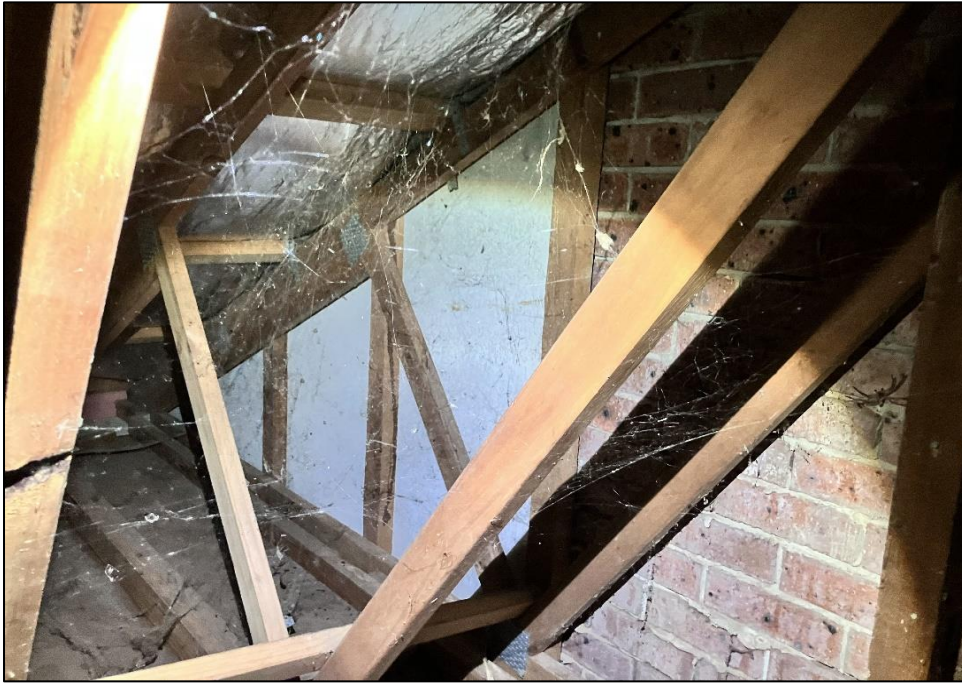
Photograph 3: B00Q, QR004, ceiling cavity, gable, fibre cement sheeting, no asbestos detected. Underside of roof, insulation, SMF identified.

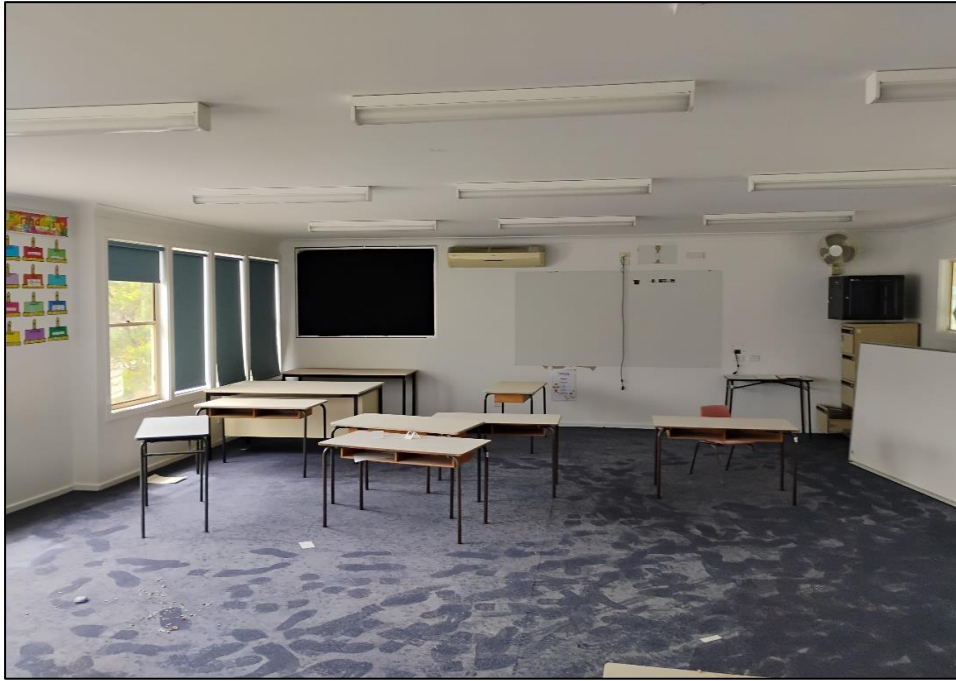
Photograph 7: B00Q, rooms and areas in general, fluorescent light fittings, internal components, nil PCB (suspected).

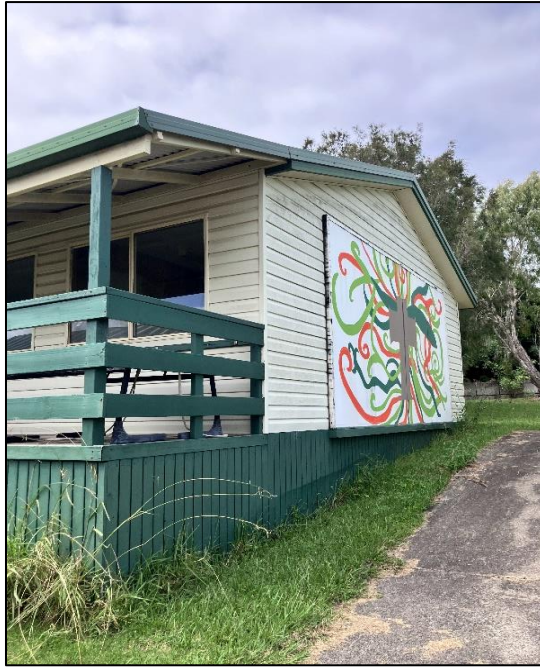
Photograph 3: B00R, exterior, subfloor area, materials in general, inaccessible.

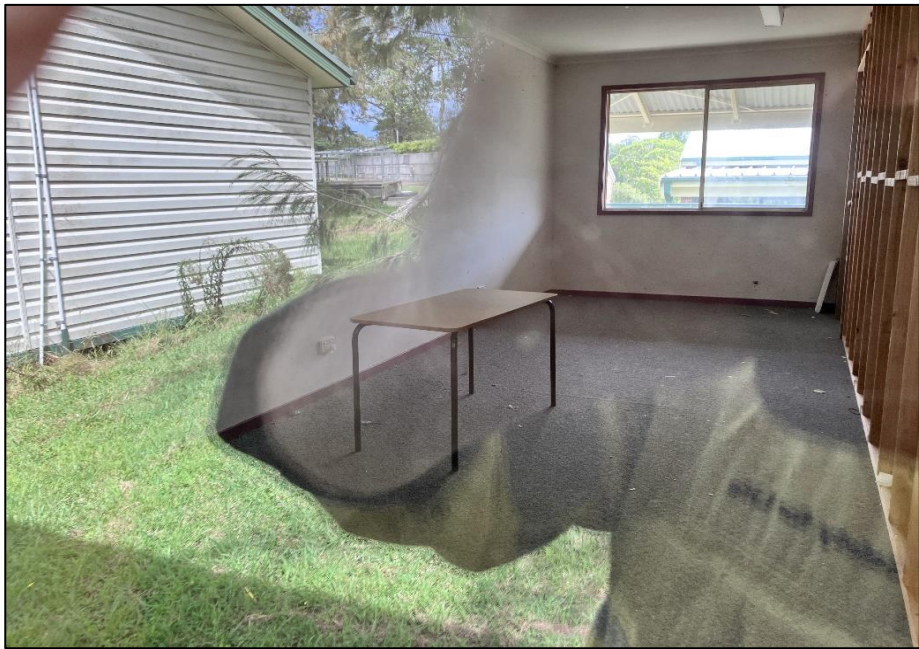
Photograph 4: B00R, interior, RR0003, materials in general, inaccessible (locked).

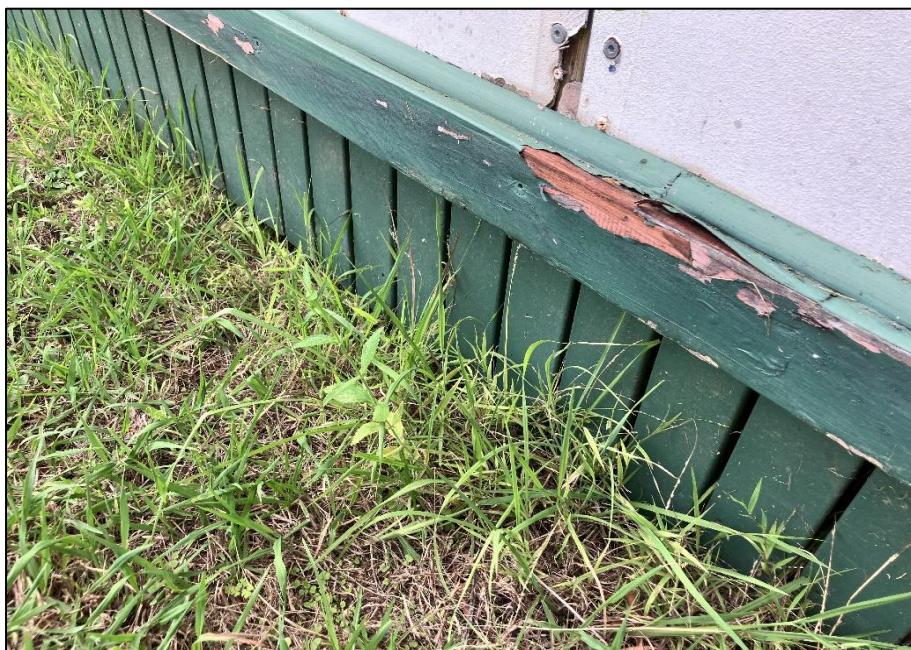
Photograph 5: B00R, exterior, southern facade timberwork, green paint.

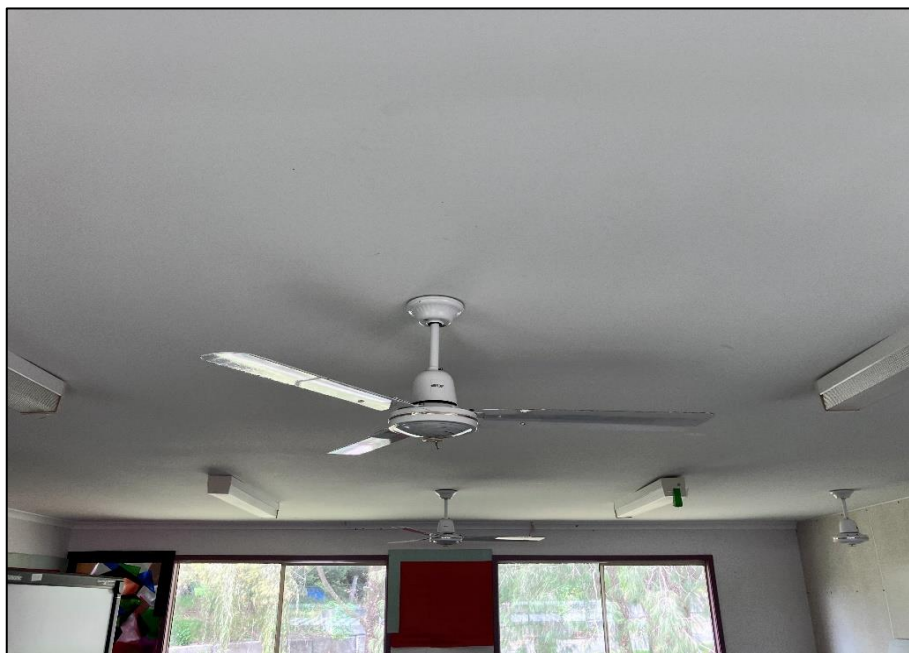
Photograph 7: B00R, rooms and areas in general, ceiling fans, internal components, nil PCB (suspected).

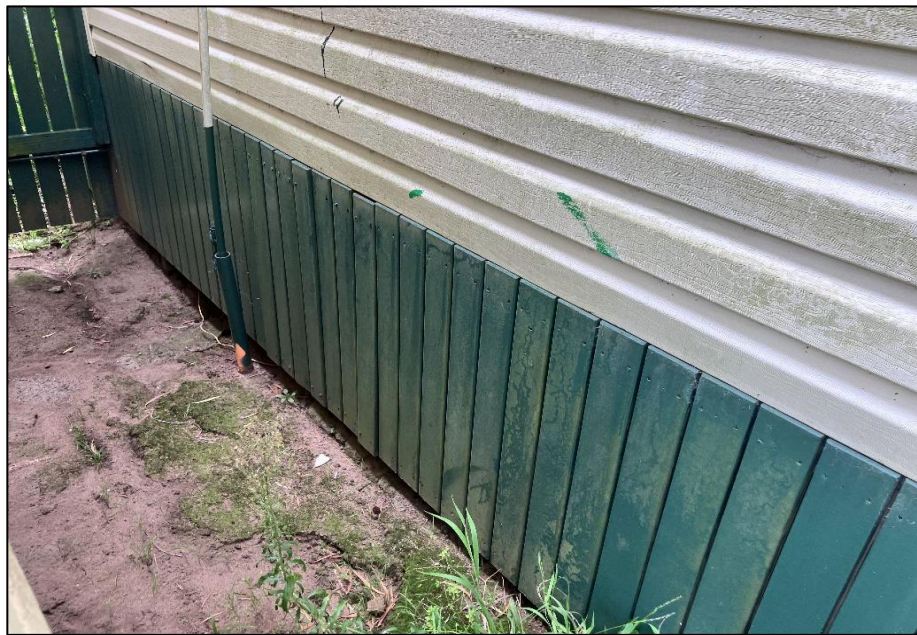
Photograph 2: B00S, exterior, subfloor area, materials in general, inaccessible.

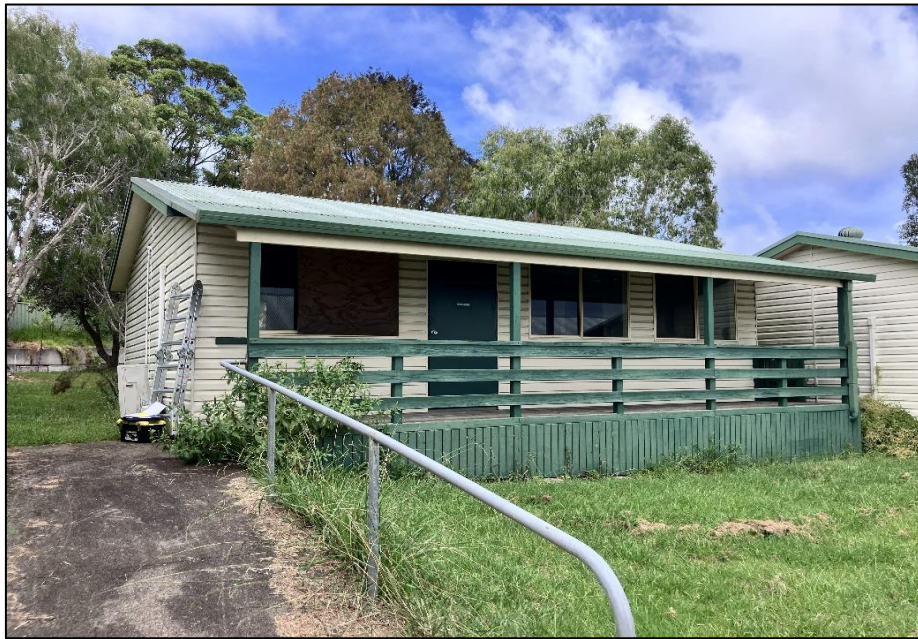
Photograph 3: B00S, exterior, front deck, timberwork, green paint.

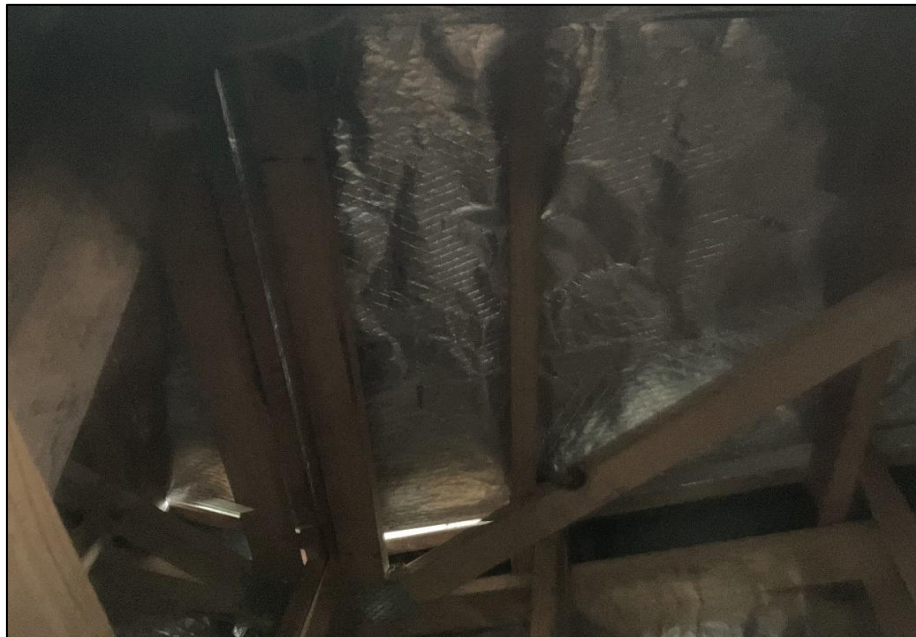
Photograph 5: B00S, interior, ceiling cavity, underside of roof, bulk insulation, SMF identified visually.

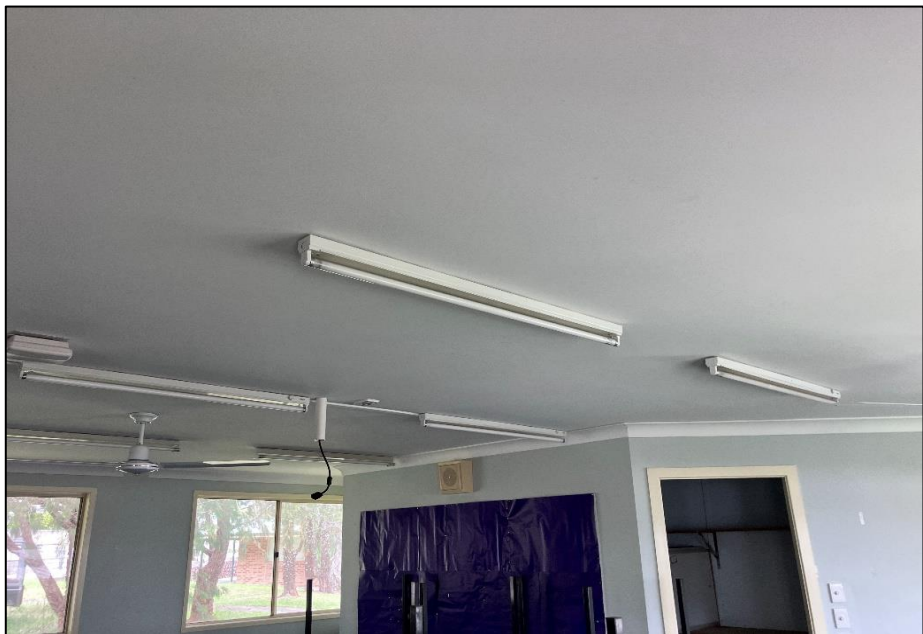
Photograph 6: B00S, rooms and areas in general, fluorescent light fittings, internal components, nil PCB (suspected).

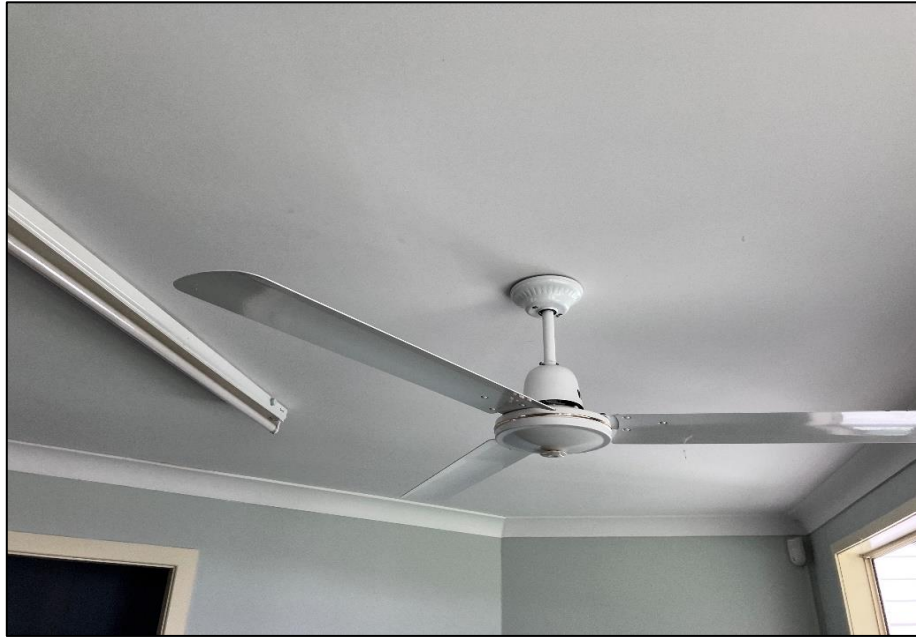
Photograph 7: B00S, rooms and areas in general, ceiling fans, internal components, nil PCB (suspected).

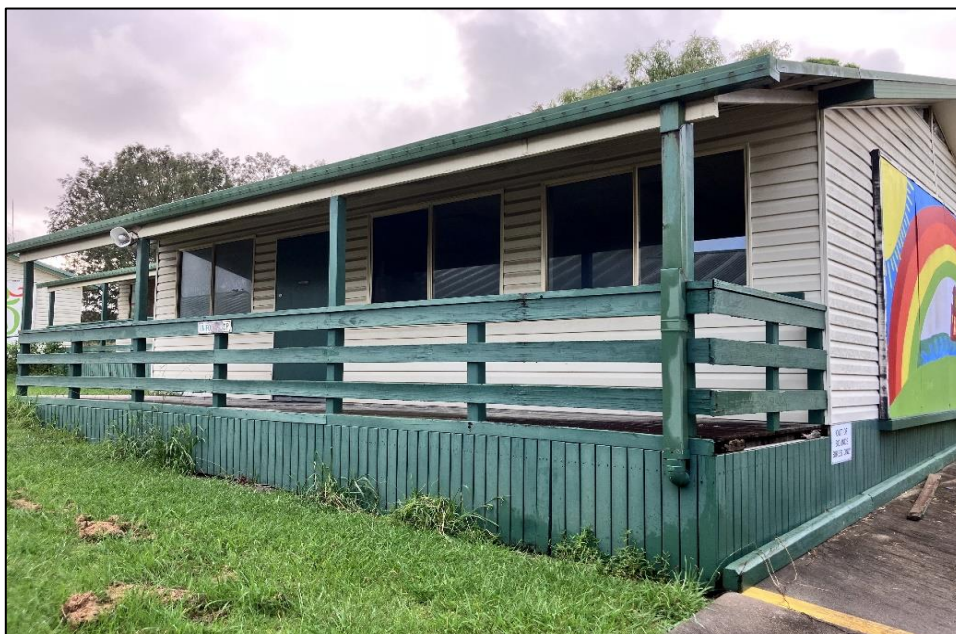
Photograph 3: B00T, exterior, west façade, timber deck and framework (green paint).

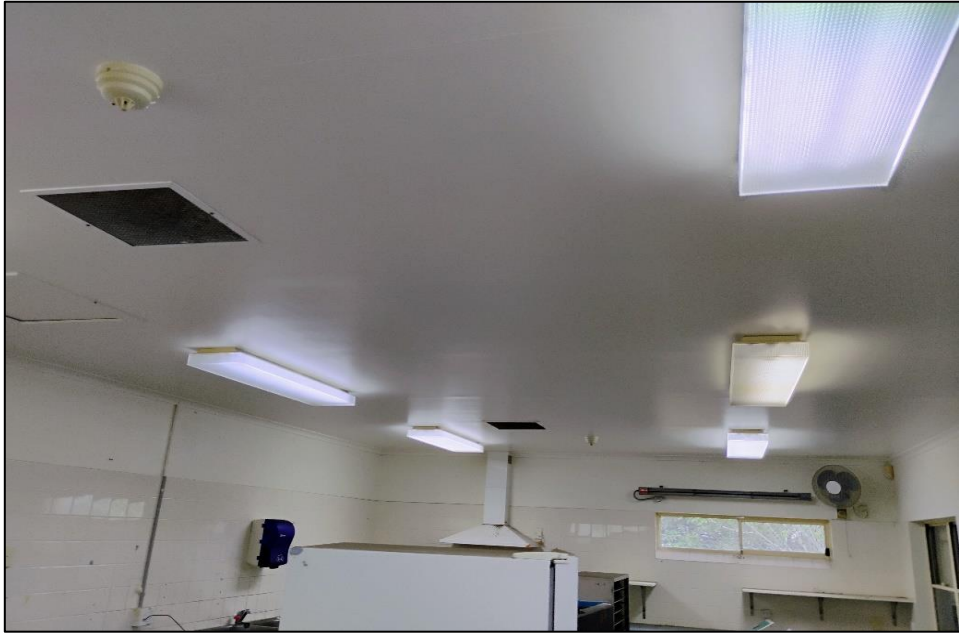
Photograph 3: B00U, interior, UR0002, ceiling, fibre cement sheeting, no asbestos detected by analysis.

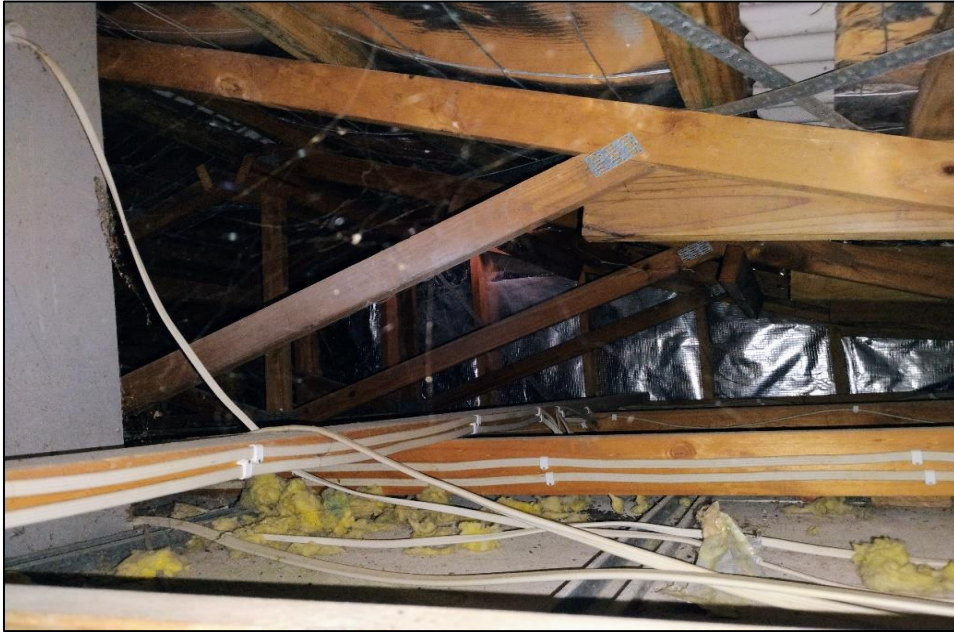
Photograph 5: B00U, rooms and areas in general, ceiling cavity, settled dust / debris, elevated lead concentration detected.

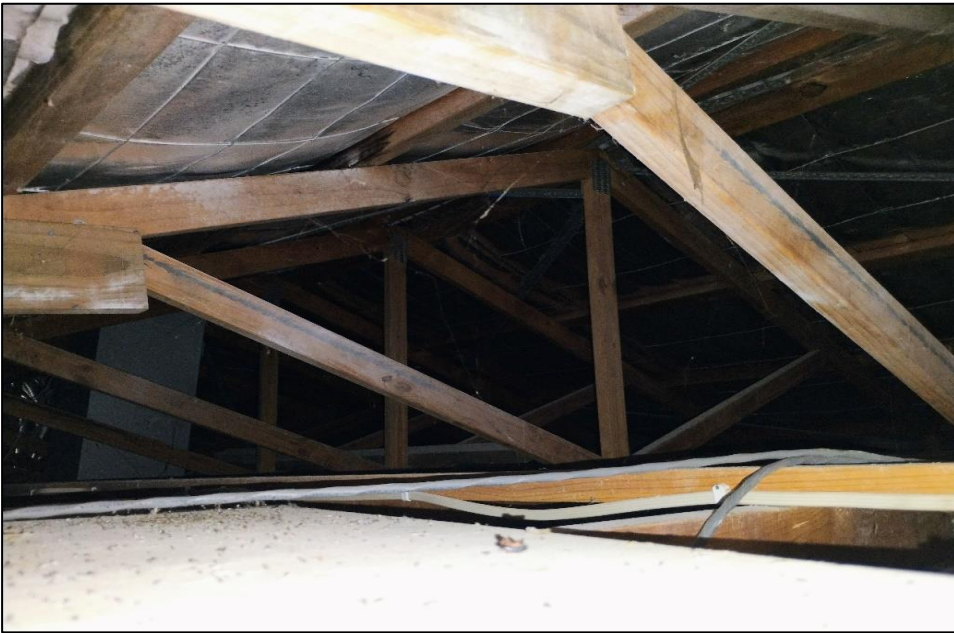
Photograph 6: B00U, rooms and areas in general, ceiling cavity, underside of roof, insulation, SMF identified visually.

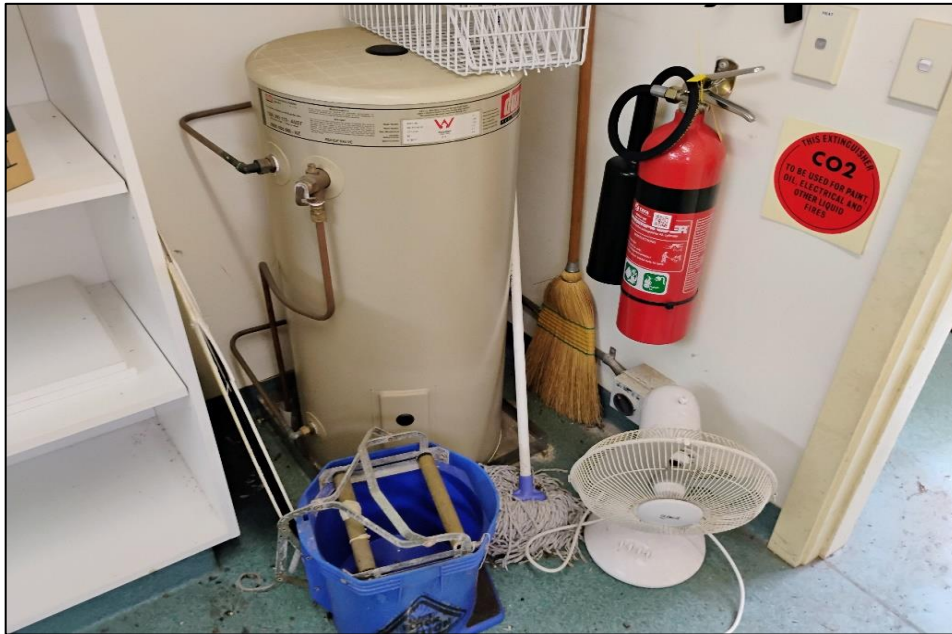
Photograph 7: B00U, UR0003, Dux hot water unit (circa 2001), insulation, SMF (suspected).

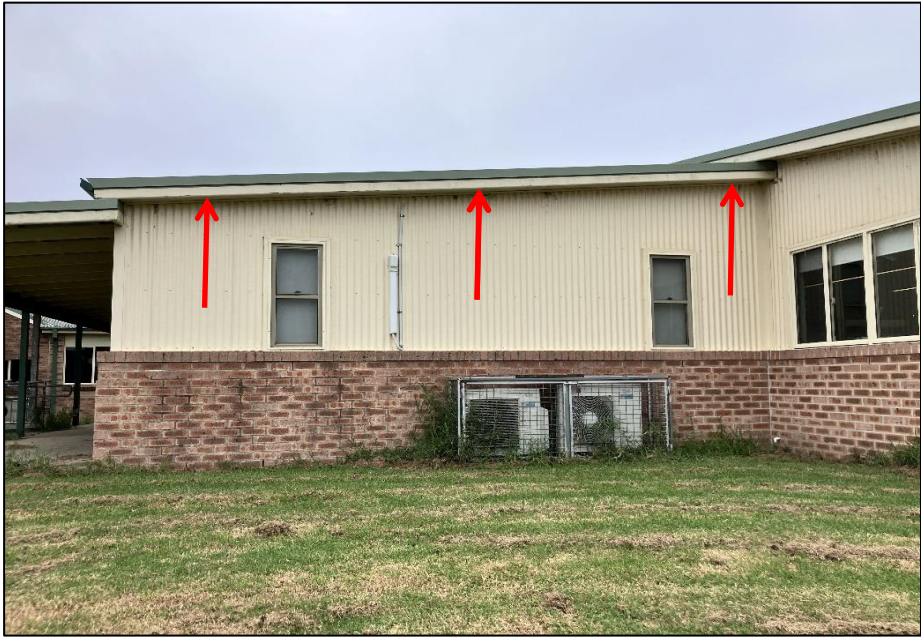
Photograph 3: B00V, exterior, western façade, north end, eave lining, no asbestos detected by analysis.

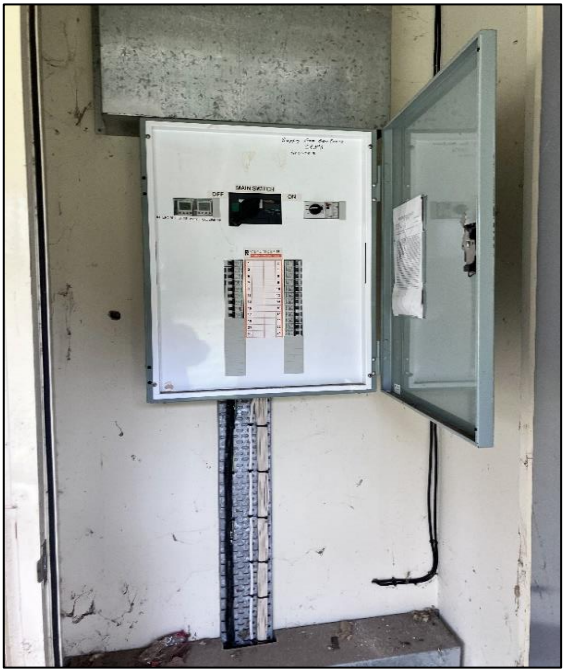
Photograph 4: B00V, interior, VR0009, within electrical panel(s), materials in general, inaccessible.

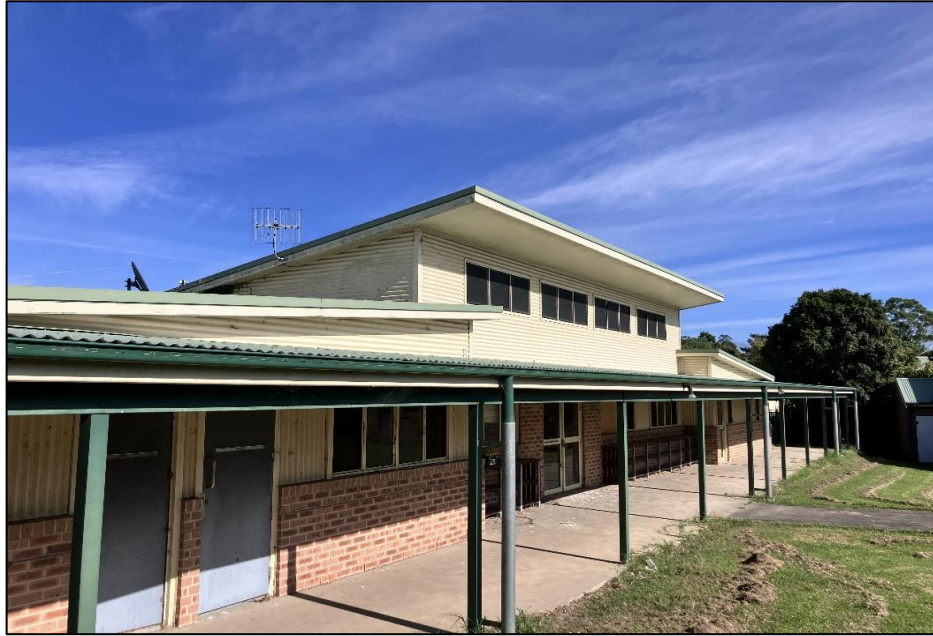
Photograph 5: B00V, exterior, east façade, timberwork (green and cream paints) and doors (grey paint).

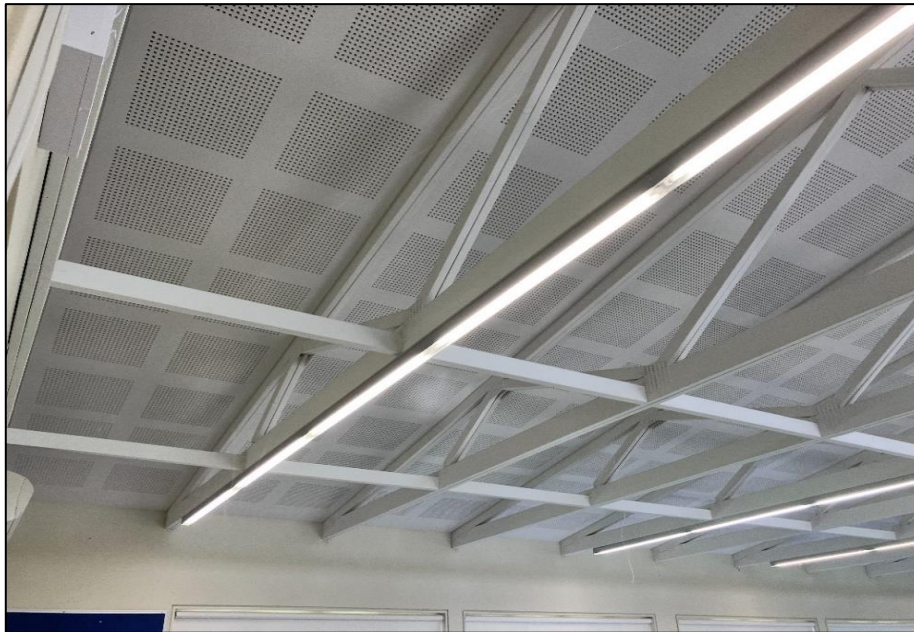
Photograph 6: B00V, interior, VR0004, ceiling, backing to perforated tiles, bulk insulation, SMF (suspected).

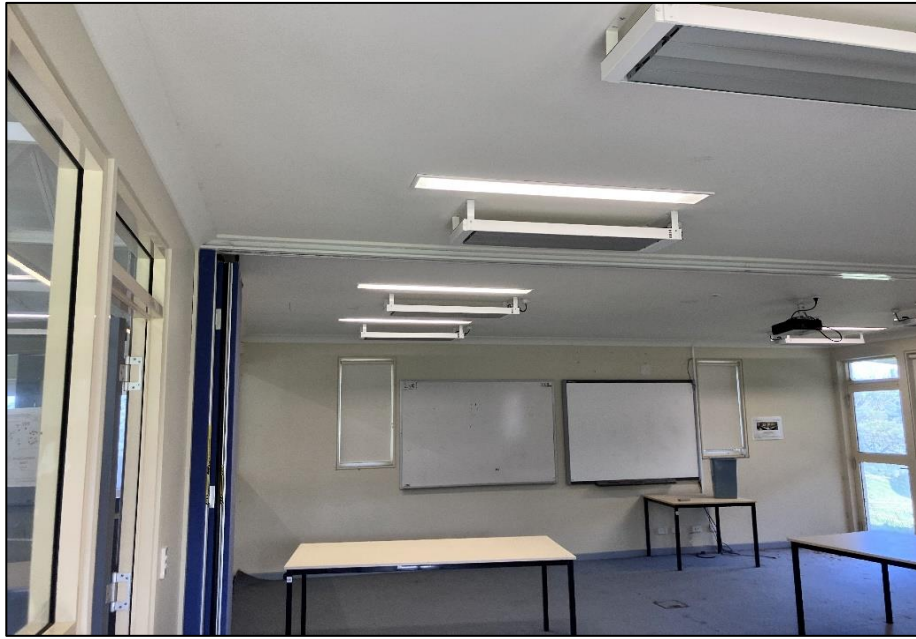
Photograph 7: B00V, rooms and areas in general, fluorescent light fittings, internal components, nil PCB (suspected).

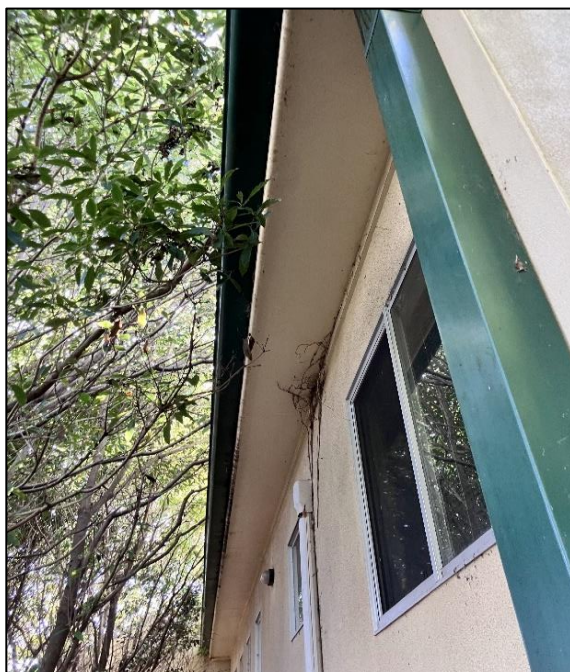
Photograph 3: B00W, exterior, northern façade, eave lining, fibre cement sheeting, no asbestos detected by analysis.

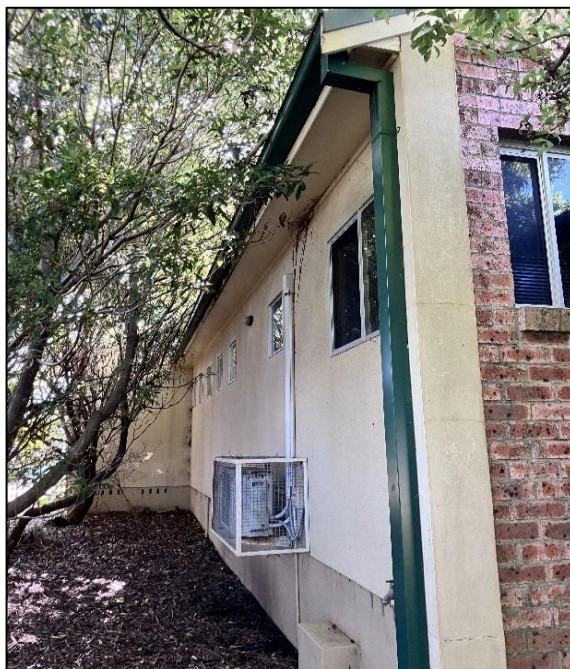
Photograph 4: B00W, exterior, northwestern façade, wall linings, fibre cement sheeting, no asbestos detected by analysis.

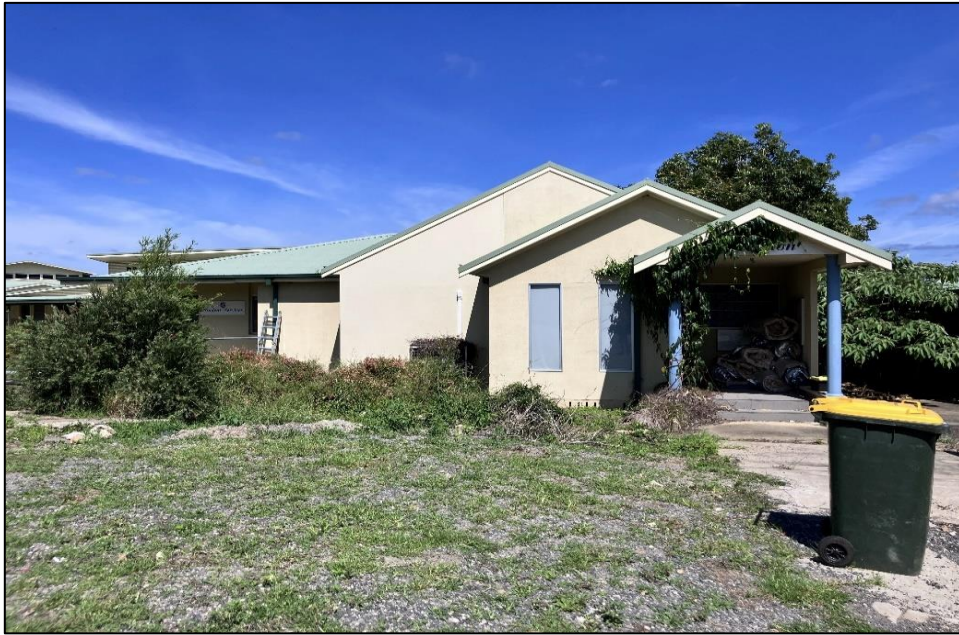
Photograph 5: B00W, exterior, northeastern façade, wall linings, fibre cement sheeting, suspected non-asbestos.

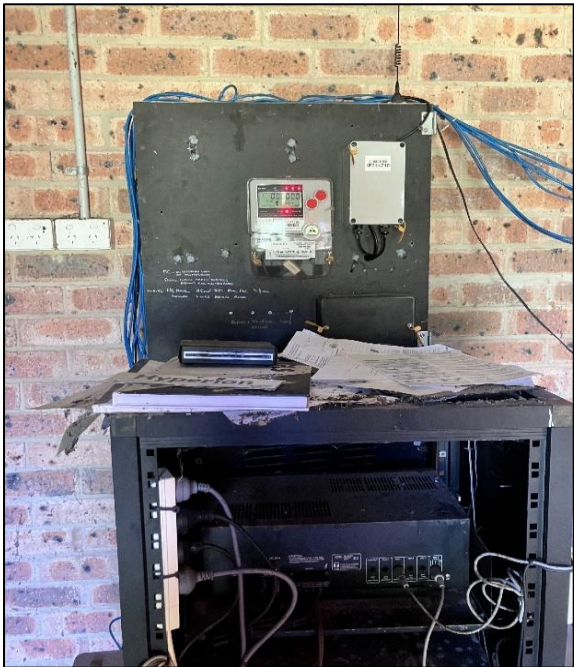
Photograph 8: B00W, WR0015, electrical panel, backing board, suspected non-asbestos.

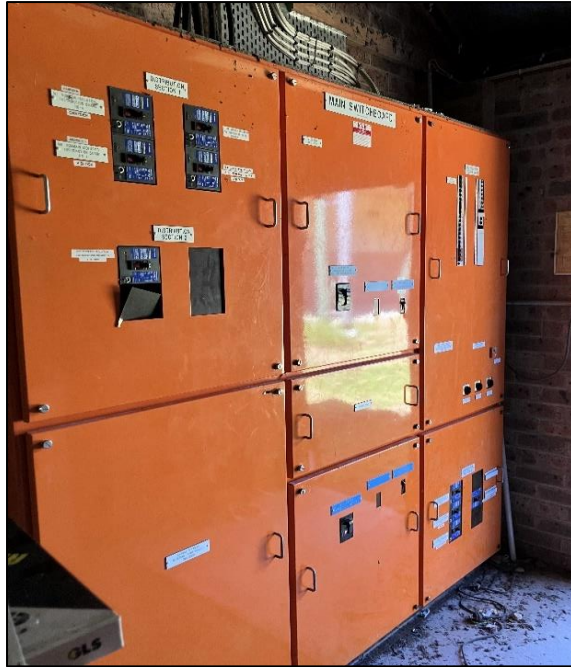
Photograph 9: B00W, WR0015, electrical cabinet(s), internal components, inaccessible.

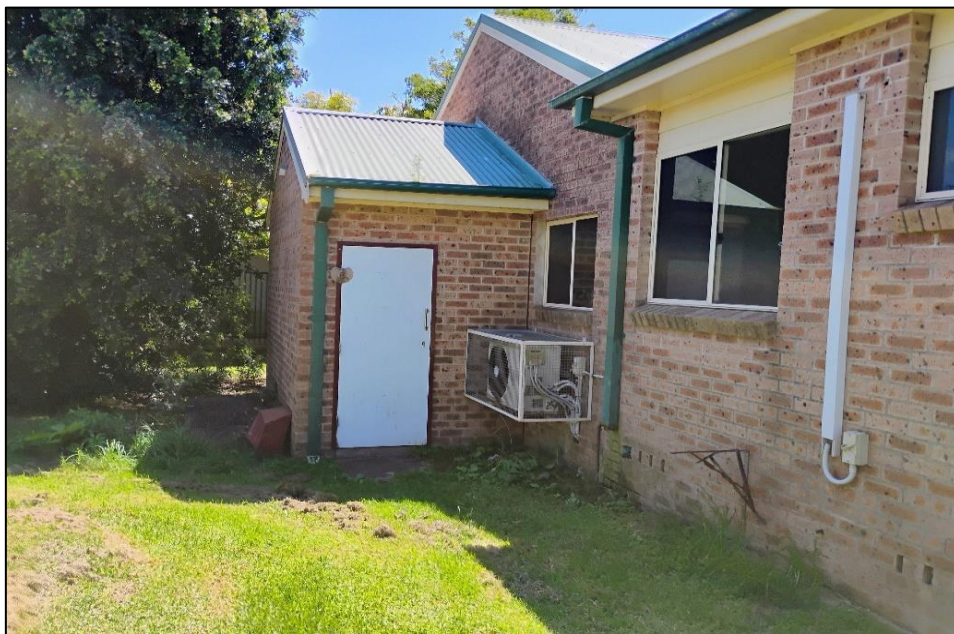
Photograph 10: B00W, WR0015, fire door, insulation, suspected non-asbestos.

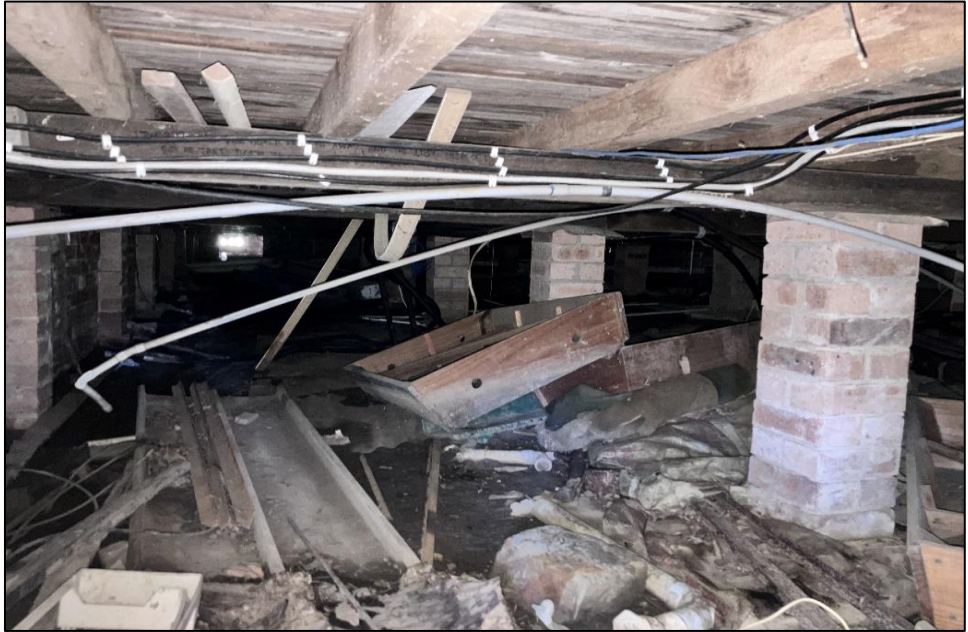
Photograph 11: B00W, subfloor, throughout, materials in general, limited / restricted access.

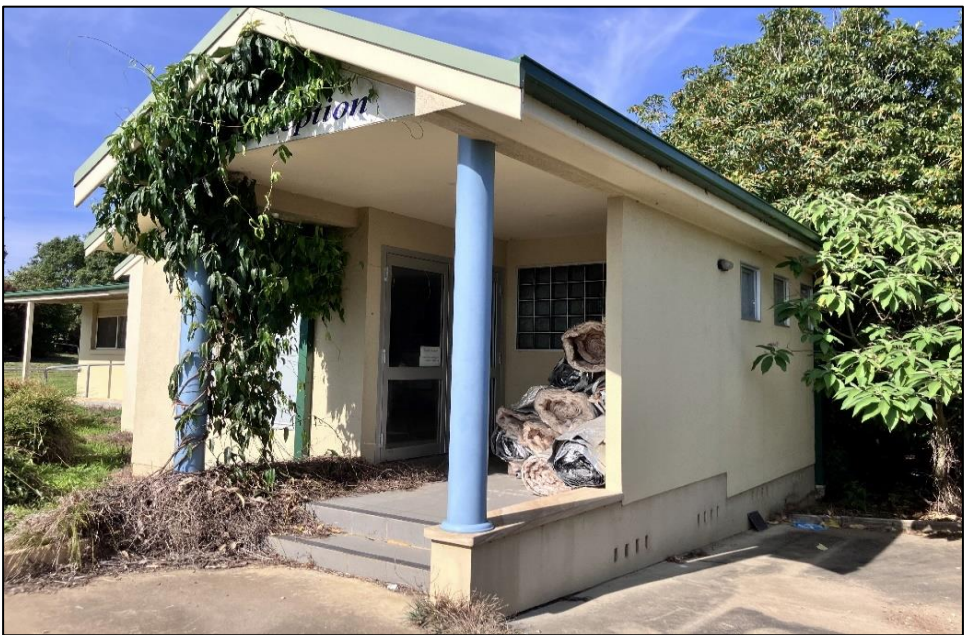
Photograph 12: B00W, WR0001, stored on porch area, rolls of insulation material, SMF identified visually.

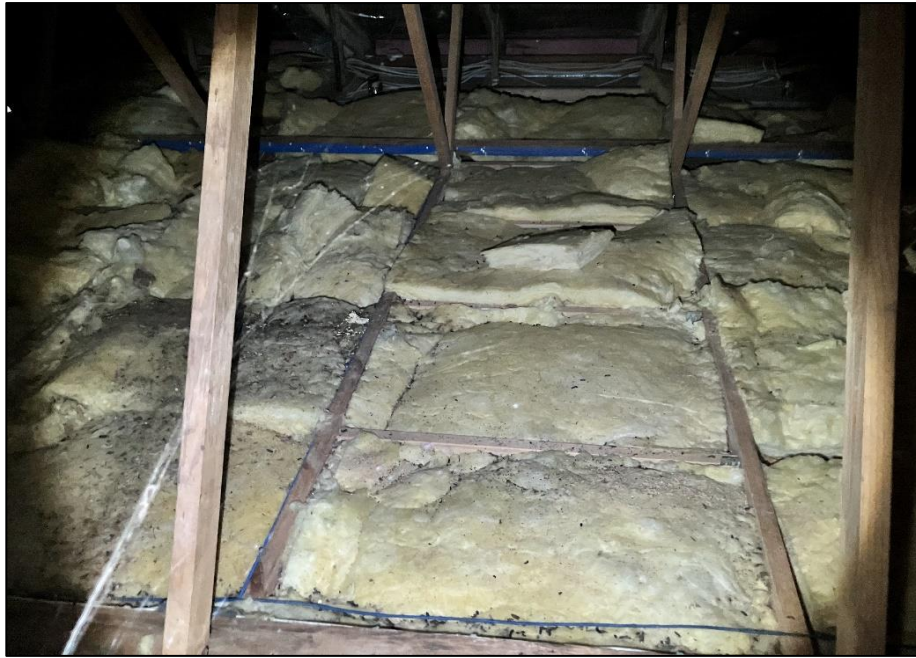
Photograph 13: B00W, ceiling cavity, top of ceiling, insulation batts, SMF identified visually.

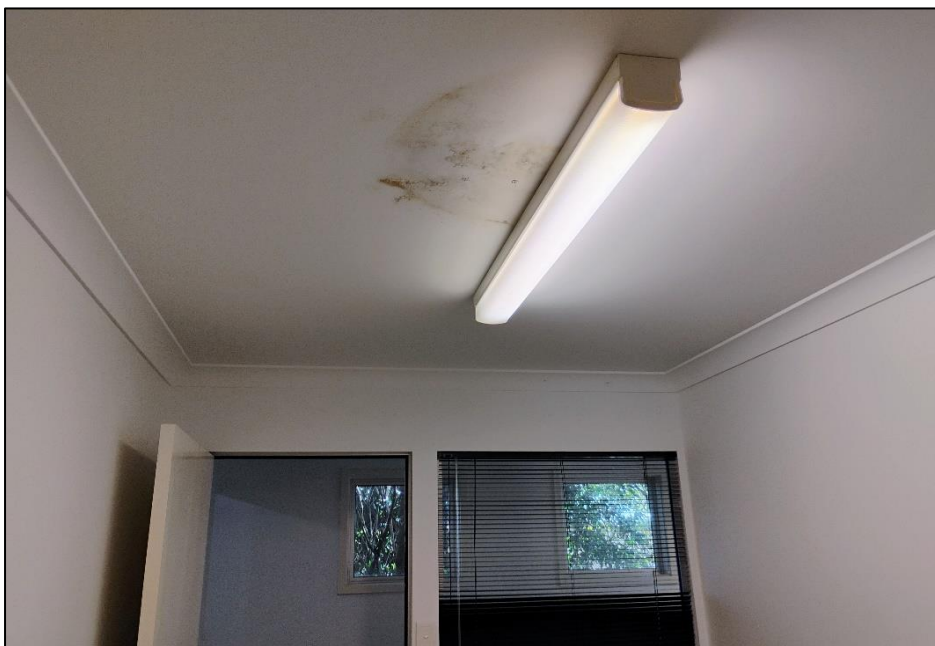
Photograph 15: B00W, rooms and areas in general, fluorescent light fittings, internal components, nil PCB (suspected).
