## DETAILED CONTAMINATION SITE INVESTIGATION REPORT

**1032 Richmond Road, Marsden Park**

REPORT No: NE083

DATE: 27 January 2017

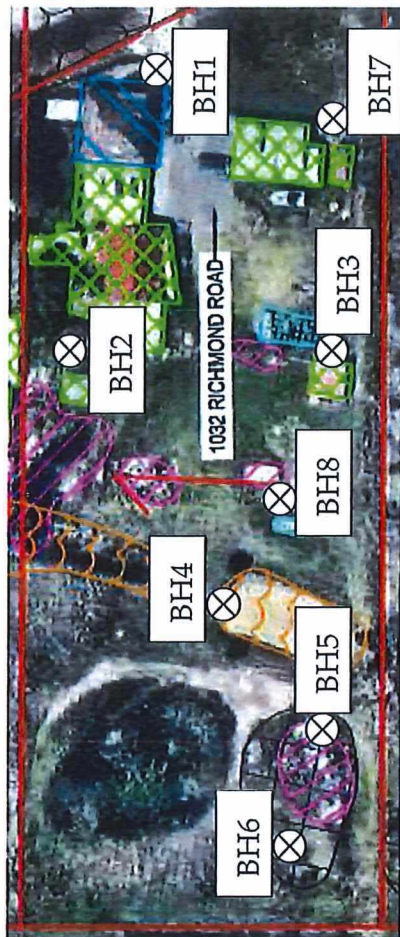
Figure 4: Borehole Locations

Fieldwork for this investigation was carried out on the 4th January 2017 and included excavation of 8 boreholes (BH1 to BH8). All boreholes were advanced by hand auger to depths varying from 50mm to 1000mm below the existing ground surface. The borehole locations are demonstrated in Figure 4. Environmental soil samples were collected from surface and at lower depths. Australian Standard (AS 4482.1—2005) procedures were used for sampling. Soil samples were collected by hand (disturbed samples) using disposable gloves which were changed between each sample. The auger was washed between each sampling to make sure no contamination is transferred. Individual samples were taken for laboratory analysis. Soil samples were placed into laboratory prepared glass jars and placed in a cooler (esky) with ice. Having collected the samples, they were transported to the laboratory within the correct holding times. A trip spike sample was stored with the samples to assess volatile loss.
