REPORT TO
SIT FAMILY PTY LTD

ON
GEOTECHNICAL ASSESSMENT

FOR
PROPOSED RESIDENTIAL DEVELOPMENT

AT
22C BURRAN AVENUE, MOSMAN, NSW

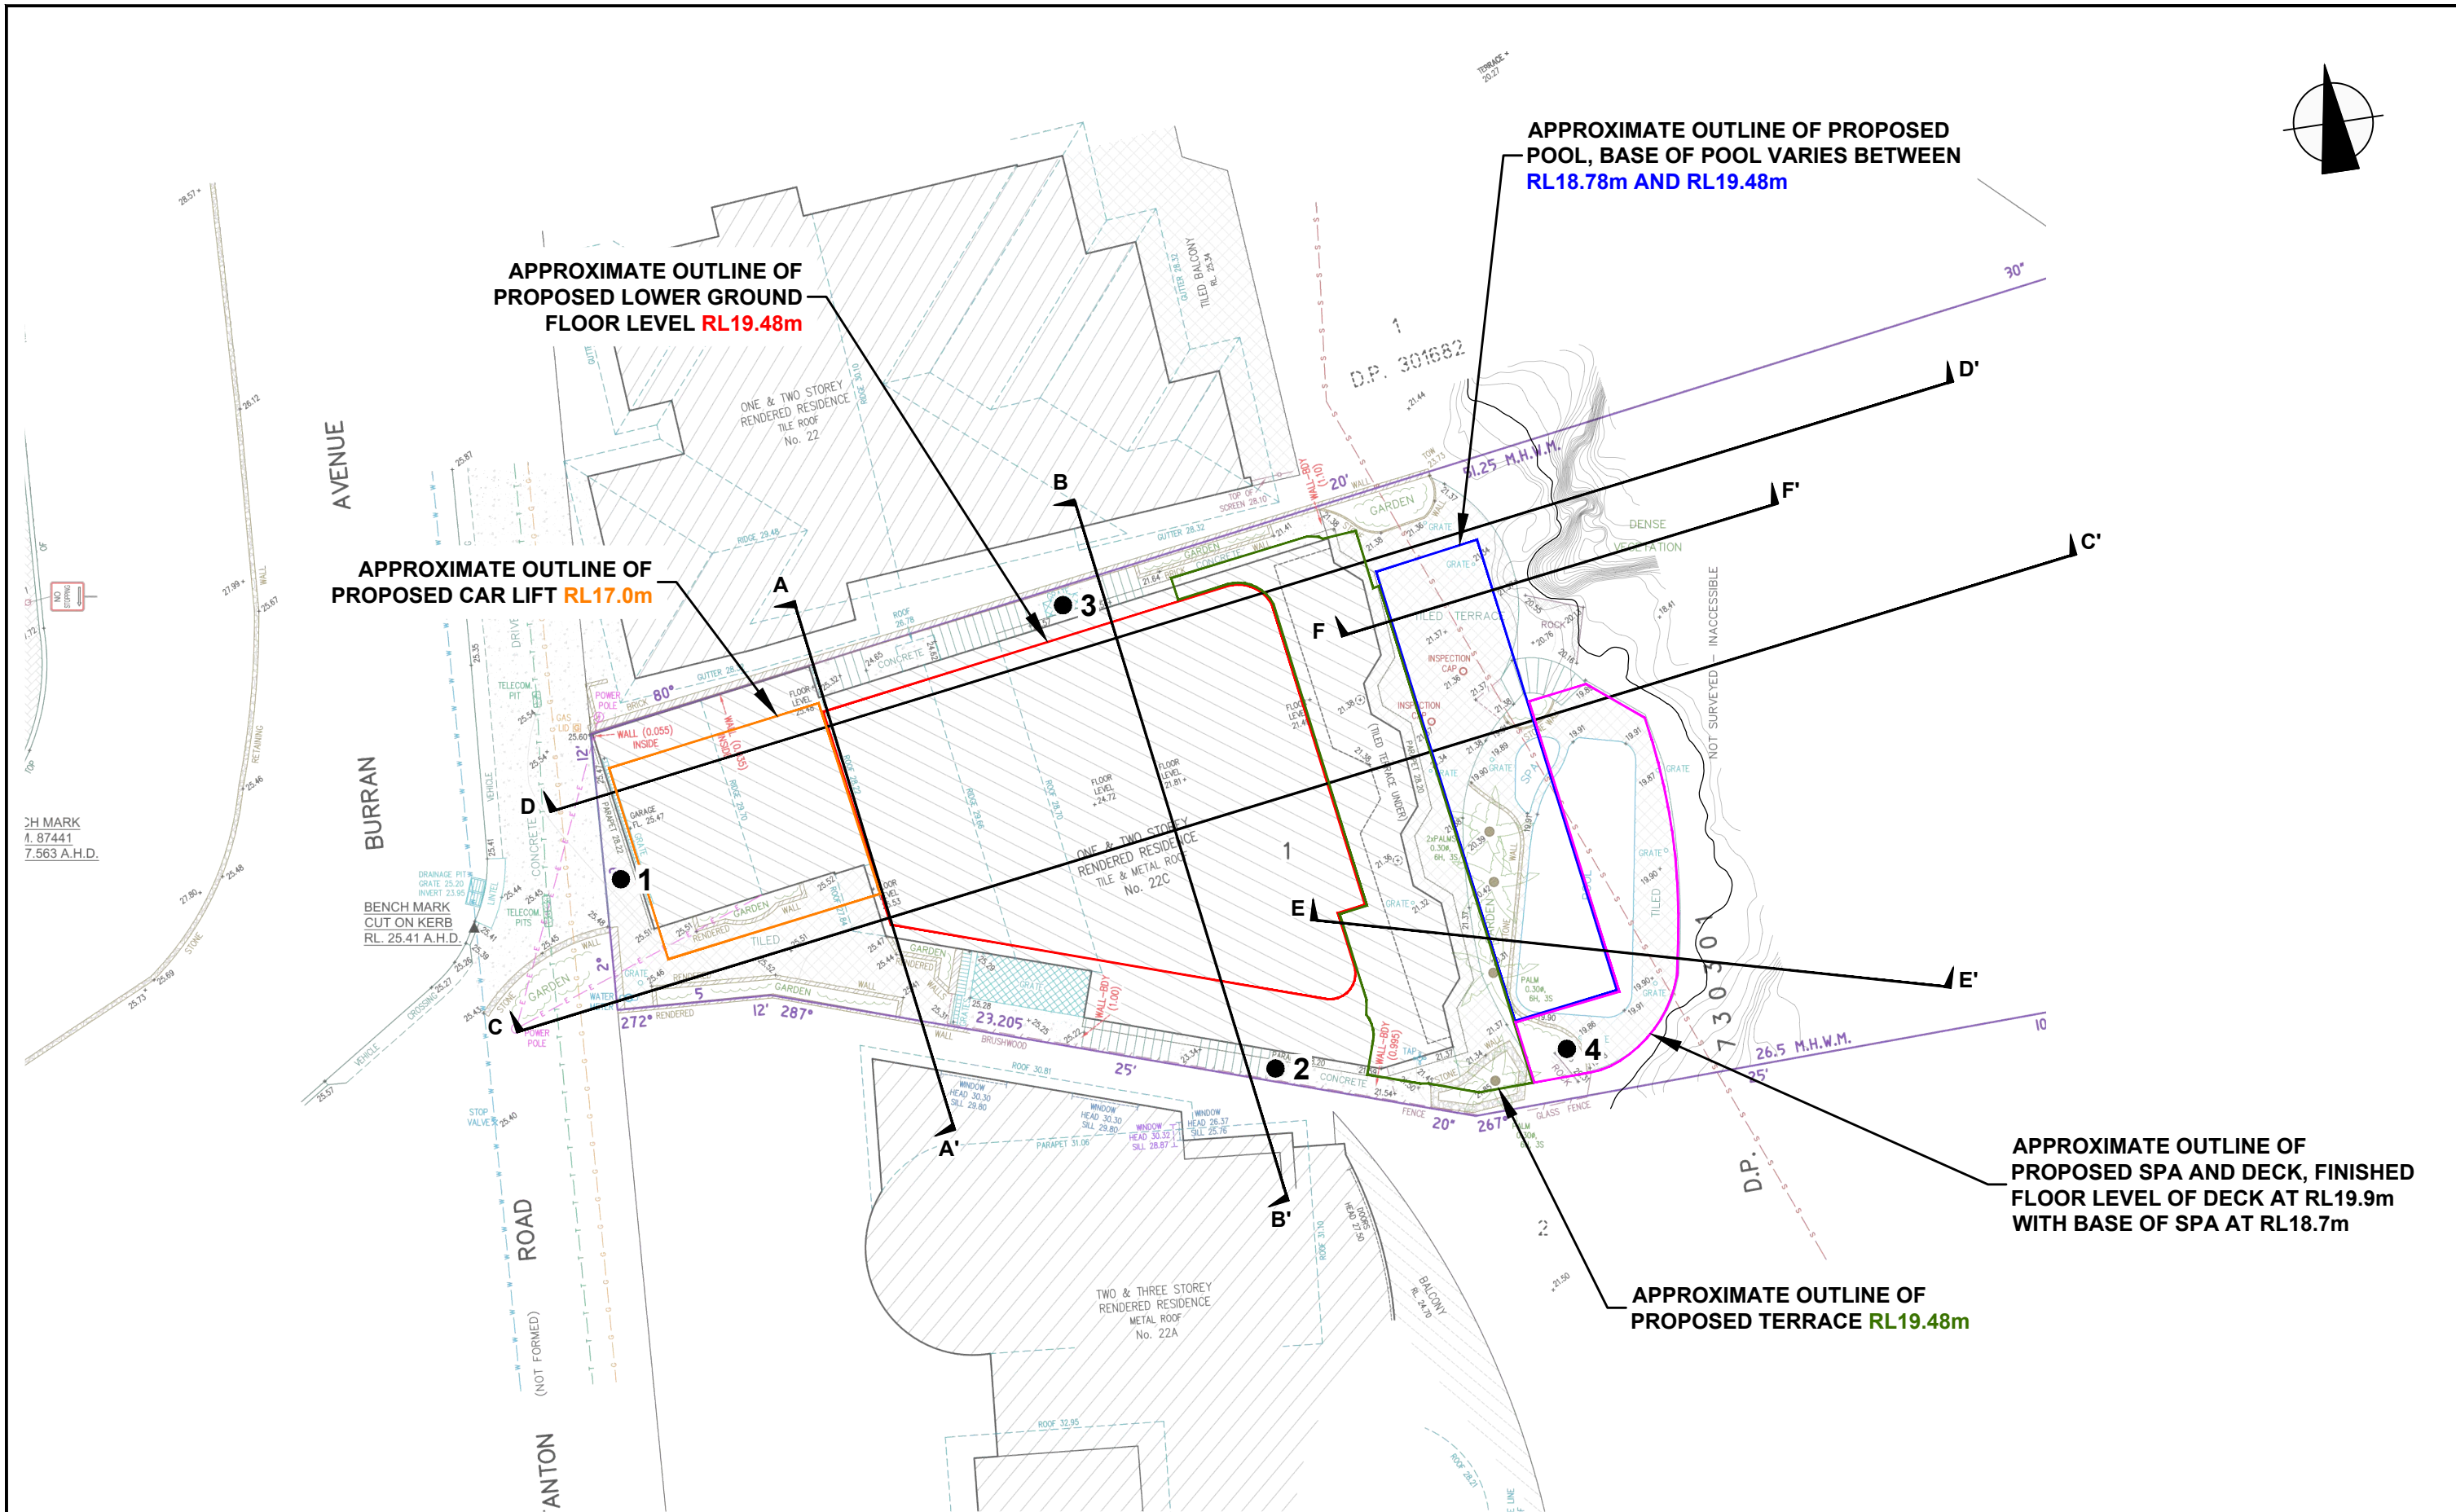
Title: PLAN OF NOTABLE GEOTECHNICAL FEATURES AND HAZARDS	
Location: 22C BURRAN AVENUE, MOSMAN, NSW	
Report No: 34431YJ	Figure No: 3
JKGeotechnics

The attached Figure 3 presents a plan showing notable geotechnical site features and geotechnical hazards. We were not able to access the area between the site and the cliff-line due to safety concerns so our geotechnical mapping was carried out from safe vantage points on the site and from the base of the cliff-line. Figure 3 is based on the land survey plan prepared by Bee & Lethbridge Pty Ltd (Bee & Lethbridge, Ref: Drawing No. 21188-02, Revision 02, dated 23 July 2019). In addition to the land survey an aerial survey was carried out by Diodrone Pty Ltd (Ref: 19AU030, Revision 1.1, dated 1 August 2019). This included LiDAR data of the cliff-line and cross sections through the cliff-line. Additional features on Figure 3 have been measured by hand held clinometer and tape measure techniques and hence are only approximate. Should any of the features be critical to the proposed development, we recommend they be located more accurately using instrument survey techniques. Figures 4 to 7 present Sections A-A' to D-D', which are typical cross-sections through the site and are based on the survey data augmented by our mapping observations. Figures 8 and 9 present Section E-E' and F-F' which includes additional sections through the cliff-line at the southern and northern portions of the site. Sections A-A' and B-B' also includes the assessed potential landslide hazards for adjoining structures. Figure 10 defines the geotechnical mapping symbols adopted and used in Figure 3.

Reference should be made to the attached Figures 3, 4 and 5, which indicate the approximate location of the potential hazards posed by this site to the adjoining properties. These hazards are described below:

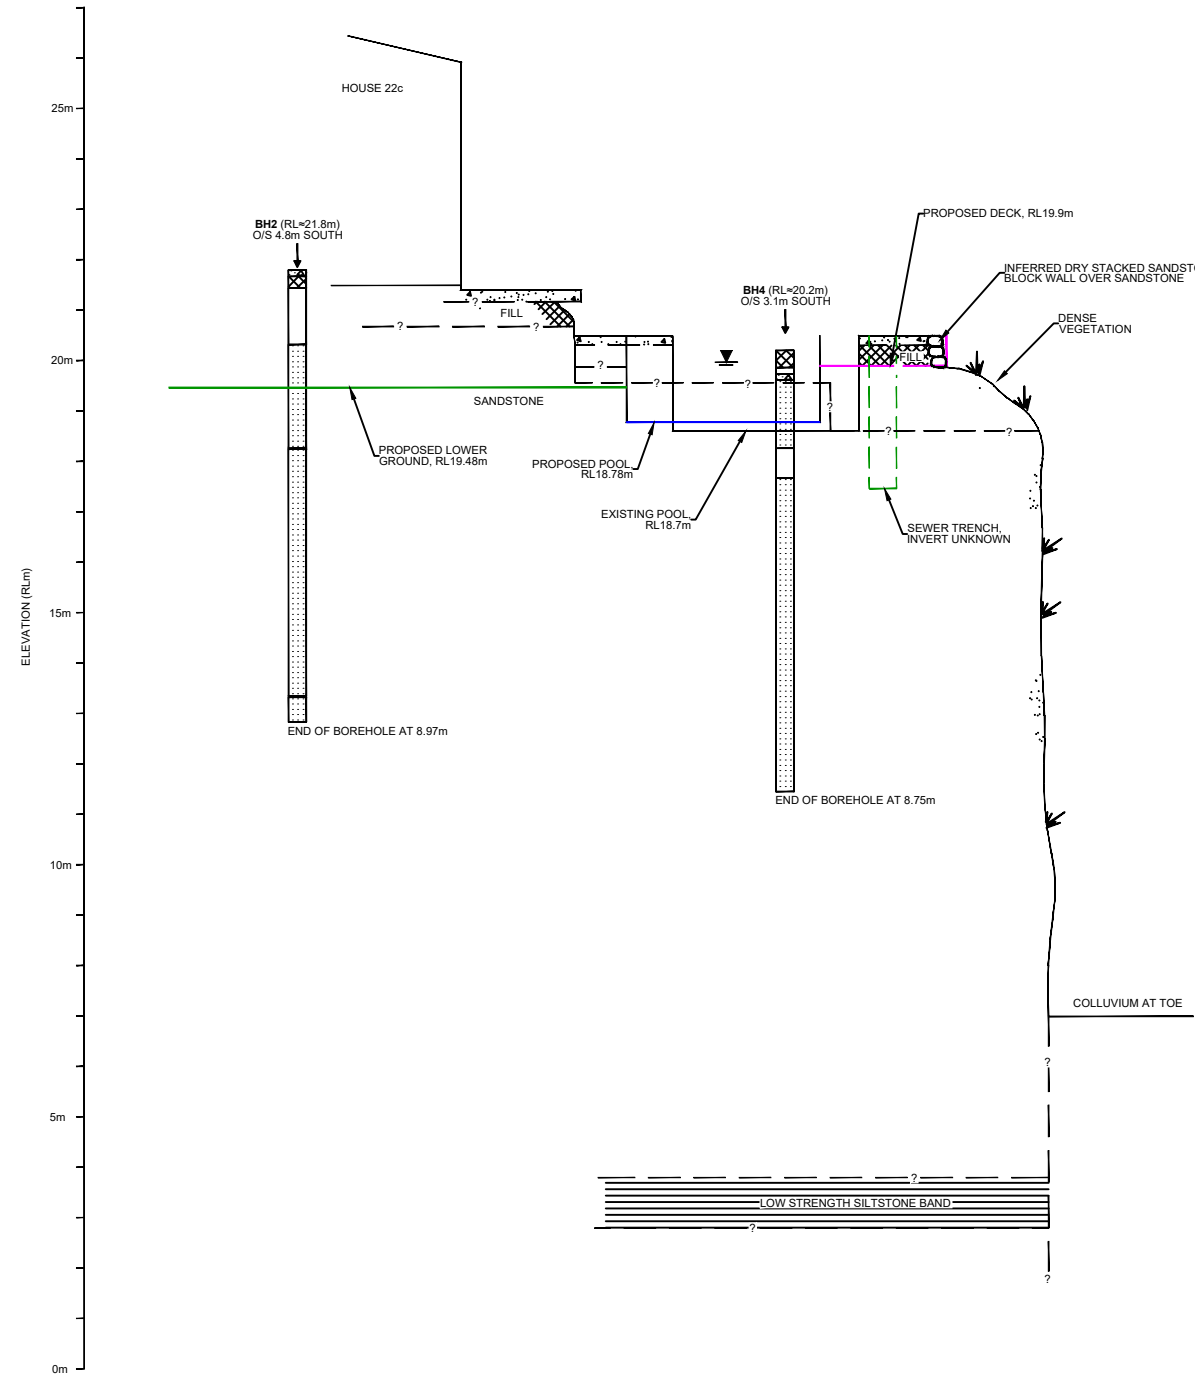
Title: SECTION E-E'	
Location: 22C BURRAN AVENUE, MOSMAN, NSW	
Report No: 34431YJ	Figure No: 8
JKGeotechnics

As discussed, the proposed pool and spa is generally located no closer than about 10m to 12m from the eastern boundary (Ref: Figure 6). However, at its northern and southern ends it extends to within about 1.5m (Ref: Figures 3, 8 and 9) of the cliff line. The spa will be wholly located within the existing pool excavation and only limited (less than 0.5m) additional excavation is expected to be required to achieve bulk excavation in this location. The proposed new pool at its southern end will be wholly located within the existing pool excavation and consequently, over the southern half of the pool no excavation adjacent to the cliff line will be required. At its northern end, excavation to maximum depths of about 2m are required but are anticipated to be predominantly through soil.
