Comments on Updates to Plans

J2578. 10th September, 2020. Page 1.

GEOTECHNICAL INVESTIGATION:

New House and driveway at 13 Pacific Road, Palm Beach

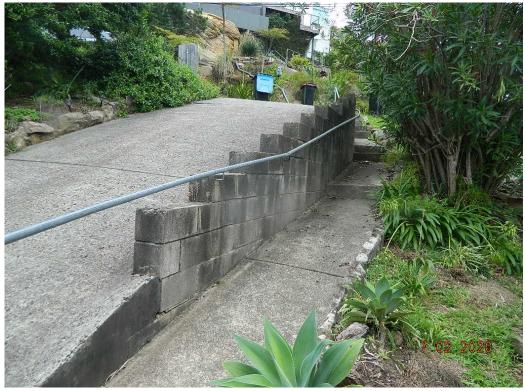
Photo 4

- 2.3 Sandstone bedrock outcrops uphill of Pacific Road (Photo 1). At the road frontage a concrete driveway runs to a carport at the SW corner of the house (Photos 2 & 3). A stable ~0.7m high concrete block retaining wall supports the driveway fill. Sandstone bedrock outcrops downhill of the retaining wall (Photo 4). The single storey brick house is supported on brick walls, brick piers and a concrete slab (Photos 5 & 6). The concrete slab is in good condition and the supporting walls and piers stand vertical and show no significant signs of movement (Photos 7 & 8). Sandstone bedrock outcrops underneath and downhill of the house (Photos 9 & 10). A timber balcony at the downhill side of the house is supported by timber posts and
