Preliminary Contaminated Land Assessment

Rezoning Proposal Lot 22 DP 1073165, 156 Stuart Street Mullumbimby

For:Byron Shire CouncilReport No:17014_sepp55.docxDate:August 2017

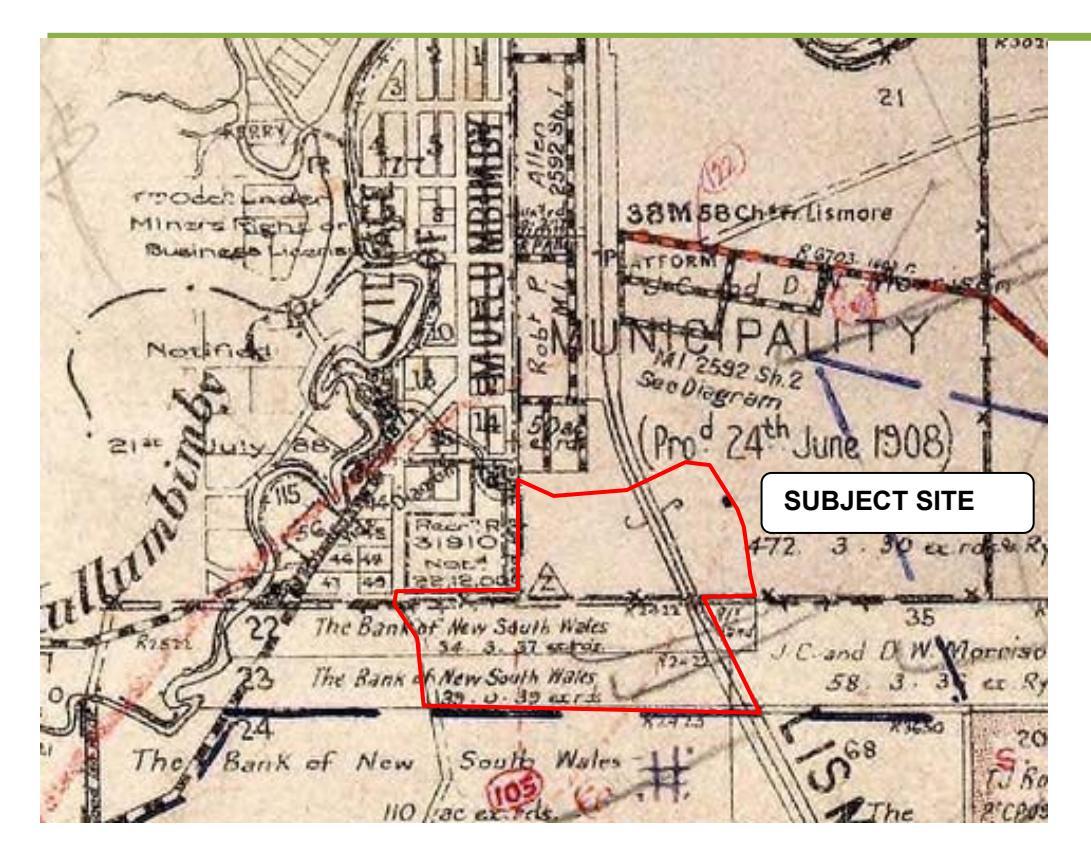
Figure 1: 1912 parish map (NSW LPI, 2016).

Parish maps present that the property was a larger rural holding, connected to the property to the east of the railway line, as shown in Figures 1 and 2.

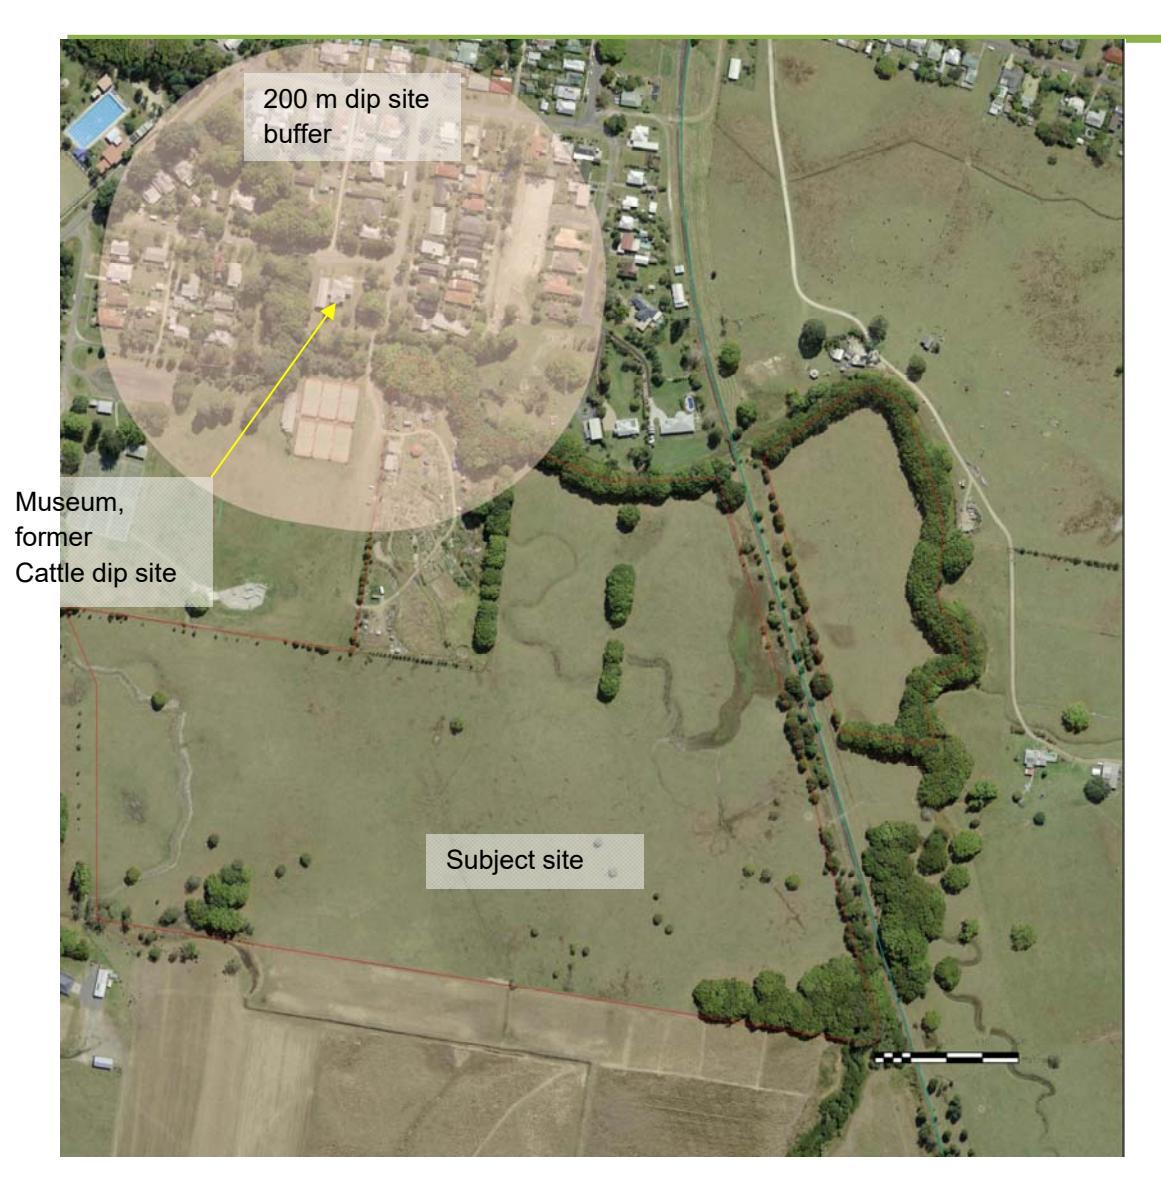
Figure 7: 2010 aerial (NSW LPI, 2017)

The neighbouring site to the north (154 Stuart Street) was once a brickworks. It is understood from newspaper articles that the brickworks were granted approval in 1948 by the then Department of Building Materials (Trove: Digitalised newspapers, Northern Star 15 March, 1948). It is understood that the site contained a kiln, brick stamping machines and electric motors were used to drive the machinery (Trove: Digitalised newspapers, Tweed Daily Friday 21 May, 1948).

The historic aerial photography also presents the landuse to the north west of the subject site containing a cattle tick dip. The site now contains the former Mullumbimby Post Office which was moved to the site in 1984. However, the use of the site of a former cattle dip site would have caused contamination at that site. The dip site is known as 'Mullumbimby old'. Further discussion of this site is presented in Section 6.3.
