## **Pacific Brands Limited**

**Report for 190 Dunmore Street  
Wentworthville NSW**

**Phase 2 Environmental Site  
Assessment**

**May 2011**

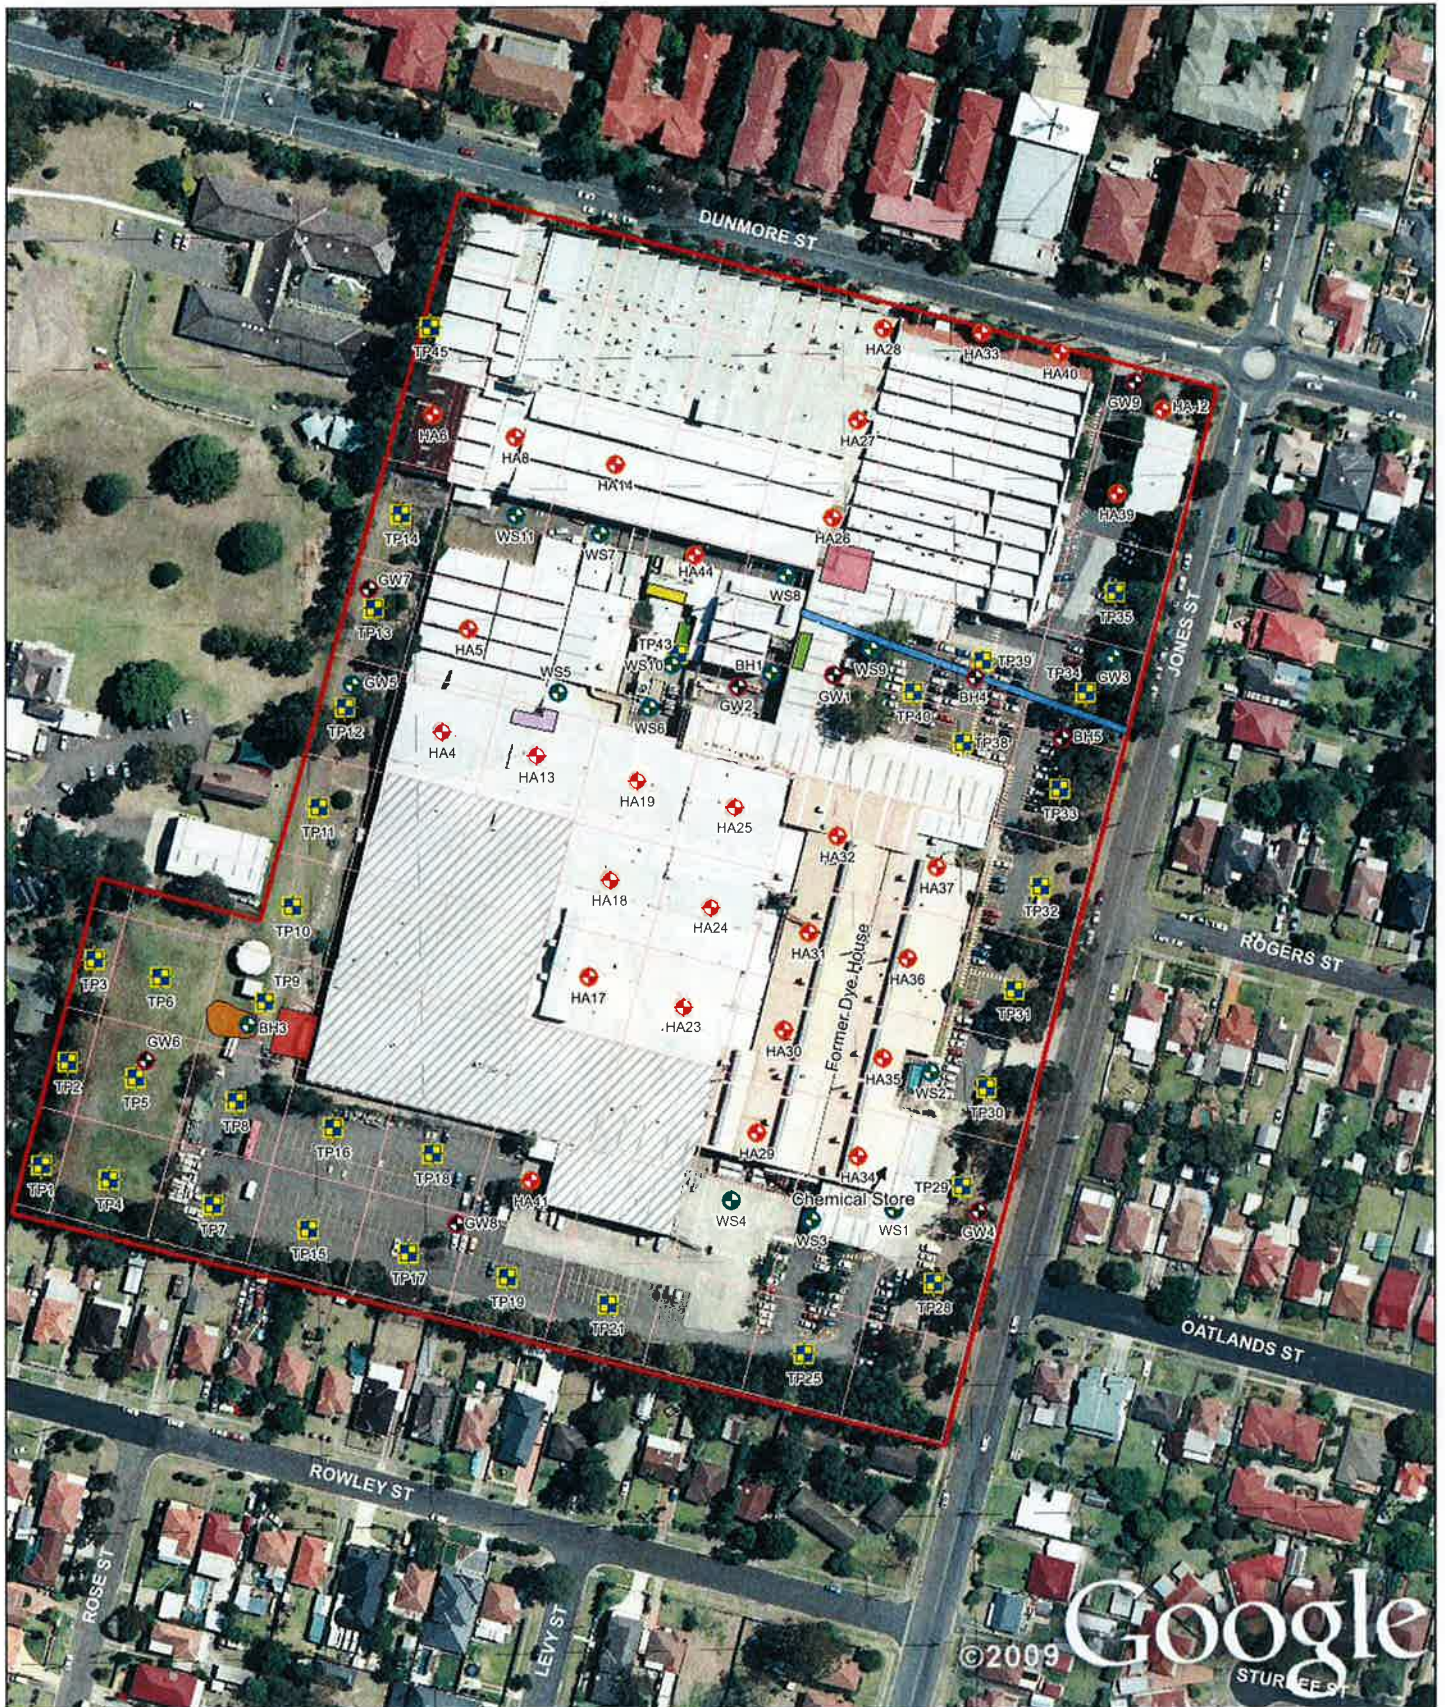
Figure 2

Soil sample locations are shown on Figure 2. A summary of the combined (Phase 1 targeted and Phase 2 grid based) soil sampling and analysis program is provided in **Table 4**.

The combined 2009 and 2011 groundwater investigations involved the drilling, installation and sampling of nine groundwater monitoring wells. The groundwater monitoring well network is shown in Figure 2. Five monitoring wells were installed as part of the 2009 investigation (GW1, GW2, GW4, BH4 and BH5) and an additional four installed in 2011 (GW6, GW7, GW8 and GW9). *Note: Monitoring wells were not installed at GW3 and GW5 (i.e. soil sample boreholes only).*

Soil sample locations are shown on Figure 2. A description of lithology encountered at each location, including samples collected and PID readings, is presented in the borehole and test pit logs provided in Appendix A.

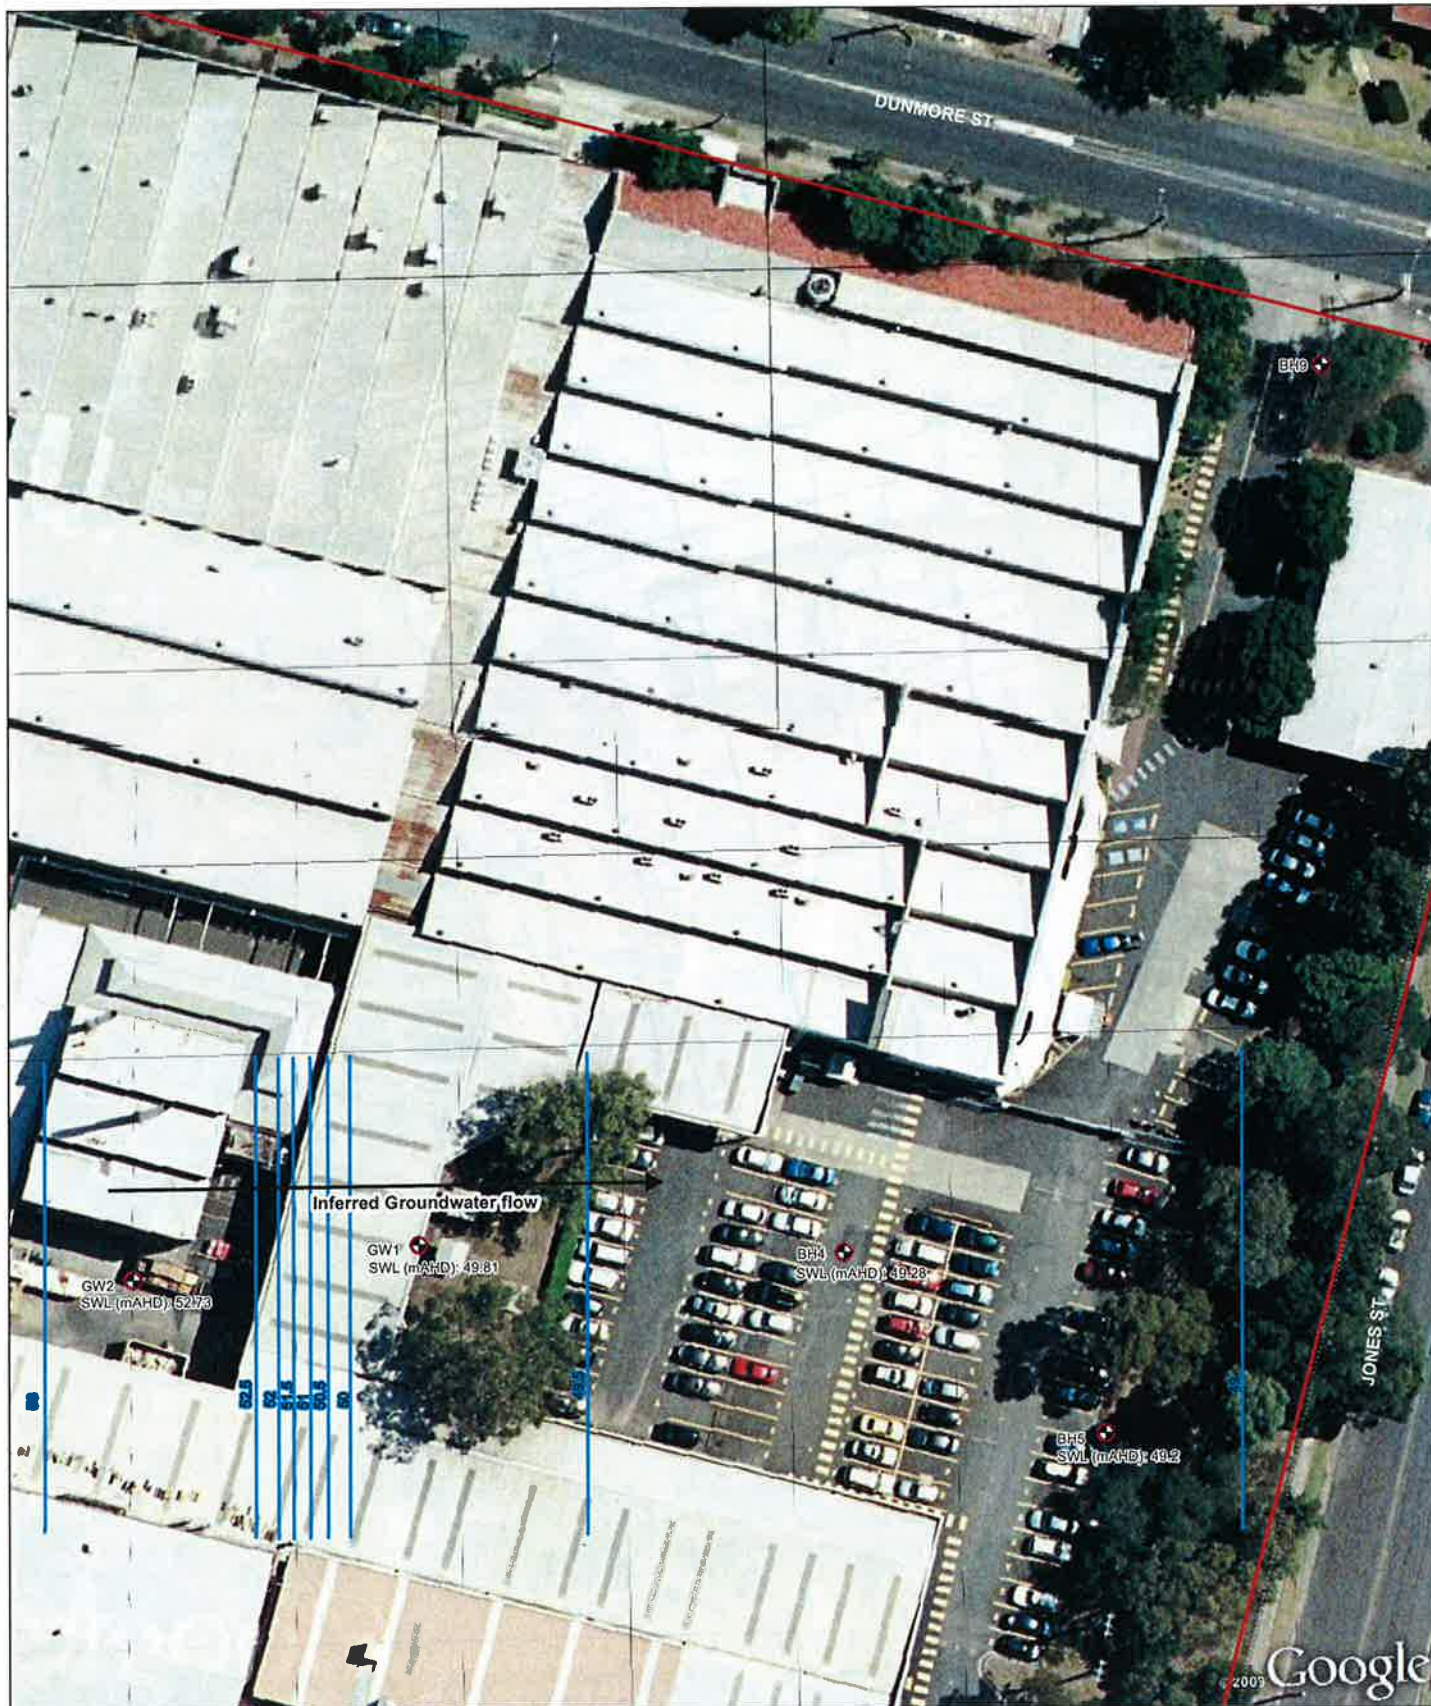
Interpreted Groundwater Contours - Fill Material **Figure 3**

The groundwater elevation at each monitoring location was determined by reducing the groundwater depth measurements using the elevation data from the well survey. These data were used to produce groundwater elevation contours to determine groundwater flow direction and hydraulic gradient. The interpreted groundwater contours for the perched water system and regional water table are provided as Figure 3 and Figure 4 respectively. These contours indicate the following:
