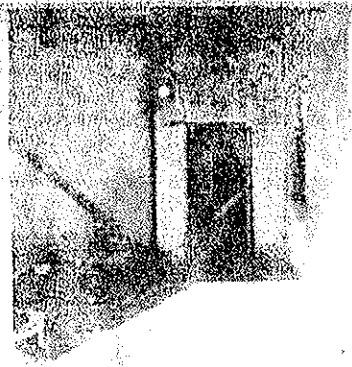
Figure No.99: View of original two storey barn.  
Within the barn the small space is thought to have  
housed the servants. LG4

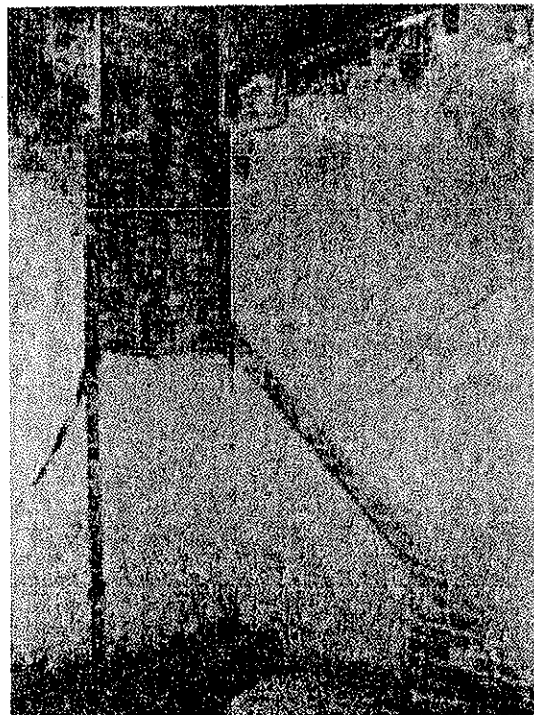
Figure No.102: View of former door opening and  
stairs leading to the outside area and upper level  
of the barn. LG4

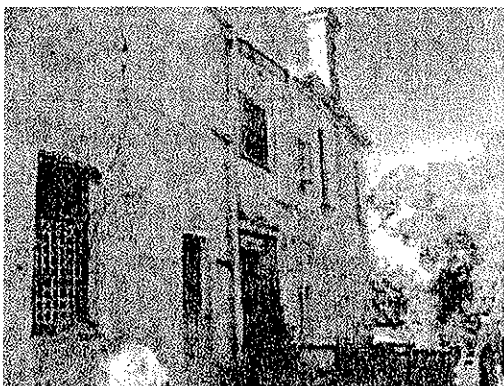
Figure No.104: External view of the west homestead façade looking south. The elevation shows the barn connected by the overhead kitchen and attached to the front bedrooms.

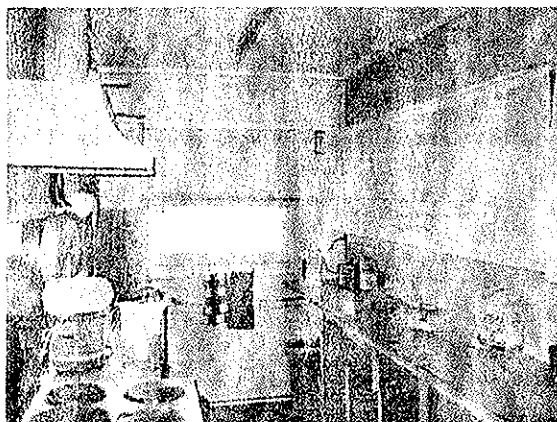
Figure No.105: Internal view of  
kitchen area from east G24

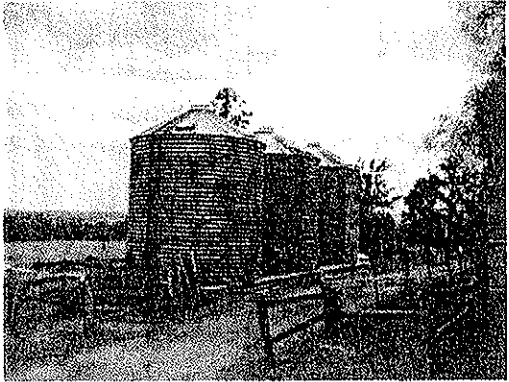
<p>Figure No.107: Silos in farm complex</p>
<p><b>General Description</b></p> <p>Construction Period: c1935 Design style: Functional – adapted 1950</p> <p><u>Construction materials</u></p> <p>Structure: corrugated metal sheeting</p> <p>Floors: silos sitting on concrete slab.</p>	
<p><b>Current use and condition</b></p> <p>The silos are in good condition. The metal sheeting is slightly weathered however the overall structure is intact. These structures are no longer in use but are maintained as an element of the former function of the working farm.</p>

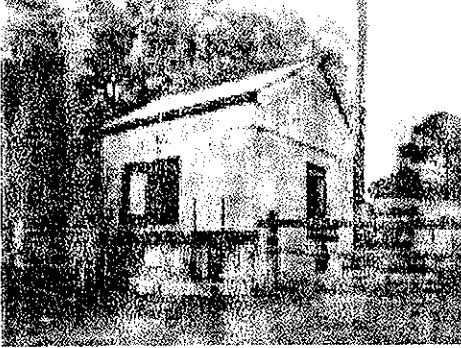
<p>Figure No.108: Early out building in farm complex</p>
<p><b>General Description</b></p> <p>Construction Period: c1850 Design style: Vernacular, Georgian Adapted: c1950</p> <p><u>Construction materials</u></p> <p>Walls: Brickwork rendered with stone coursing.</p> <p>Roof: Timber framed and metal sheeting (later addition)</p> <p>Floors: Compacted earth</p> <p><b>Current use and condition</b></p> <p>The outbuilding is in poor condition and currently used as shelter for horses. The small structure is thought to have been a workers cottage the Millers Cottage or outbuilding closely associated with the operations of the farm complex.</p>

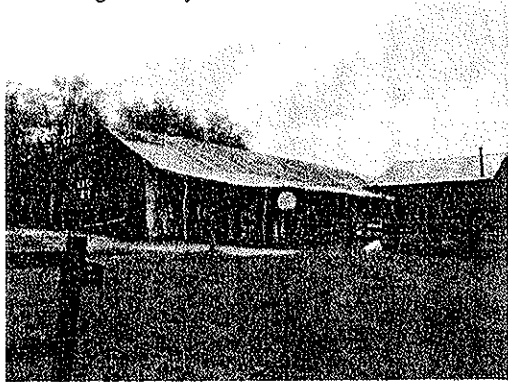
<p>Figure No.109: Large stables in farm complex</p>
<p><b>General Description</b></p> <p>Construction Period: c1930 Design style: Vernacular Adapted 1950, 1990</p> <p><u>Construction materials</u></p> <p>Walls: Timber with metal sheeting Verandah – round timber posts</p> <p>Roof: Timber framed and metal sheeting (later addition)</p> <p>Floors: Compacted earth – evidence of early brick paving</p>

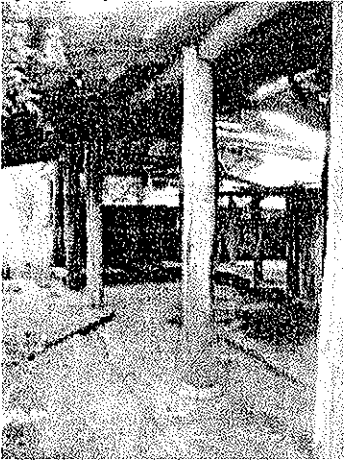
<p>Figure No.112: Early milking shed in farm complex no longer used.</p>
<p><b>General Description</b></p> <p>Construction Period: c1920 (1900) Design style: Vernacular, Georgian</p> <p><u>Construction materials</u></p> <p>Walls: Timber framed construction</p> <p>Roof: Timber framed and metal sheet roofing</p> <p>Floors: concrete slab on compacted earth</p>

<p>Figure No.113: Early milking shed in farm complex overgrown by the Peppercorn tree.</p>
<p><b>Current use and condition</b></p> <p>This early milking shed is no longer used and in poor condition. The timber structure is supported by the Pepper corn. The structure is in urgent need of repair.</p>

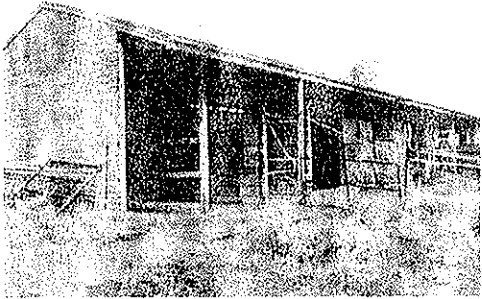
<p>Figure No.114: Former milking shed associated with the Fairfax occupation later converted to horse stables in 1990.</p>
<p><b>General Description</b></p> <p>Construction Period: 1935 Design style: Vernacular Adapted: c1950-c1990</p> <p><b>Construction materials</b></p> <p>Walls: Timber framed structure with sheet metal cladding Roof: Timber framed structure with sheet metal roofing Floors: Concrete slab on compacted earth.</p>	
<p><b>Current use and condition</b></p> <p>Formerly a milking shed the area is currently used as stables for the operation of horse agistment. The milking shed is thought to date back to the Fairfax occupation. Unoccupied by the successive managers of the site, the space was converted to stables in 1990 with change over to horse agistment. The area is in good condition with evidence of its former use.</p>

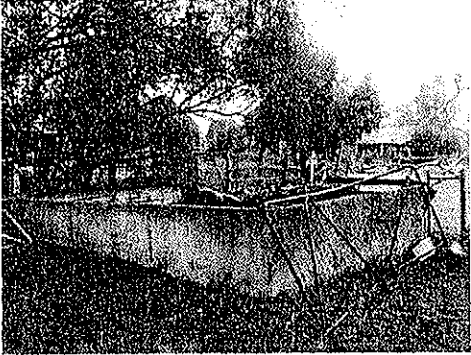
<p>Figure No.115: Concrete bin associated with the feeding of the cows during the Fairfax occupation.</p>
<p><b>General Description</b></p> <p>Construction Period: c. 1935 Design style: Adapted: c.1950, c.1990 <u>Construction materials</u></p> <p>Structure – concrete on compacted earth</p> <p><b>Current use and condition</b></p> <p>Currently used as a sand pit the bin is thought to have been a mash bin closely associated with the milking shed. The structure is in fair condition however the sand ring now used for horses (closely associated with the bin) no longer exists.</p>

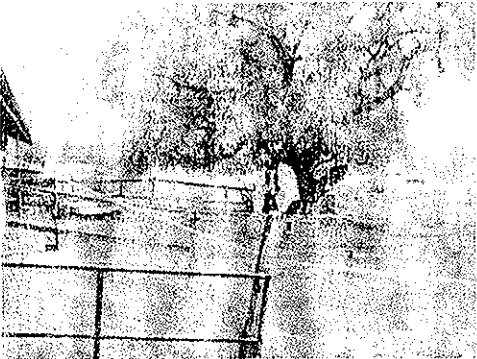
<p>Figure No.116: Location of sales yards and auctioneers stand associated with the Fairfax occupation.</p>
<p><b>General Description</b></p> <p>Construction Period: c. 1950s              Design style:</p> <p><u>Construction materials</u></p> <p>Remnant slabs for auctioneers stand</p>

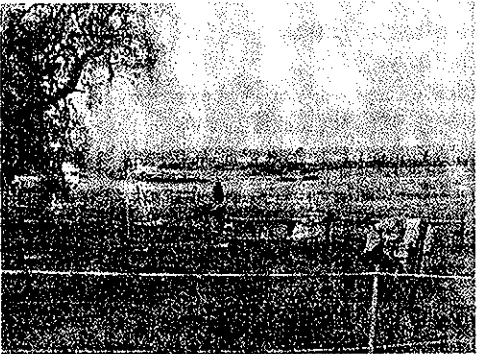
<p>Figure No.117: Location of stock yards closely located to The Northern road and Harrington Park associated with the Fairfax occupation.</p>
<p><b>Current use and condition</b></p> <p>The area was once used as piling stock yards associated with the Swan and Fairfax occupation. Currently used as a horse paddock there is no evidence of the yards and bales.</p>

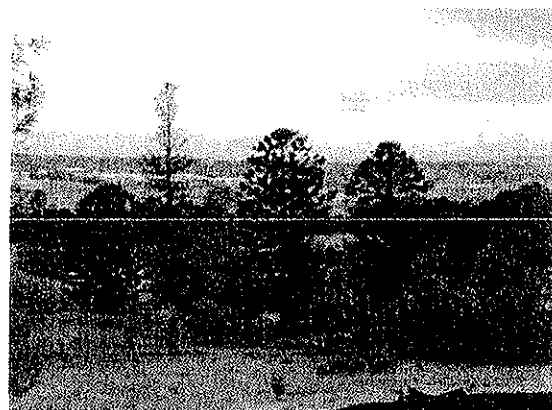
Figure No.119: Presentation Gardens

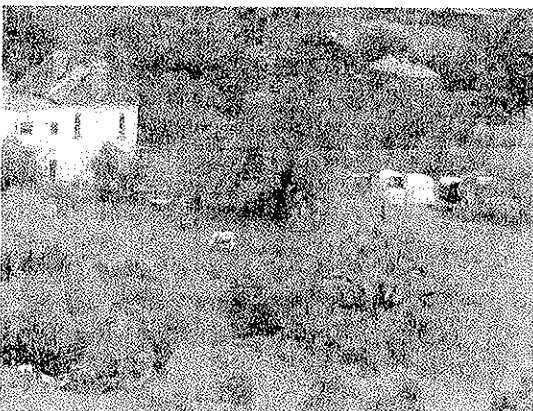
Figure No.120: Looking to recreation gardens over the productive gardens.

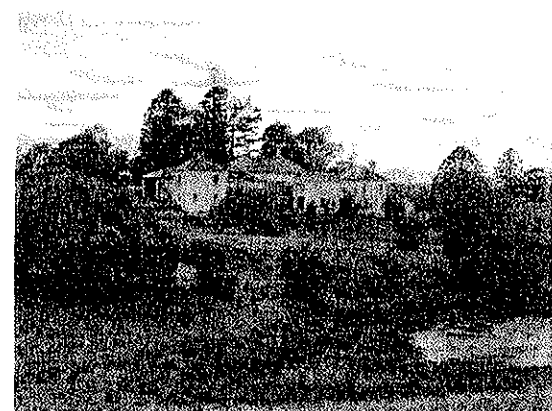
Figure No.121: Productive garden.

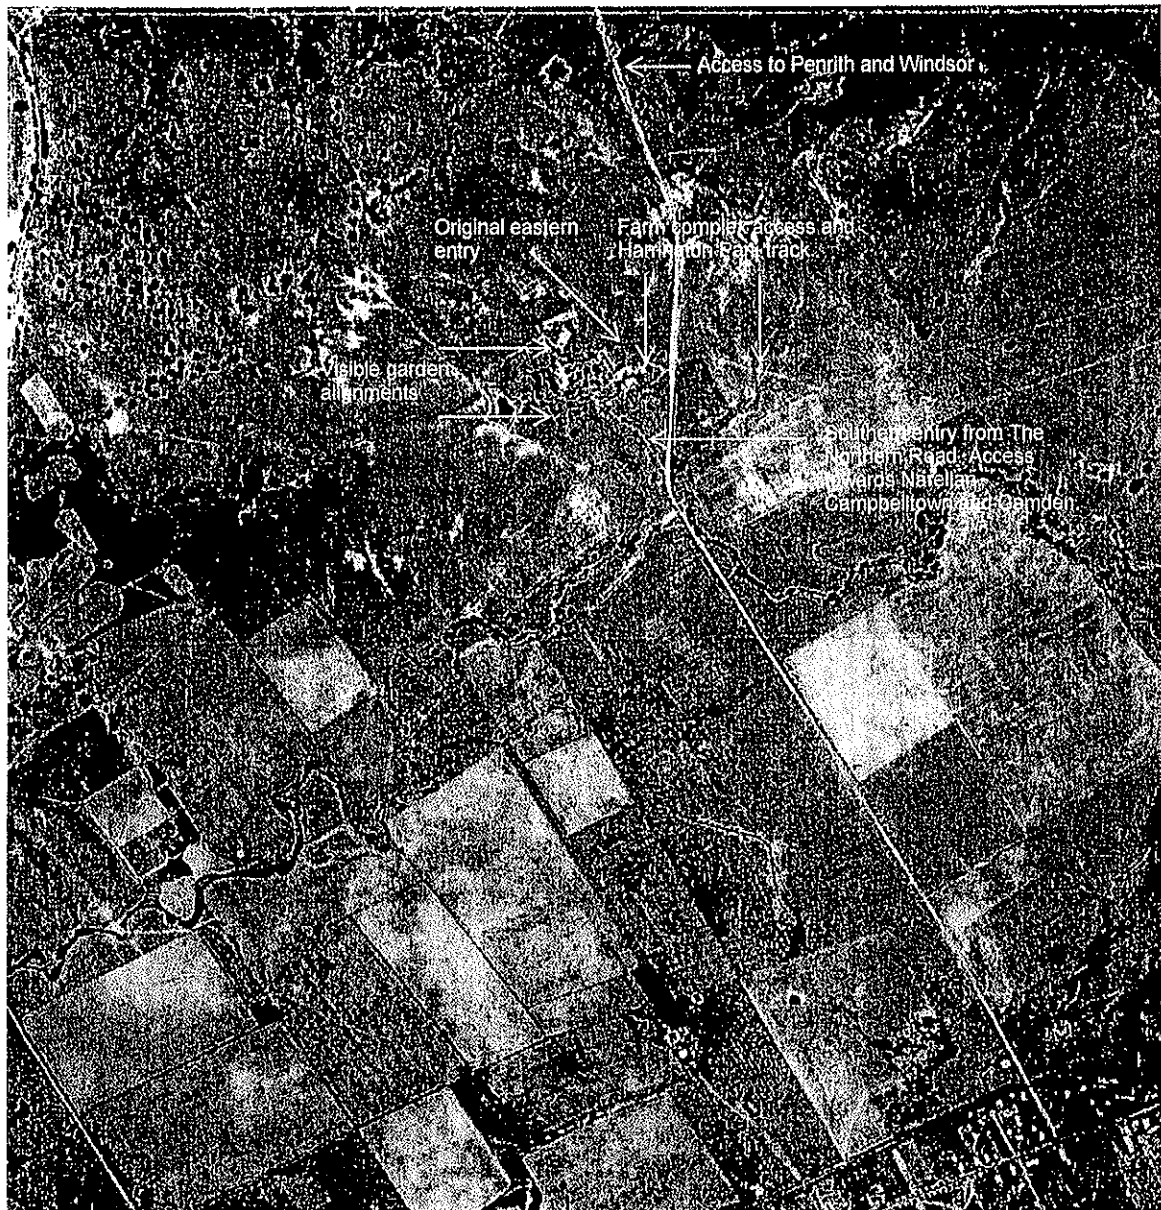
Figure No. 122 (pg.86) is an aerial photograph taken in 1947. The photograph shows much of the area surrounding Orielson to be open grazing pasture. There is a clear indication of the access routes associated with the property including the original eastern entry, redirected southern entry prior to the adjustment of The Northern road and the farm complex access routes. The track within Harrington Park that is closely associated with the Orielson farm complex access is indicative of the relationship between the two neighbouring properties. At this time Fairfax owned both properties. The aerial indicates the former gardens associated with the property are no longer discernable on site. The 1947 aerial also shows the military occupation that occurred to the north of the site. The road networks have been established which have since been lost. Official mapping confirms military location.

Figure No.122: Aerial photograph from 1947 (Source: Lands Department).

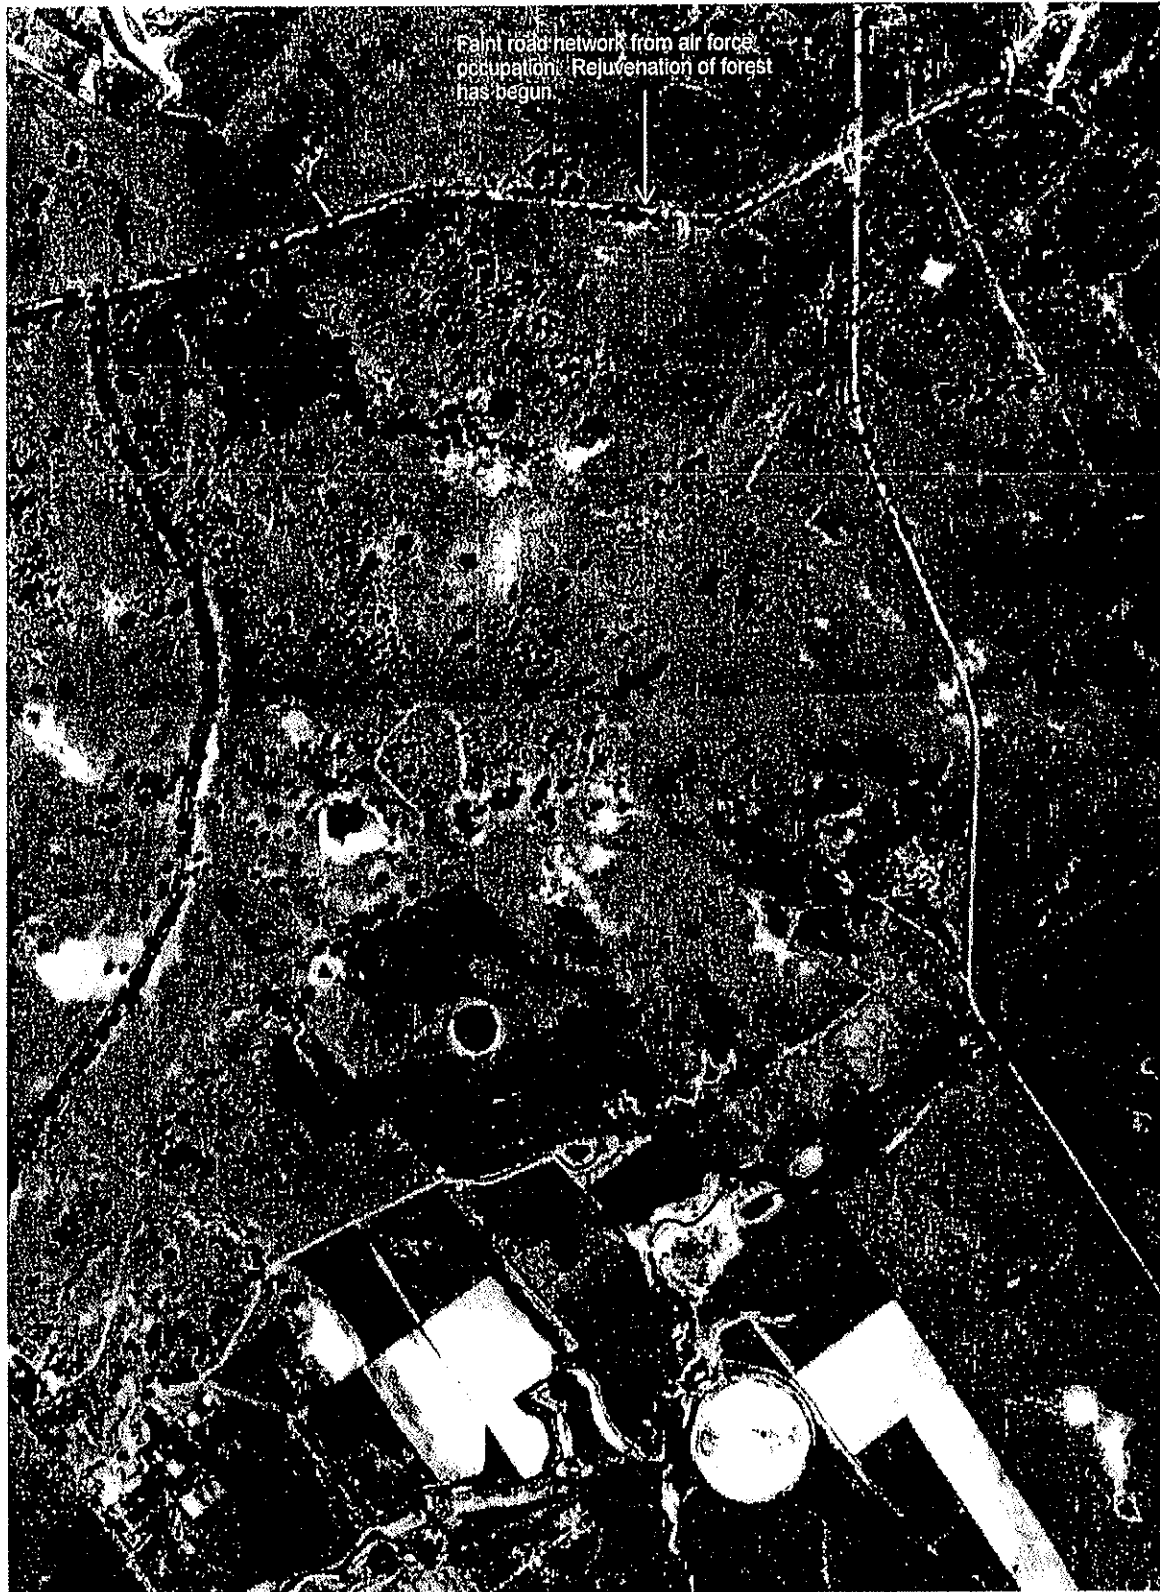
Figure No.123 (pg.87) was taken in 1966 and shows no major changes to the property. Evidence of military occupation, however, has substantially diminished. The woodland along Cobbitty road has begun rejuvenation and the former road networks are faintly visible.

Figure No.123: Enlargement of aerial photograph from 1966 (Source Lands Department).

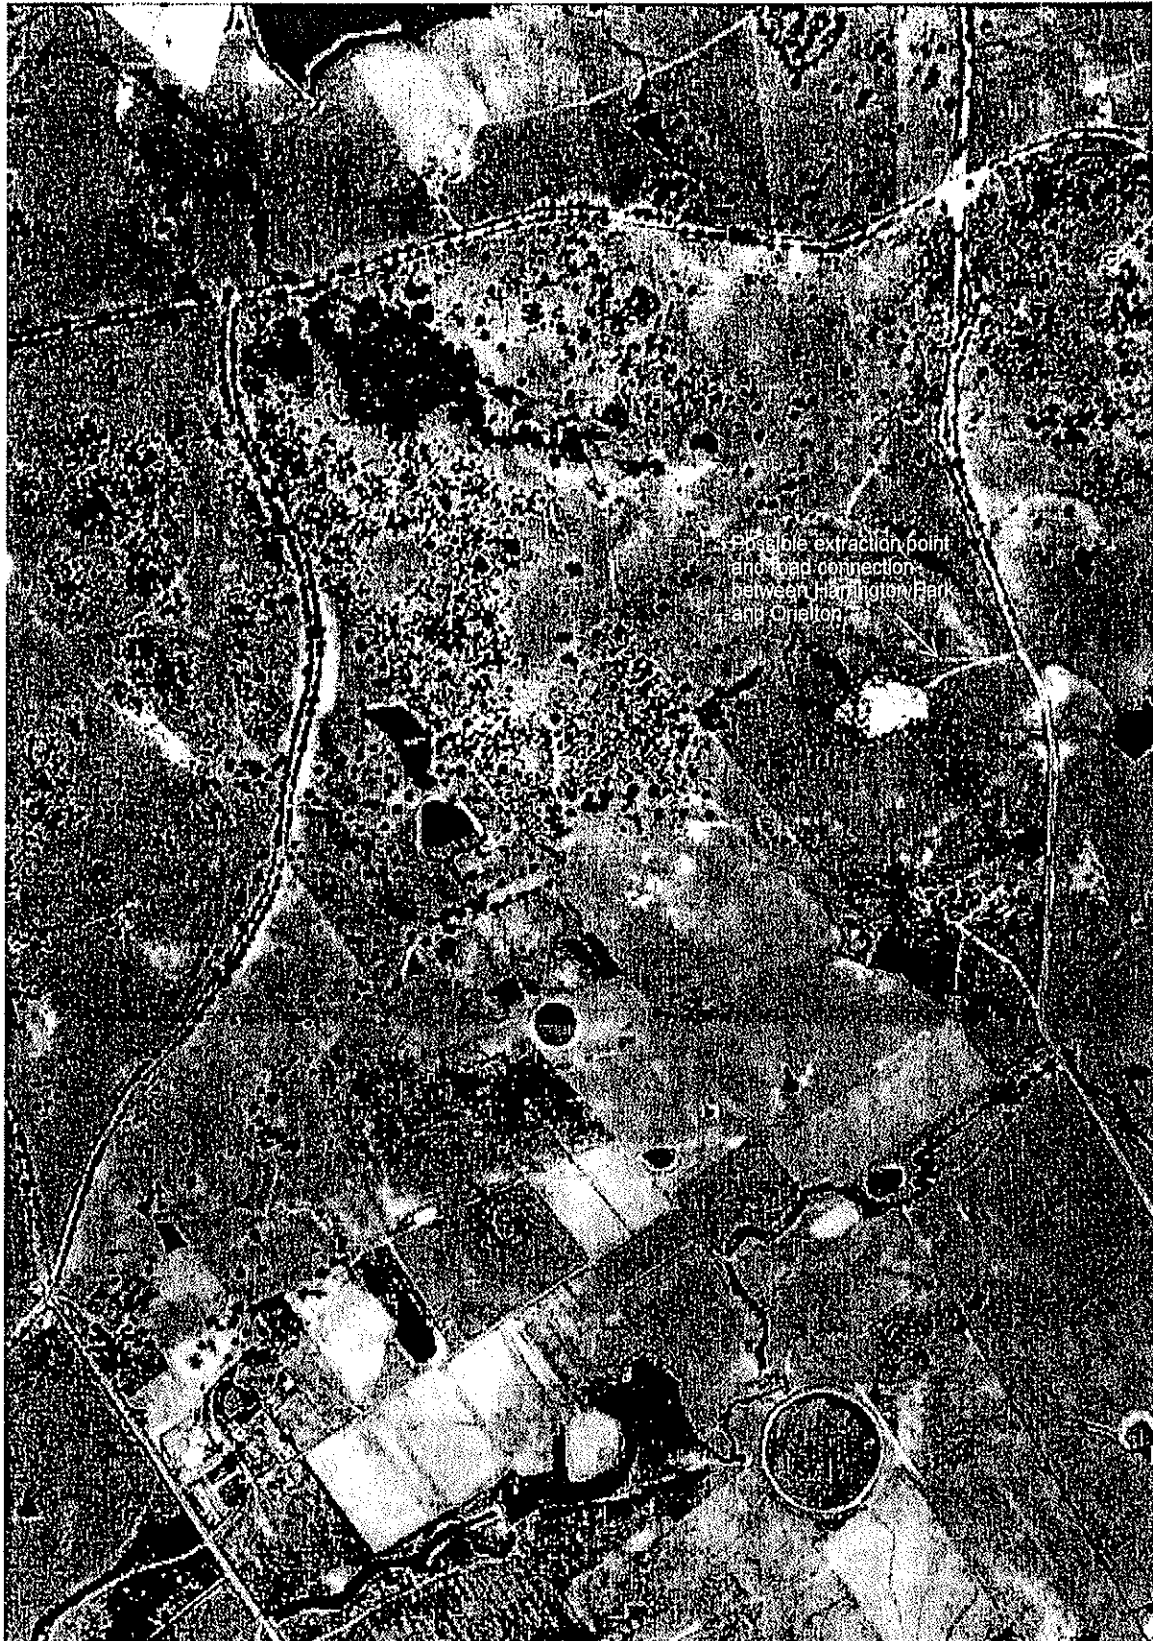
No major changes to the property are visible in the 1975 aerial indicated in Figure No.124 (pg.88). Evidence of military occupation has disappeared, however a strong entry point from The Northern road (north of the homestead) connects to Harrington Park. This area may have been an extraction point used by the Fairfax's (owners of both sites).

Figure No.124: Enlargement of aerial photograph from 1975 (Source: Lands Department).

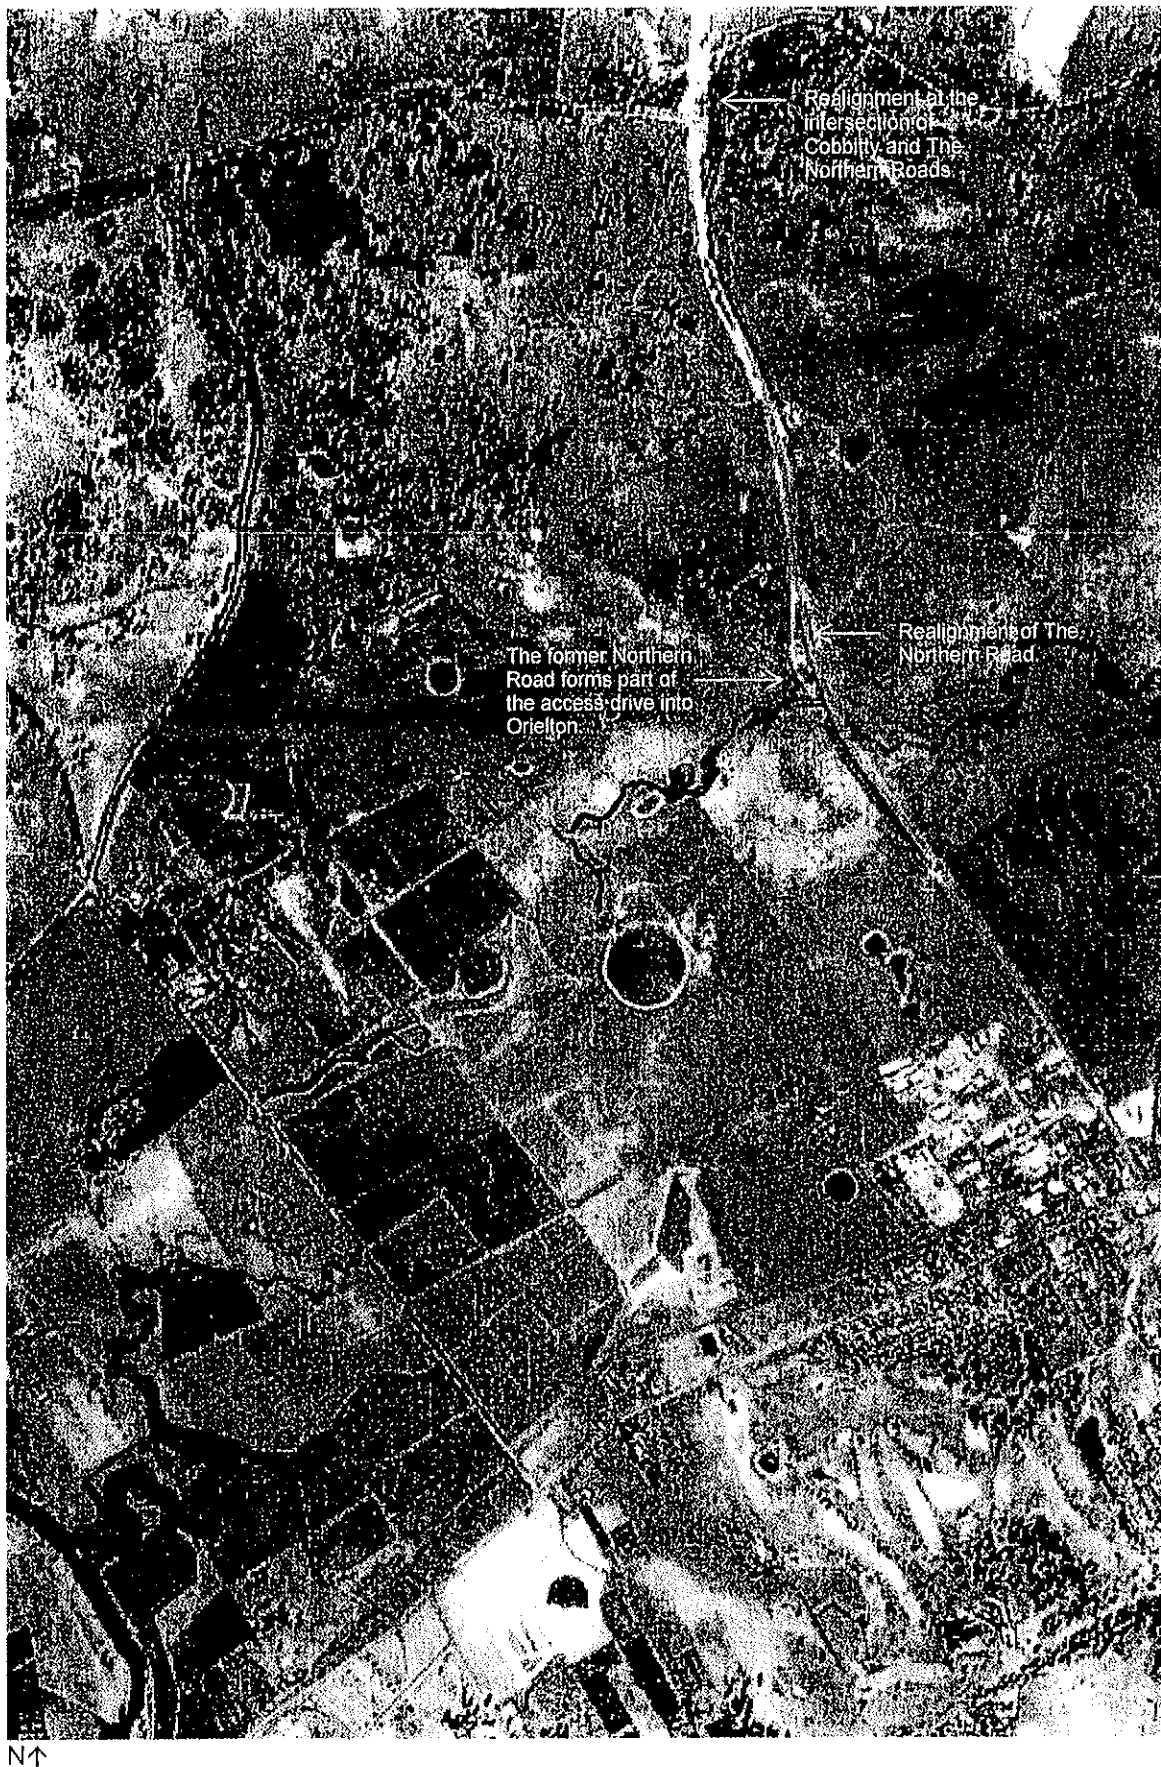
Figure No.125 (pg.89) is an aerial photograph taken in 1980 indicating the changed road alignment. Land was surrendered and the intersection at the corner of Cobbitty and The Northern roads was realigned. The Northern road was also realigned east of the homestead. This caused the entry drive into the homestead to be extended.

Figure No.125: Enlargement of aerial photograph from 1980 (Source: Lands Department).

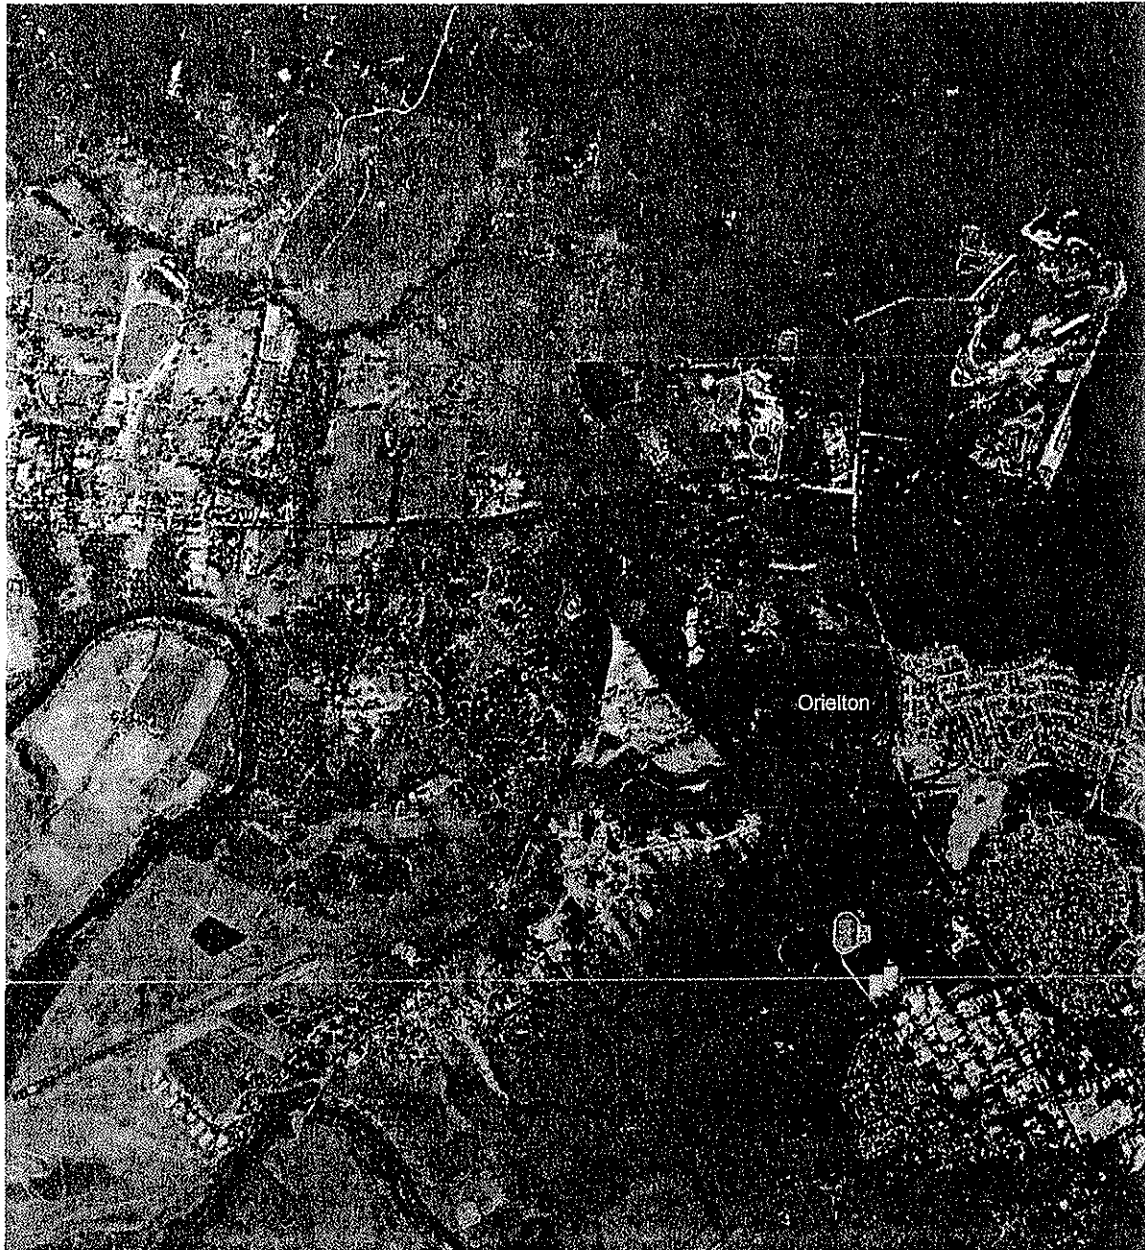
The rejuvenated forest (particularly in the north-west corner of the site) indicated in the 2002 aerial clearly defines the current boundaries of the property. Refer to Figure No.126 (pg.90).

Figure No.126: Aerial photograph from 2002 (Source: Lands Department).
