**REPORT ON**

#### GEOTECHNICAL INVESTIGATION PLANNING PROPOSAL FOR REZONING PROPOSED SUBDIVISION AND RESIDENTIAL DEVELOPMENT

## NO.39 – 55 (LOT 8 DP1191647) ORATAVA AVE AND PART OF NO.570 (LOT 3 DP1096405) PENNANT HILLS RD WEST PENNANT HILLS NSW

report ref: R/15-004.G Final

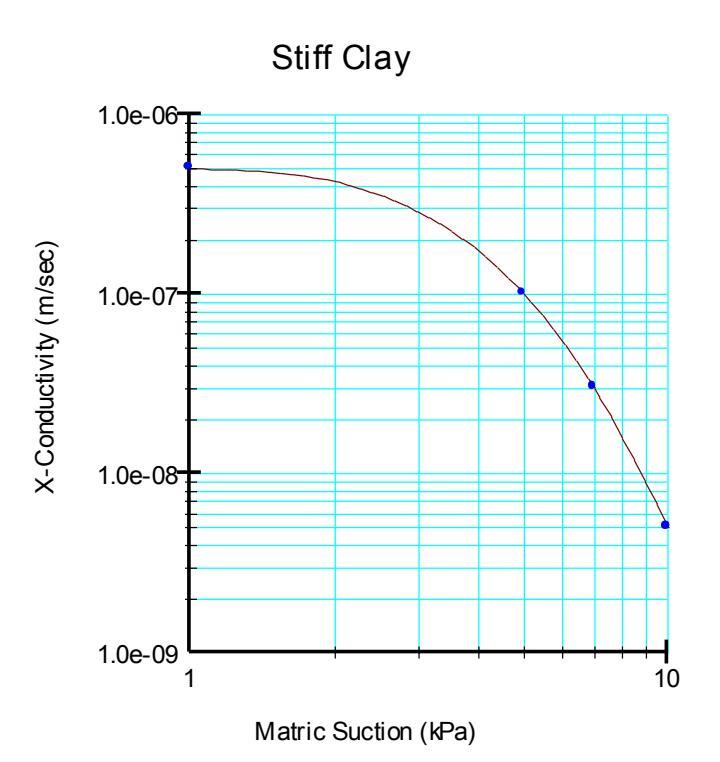
In the Seep/W programme Unit 1 and Unit 2 was modelled with Sat/Unsat material where Permeability is allowed to vary with suction. A variable function chosen for Unit 1 and Unit 2 material where a metric suction of 10 kPa corresponds to a reduced permeability of two order of magnitude. The following plot shows the unsaturated permeability characteristics of unit 2 stiff clay.

A high permeable flow layer (unit 3A) of half a meter thick is assumed to exist at the interface with the underlying SW/Fr shale.

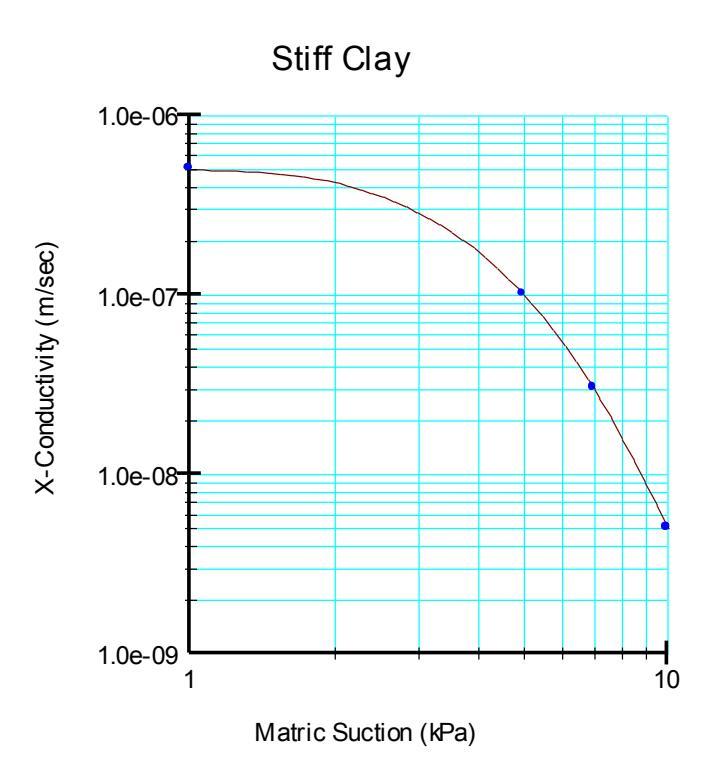
In the Seep/W programme Unit 1 and Unit 2 was modelled with Sat/Unsat material where Permeability is allowed to vary with suction. A variable function chosen for Unit 1 and Unit 2 material where a metric suction of 10 kPa corresponds to a reduced permeability of two order of magnitude. The following plot shows the unsaturated permeability characteristics of unit 2 stiff clay.

A half a metre thick high permeable flow layer (unit 3A) was assumed to exist at the interface with the underlying SW/Fr shale.

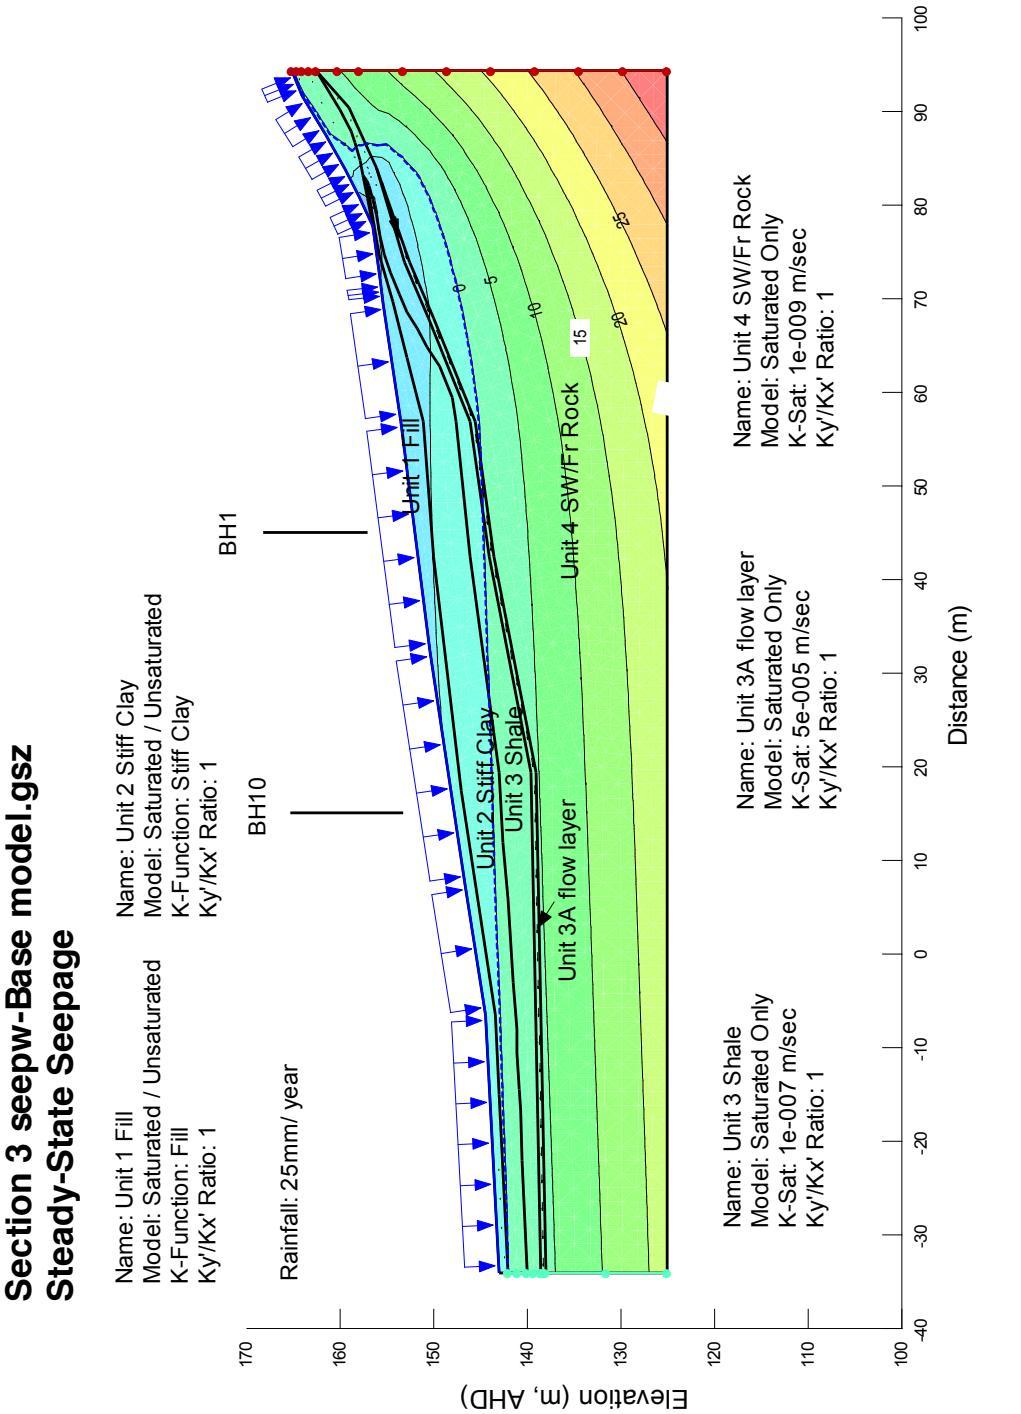
- Plot 1 Base model simulation (ie. no trench drains). It is noted that on 29 April 2105 BH10, located in the vicinity of Section 3, recorded a groundwater at about 1.9 m below ground surface. However groundwater level was analysed to be at about 4.1 m below ground surface in the BH10 area. Across and at BH1, which has an offset of about 15m from Section 3, the groundwater table was analysed to be at about 7 m below the surface as compared to the field measured 1.5 m below ground surface.

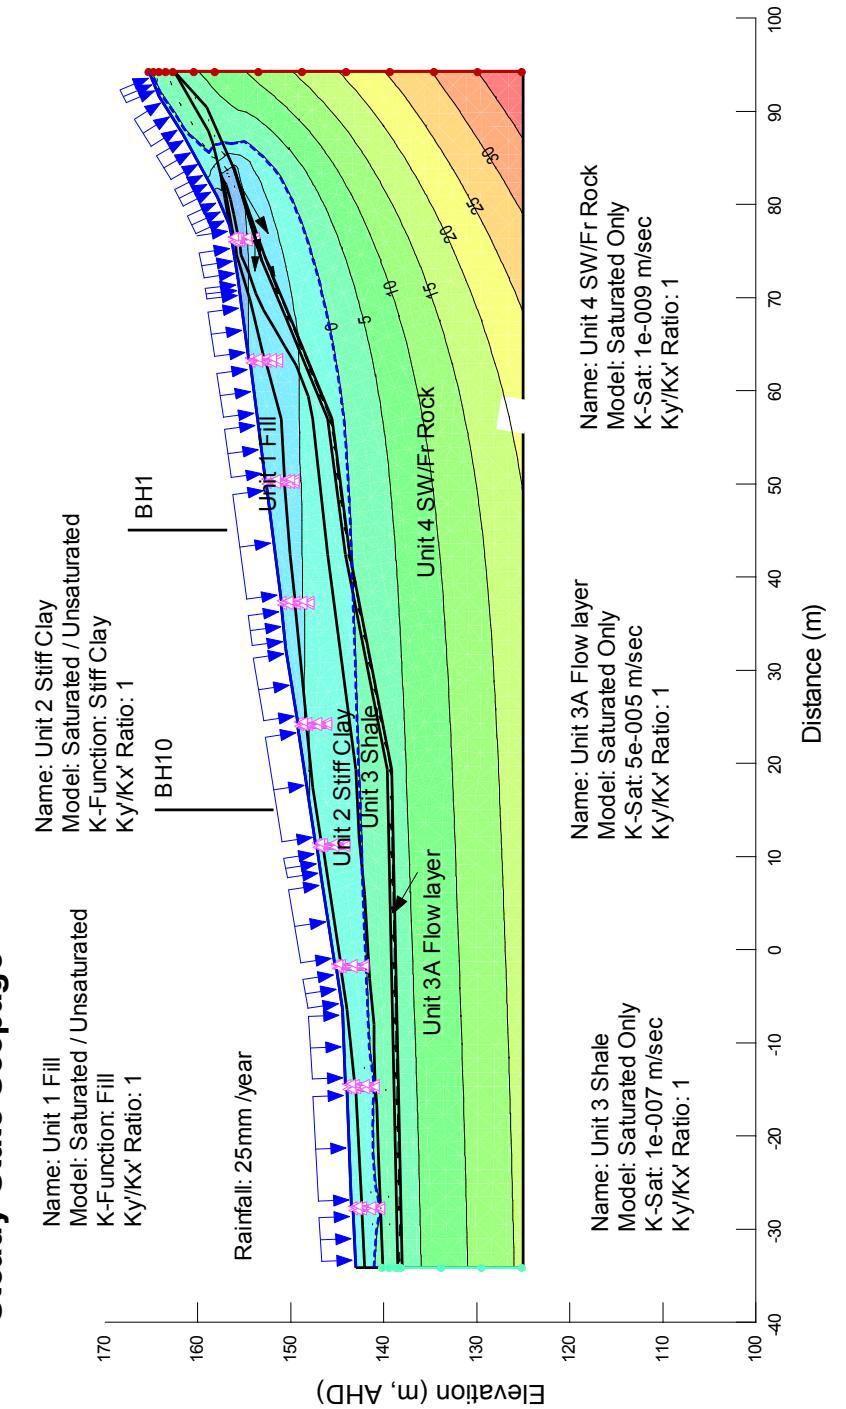
Plot 2

55 Oratava Avenue West Penant Hills Section 3 seepw-R03 trench.gsz Steady-State Seepage

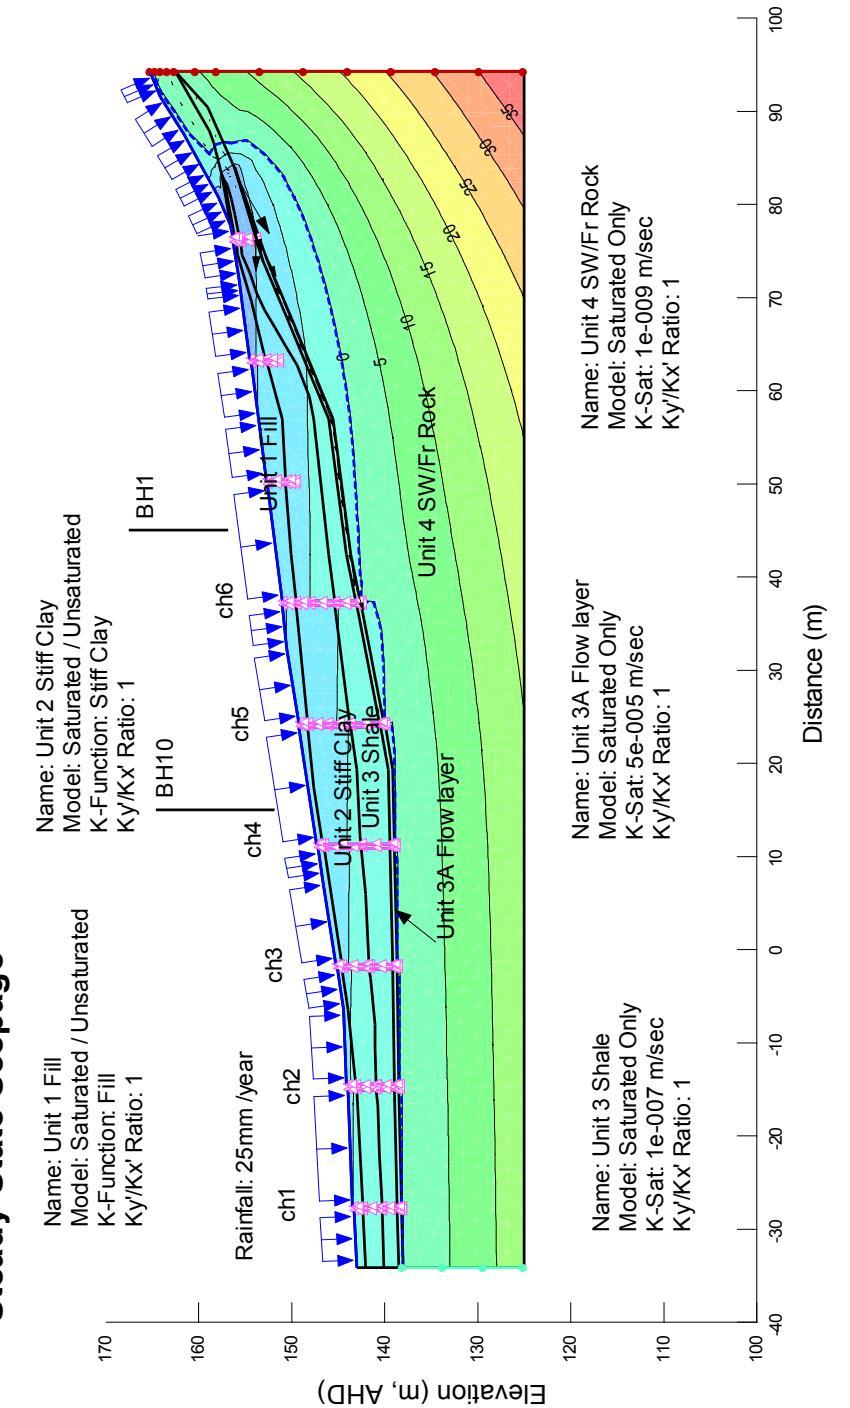
### Plot 3

55 Oratava Avenue West Penant Hills Section 3 seepw-R04 chimney.gsz Steady-State Seepage
