Preliminary contamination assessment

Daisy Hill Estate

Proposed subdivision of Lot 200 DP825059, Lots 661 and 662 DP565756, Lots 64 and 65 DP754287, Lots 316 and 317 DP754308 Eulomogo Road, Dubbo NSW

Ref: R13365c.2 Date: 23 February 2015

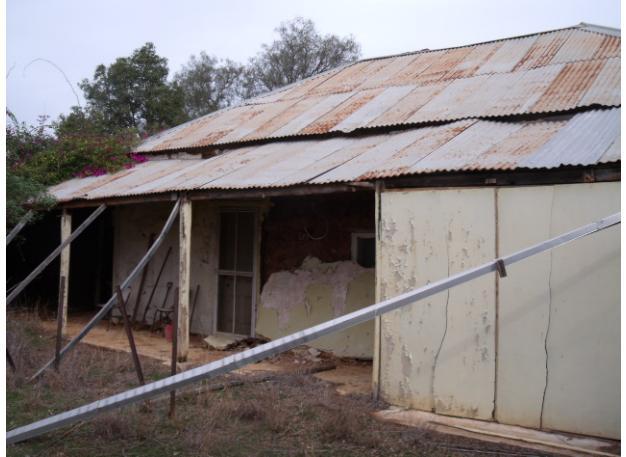
- Dwelling corrugated iron roof, mud brick walls (Figure 3.3)
- Garage corrugated iron
- Shearing shed and yards corrugated iron
- Wood shed corrugated iron
- Milking shed corrugated iron
- Tool shed corrugated iron

Figure 3.3. Mt Olivetta homestead

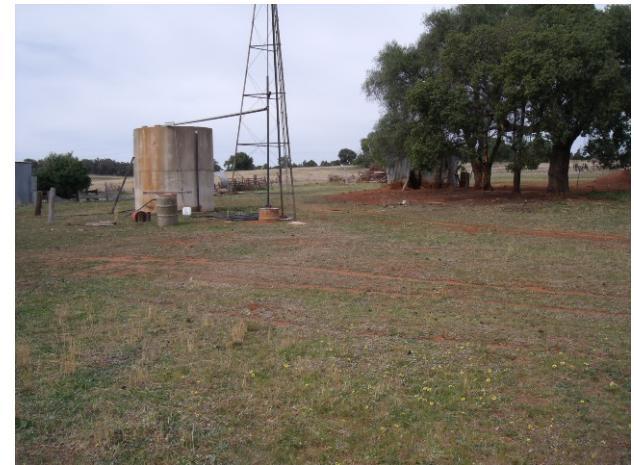
A windmill, bore and associated water tank (Figure 3.6) were located east of the dwelling.

Figure 3.6. Windmill on Lot 65

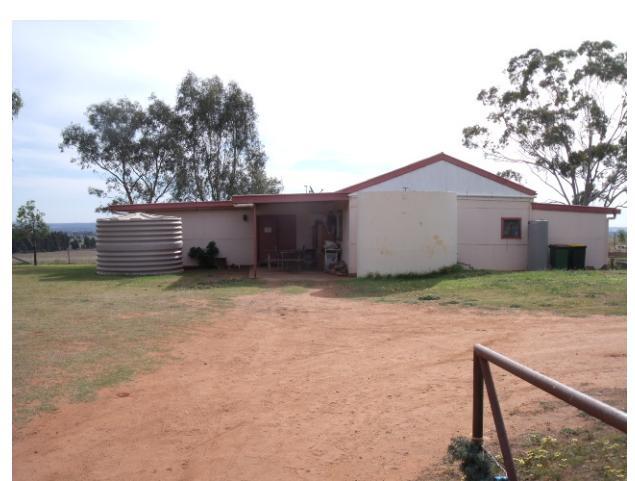
- Dwelling corrugated iron roof, fibro walls (Figure 3.7)
- Tool shed corrugated iron

Figure 3.7. Dwelling on Lot 662

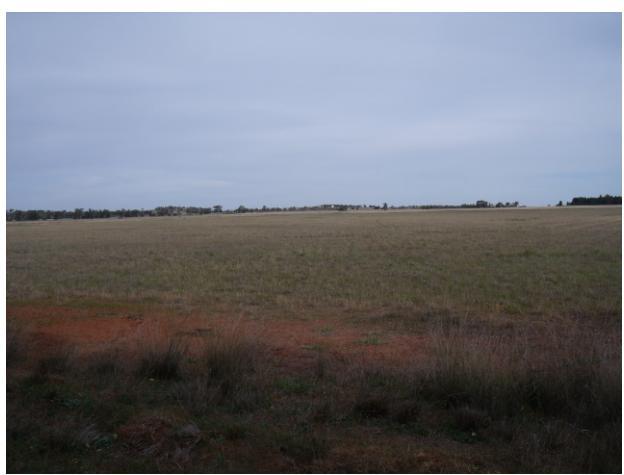
A granite quarry was located in the south western section of the lot. The quarry was used by the Talbragar Shire for road material. The quarry was no longer used and is undergoing rehabilitation by backfilling (Figure 3.8).

Figure 3.8. Rehabilitation of quarry on Lot 200
