## Attachment 1 – Watercourses Investigation

Our Reference: 150715  
23 November 2015

**Re: 11 Westminster Place, Razorback**

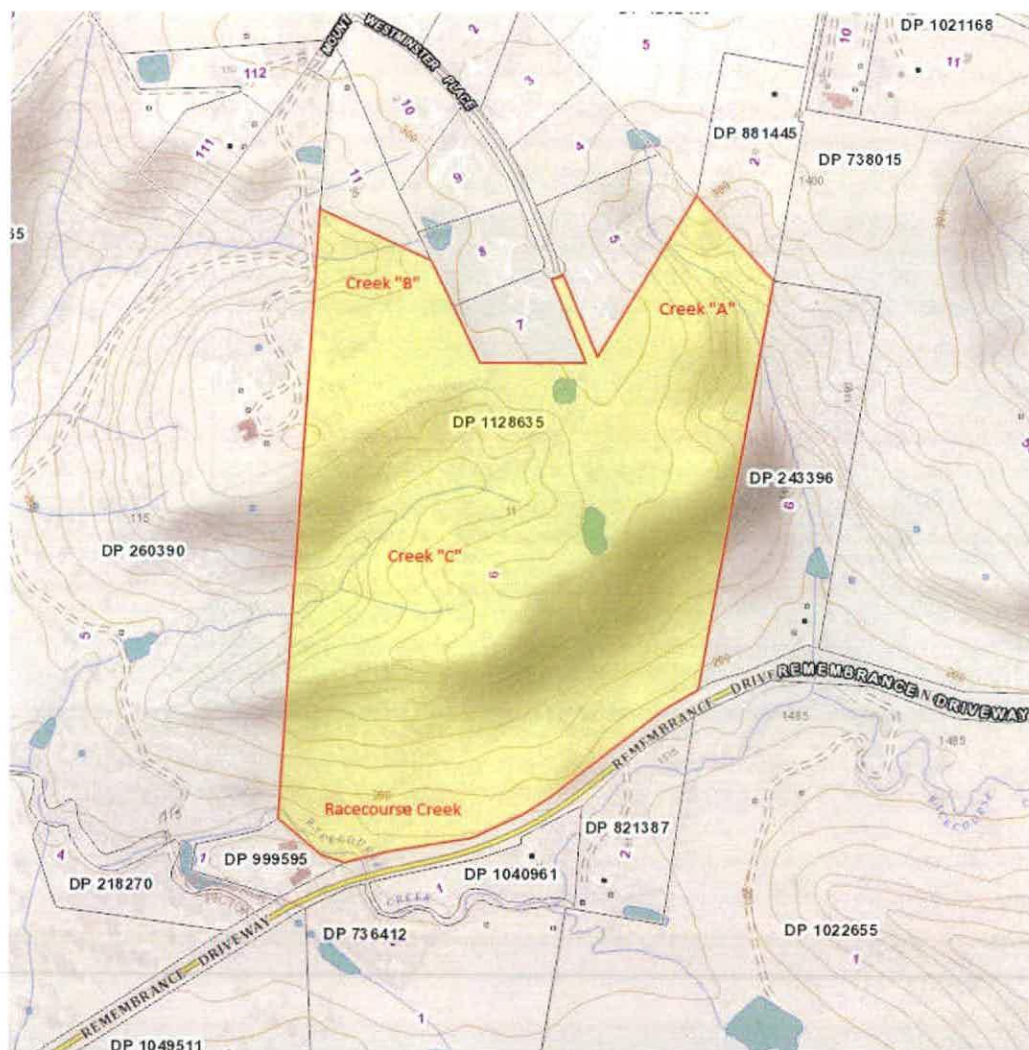
A copy of the 1: 25 000 topography maps is listed below, together with the 4 mapped water courses, listed as creeks A, B, C and racecourse creek.
