Moore Trees
Arboricultural Services

Arboricultural Development Assessment Report

160 Burwood Road
Concord NSW 2137
Lot 5 in DP 129 325
Lots 398 and 399 in DP752023
Lot 2 in DP 230294
July 2018
FINAL (Updated 5th September 2019)

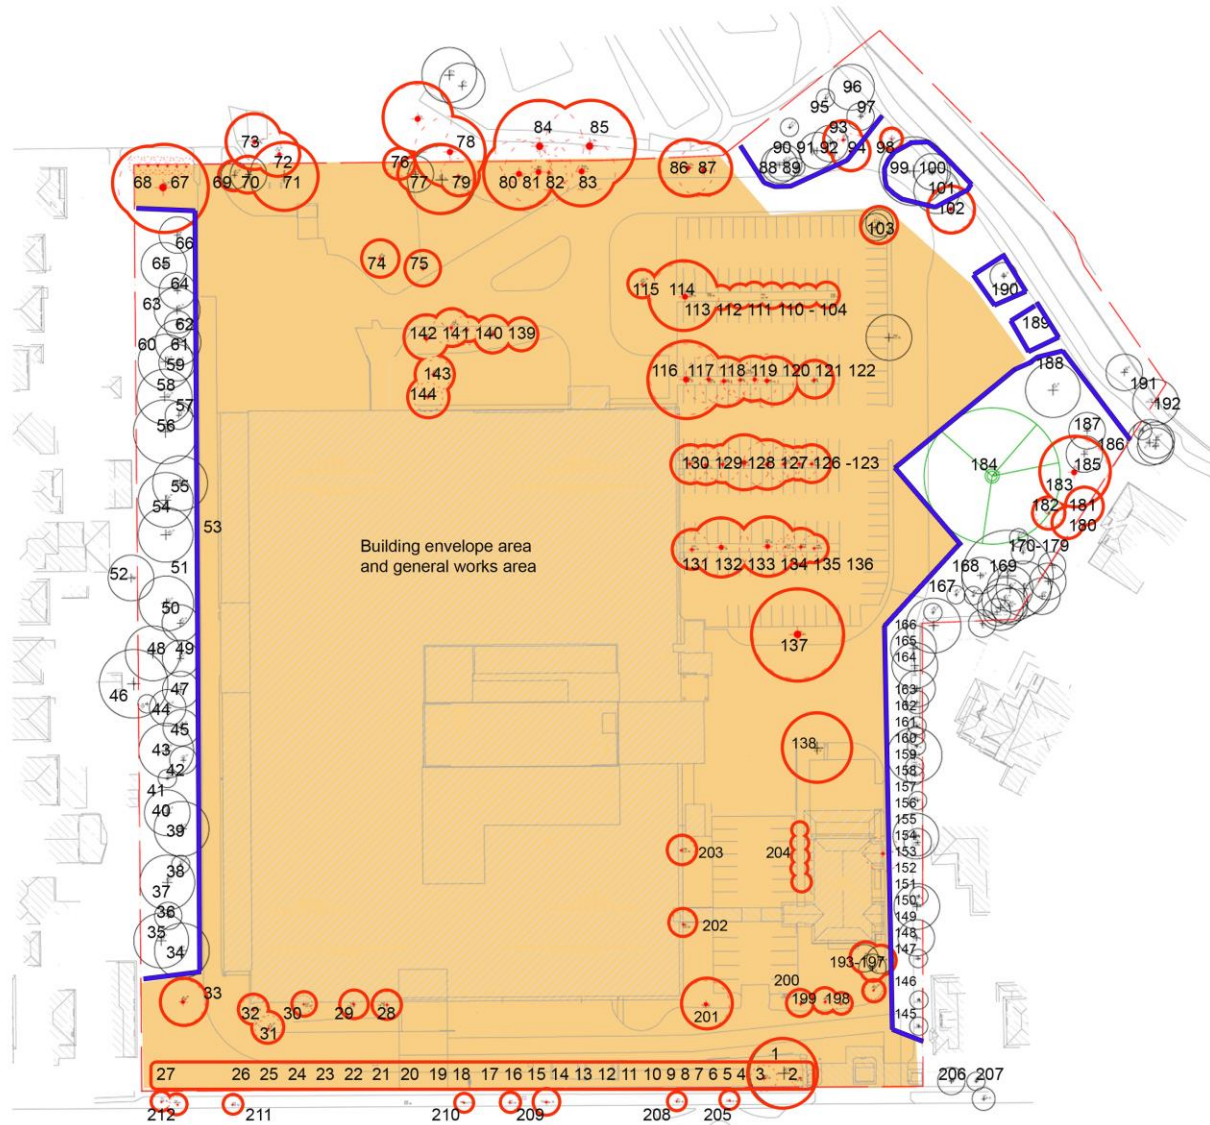
Tree protection plan

Tree 184 to be relocated within the site.
Refer to site specific tree relocation specification.

Fence. Implementation of tree protection zone (TPZ). All tree protection works should be carried out before the start of demolition or building works. It is recommended that chain mesh fencing with a minimum height of 1.8 metres be erected
