Report on  
Updated Preliminary Site Investigation

Former Oatley Bowling Club  
River Road, Oatley

Prepared for  
Hurstville City Council

Project 73308.01  
January 2016

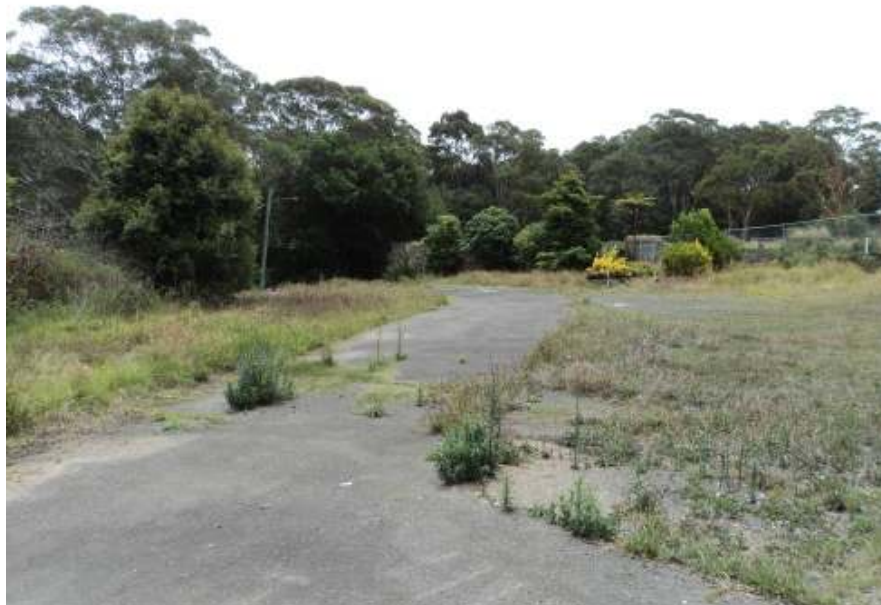
Photo 1 – Site Looking North

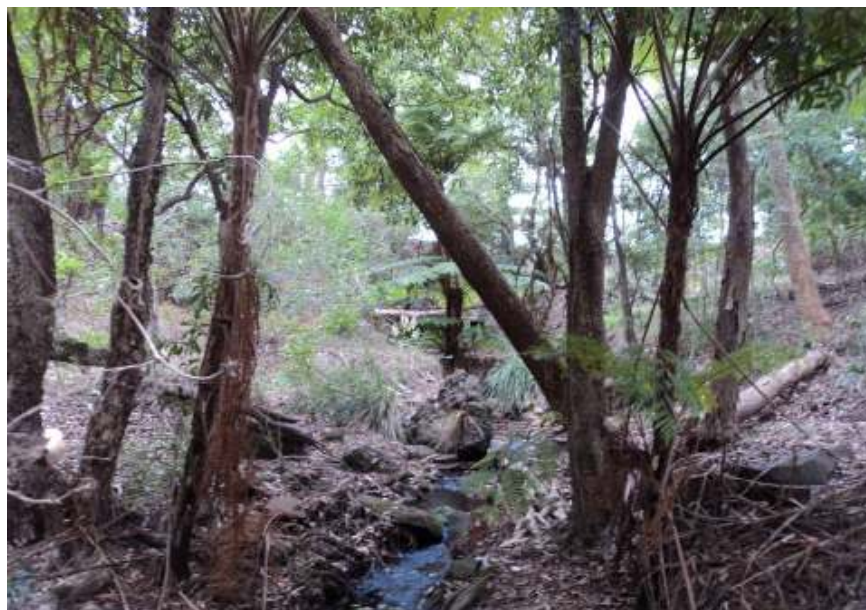
Photo 2 – Stream and bush land to the south and west

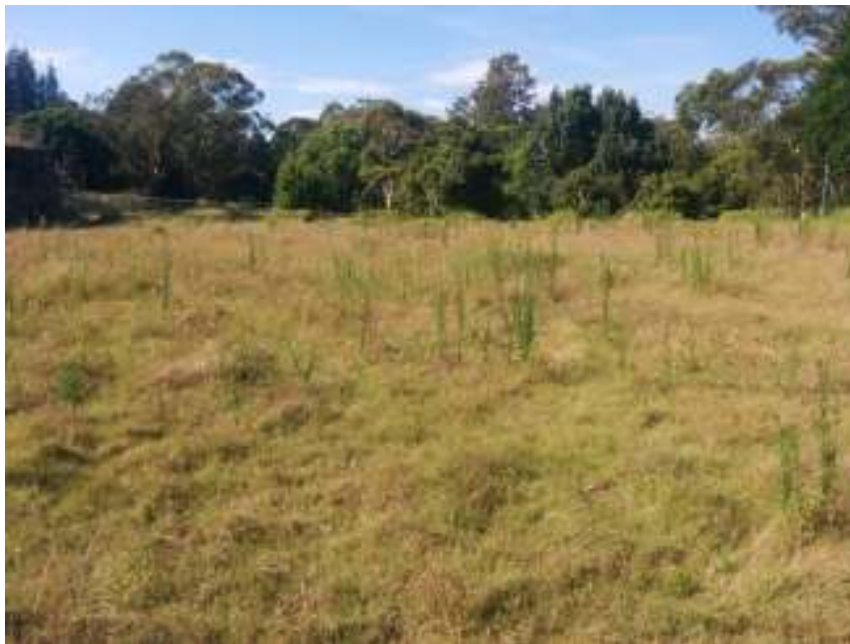
- The two bowling greens were still present and remained overgrown with weeds. On the upper and lower green an electrical box in the south east corner of the green was present. The greens were still supported by sandstone block retaining walls, however these appeared to be failing and one section had been braced to maintain structural integrity;

Photo 8 – Lower bowling green looking south-east

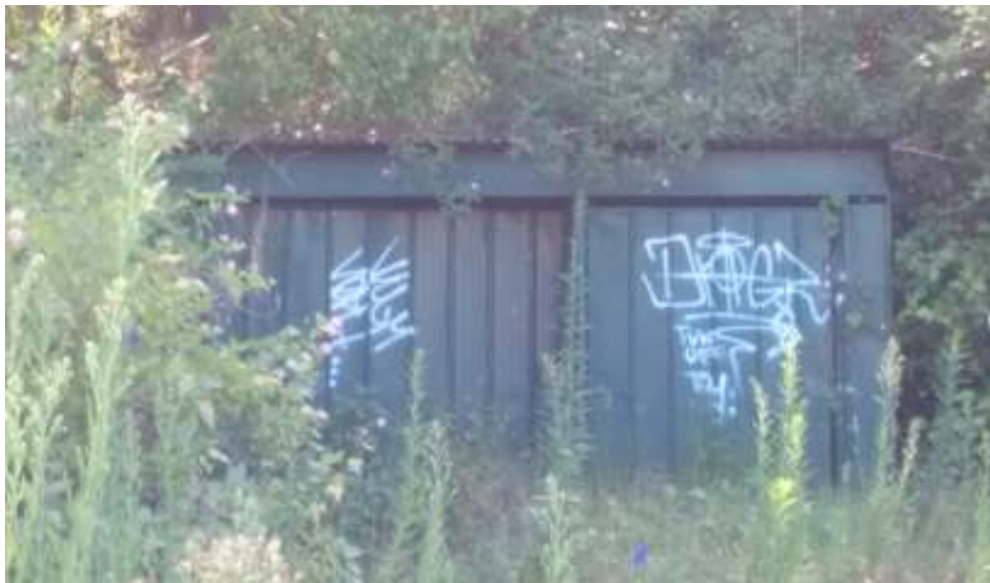
- There was a metal shed in the north-eastern corner of each green;
- Some small stockpiles of filling were noted, possibly associated with the demolition works;

Photo 12 – Metal shed on upper green
