## **48 Dudley Street Coogee**

### **Heritage Assessment**

Report prepared for Randwick City Council

January 2017

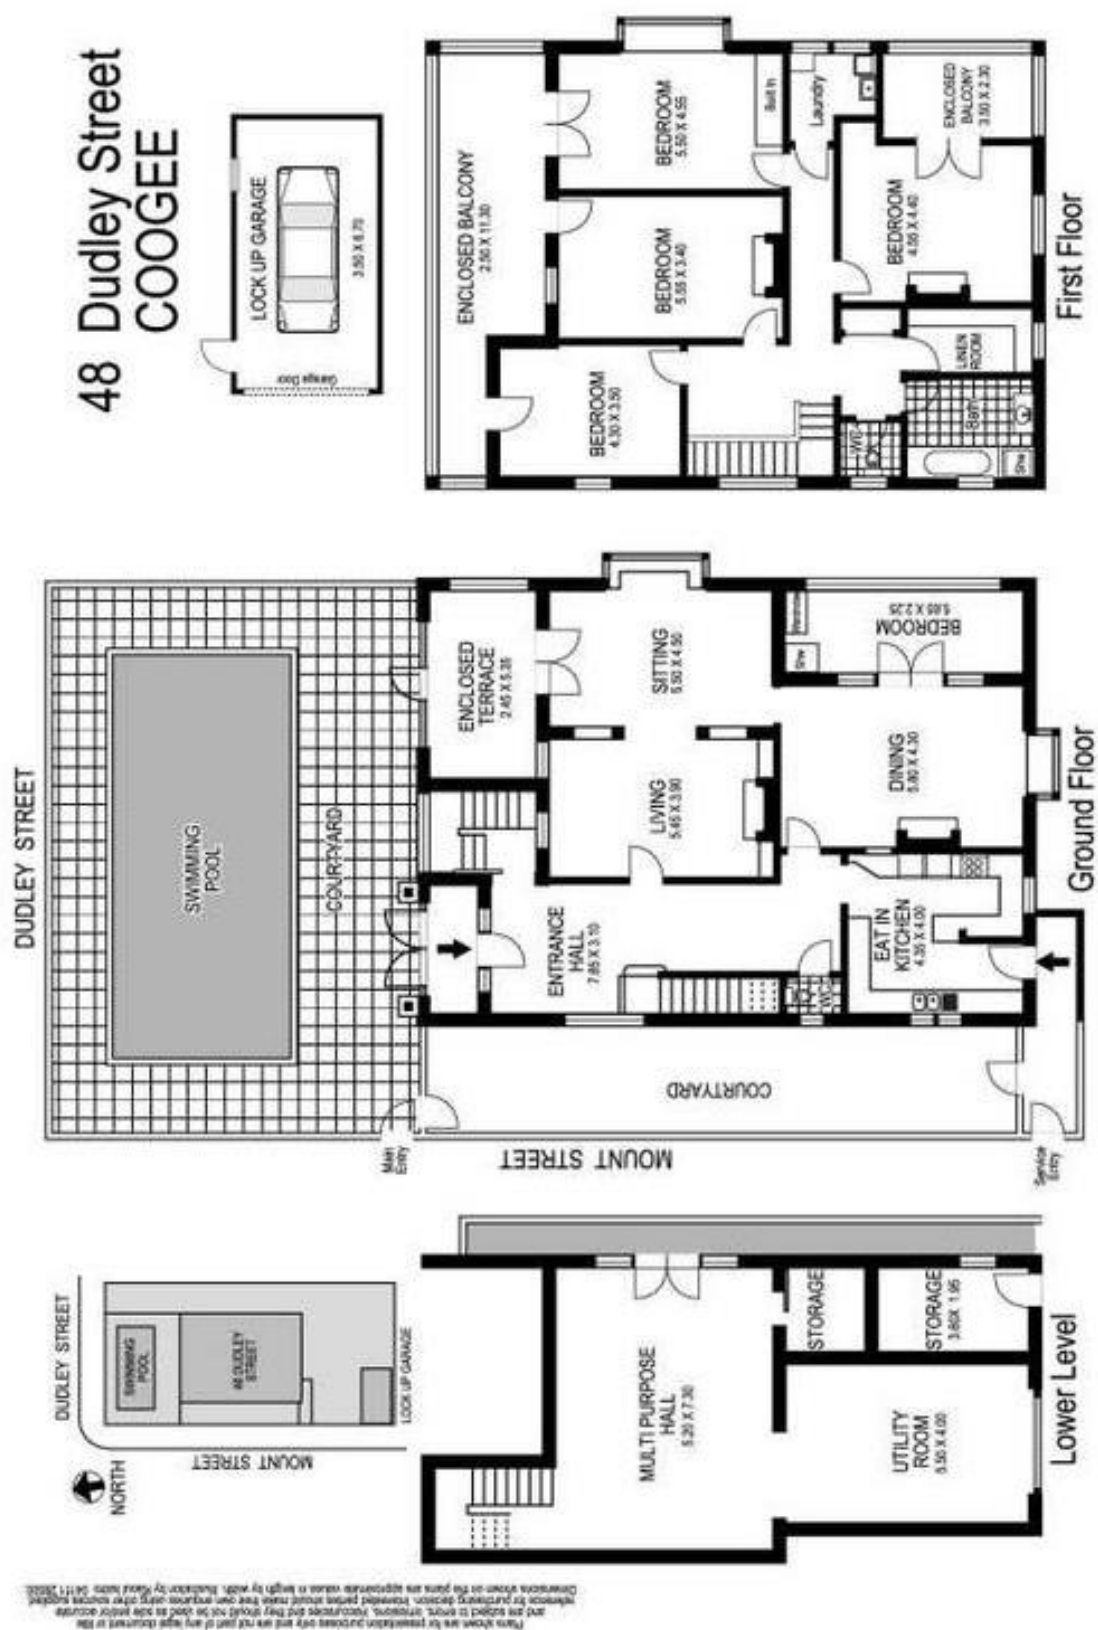
**Figure 2.12** Floor plan of 48 Dudley House, as featured in real estate brochures and websites advertising the 2016 sale of the site.  
(Source: <realestate.com.au>)

The layout of the building was generally found to be consistent with the layout plan included in the brochure prepared for (and prior to) the sale of the site earlier in 2016, though some details (eg the bay window in the south wall of the dining room) differed from the plans. These plans are included as Figure 2.12 in this report.

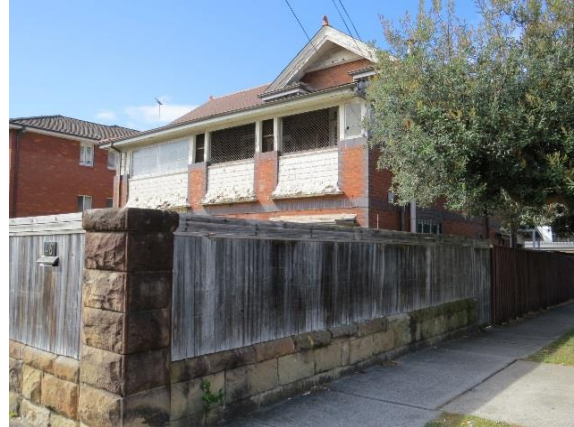
**Figure 3.14** Northeast corner of site with adapted fencing on street boundaries around front yard and pool. (Source: GML, 2016)

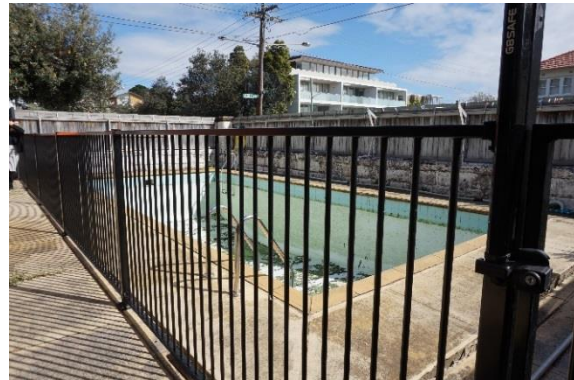
The original front (north-facing) yard is today occupied by the 1960s swimming pool, surrounded by concrete paving. Timber paling fences added to the top of the original stone boundary walls screen views from the north and west street frontages. (Changes to these walls include removal of the original gateway, changes to layout and painting of stonework.) Modern coloured steel fencing encloses the east side of the pool, fixed along the top of a rusticated stone retaining wall. This wall appears to be a modification of the staggered retaining walls and steps that originally provided access to the lowered basement and lawn level on the east side of the residence (refer to Figures 2.4, 2.5 and 2.7). Whether any remaining evidence of the layout or fabric of the original walls and steps is left under the modern raised level of the pool surrounds is unknown. A modern aluminium pool fence along the south edge of pool (separating this from the main entrance porch and an enclosed terrace on the front elevation of the residence) appears to have been erected (to meet current code requirements) since the publicity photographs taken for the sale of the site earlier this year.

**Figure 3.16** Modern (c1960s) swimming pool, paving and fence in front yard. (Source: GML, 2016)

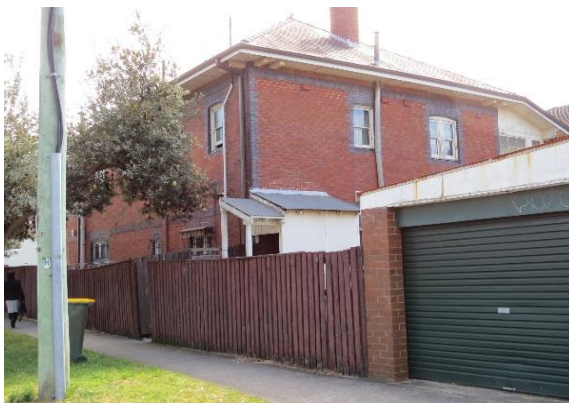
**Figure 3.17** Southwest corner of Hillsea site with later garage and enclosure over entry door to kitchen. (Source: GML, 2016)

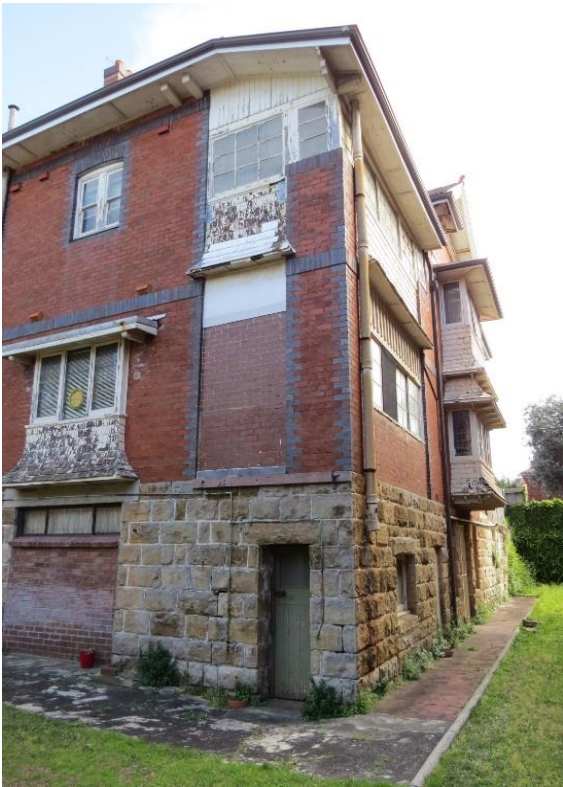
The small laundry in the southeast corner of the basement is only accessible externally and appears to have changed little over its life. It includes the remains of an old cast iron hot water heater as well as cement washtubs and the remains of old distemper/paint finishes on the plaster walls (Figures 3.19 and 3.21).

**Figure 3.21** Southeast corner with door to basement laundry and bricked-up opening to former garage. (Source: GML, 2016)

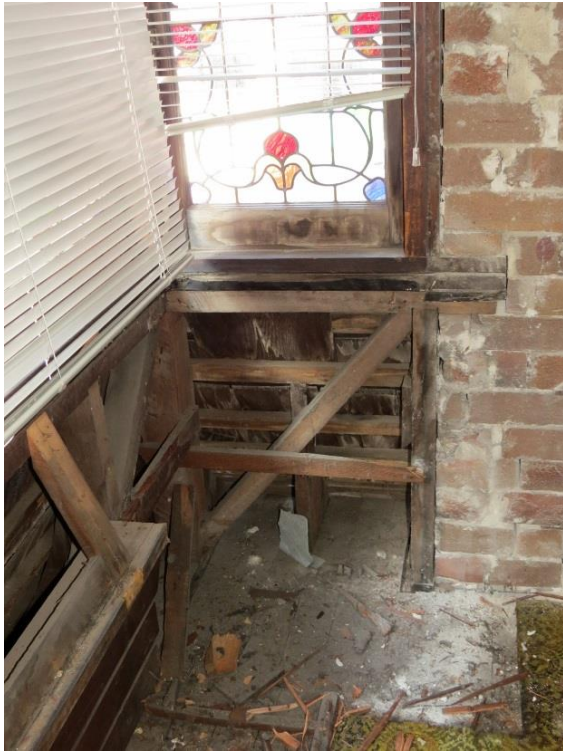
**Figure 3.33** Detail of original bay window, stained glass leadlight and remains of window seat to sitting room. (Source: GML, 2016)

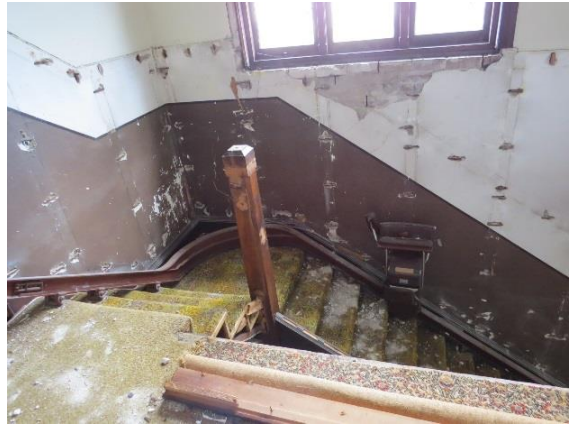
At first floor level most of the original and early features and fabric of the building have been retained as well as the original layout, spatial and structural components. As noted previously, while the early stained wall linings (wainscoting) to the stairs, first floor landing and corridor have recently been removed (as well as the stair balustrade along the landing), this has exposed a previous (ie original) painted dado on the plastered walls of these areas (Figures 3.37, 3.38, 3.39 and 3.48).

**Figure 3.37** Main staircase from ground to first floor landing after removal of balustrade and wall linings. (Source: GML, 2016)

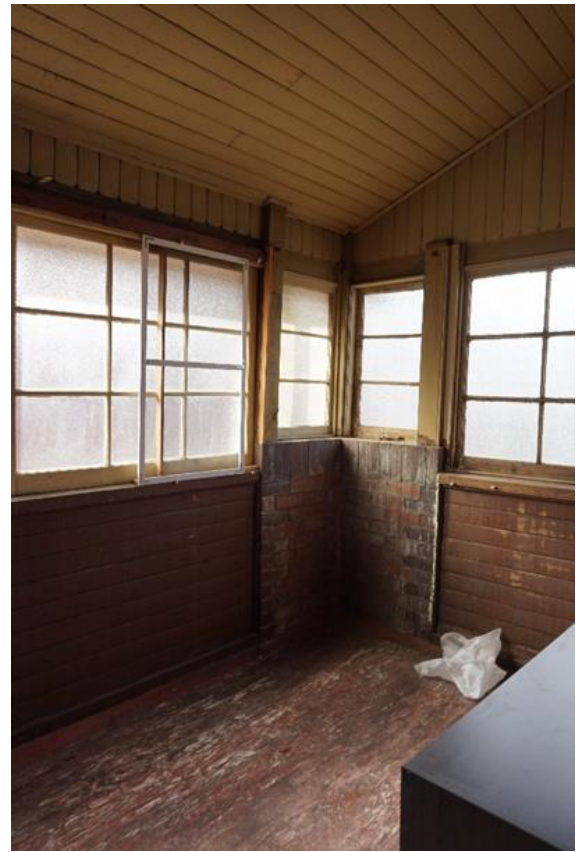
All four bedrooms at first floor level have access to external balconies. The balconies of two bedrooms have been enclosed with sliding timber windows fitted above the original balustrade (Figures 3.42 and 3.46). This type of light-weight, low cost and readily removable weather-protection for verandahs was frequently used up to (and even after) the mid-twentieth century for 'sleep outs' and additional accommodation for large families (such as the Josephs).

Off the main (southern) bedroom, the small enclosed balcony features an unusual hand-painted timber stud wall picked out to resemble red and black brickwork to match the exterior facades (figures 3.45 and 3.46). This appears to be an early alteration, though the laundry fitout and finishes on the other side of the wall are of a much later period (and prevented examination of the construction and finishes of the wall from this side).

**Figure 3.46** Enclosed southeast balcony with boarded timber ceiling, timber framed sash windows above original brick balustrade and vinyl flooring (possibly mid-twentieth century). (Source: GML, 2016)

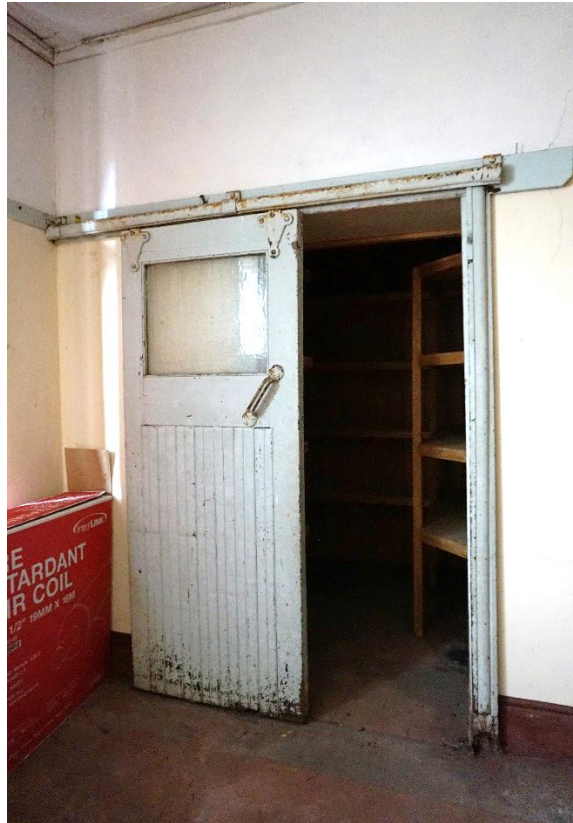
The main basement room (labelled 'multi-purpose hall' in the 2016 layout plans, included as Figure 2.12) is accessed from the small staircase off the entrance hall (Figure 3.53 and 3.55) and lit via stained leadlight windows on the north elevation (Figure 3.25) which also light up the internal living room via a small circular window (Figure 3.54). The room's features include an early painted cement floor, a small recessed 'fireplace' (probably for a fuel or gas heater) and a large walk-in cool room with sliding timber door (Figure 3.56). A pair of timber doors and flanking timber-framed sash windows provide light and access from the east elevation (Figures 3.57 and 3.22).

**Figure 3.57** Boarded timber and half-glazed doors and flaking timber sash windows to east wall of basement. (GML 2016)

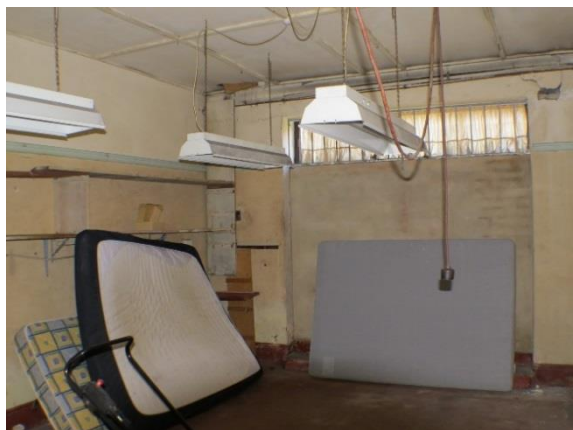
The rear utility room is a more utilitarian space, with evidence of its modification for use as a garage, possibly as part of the 1970 subdivision which required demolition of the original garage (Figure 3.58). The opening made in the stone basement wall facing south was subsequently bricked in, with highlight windows installed to light the space. The arched opening between the two basement rooms also appears to have been enlarged in the later years of the building's use.

**Figure 3.58** South basement room formerly used as a garage with brick-infilled wall and highlight windows. (GML 2016)
