Phase 2 Environmental Site Assessment, Parcel 9

Prepared for: Hydro Aluminium Kurri Kurri Pty Ltd

Prepared by: ENVIRON Australia Pty Ltd

Date: April 2015

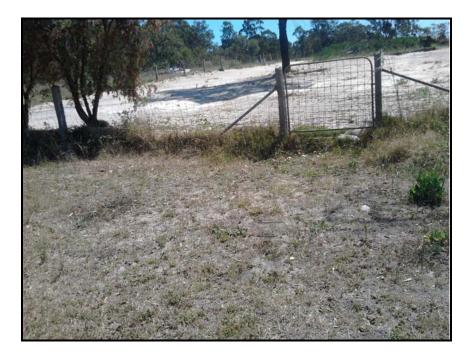
Photo 10: 10/10/13 Photograph looking towards Lot 439 from the front of Lot 449.

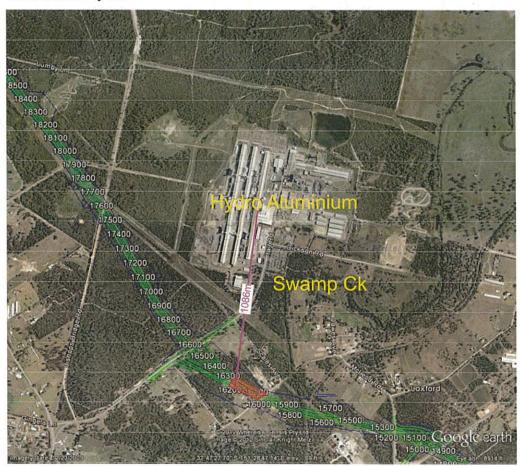
1. Site Location (red)

According to the topography map (Cessnock Sheet), the site is within the alluvial sediments of Swamp Creek. Geologically the site is mapped as Quaternary sands, from a dune or beach environment. (Geology Sheet) (Thomson, 2012).

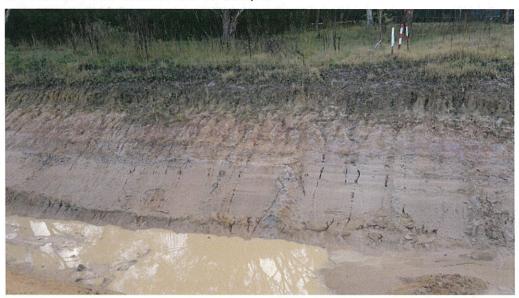
1. Soil Profile

The material observed at the site was a yellow-gold sand, unconsolidated and highly erodible. This corroborates the mapping data and confirms that the material observed is in-situ. The soil profile is clear and developed. The established and mature nature of the surrounding vegetation indicates that the material is undisturbed. Access to the site was limited due to recent rainfall and an excavator was not available for test pits.

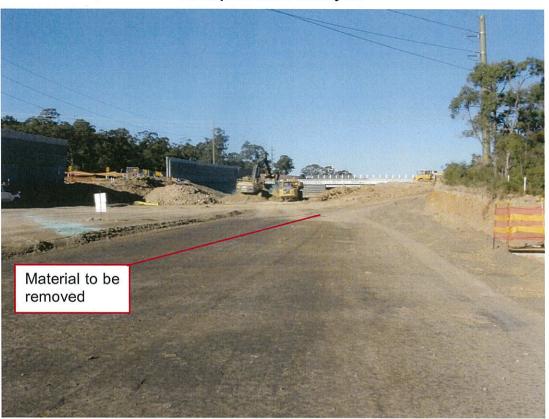
Photoplate One: Site layout

Site Observations: The area is currently being excavated as such it is highly disturbed, surrounded by road work activities, and is constrained by side batters, and road floor, see Photoplates 1 and 2 below.

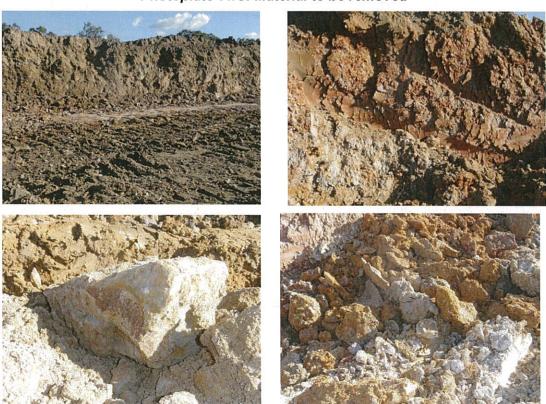
Photoplate Two: Material to be removed

Assessment: No test pits were required for this site, as a visual assessment could be made, due to the existing earth movements which showed both sides of the area to be excavated. The material currently being excavated was seen to be of VENM in nature with no visual external contamination and no discernible foreign odours or discolouration. Prior to the roadworks, the site was a powerline easement and Google Air shows no occupation from 2004 until roadworks began.
