## **GROUNDWATER IMPACT ASSESSMENT**

**Part Lot 4 in DP834254  
510 Beach Road Berry**

**Rep.No. 17134-B**

**8<sup>th</sup> March 2018**

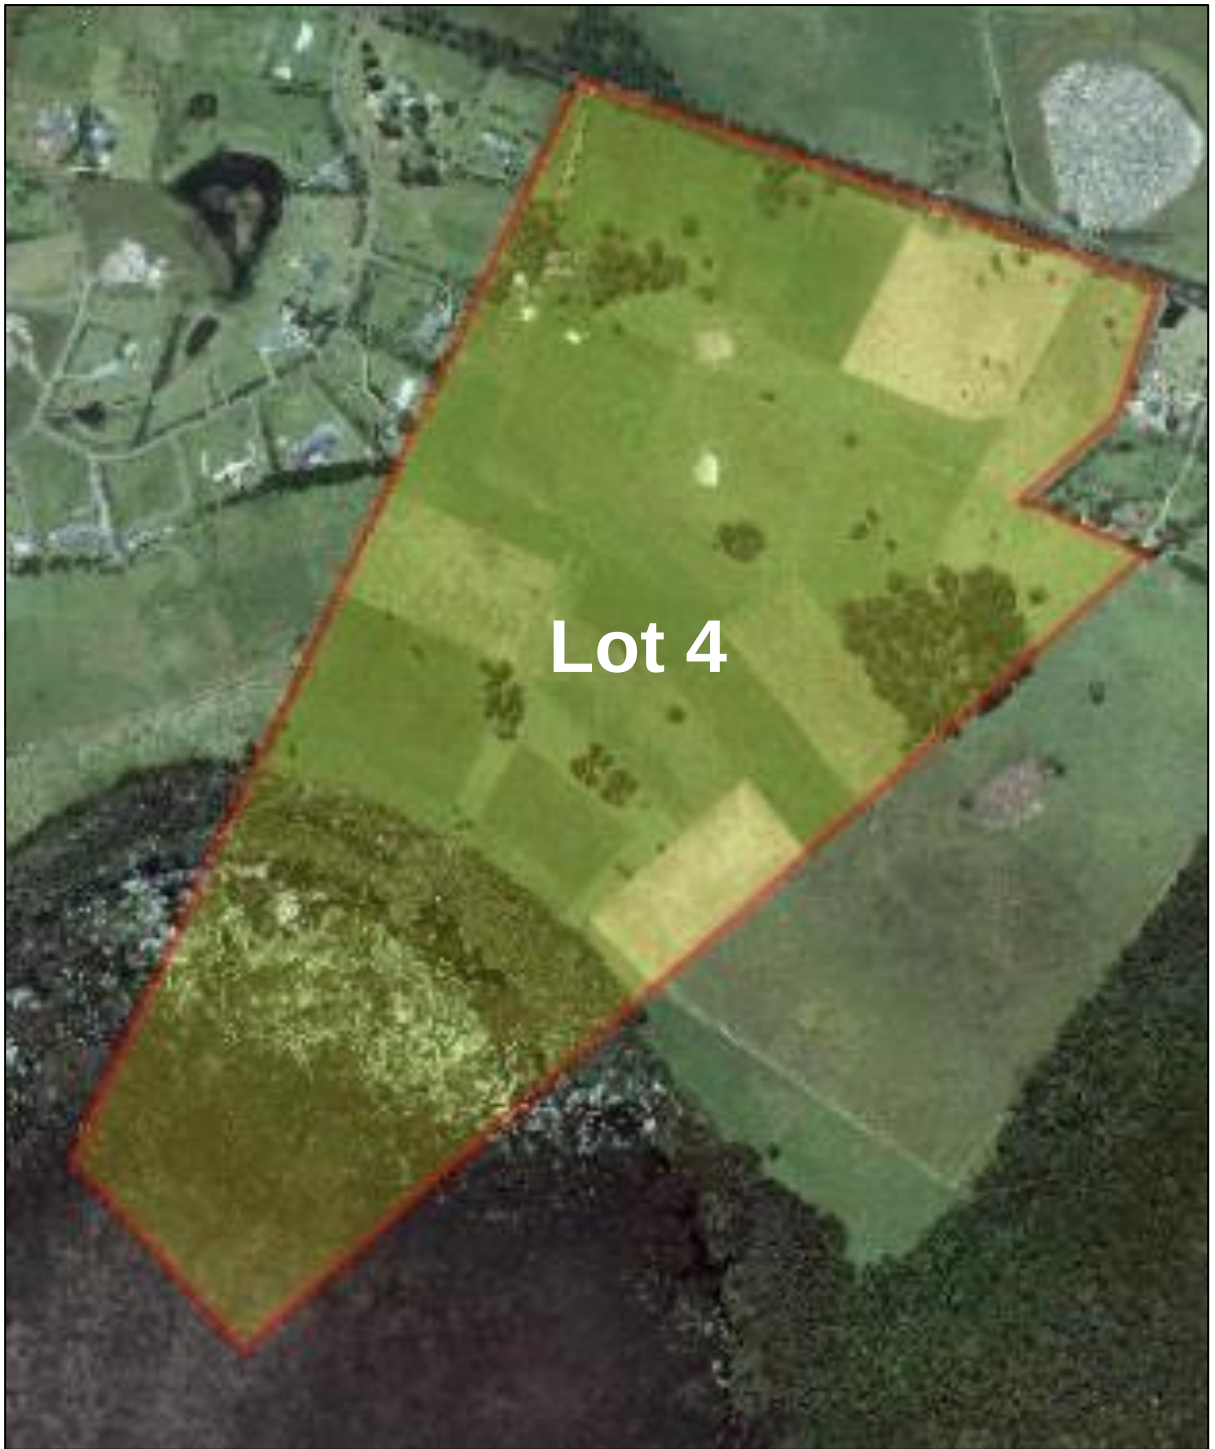
**FIGURE 1**

The Site is a mostly cleared and partly developed parcel of land. A *Google Earth* image over the Site showing existing conditions is presented in **Figure 1**. Fenced paddocks cover the northern 60% of the Site. Three small farm dams are located in the northern part, two of these on the north-eastern fall and the third in the north-western corner. A wind mill is located on the northern edge of Coomonderry Swamp in the southern part of the Site (**see Plate 1**).

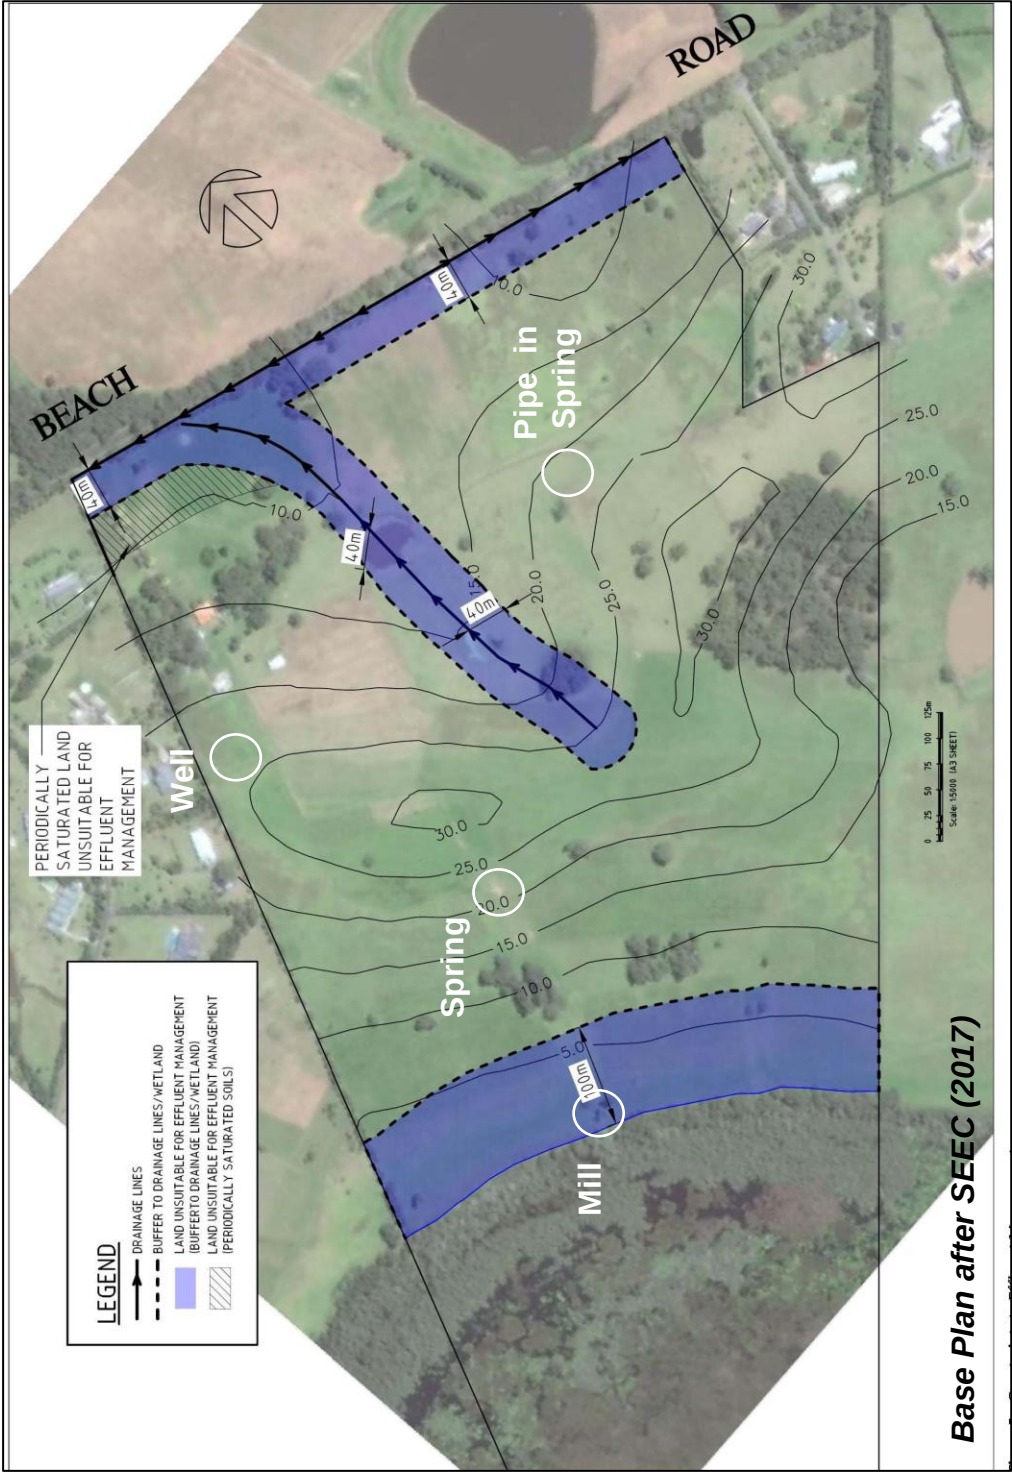
| N | | FIGURE 3 | |

The Site is located within undulating low coastal hills and coastal wetlands. The Site is separated into two watersheds by a low-lying northwest-southeast trending ridge system that dissects the central northern part of the Site (**Figure 3**). Although no defined drainages occur on the Site, Coomonderry Swamp covers the southern 30 %. Overland flow north of the divide drains to Beach Road and south of the divide to Coomonderry Swamp. The elevation of the Site ranges from close to sea level at Coomonderry Swamp to about 30.0 m in the central part atop the divide.
