Report on  
Mine Subsidence Investigation

Proposed Rezoning Lot 42, DP 846326  
Corner Wilton Drive and Mount Vincent Road,  
East Maitland

Project 81674  
September 2015

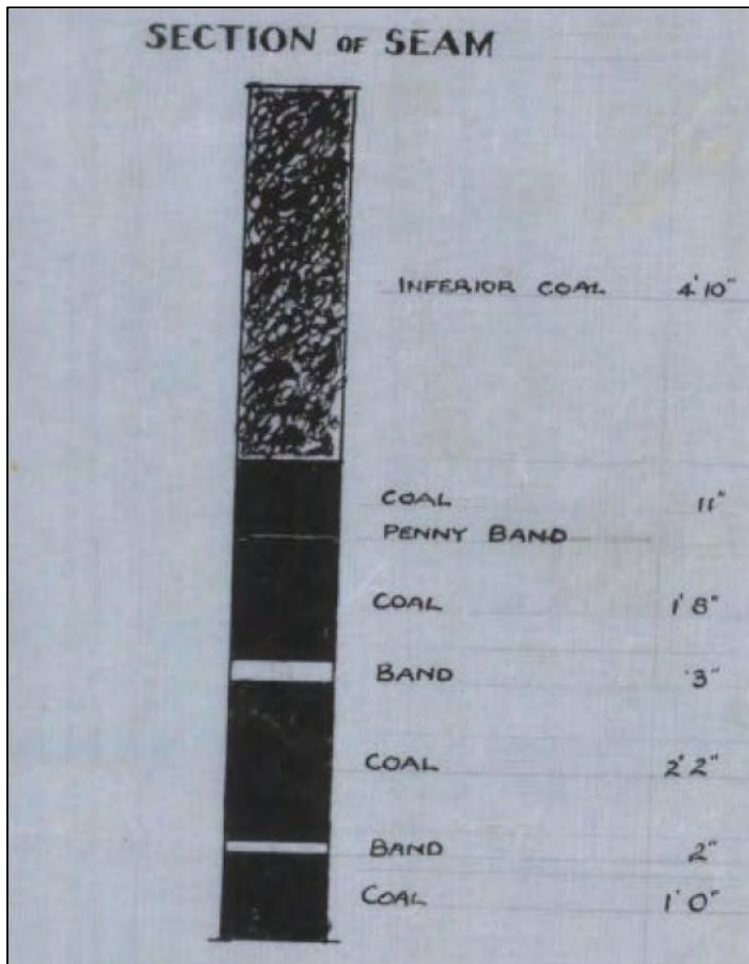
Figure 5: Rathluba Seam Section from RT 603

- All workings below the site were bord and pillar (rectangular, trapezoidal and triangular in shape);
- The eastern most workings located the below the site had been surveyed in several stages from 1952 to 1953;
- Pillar widths range from about 3.5 m to 20 m with occasional narrower and wider pillars;
- Bord widths are generally in the range 3 m to 5.5 m with occasional narrower and wider bords;
- Pillar lengths are generally in the range 5 m to 36 m;
- A seam section is shown, which indicates a total seam thickness of 11'0" (3.35 m), with an upper inferior coal 4'10" (1.47 m);
- Dip rate of 1 in 12, and a direction of dip S 30° E;
- Three shafts located just south of the study site labelled as Shaft, Tunnel Mouth and Fan Shaft;

- A borehole located in south east corner of the site; and
- RT603 includes workings shown on RT 238 (i.e. western most part of workings) and indicates that these were inaccessible parts of the workings in the 1950's and were positioned at the time based on the RT 238 and surface features such as tunnel and shafts.
