Report on
Geotechnical Investigation

Pondicherry Residential Rezoning
Pondicherry, Oran Park, NSW

Prepared for
Department of Planning and Environment
And Camden Council

Project 76778.28
August 2017

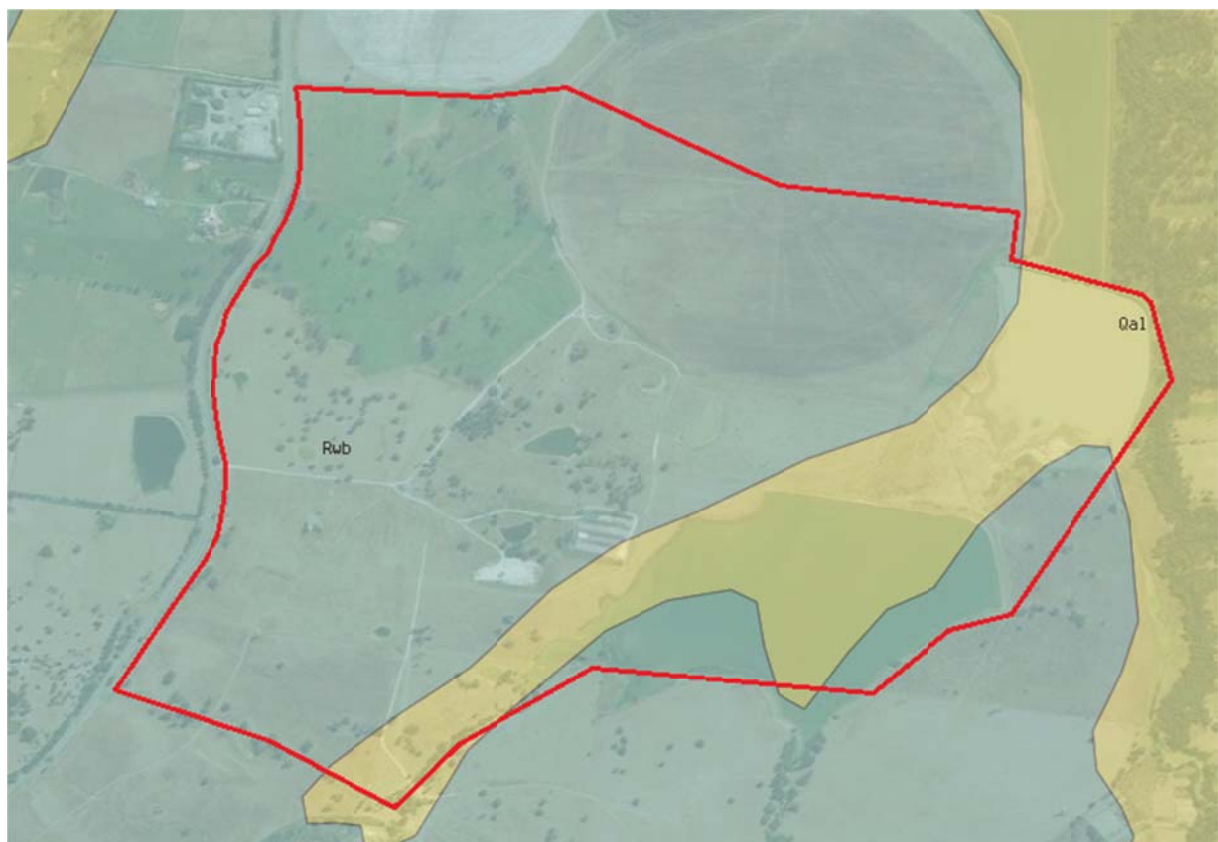
The rolling hills, ridgelines and lower slopes in the northern, western and central portions of the site are underlain by Bringelly Shale (mapping unit Rub) of the Triassic age Wianamatta Group (Penrith 1:100 000 Geological Series Sheet 9030; Ref 1). The Bringelly Shale in the vicinity of the site includes an unnamed, fine to medium grained quartz-lithic sandstone member, typically comprises shale, carbonaceous claystone, laminite and some minor coaly bands which weather to form clays of high plasticity.

The lower lying eastern portion of the site is generally underlain by Quaternary alluvial deposits (mapping unit Qal) of the Nepean River which are mainly derived from weathering of Permian and Triassic bedrock and typically comprise grey-brown, medium grained quartz sand with layers of silt and humic clay.

Figure 1: Geological Landscapes (Yellow – Quaternary Alluvium and Blue – Bringelly Shale)

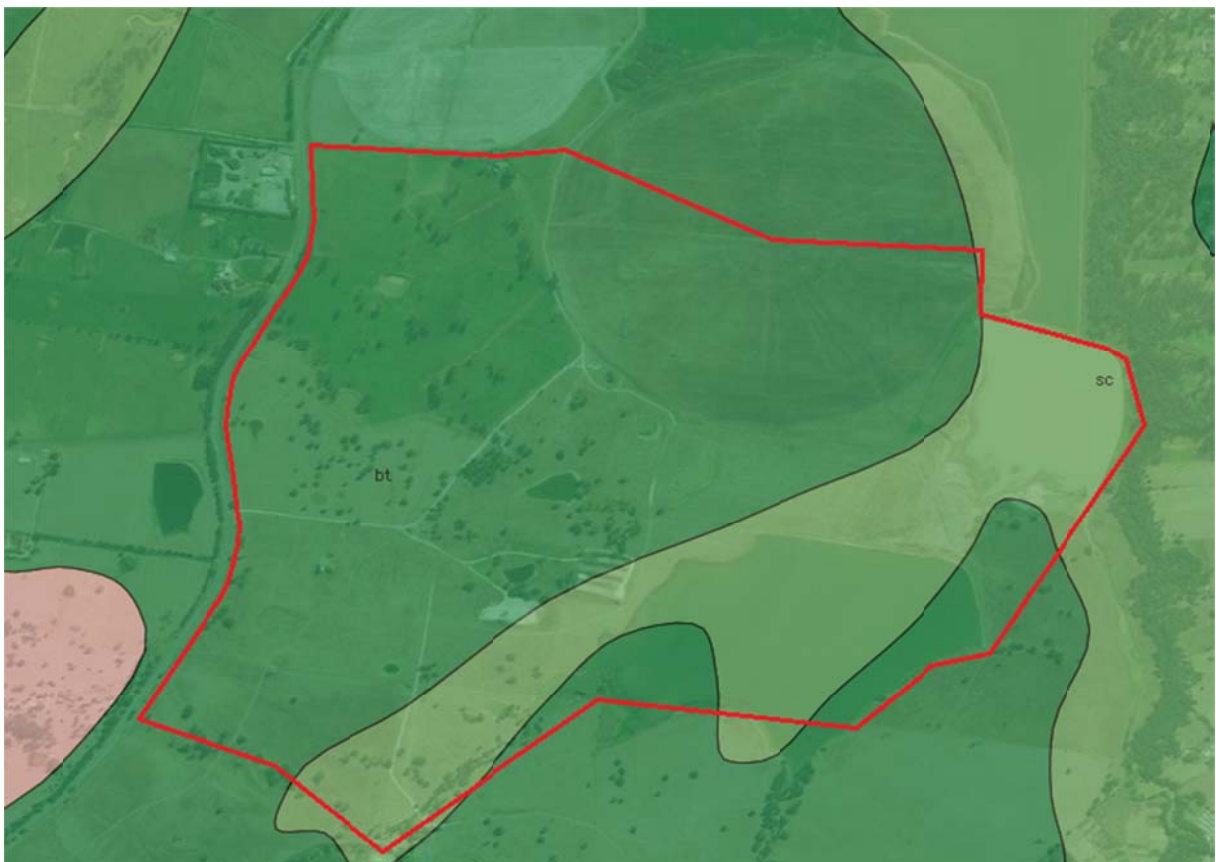
- **The Blacktown Soil Landscape** (mapping unit bt) is a residual soil group associated with the gently undulating slopes and broad rounded crests and ridges on the Wianamatta Group in the eastern part of the site. The unit comprises up to four soil horizons that range from shallow red-brown hard-setting sandy clay soils on crests and upper slopes to deep brown to yellow sand and clay soils overlying grey plastic mottled clay on mid to lower slopes. These soils are typically of low fertility, are moderately reactive and have a generally low wet bearing strength.

- **South Creek Soil Landscape** (mapping unit sc) is an alluvial soil group associated with floodplains, valley flats and drainage depressions of the channels on the Cumberland Plain. Usually flat with incised channels, mainly cleared, and is mapped along South Creek and associated minor creek extending south and south-west through southernmost dam. Mapping indicates soils associated with this landscape comprise very deep layered sediments over bedrock or relict soils. Red and yellow podsolic soils occur.

Figure 2: Soil Landscapes (Dark Green – Blacktown Soils and Light Green – South Creek Soils)
