Traffic Engineering – Road Safety Audit

Existing Road Stage

At 150 Lismore Road, Bangalow NSW

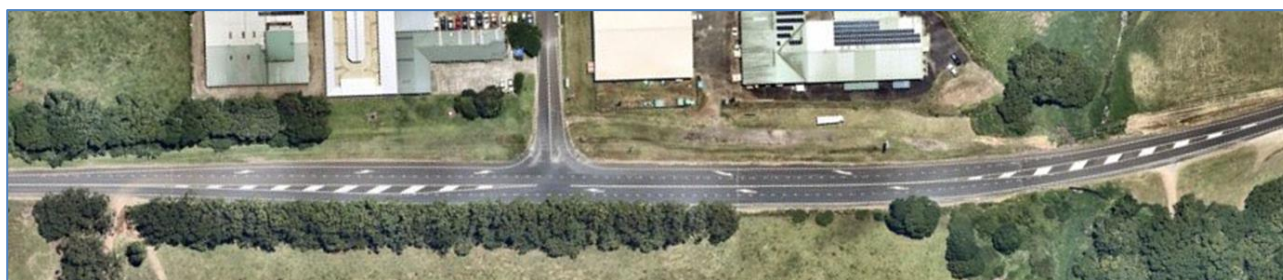
Figure 2-1: Lismore Road / Dudgeons Lane intersection

It was noted during the site inspection that the intersection of Lismore Road / Dudgeons Lane has recently been resurfaced, with line marking still to be carried out.
