A Geomorphic Assessment of 'Keyhole Site', Horsley Park, NSW

Flow and Loam Environmental

Report prepared for:
écologique

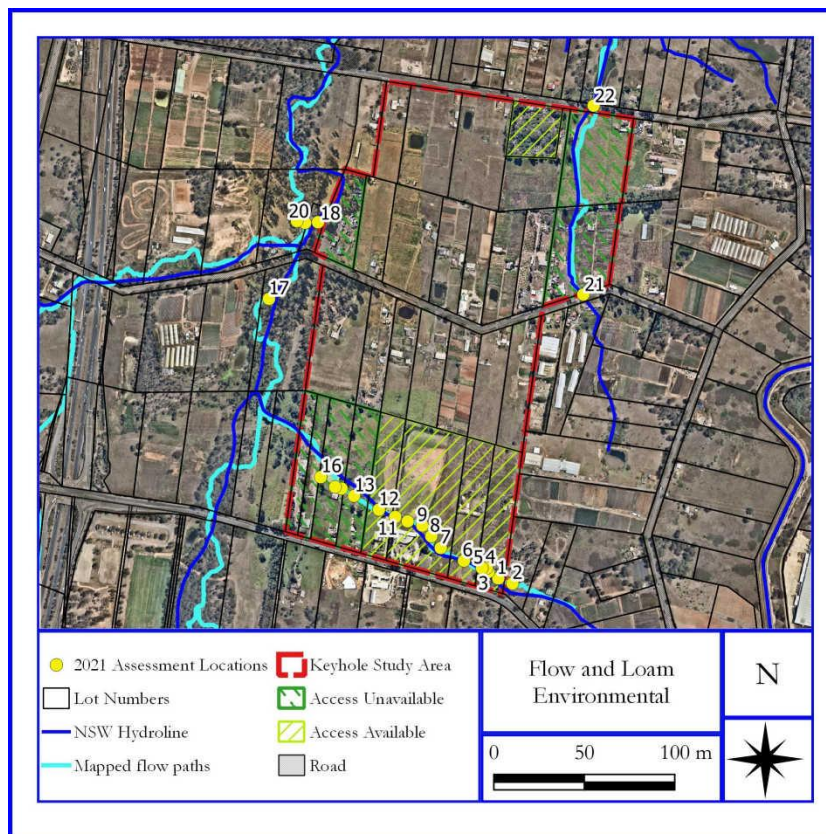
Figure 1. Location of study areas

Hydroline mapping indicates a first order watercourse extending through lots 63 and 54 on the north eastern (Area 1), a second order stream encroaching on to lot 59B on the western boundary and a first order stream extending laterally across the study area close to the southern boundary (Figure 1).

There are three areas within the 'Keyhole Site' that have drainage pathways as defined by the Hydroline data set. Access has been granted to only part of these areas and so it is necessary to evaluate the remainder by desktop assessment (Figure 1).

The Hydroline Data Set (Planning, Industry and Environment 2018) utilised Strahler Stream Order assessment to identify stream within the study area (Figure 1). During preliminary desktop assessment using QGIS, three study areas were defined by locations that the Hydroline extended within the Keyhole Site. The Hydroline defined first order streams in Areas 1 and 3 and a second order stream in Area 2.
