Slope Risk Assessment

Proposed Subdivision - 18 Winterlake
Road, Warners Bay

CGS2708

July 2015

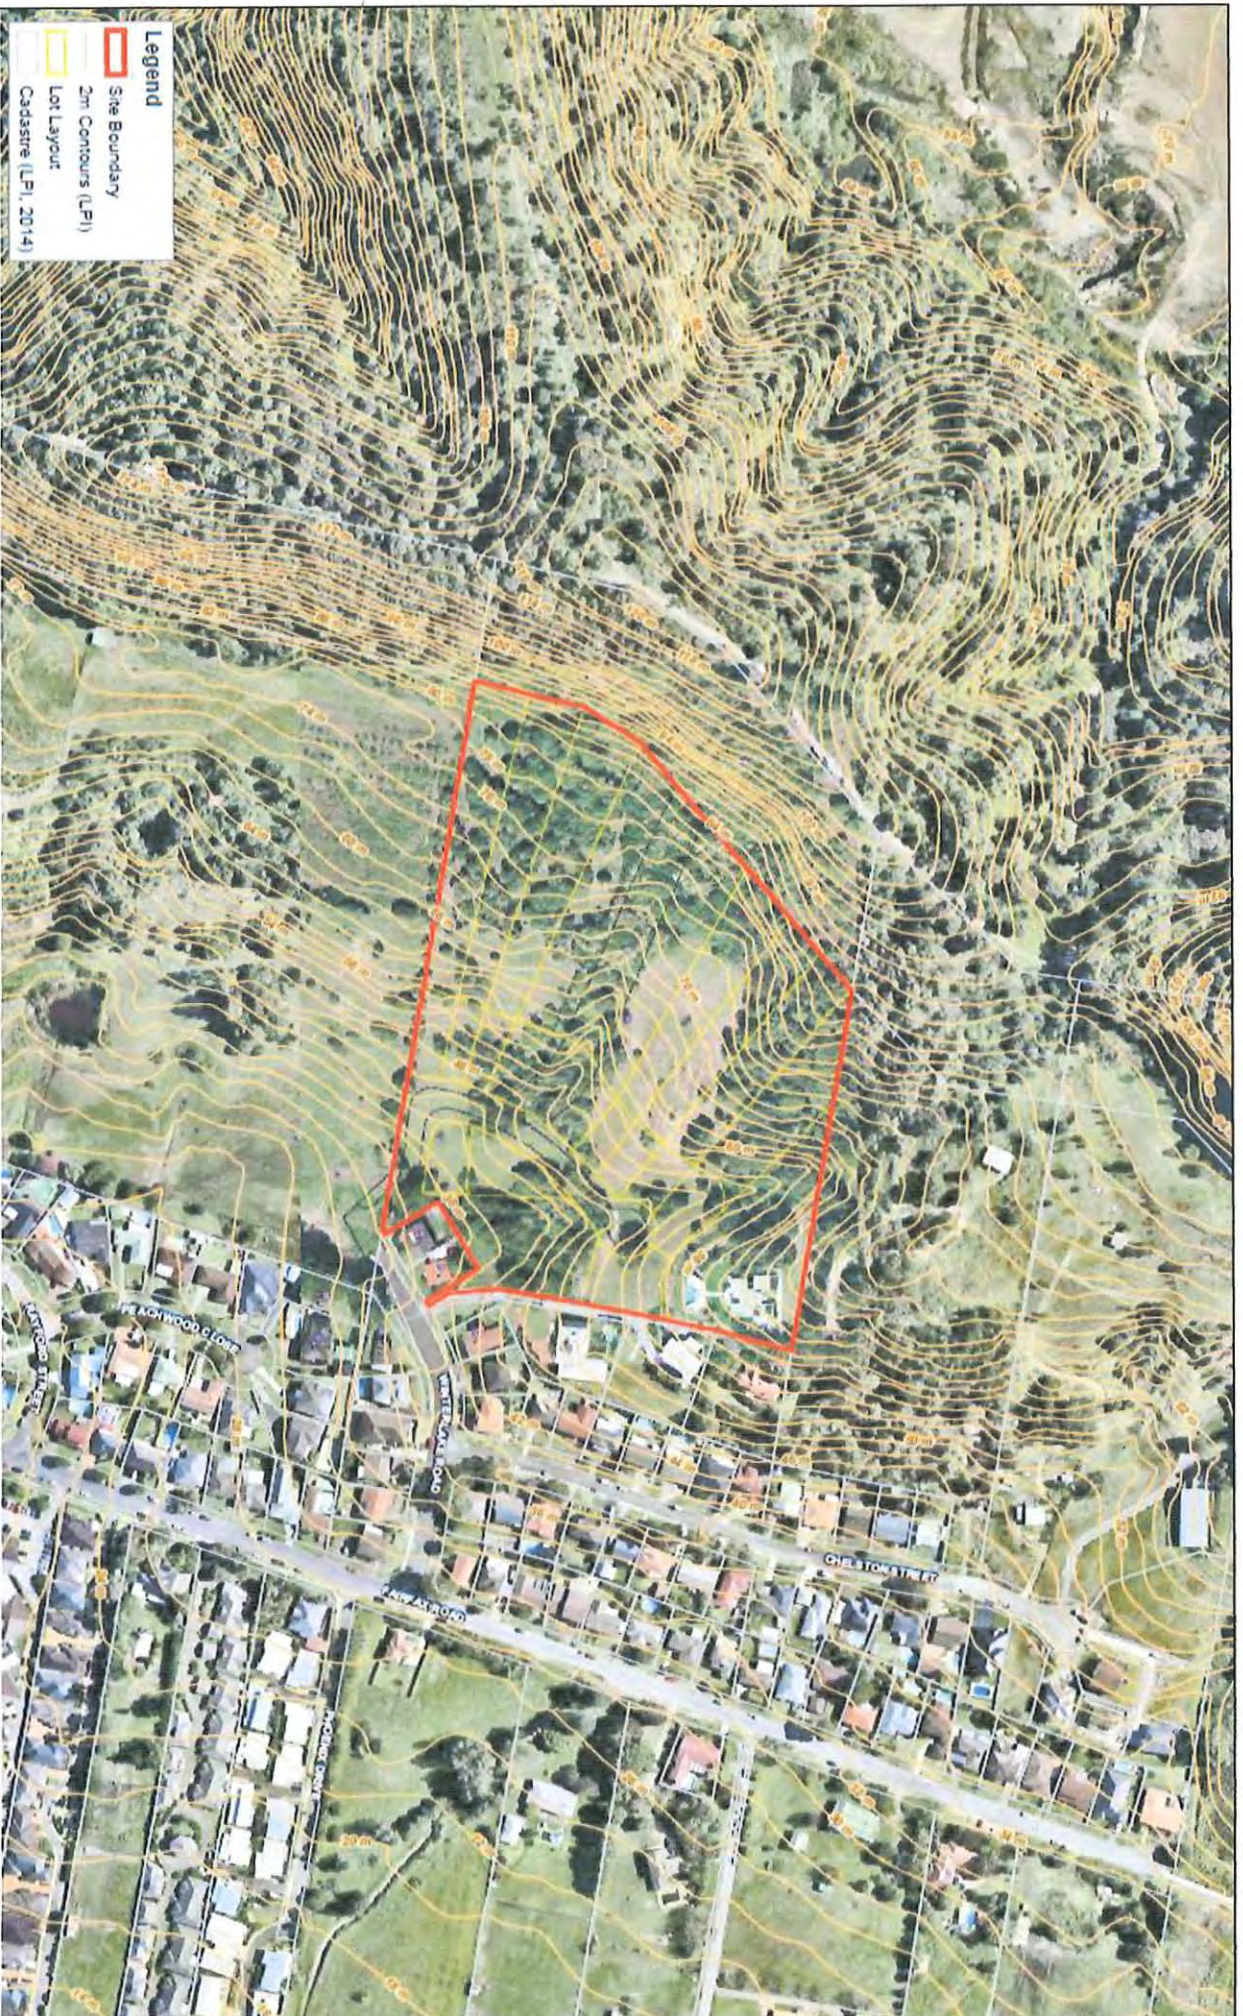
Surficial slips and evidence of ongoing soil creep were noted in both of the steep sided gullies. The slip in the south gully appears to involve natural soils and uncontrolled fill that has been tipped into the gully. The slip in the north gully involves colluvial soils. The instability appears to be confined to the gullies, and no scarps, tension cracks, or disturbed ground that could not be attributed to past earthworks were noted outside the gully areas.

Purple denotes location of old vehicle track

Orange indicates approximate location of slips.
