**Proposed Residential Subdivision
Rayford Street and Daydawn Avenue, Warners Bay**

Slope Stability Assessment

Report No. RGS01426.1-AE

30 May 2017

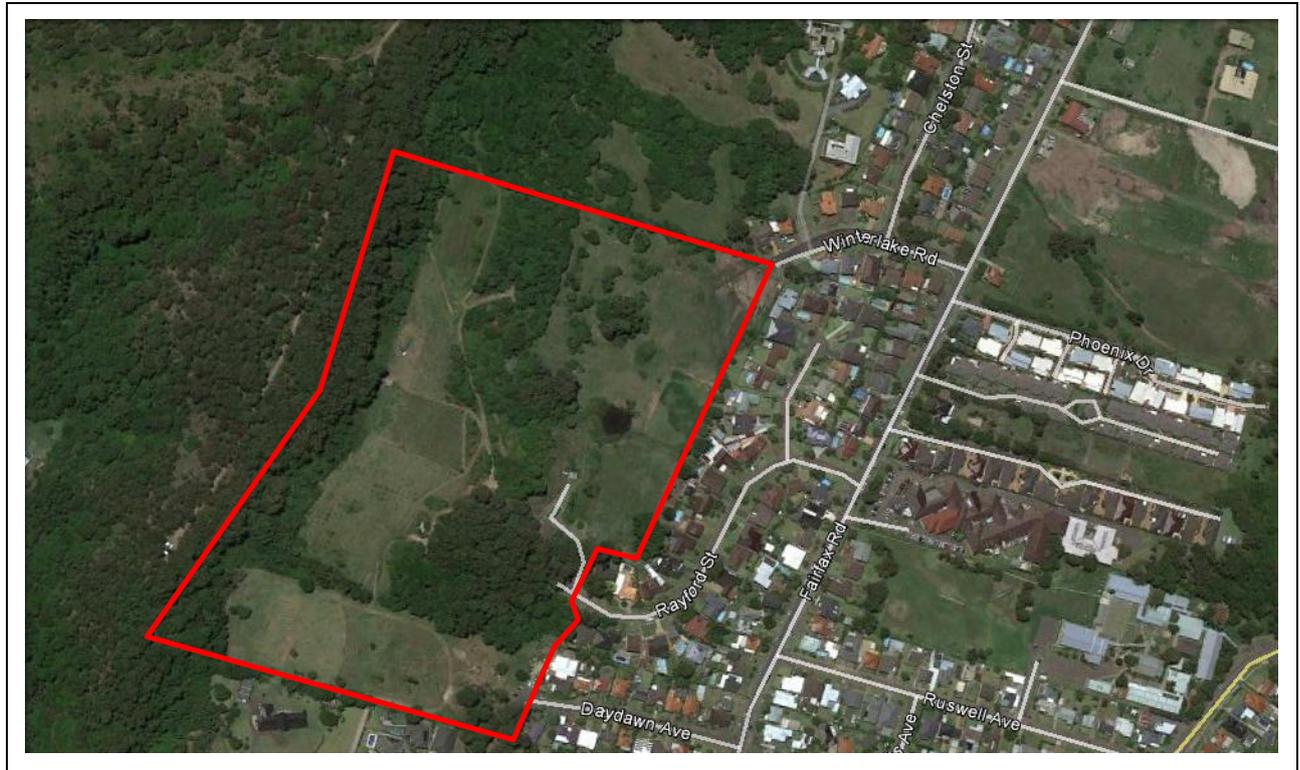
Google Earth image with approximate outline of subject site shown in red. Cleared upper bench zone visible on western third of site. Heavily vegetated central slope zone in middle of site. Eastern third occupied by cleared zone of gentle lower slopes. Daydawn Avenue end of site (southern end) is cleared and vegetated by maintained grass with minor scattered trees.

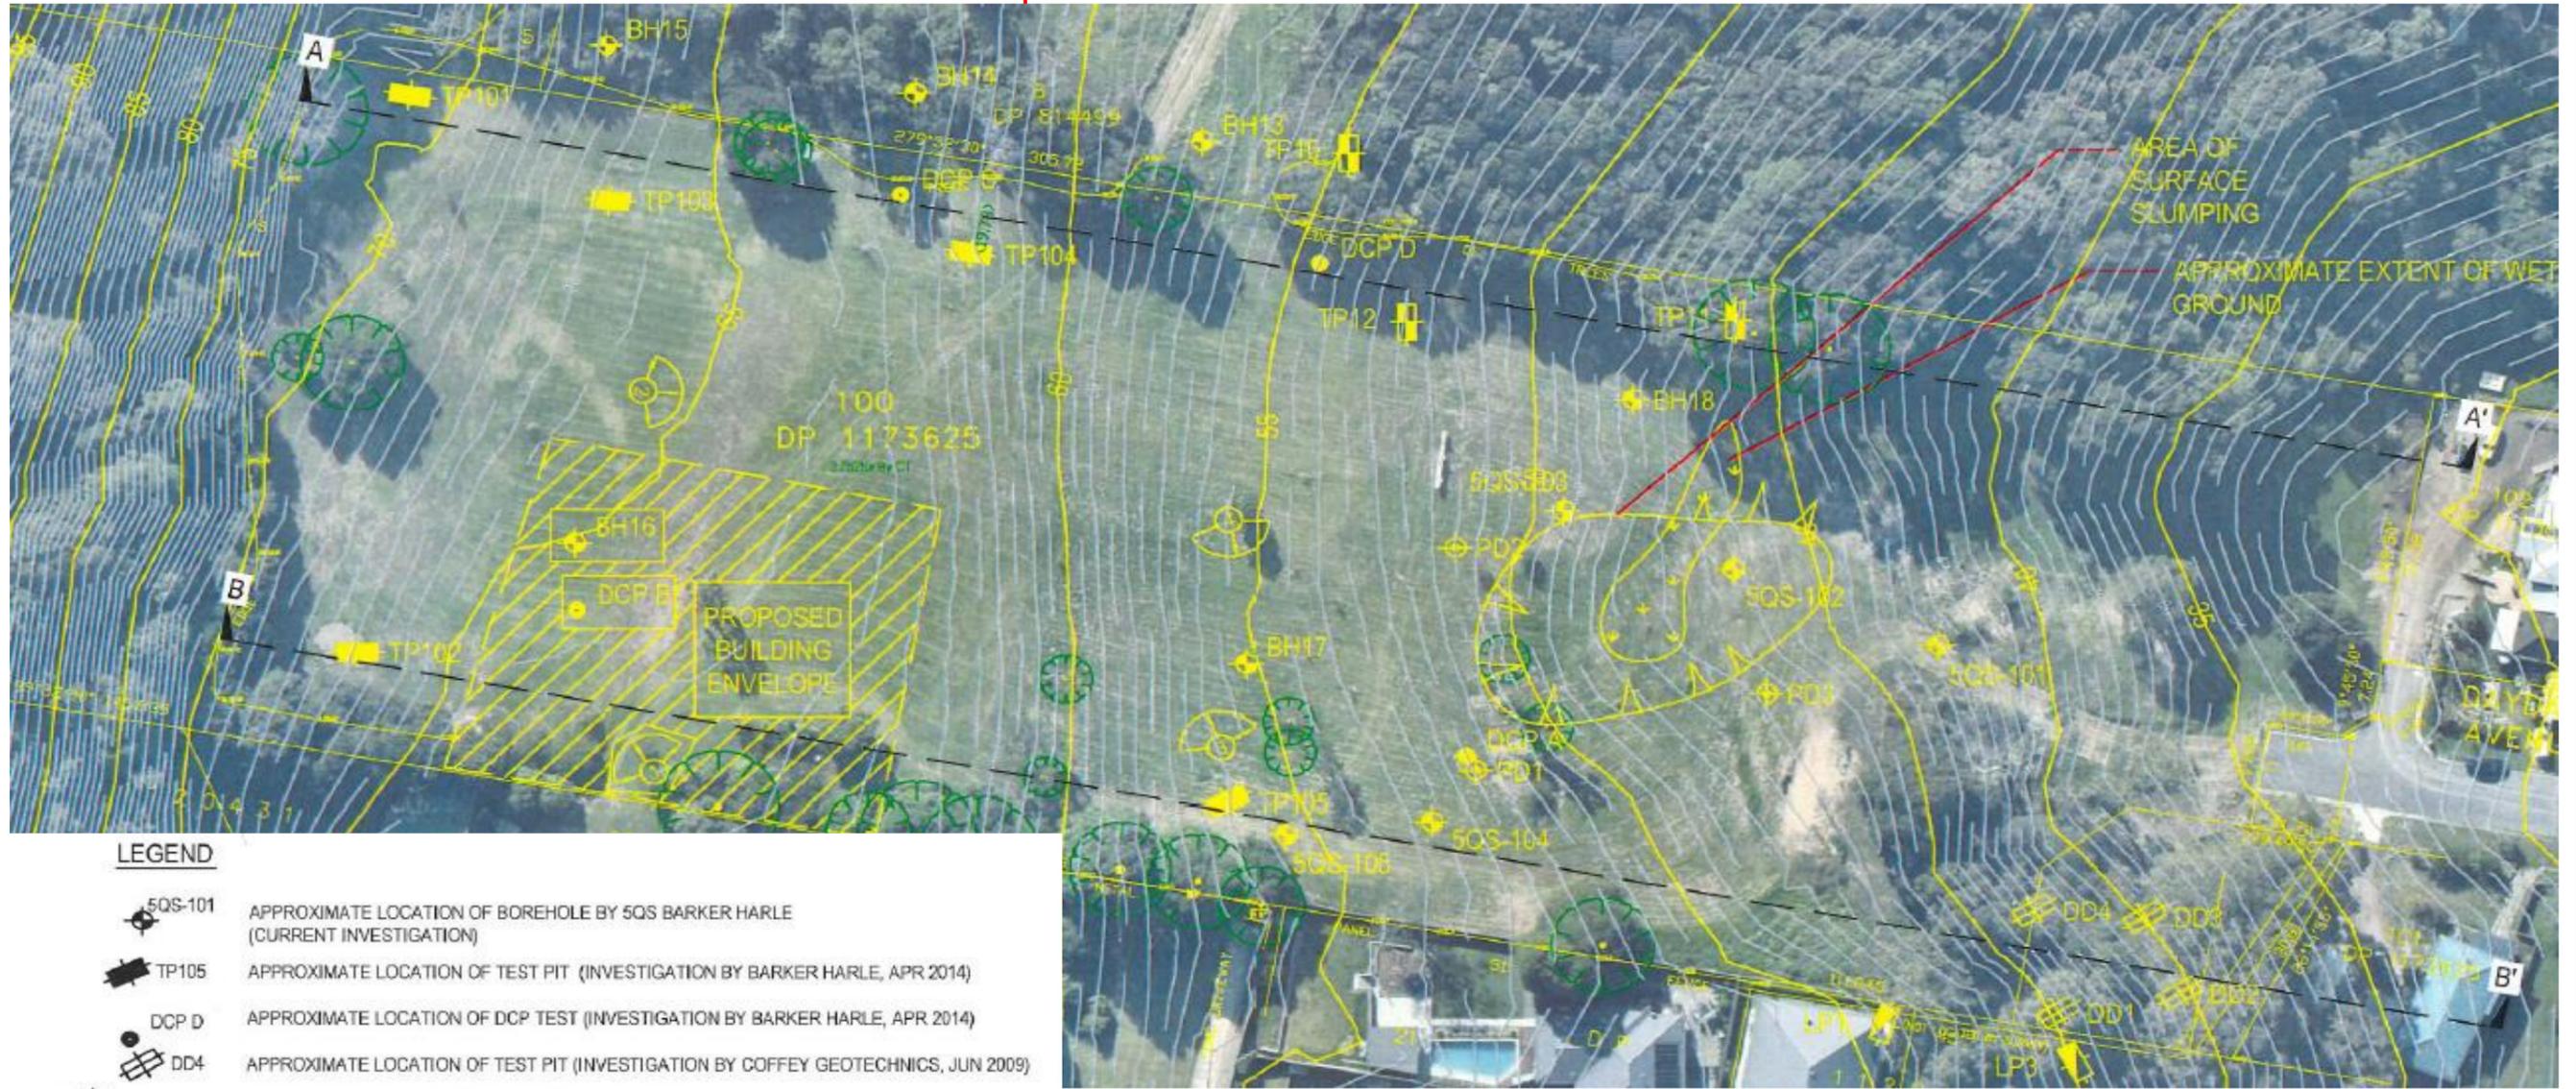
Client:	Pulver Cooper Blackley Pty Ltd	Job No.:	RGS01426.1
	Project:	Residential Subdivision Geotechnical Assessment 19 Daydown Ave and 40 Rayford Street, Warners Bay	Drawn By:	SRM
			Date:	30-May-17
	Title:	Locations of Previous Investigations - Daydown Avenue	Drawing No.:	Figure 2

*Locations of previous investigations on 19 Daydown Avenue, reproduced from Drawing 2 of Bashi report (Ref 2)

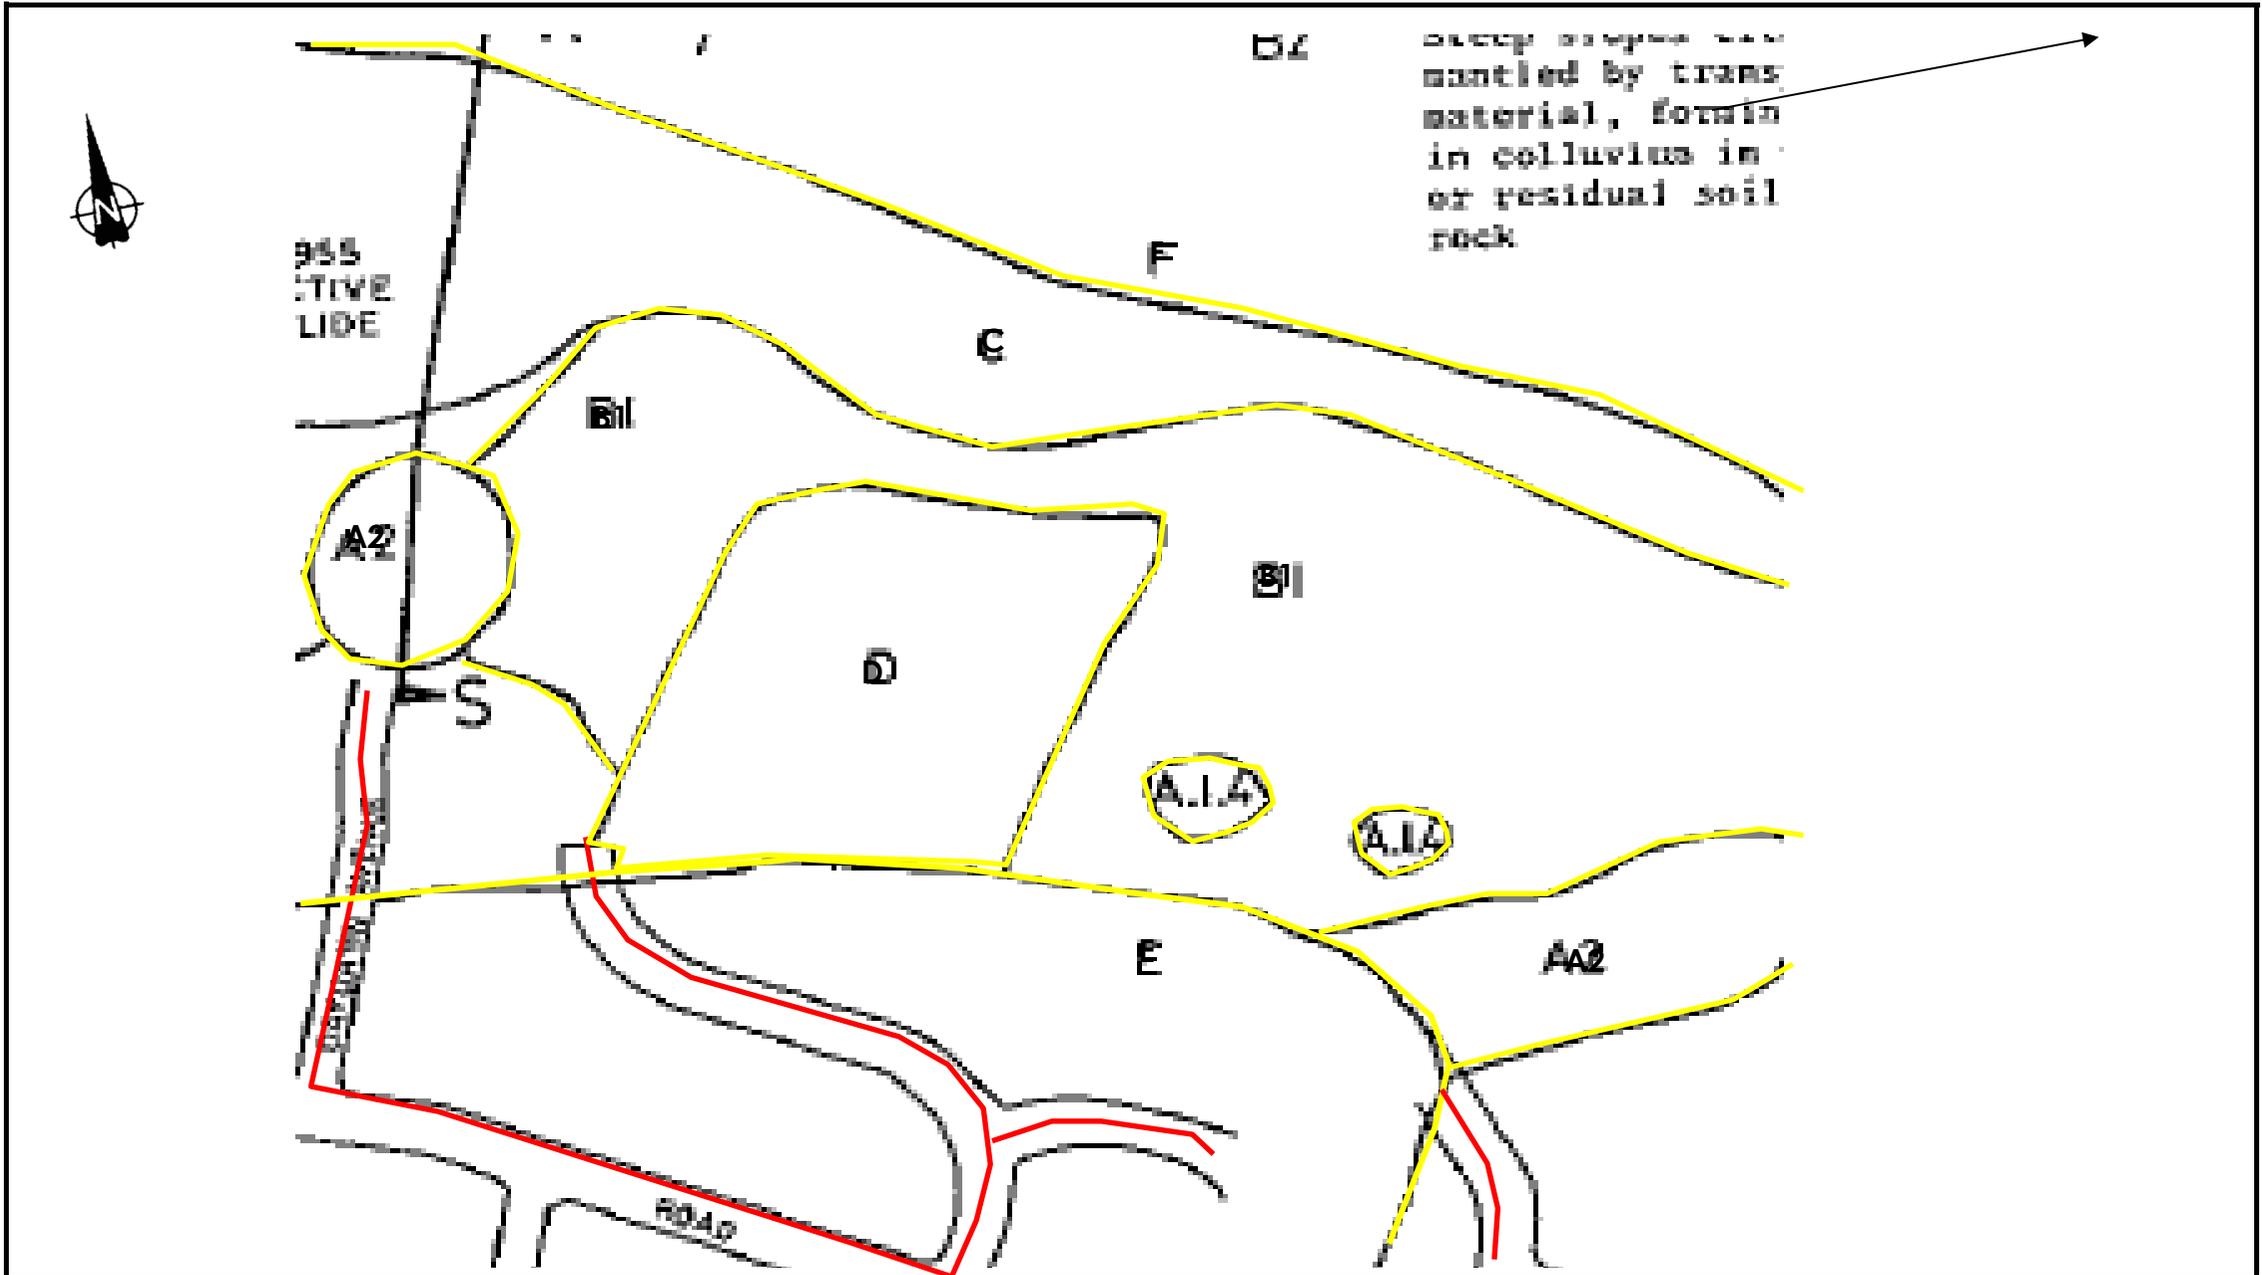
Client	Pulver Cooper Blackley	Job No.	RGS01426.1
	Project:	19 Daydawn Avenue & 40 Rayford Street Warners Bay	Drawn By:	SRM
	Title:	Landslide Zones (Fell)	Date:	30-May-17
			Drawing No.	Figure 3

As shown on Figures 3 and 4, the previous mapping identified an inferred "old" landslide on the lower slopes of the property at 19 Daydawn Avenue.

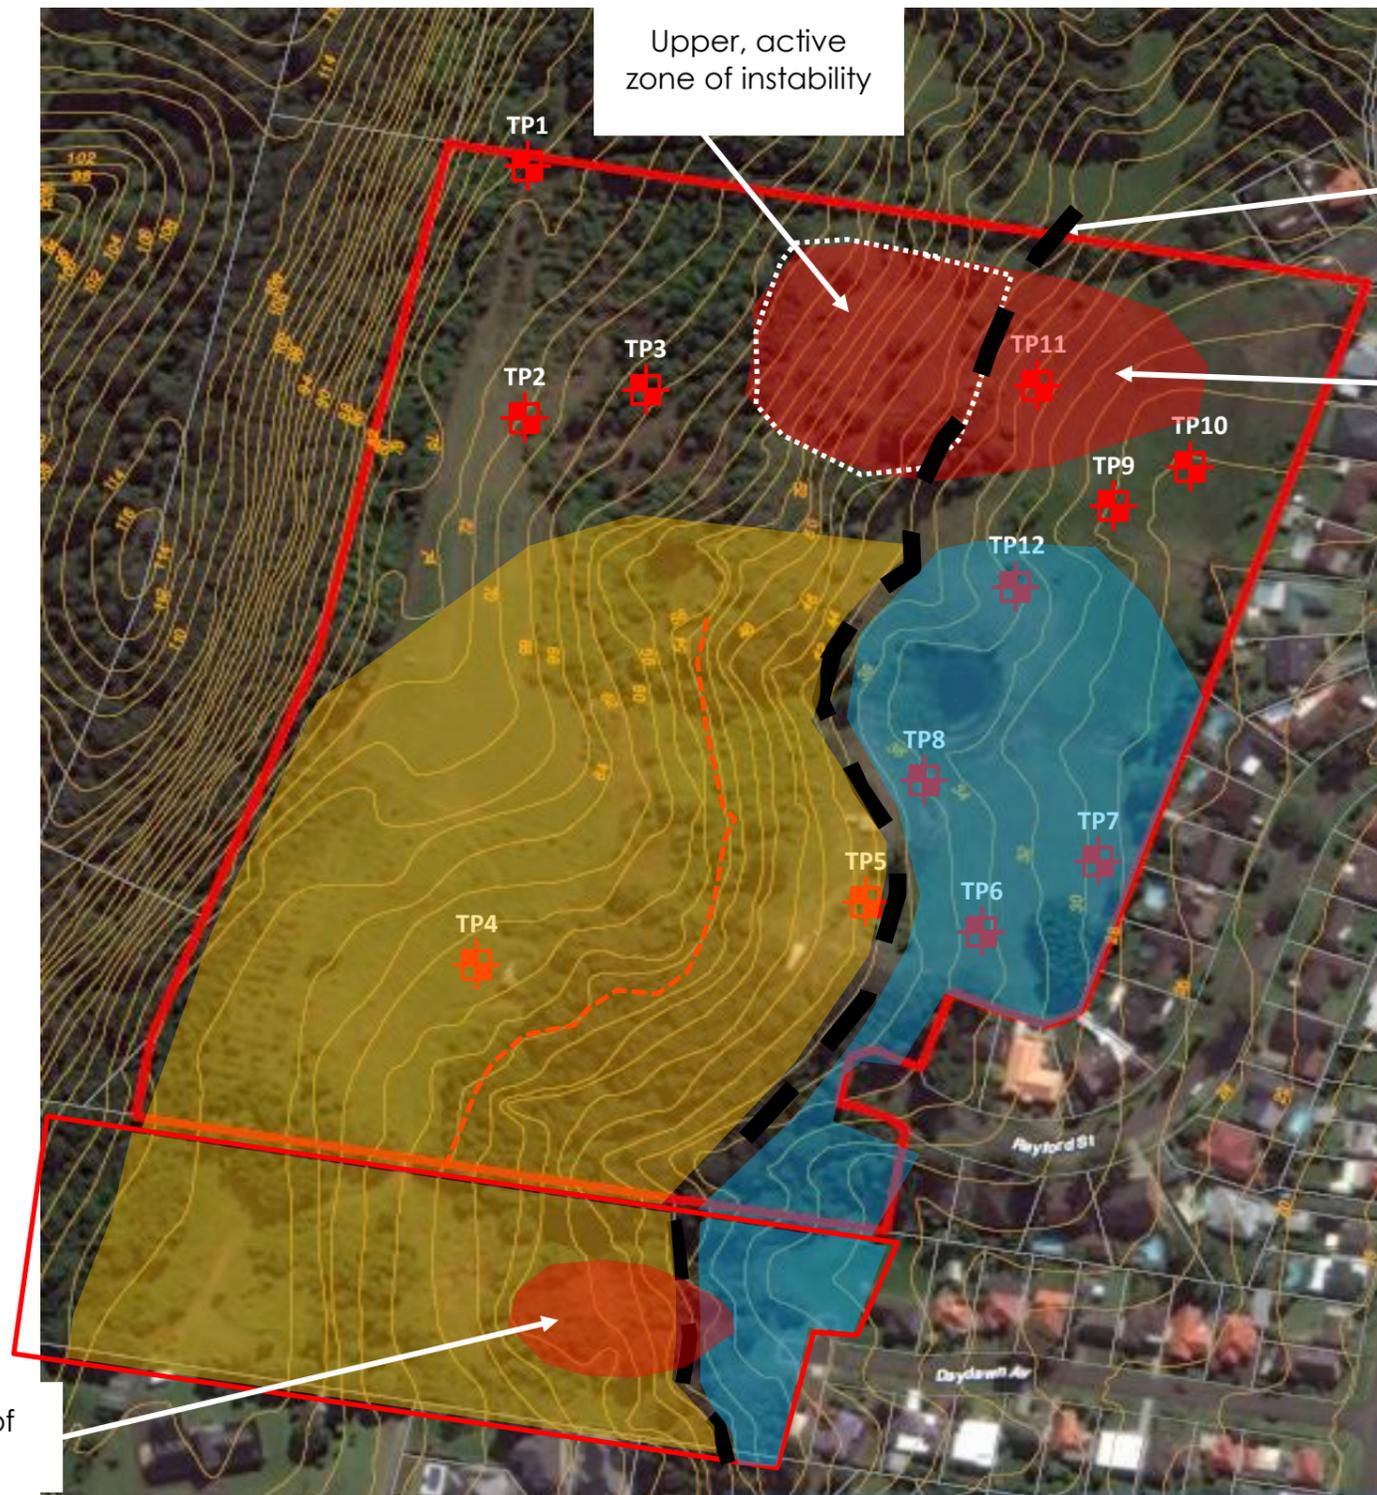
Client	Pulver Cooper Blackley Pty Ltd	Job No.	RGS01426.1	
	Project:	Residential Subdivision Geotechnical Assessment	Drawn By:	SRM
		19 Daydown Avenue & 40 Rayford Street, Warners Bay	Date:	30-May-17
	Title:	Geotechnical Zones	Drawing No.	Figure 5

- Disturbed coal was observed in TP11 at the northern end of the site within the zone of recent landslide activity.
- No water inflows were encountered in the test pits.

Inferred subcrop
of Great Northern
Seam

Lower, depositional
zone or debris lobe

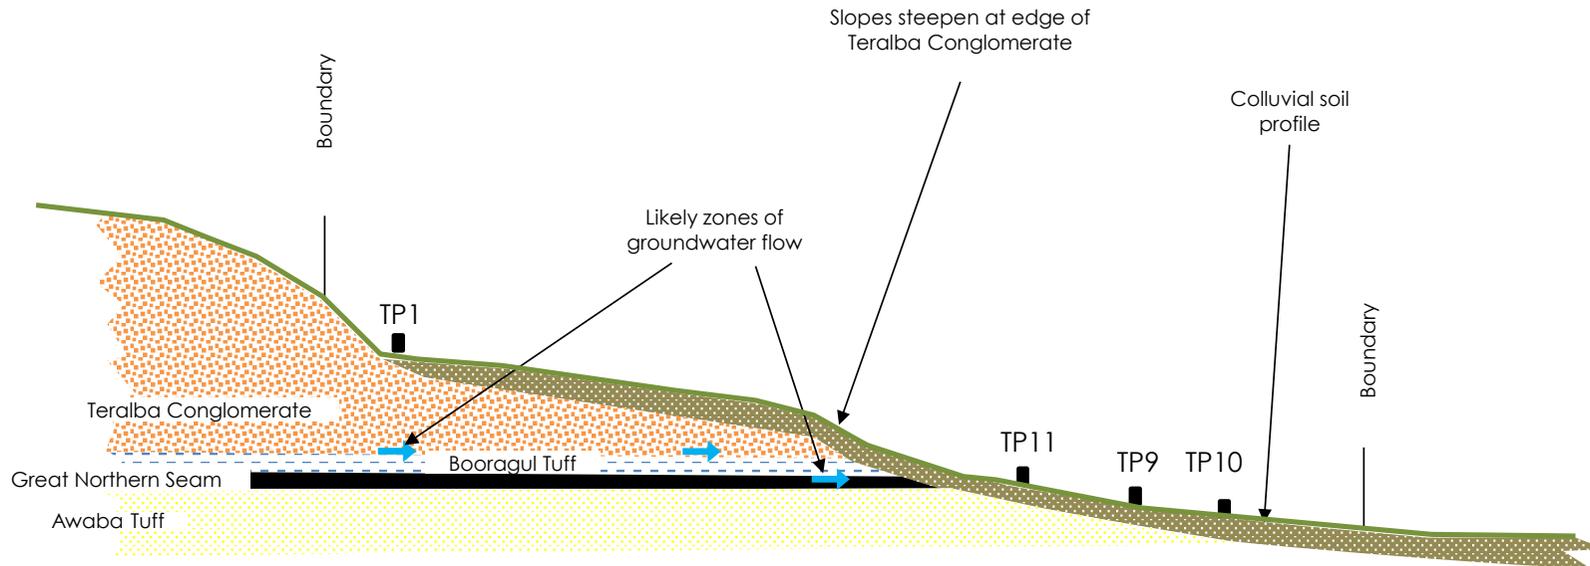
Client	Pulver Cooper & Blackley	Job No.	RGS01426.1
Project:	Residential Subdivision Geotechnical Assessment 19 Daydown Ave & 40 Rayford Street, Warners Bay	Drawn By:	SRM
Title:	CROSS SECTION	Date:	30-May-17
		Drawing No	Figure 6

The subsurface materials encountered in the test pits varied across the site, however, the findings correlate well with the known regional geology. Based on the profiles encountered in the test pits and the regional geological setting discussed in Section 3.1 above, a geotechnical model for the site is presented in Figures 5 and 6.
