**Proposed Residential Subdivision  
Rayford Street and Daydawn Avenue, Warners Bay**

**Additional Geotechnical Assessment**

Report No. RGS01426.1-AGrev2

29 March 2019

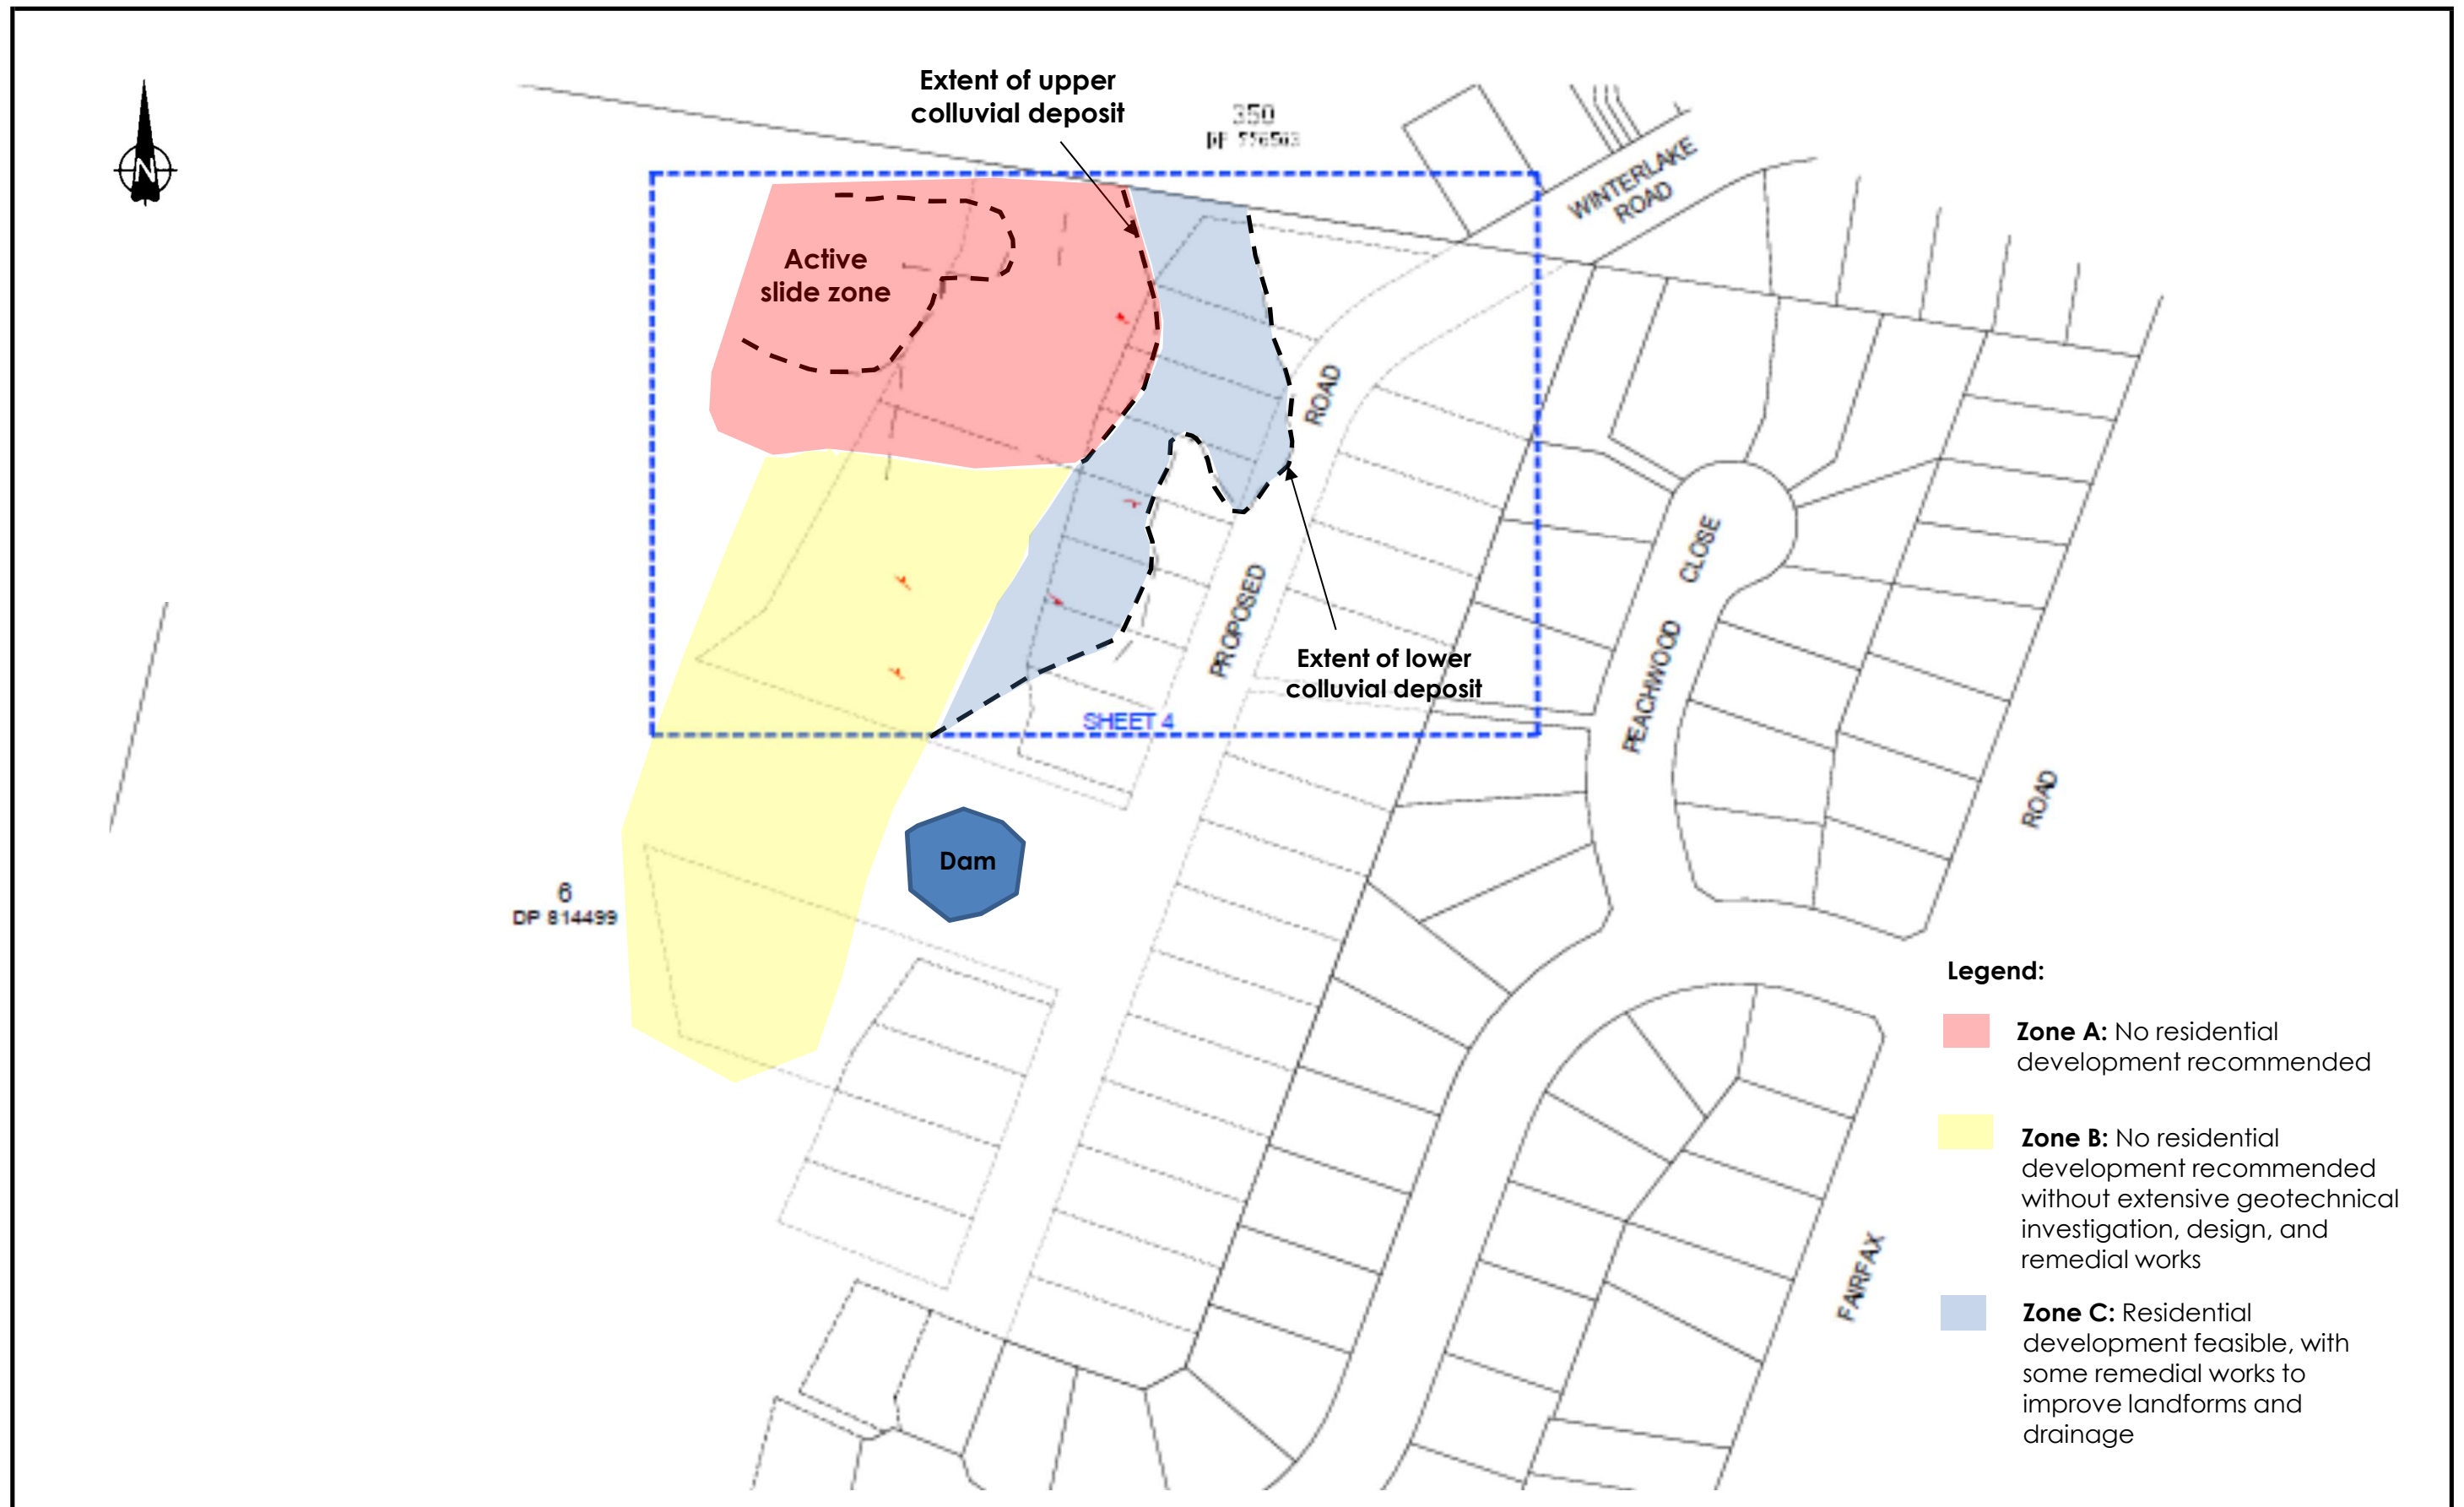
<b>Client</b>	Pulver Cooper Blackley Pty Ltd	Job No.	RGS01426.1
<b>Project:</b>	Residential Subdivision Geotechnical Assessment 19 Daydown Ave and 40 Rayford Street, Warners Bay	Drawn By:	SRM
		Date:	15-Jan-19
<b>Title:</b>	Geotechnical Zoning of Northern Landslide Area	Drawing No.	<b>Figure 4</b>

Based on the findings of this investigation, the geotechnical risk zones identified in the previous report have been further defined as shown in Figure 4. Issues regarding the development of each of these zones are discussed below:
