**Geotechnical Slope Risk Assessment**

**Proposed Subdivision**

**18 Winterlake Road, Warners Bay**

Report No. RGS02268.1-ABrev1

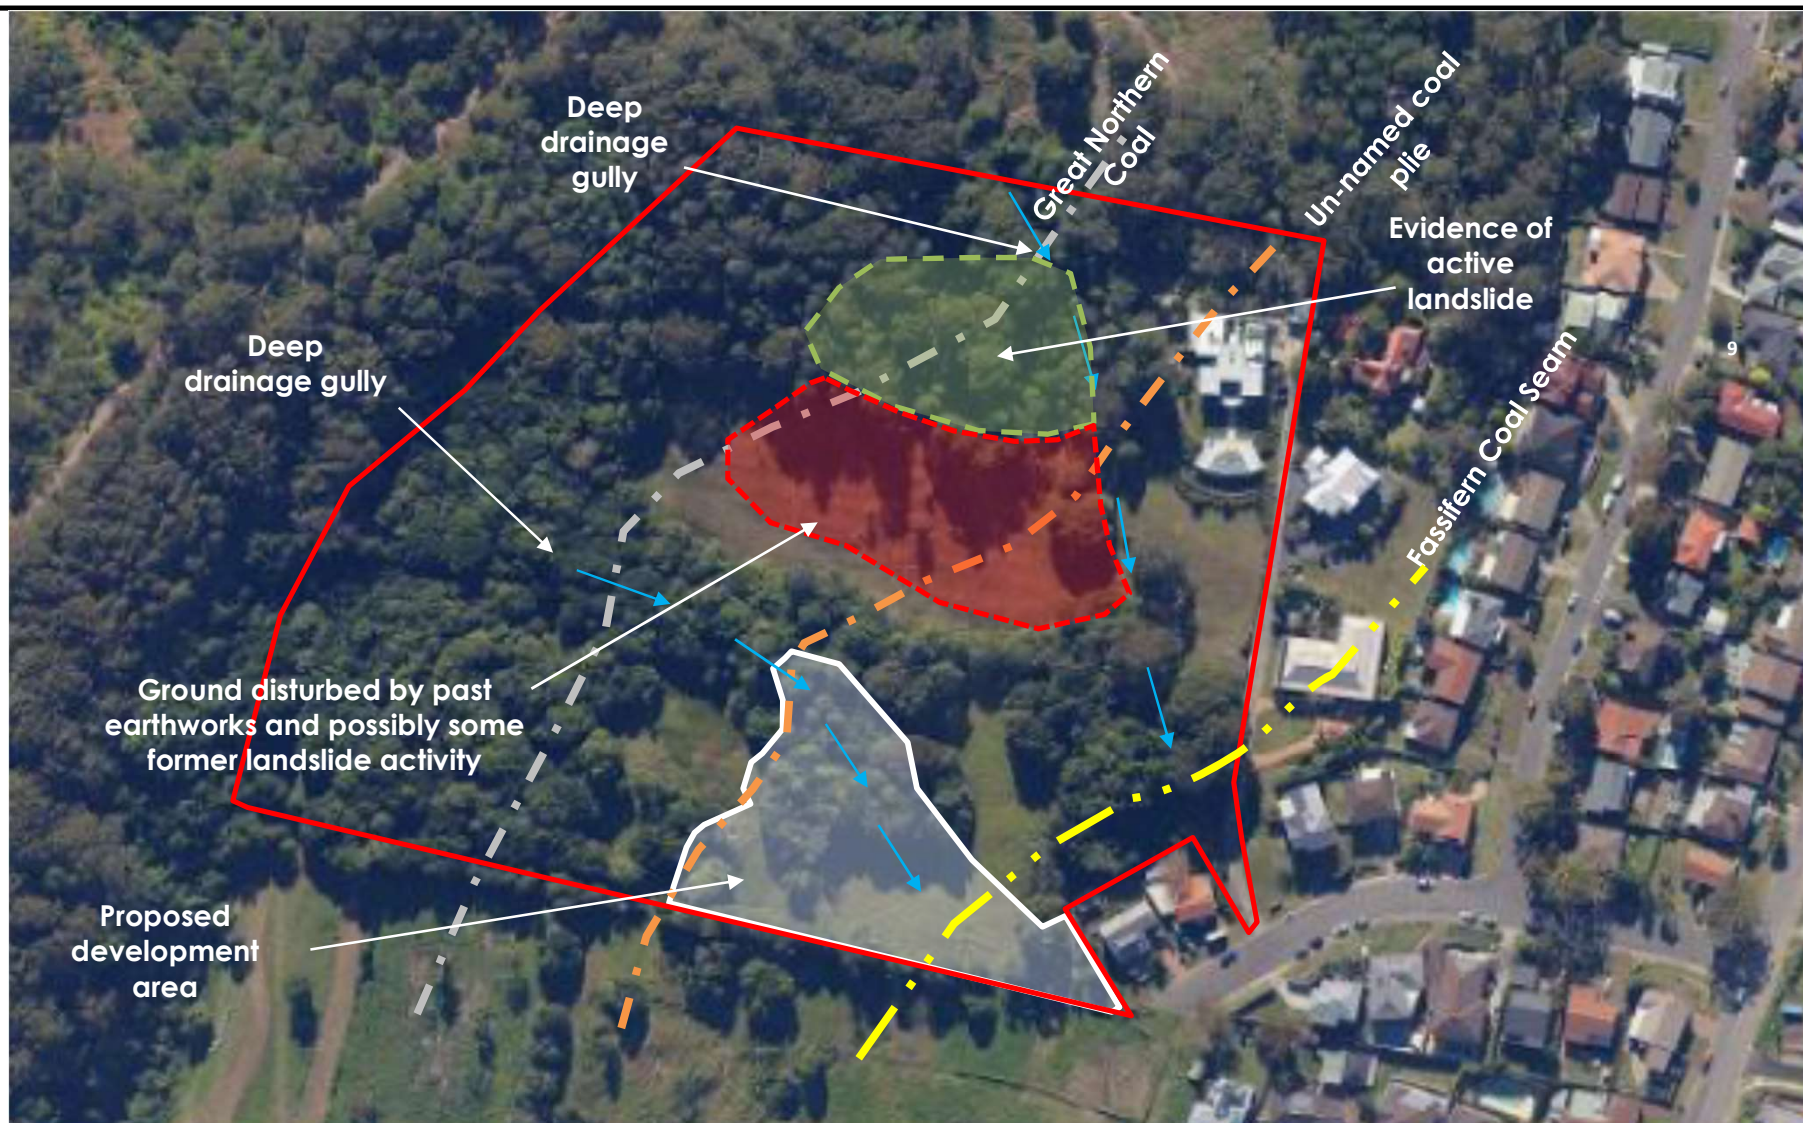
<b>Client:</b>	Valley Planning Pty Ltd	Job No.	RGS02268.1
	Proposed residential subdivision 18 Winterlake Road, Warners Bay	Drawn By:	SRM
		Scale:	NTS
		Date:	30-Jan-20
<b>Title:</b>	Site features and geology	Drawing No.	<b>Figure 3</b>

The lower slopes are typically underlain by the fine grained tuffaceous sandstones, siltstones and claystones of the Awaba Tuff. This directly overlies the Fassifern coal seam, which sub-crops slightly above the level of the rear of the existing properties fronting Winterlake Road, as shown in Figure 3.

The approximate sub-crops of the Great Northern Seams and an un-named coal plie, as mapped by Shirley Partners in 1987 (Ref 2) are also marked on Figure 3.

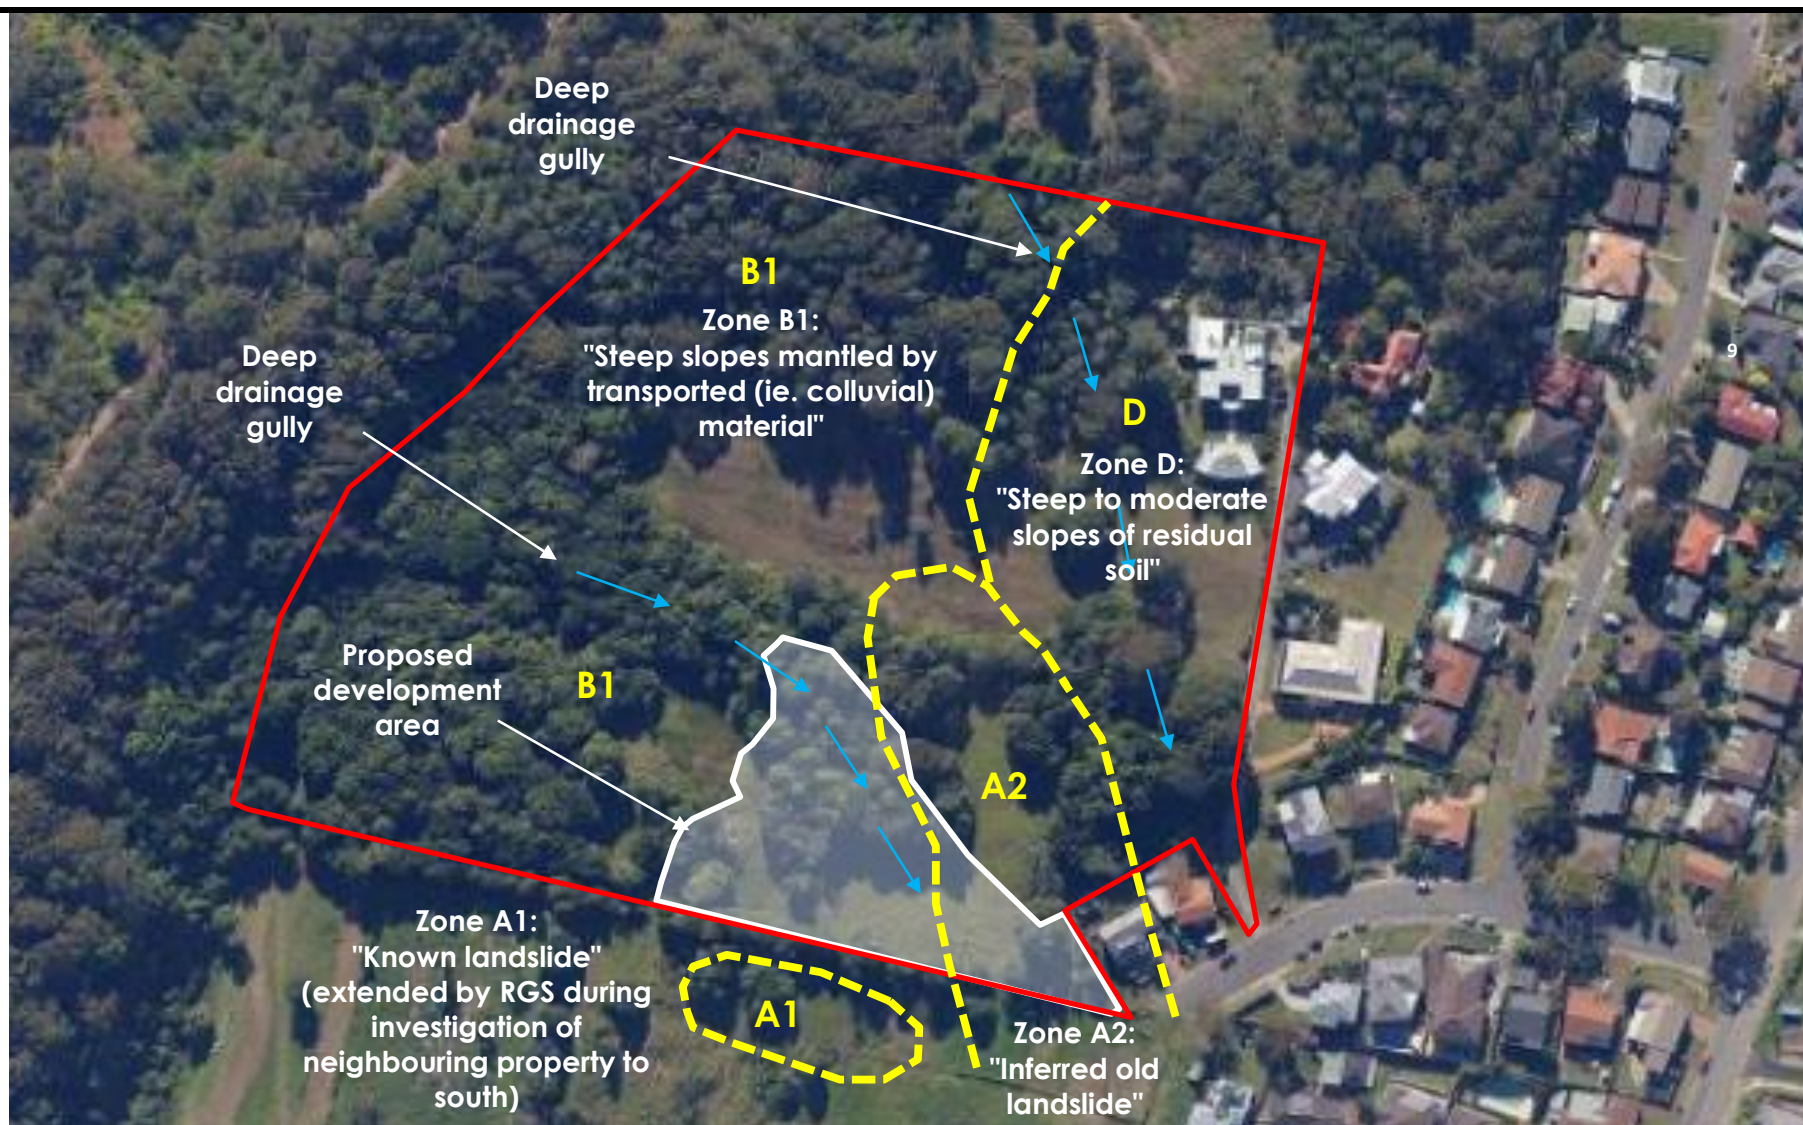
<b>Client:</b>	Valley Planning Pty Ltd	Job No.	RGS02268.1
	Proposed residential subdivision 18 Winterlake Road, Warners Bay	Drawn By:	SRM
		Scale:	NTS
		Date:	30-Jan-20
<b>Title:</b>	Landslide Zones (Fell) Relative to Subject Site	Drawing No.	<b>Figure 4</b>

Groundwater levels in the area have been shown to be a major contributor to triggering of the landslides with a study by Fell et al (Ref.3) indicating that landslides occurred on these slopes when groundwater levels rose to, or near to, the ground surface and that, based on available records at the time, this was likely to occur on an average return interval of approximately 25 to 30 years. The Fell paper included broad scale mapping of landslide-related zones within the study area. This mapping is overlain on the current subject site in Figure 4.

To the north of the drainage gully, beyond the proposed development area, is a rounded ridge spur that appears disturbed by previous earthworks and possibly by some ancient landslide activity. The lobe of the possible former landslide activity extends in a southeasterly direction, forming a broad spur that follows the eastern edge of the proposed development area, before crossing the southeastern third of the area, as shown by zone A2 on Figure 4.

These are the areas delineated in green on Figure 7. The findings of the investigation indicated a deep, disturbed profile and some subsurface water within the area defined as former landslide debris (A2) in Figure 4.
