## **Studies (Part 1)**

## **Aboriginal Cultural Heritage Assessment Report**

### **Proposed Rezoning and Sub-division for Residential Development 15 Malloway Road Chain Valley Bay Lot273 DP755266**

Report for  
Optima Developments Pty Ltd

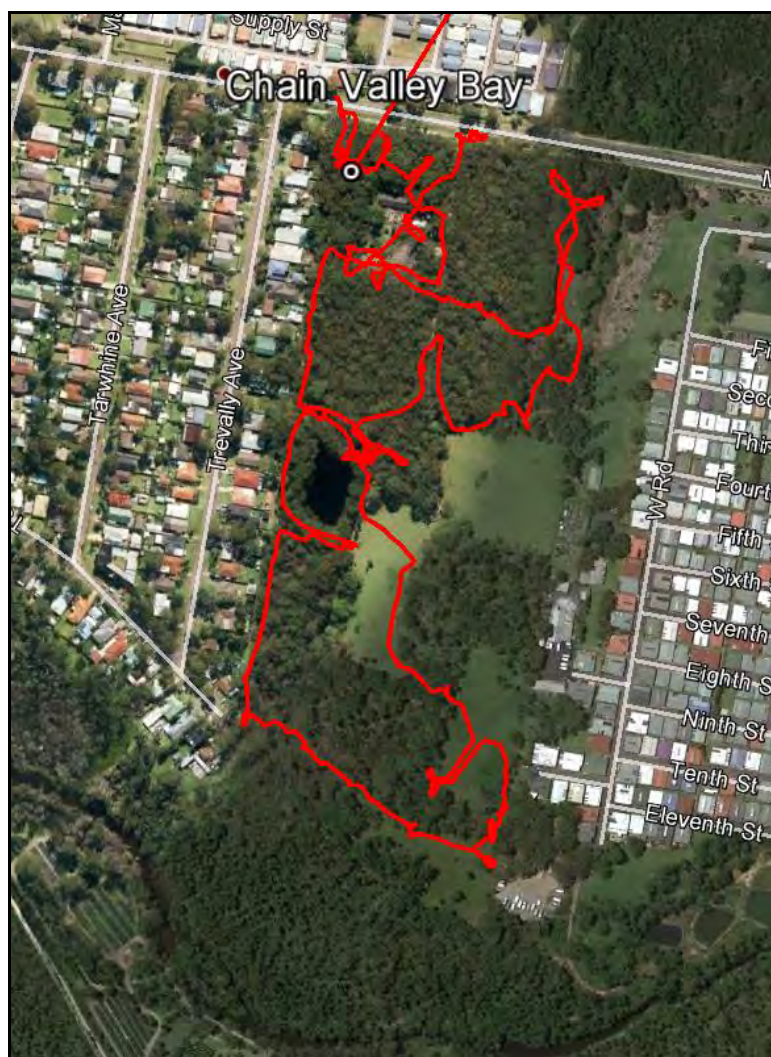
Ground surface visibility was average through most areas within the study area due to thick or long grass and/or leaf litter. Ground surface exposure in some areas was due to well-worn vehicle tracks throughout the property and disturbed ground surface around the edge of the dam.

Figure 5: Path traversed during the site assessment indicated by red line.

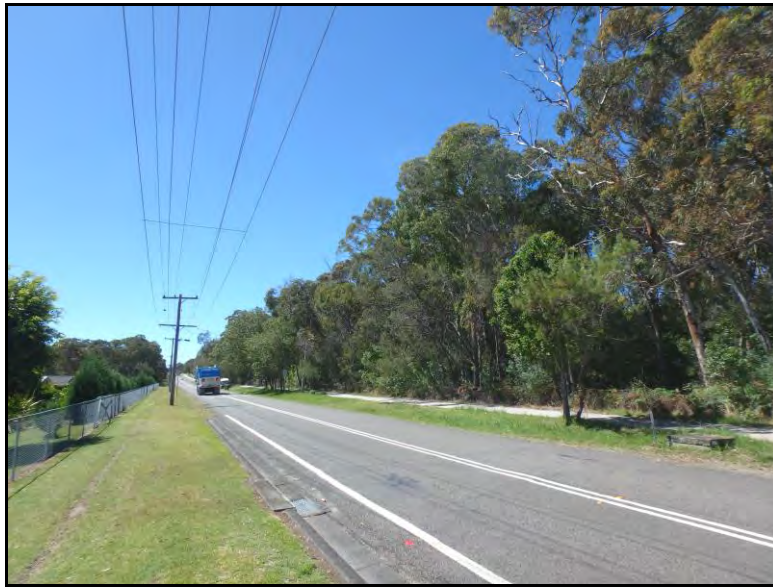
Figure 6: Mulloway Road, Chain Valley Bay. The assessment site (15 Mulloway Road) can be seen on the south side of Mulloway Road (right). View south east.

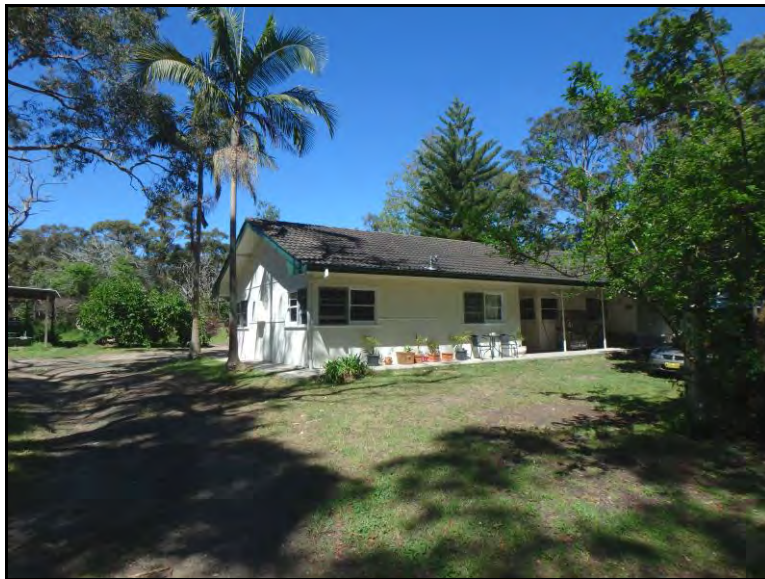
Figure 7: Residential dwelling and associated vehicle access (driveway) at the front (north end) of the property. View south west.

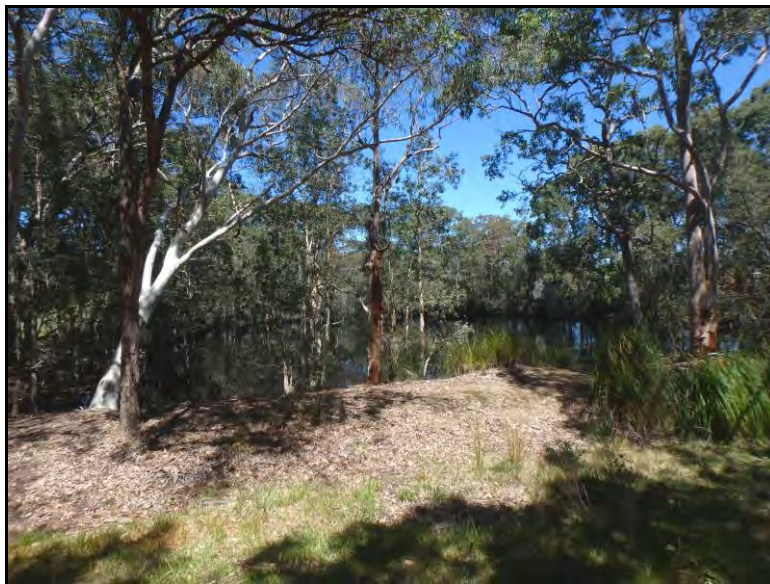
Figure 11: The dam located on the western edge of the mid-section of the property. View south west.

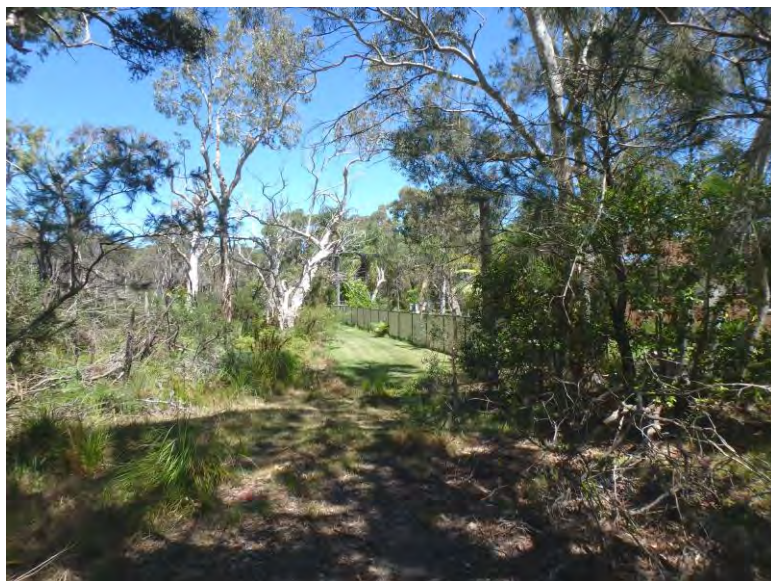
Figure 14: Neighbouring residential development on the property's western boundary. View south.

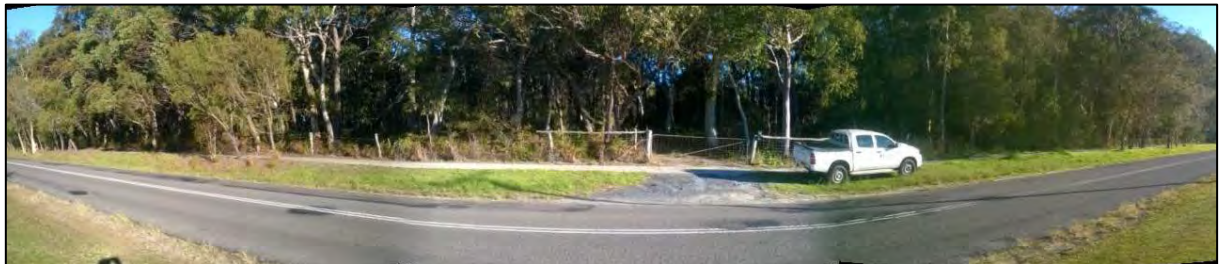
**Figure 8 – Photograph from Mullet Road showing bushland vegetation with single driveway access into site – looking south.**
