Urbis Pty Ltd  
Doyalson Wyee RSL Structure Plan  
Preliminary site investigation - FINAL REPORT

May 2018

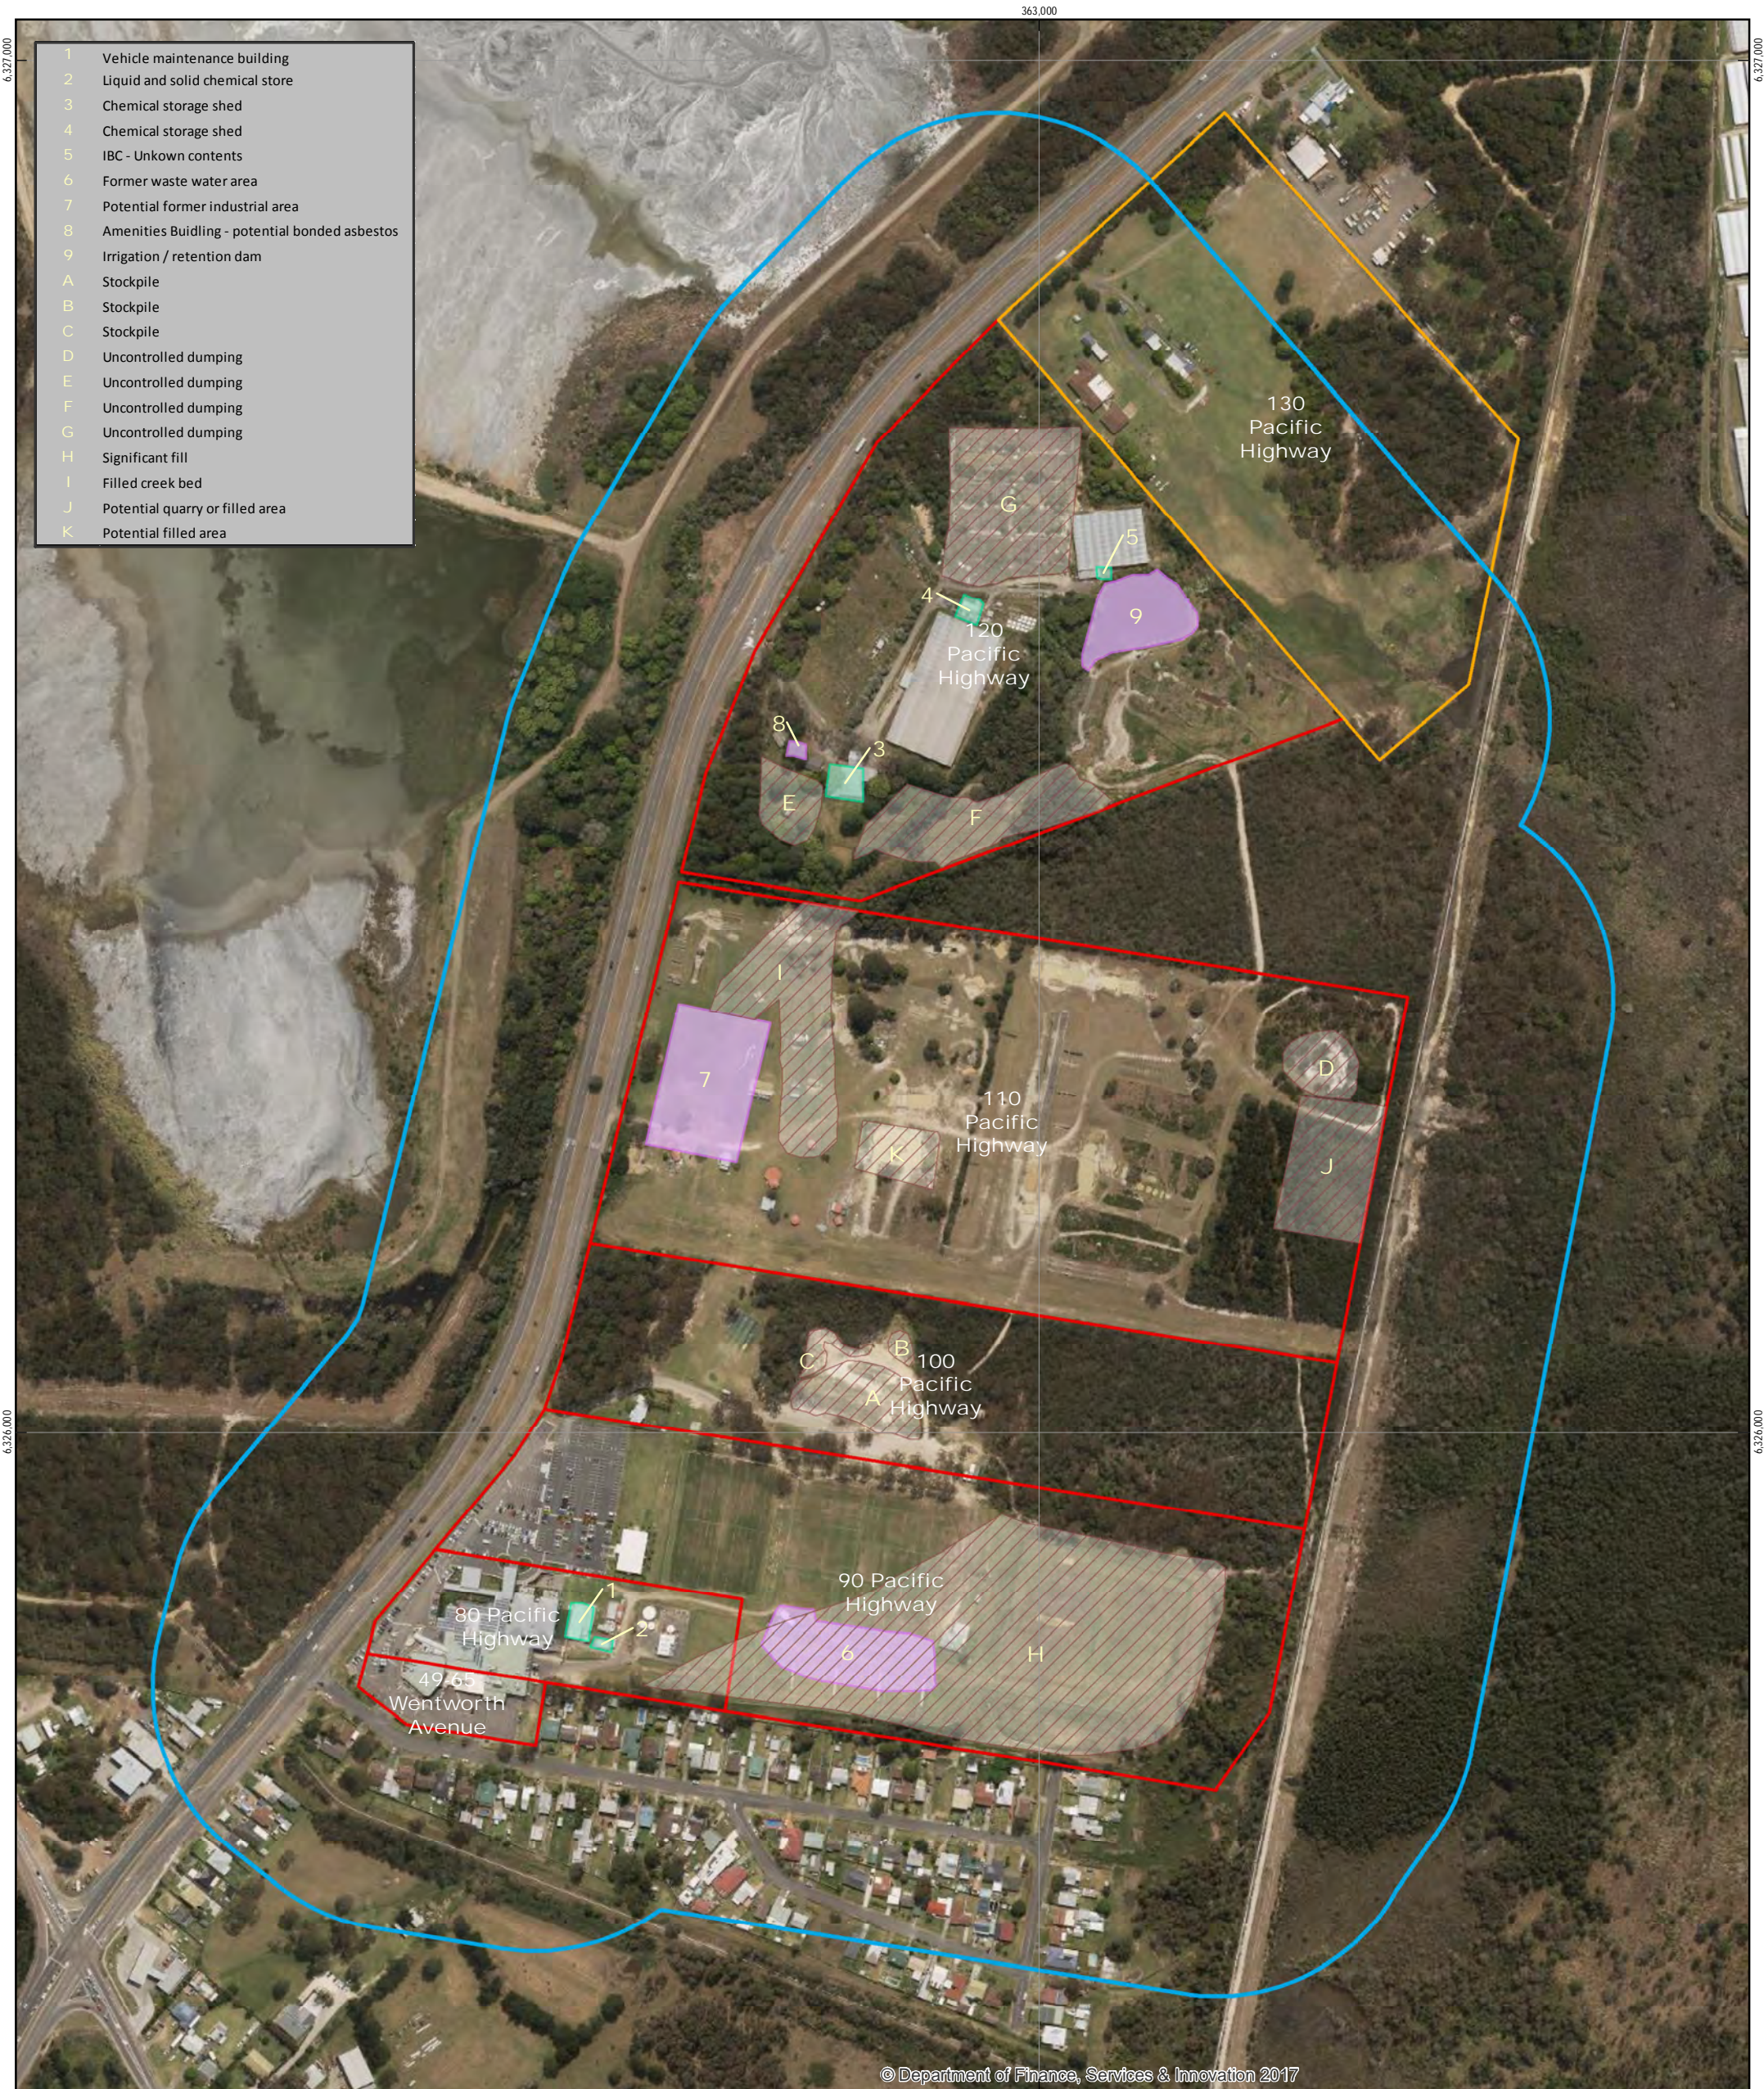
**Figure 2 – Potential site constraints**

A number of stockpiles were identified during the site inspection. The location of these is indicated in Figure 2 in **Appendix A** and photographs provided in **Appendix D**. A description of the stockpile content is summarised in **Table 18**.

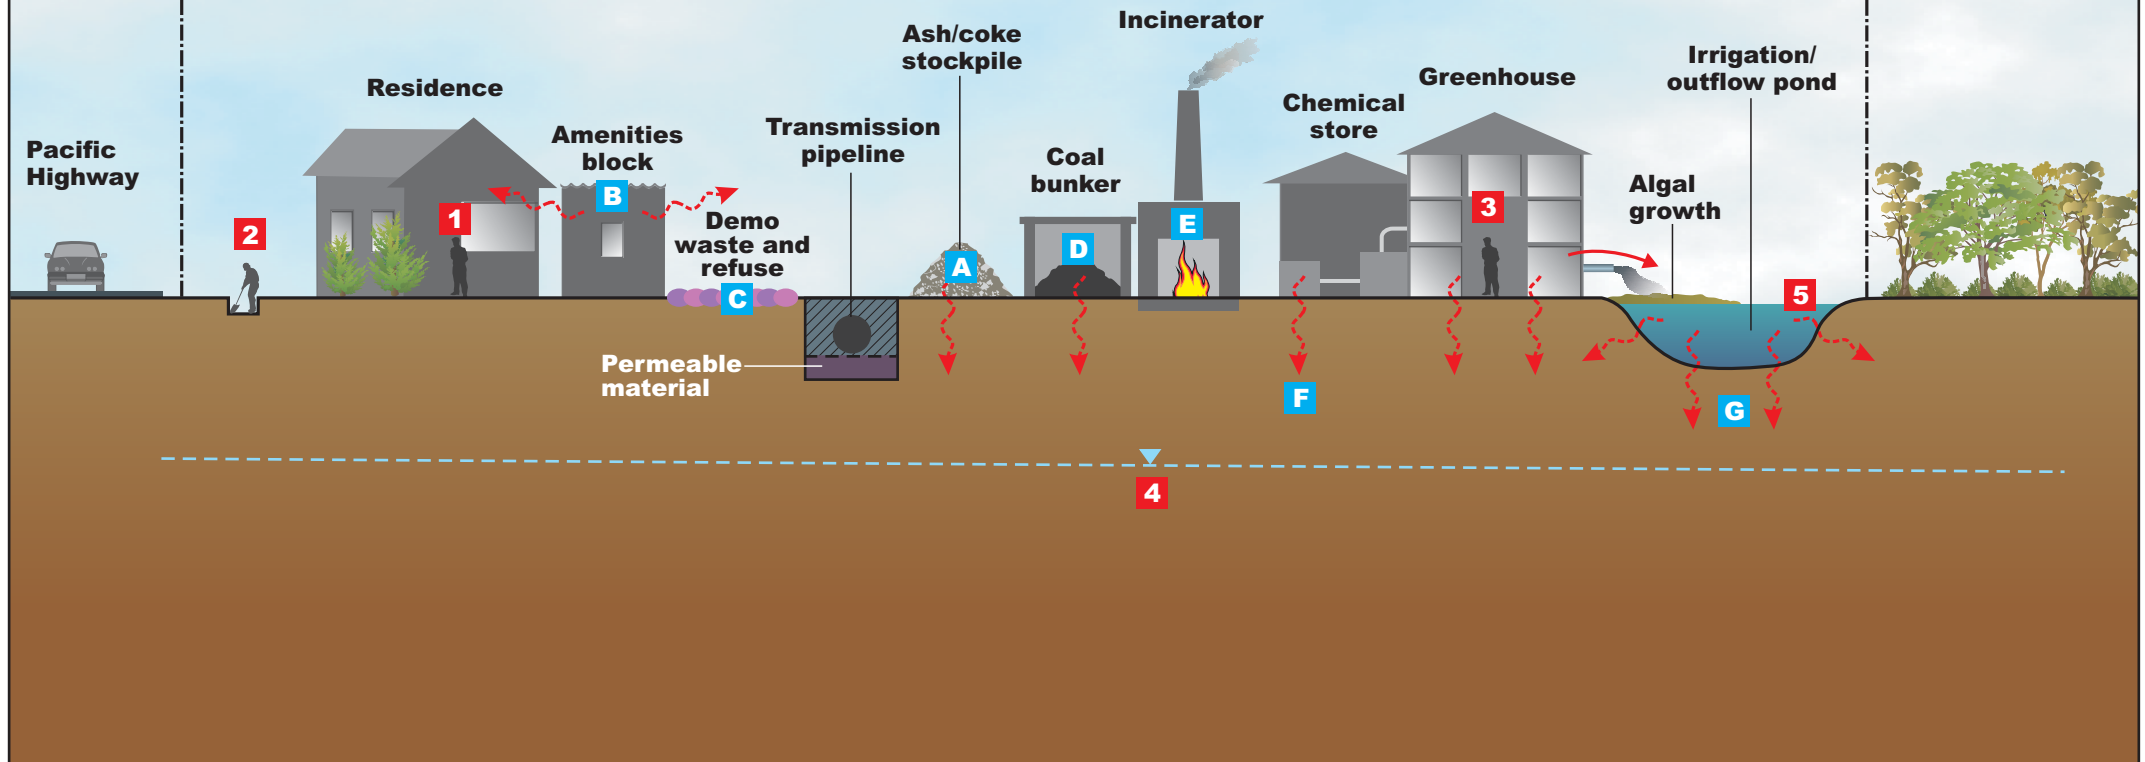
- A** Ash/coke stockpile
- B** Asbestos building materials
- C** Unknown demolition waste and refuse
- D** Coal
- E** Ash from incinerator
- F** Chemicals/nutrients and leaking pipework
- G** Leaching nutrients from surface water bodies
