REPORT TO
THE DEPARTMENT OF PLANNING, INDUSTRY AND
ENVIRONMENT – DEVELOPMENT AND TRANSACTIONS

ON
GEOTECHNICAL ASSESSMENT

AT
FORMER MANLY HOSPITAL, 150 DARLEY STREET,
MANLY, NSW

Date: 9 September 2020
Ref: 31233YJrpt3

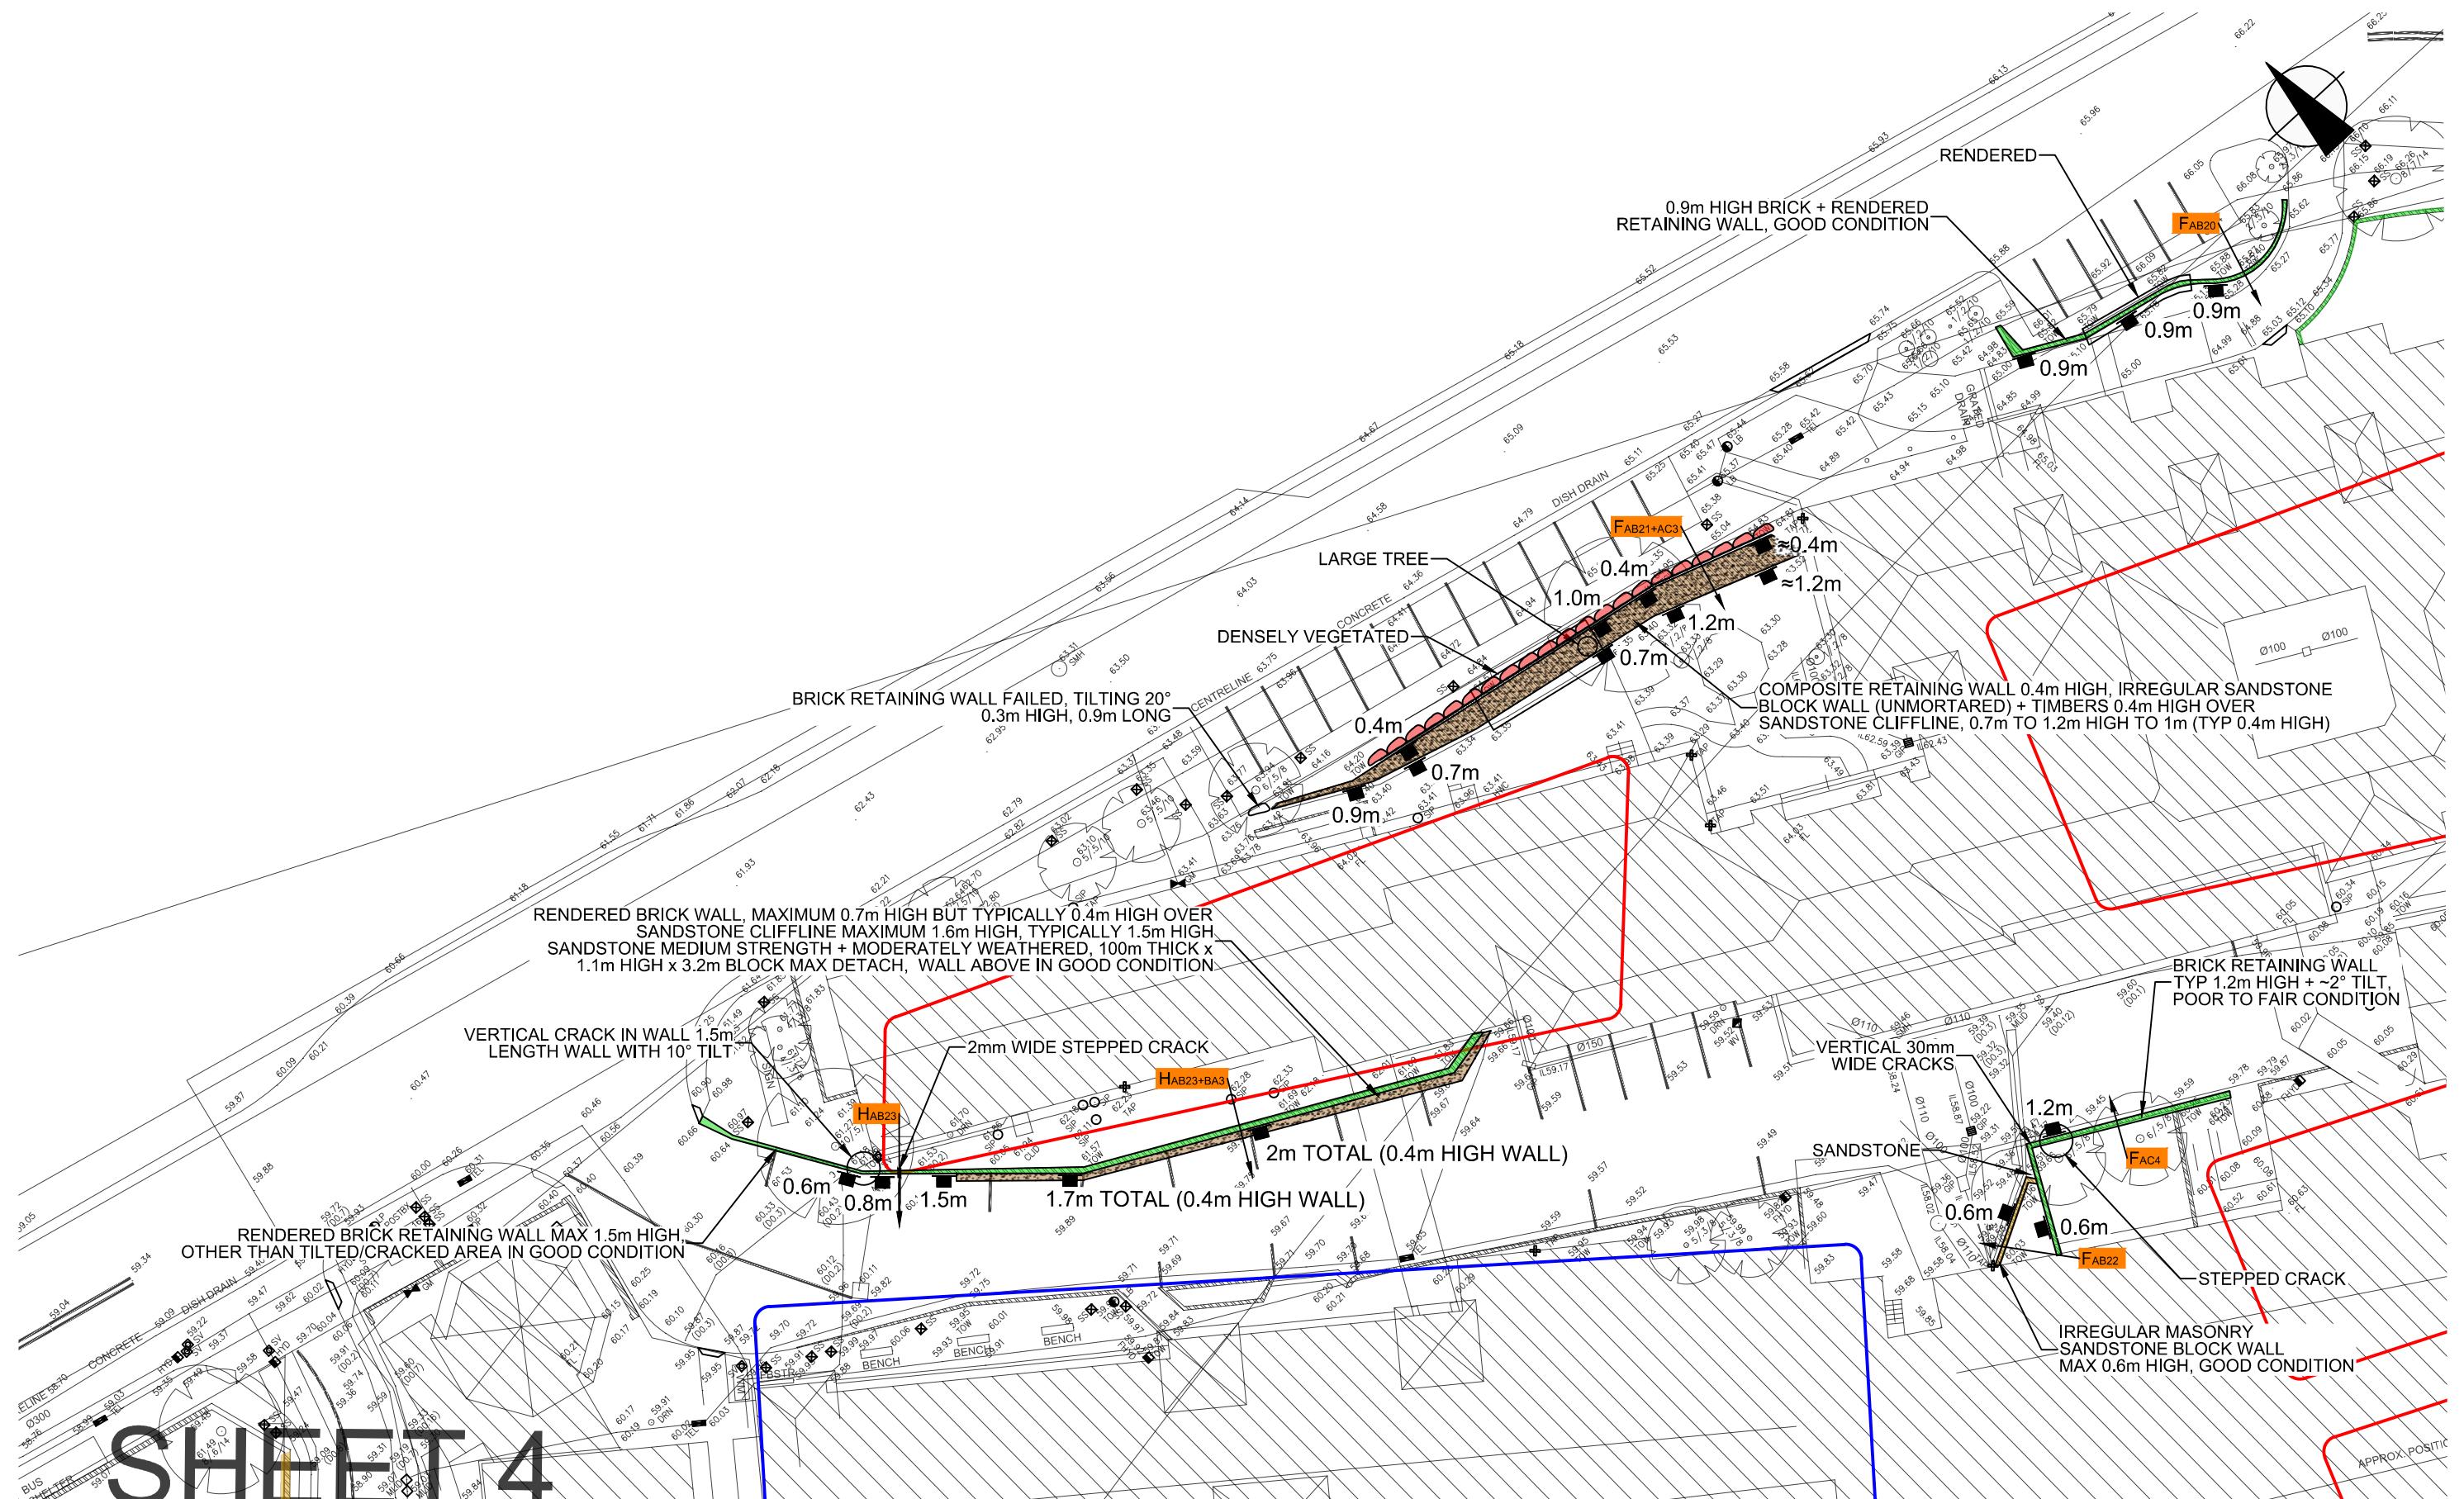
Figure 4a: Geotechnical Hazard Plan (1 of 6)

- Brick retaining wall, 1.2m high with 30mm wide vertical cracking and approximately 2° tilt at north-western end, as shown on Figure 4a and Plate 1 below.

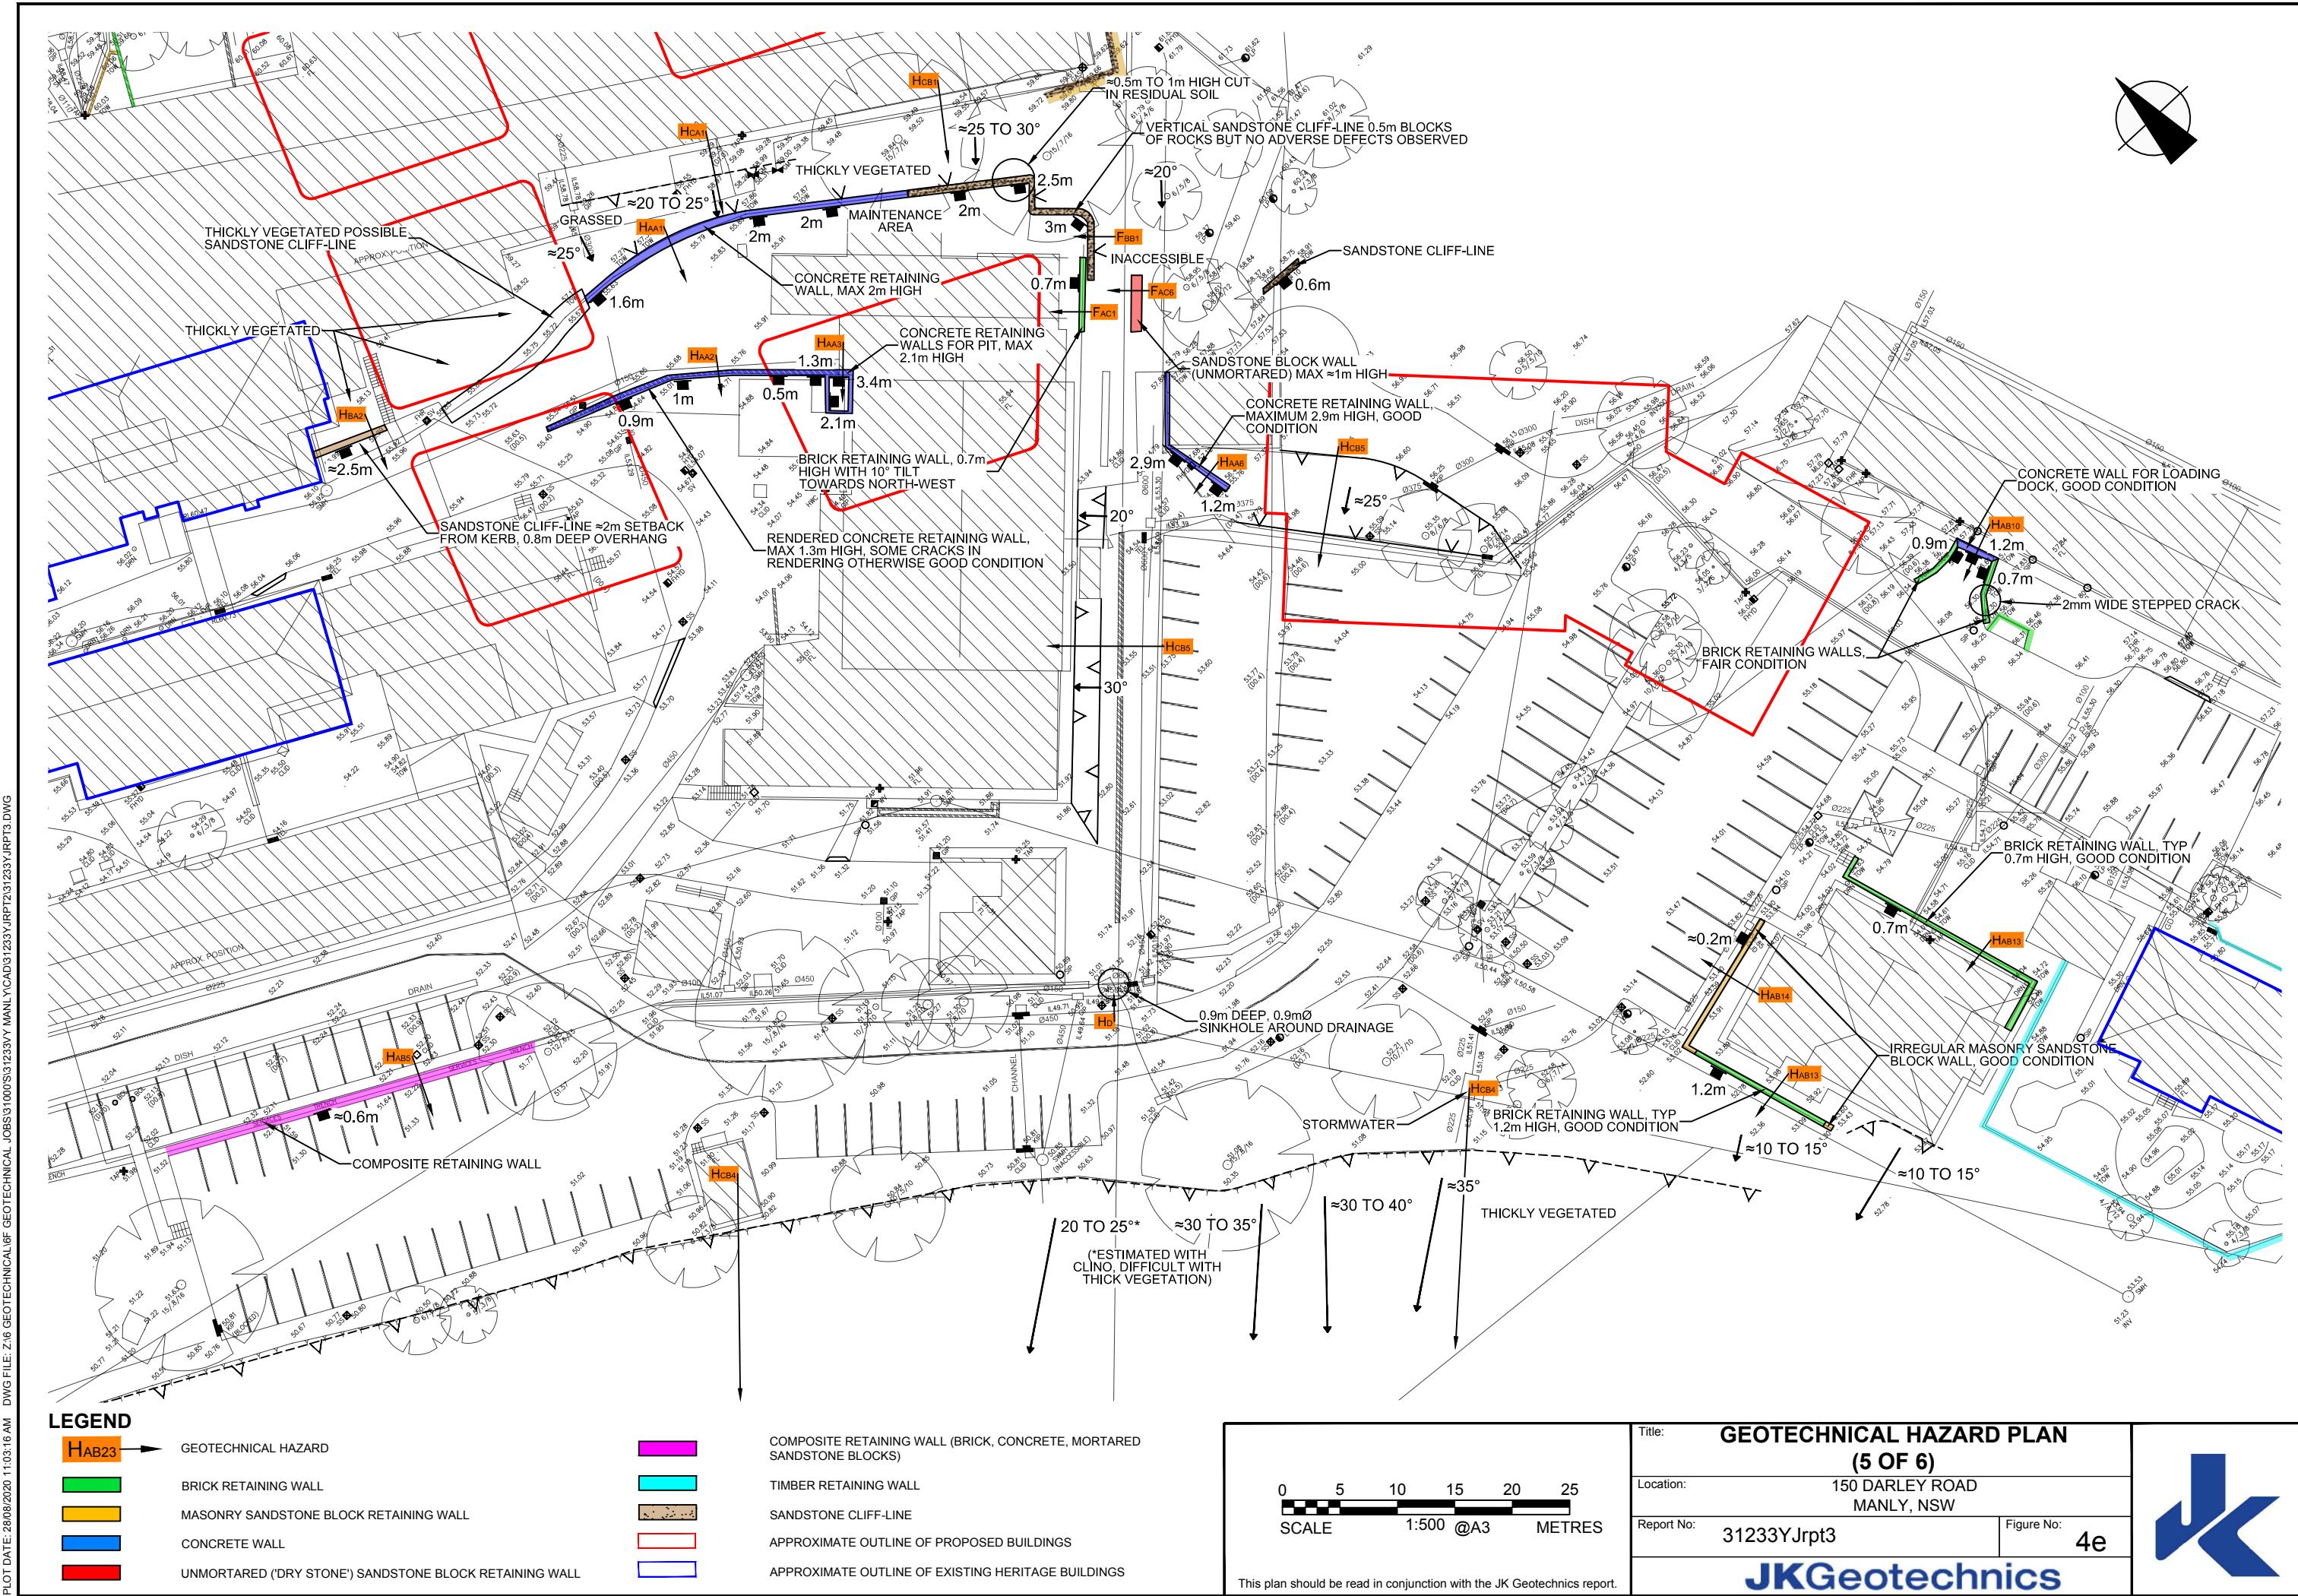
Figure 4e: Geotechnical Hazard Plan (5 of 6)

- Brick retaining wall, 0.7m high with 10° tilt over extents of wall (about 7m in length), as shown on Figure 4e and Plate 2 below.

A relatively small sink hole was observed around buried water services to the north of a car park area as shown on Figure 4e and Plate 3 below. The sink hole was about 0.9m diameter and about 0.9m deep.
