Proposed “Bunderra” Residential Subdivision
Boolaroo

Geotechnical Slope Risk Assessment

Report No. RGS01611.1-AB

10 August 2017

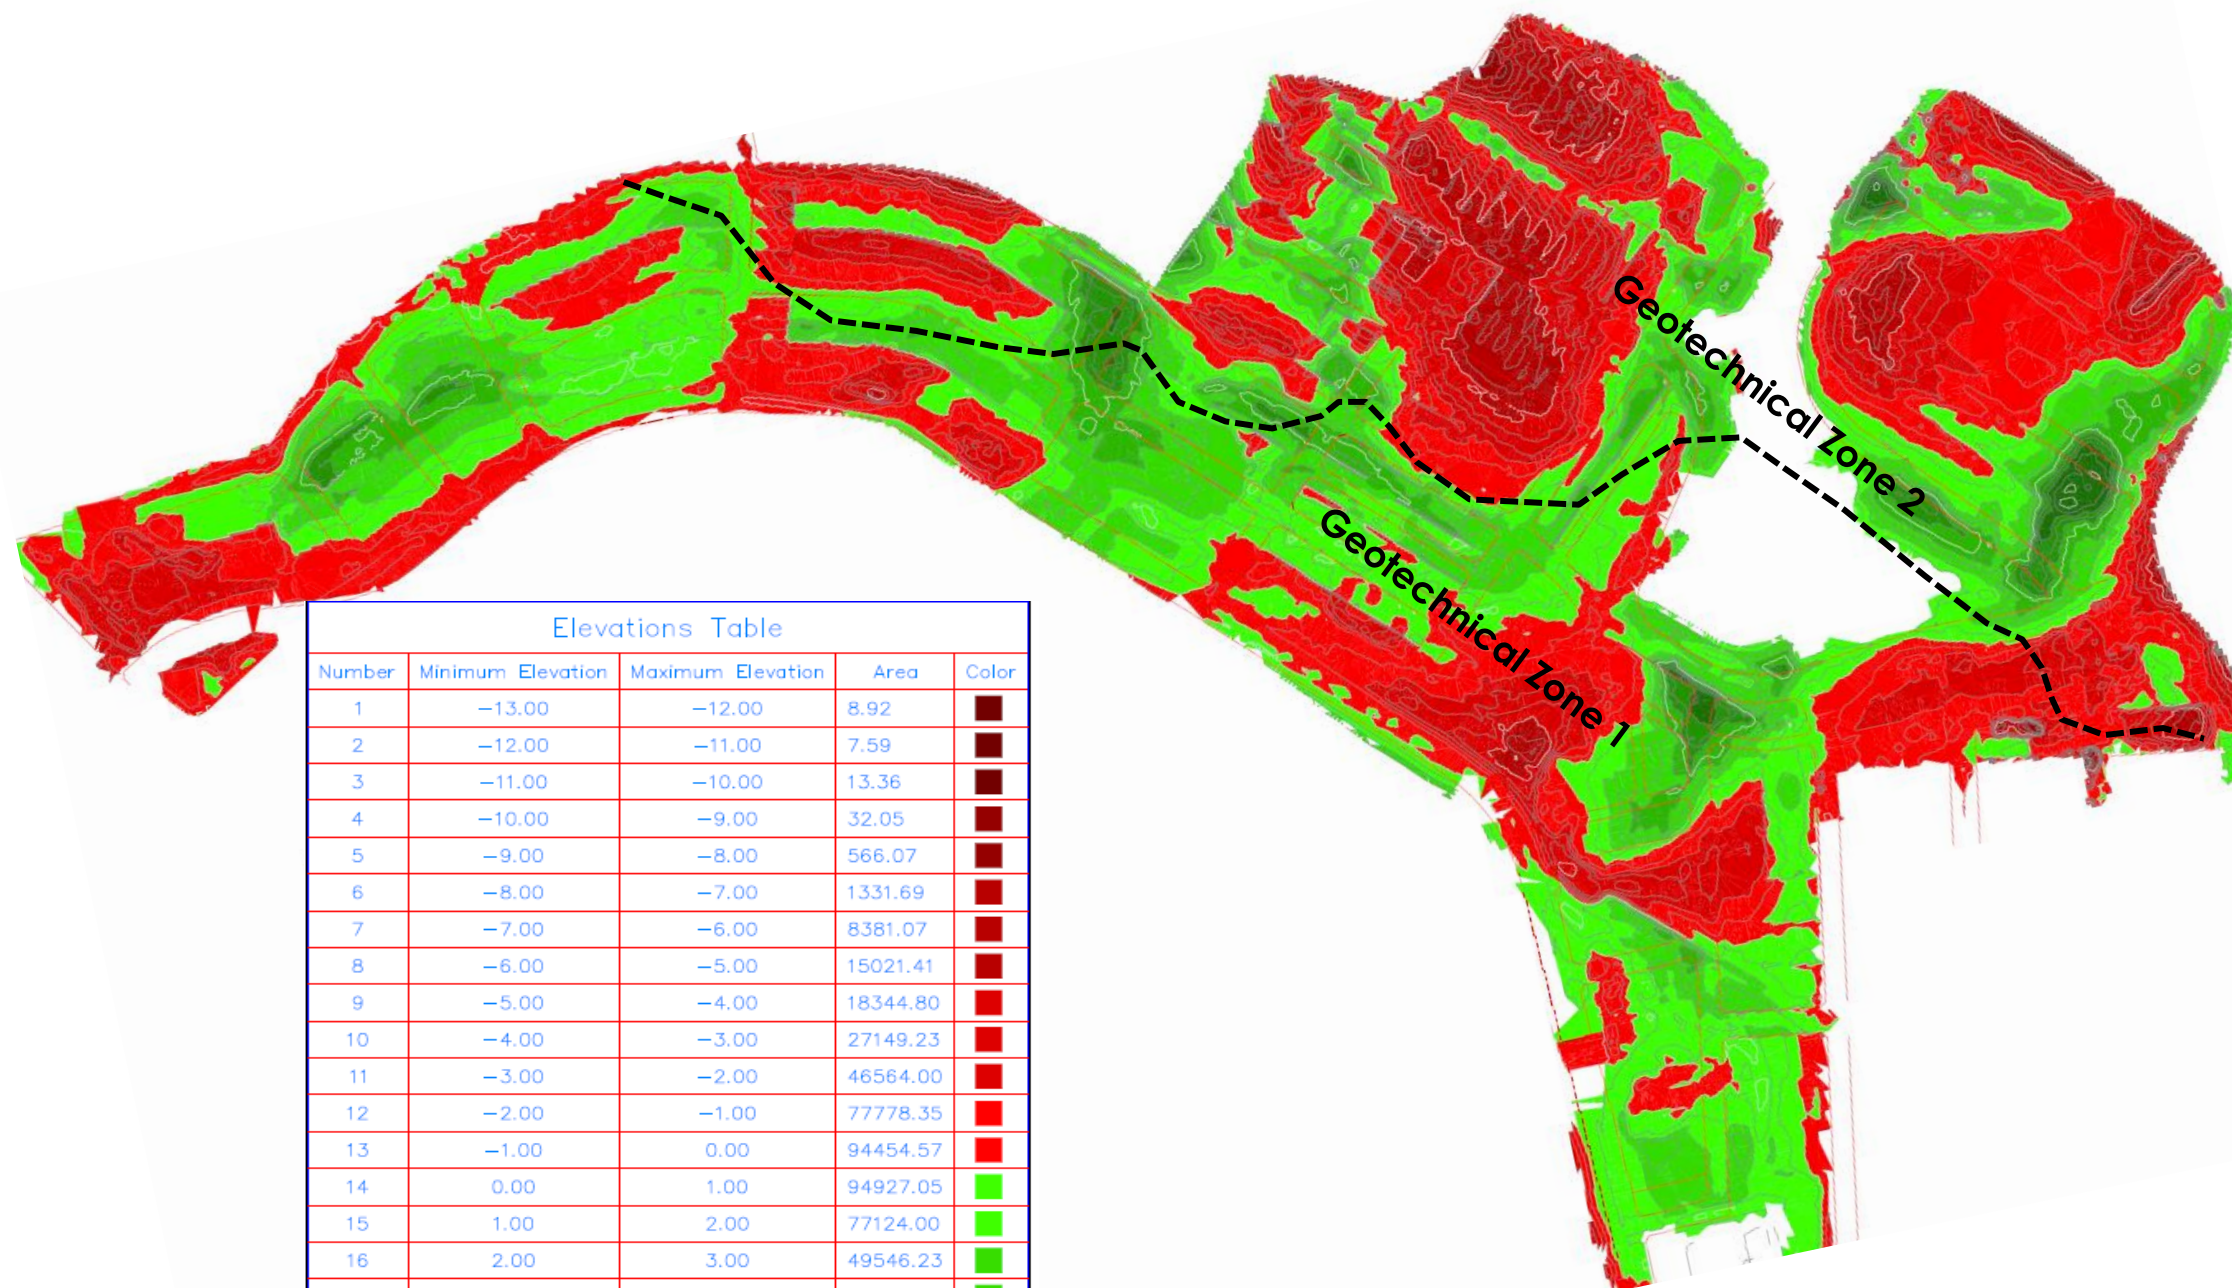
Client	HDB Town Planning and Design	Job No.	RGS01611.1
	Residential Subdivision Geotechnical Assessment	Drawn By:	SRM
	"Bunderra" site, Main Road Boolaroo	Date:	11-Aug-17
	Geotechnical Zones and Areas with Evidence of Slope Instability	Drawing No.	Figure 2

In the Zone 2 terrain, evidence of slope instability was observed in two areas, as shown on Figure 2. At the eastern site boundary, an area of apparent former large scale instability is evidenced by the separation and disturbance of conglomerate blocks over thinly bedded disturbed siltstone and claystone. This area is visible on aerial images and appears to be a large scale lateral movement of the crest and upper slopes of a ridge spur, towards the west. Laterally oriented drainage courses
