Report on
Preliminary Site Investigation

Proposed Appin (Part) Precinct
Appin, NSW

Prepared for
Walker Corporation Pty Ltd

Project 76589.06
October 2022

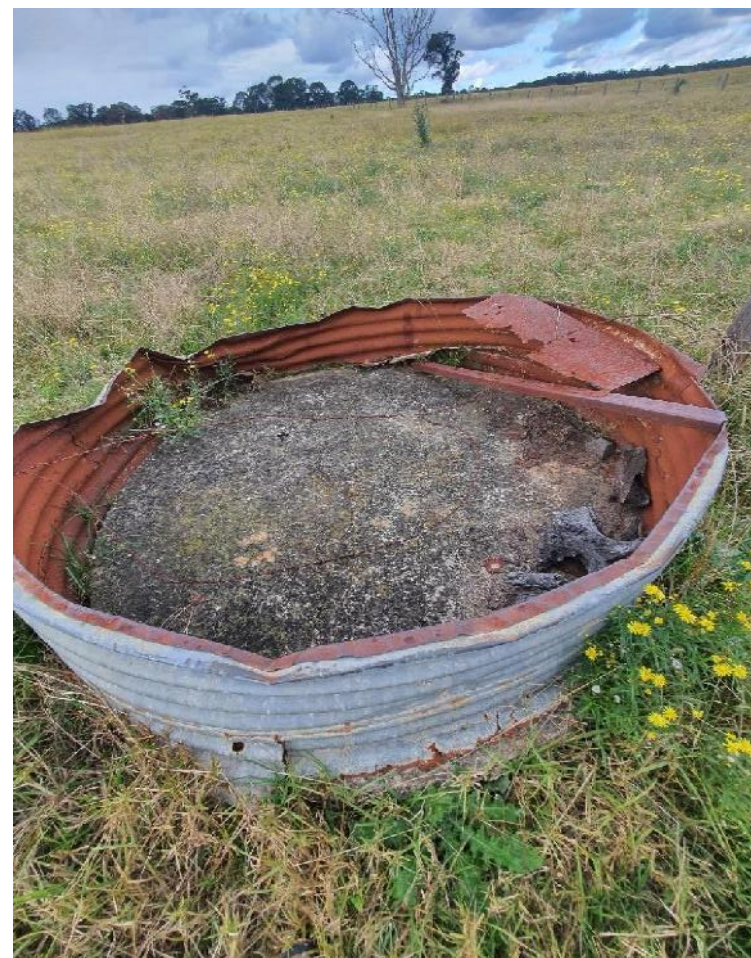
Photo 6 - Water Trough (No Sign of Buried Pipe) (MRP6)

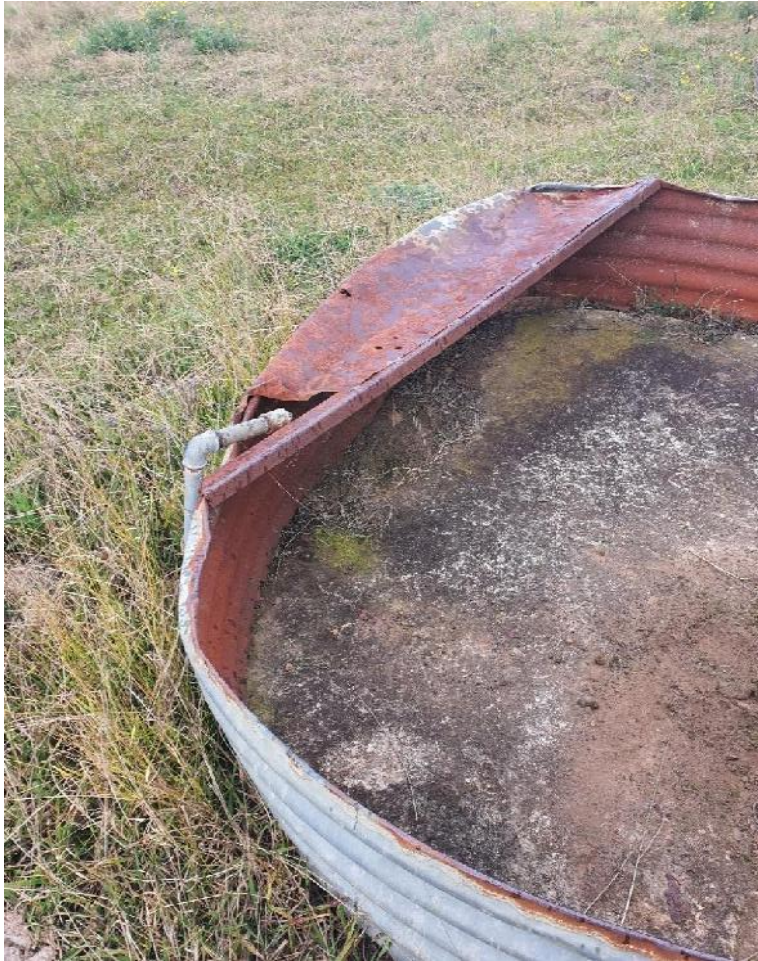
Photo 7 - Trough with Steel Pipe Inlet Riser (MRP7)

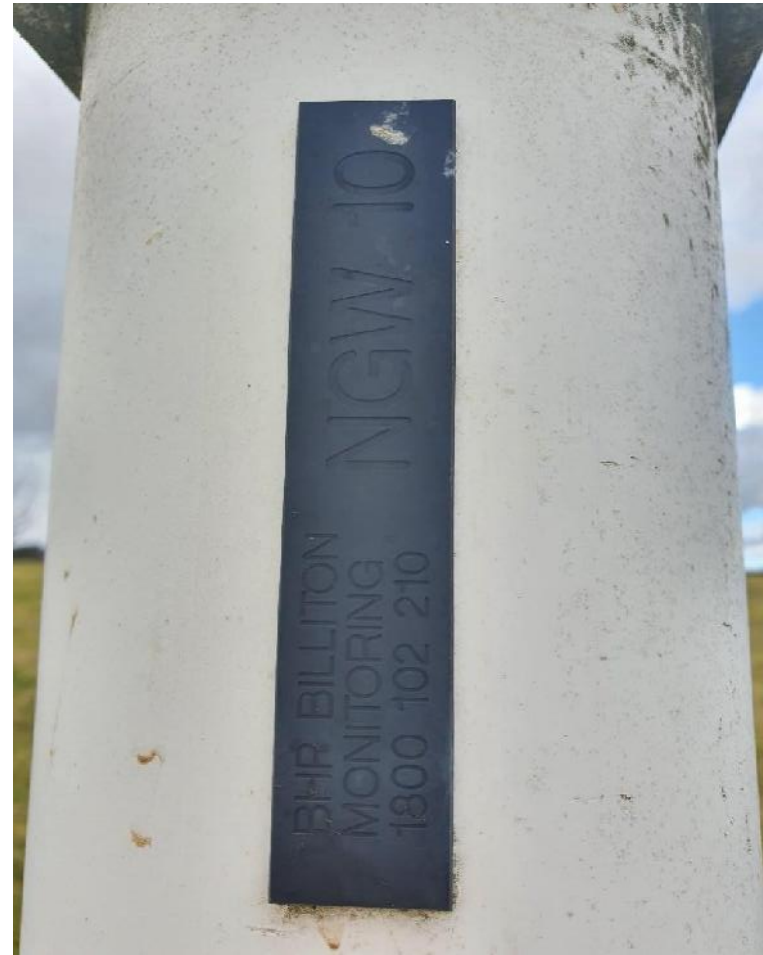
- Three monitoring bores belonging to BHP Billiton or South32 were observed on this portion of the site (MRP 8; plates 8 and 9, MRP28; plate 33 and MRP 53; plate 60).

Photo 8 - BHP Monitoring Bore (MRP8)

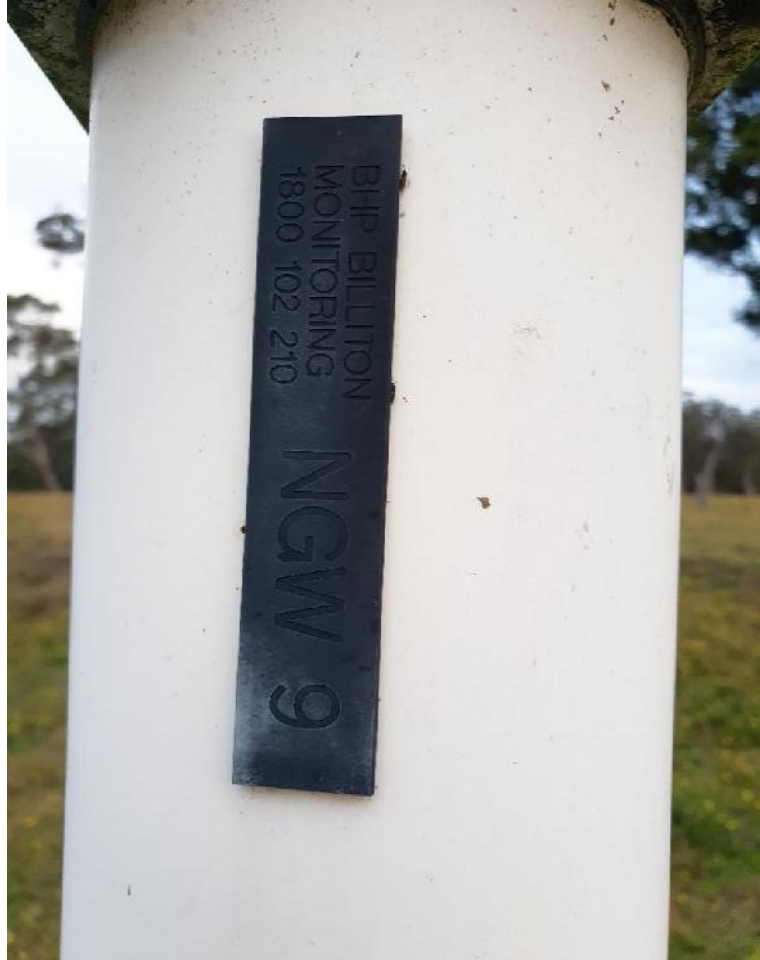
Photo 11 - BHP Monitoring Bore (MRP10)

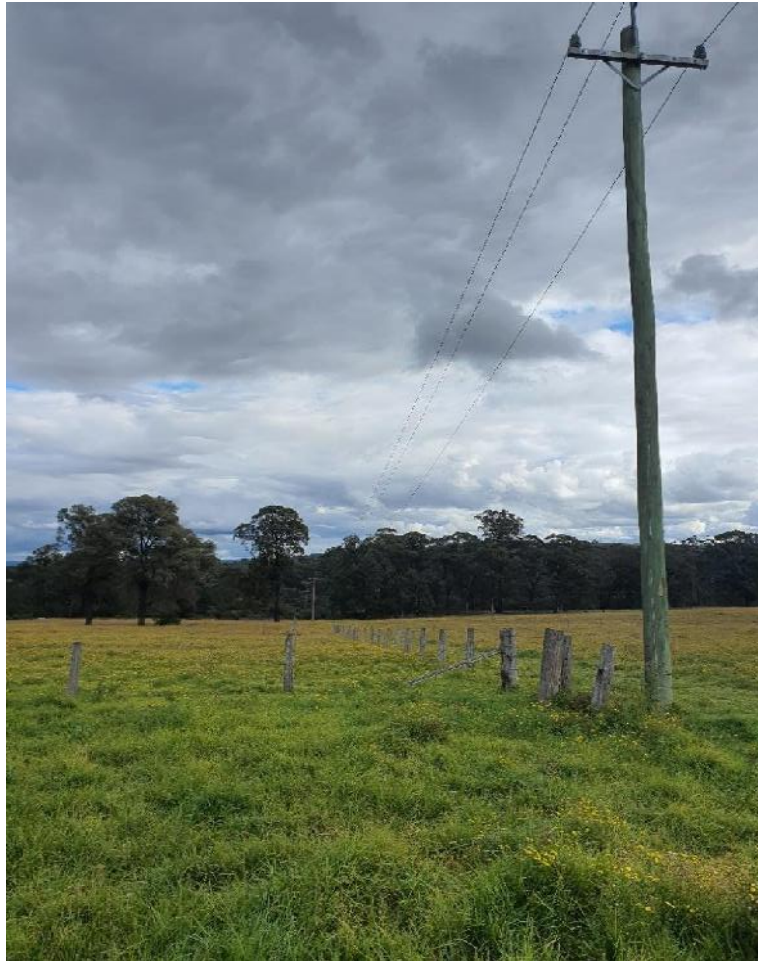
Photo 15 - Power Poles (MRP13)

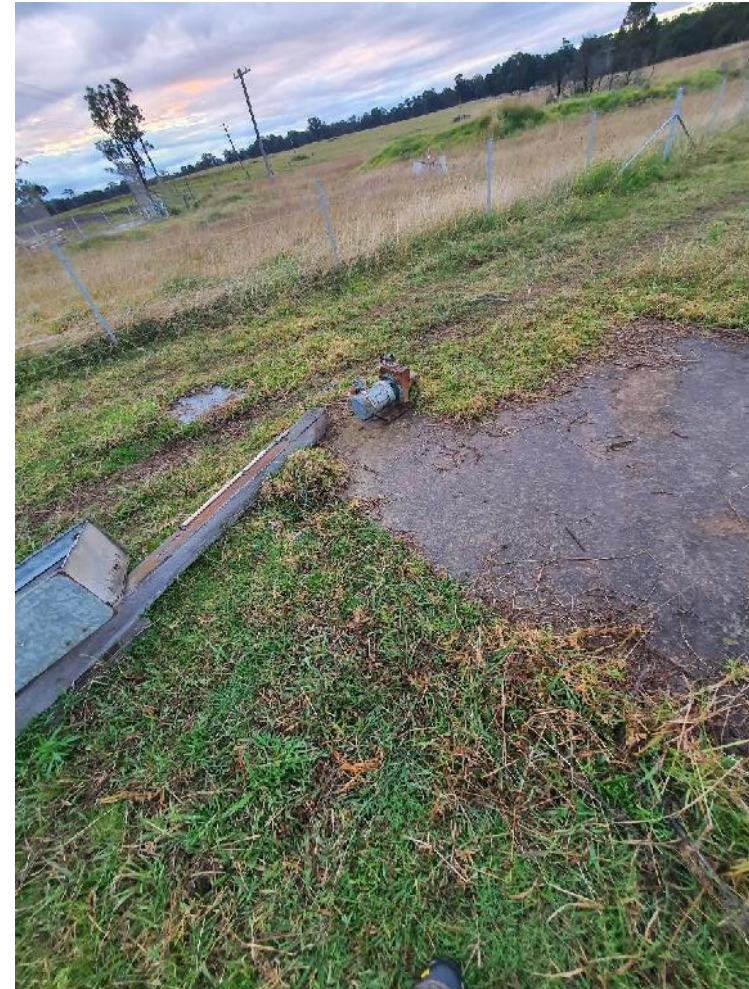
Photo 22 - Slab Pump and Meter Box (MRP18)

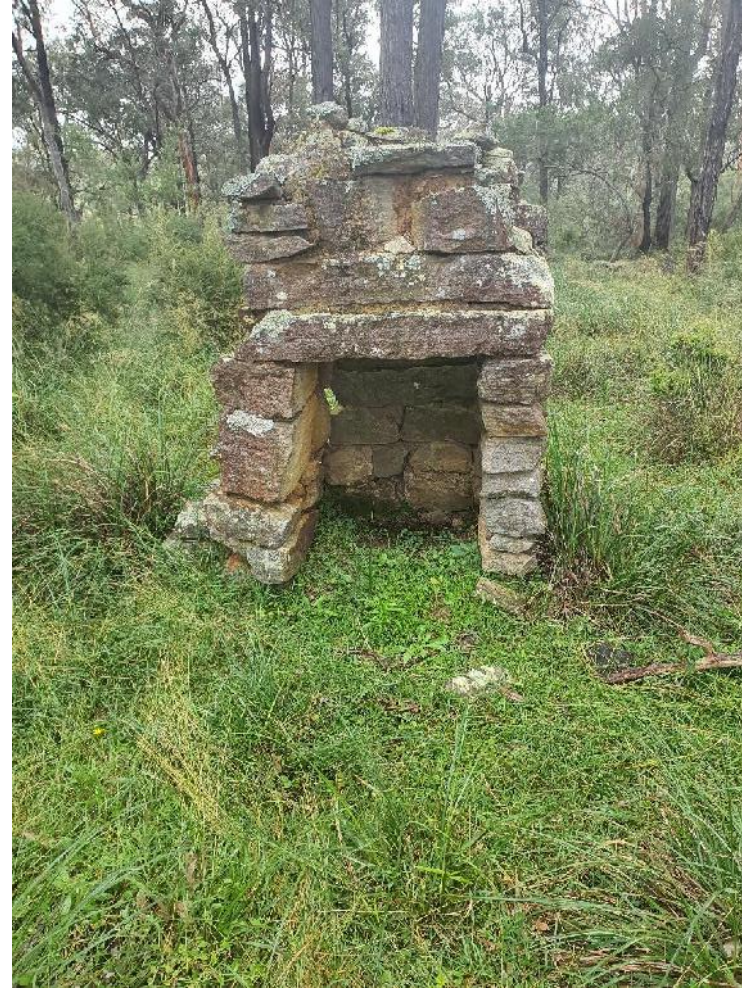
Photo 24 - Sandstone Chimney (MRP21)

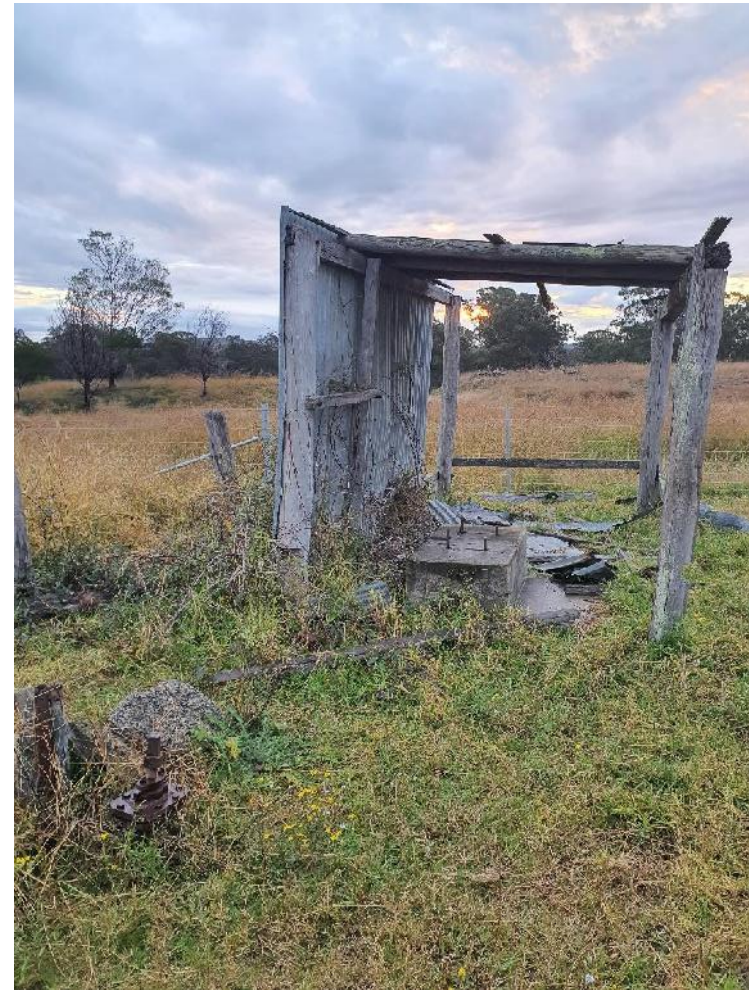
Photo 26 - Structure (Possible Pump House) (MRP23)

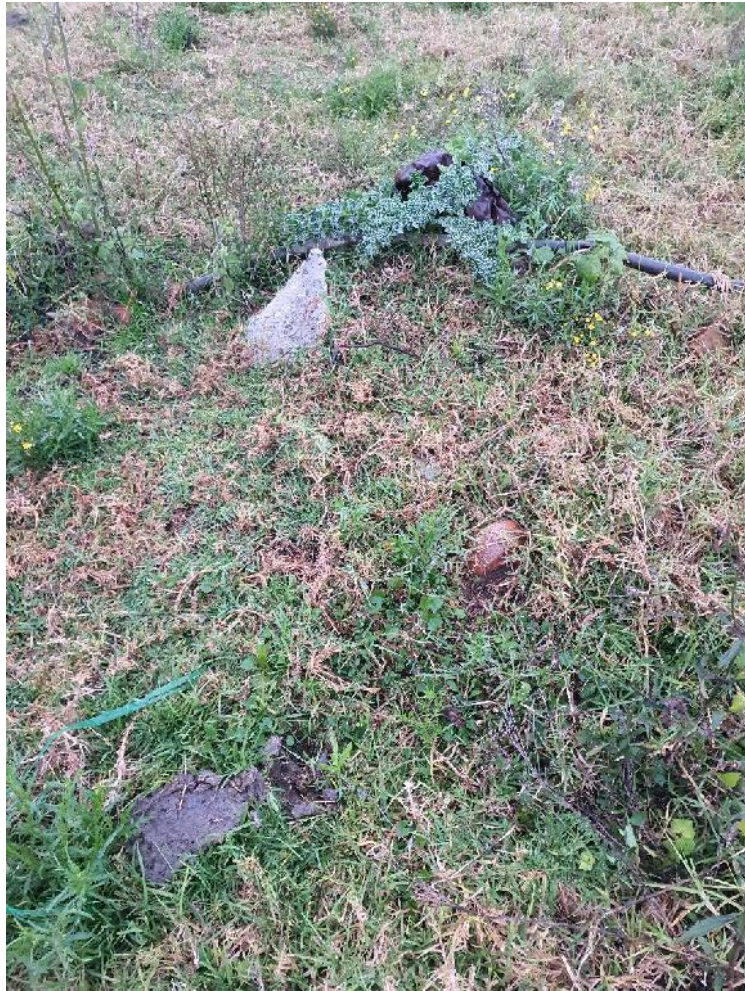
Photo 27 - Building Rubble (MRP24)

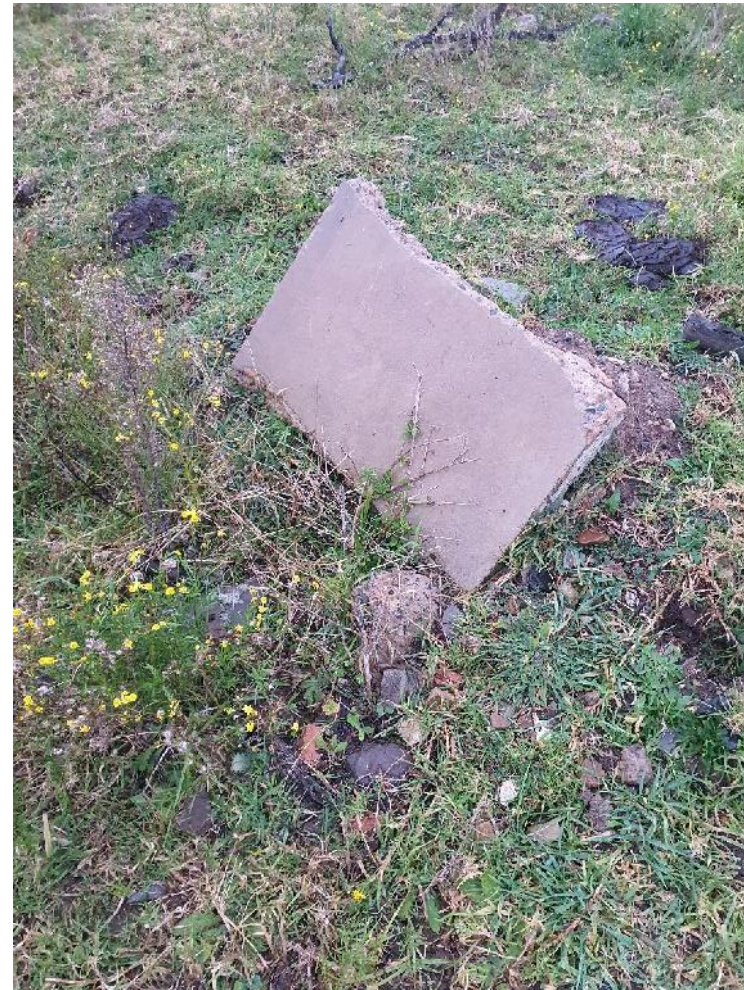
Photo 28 - Building Rubble (MRP24)

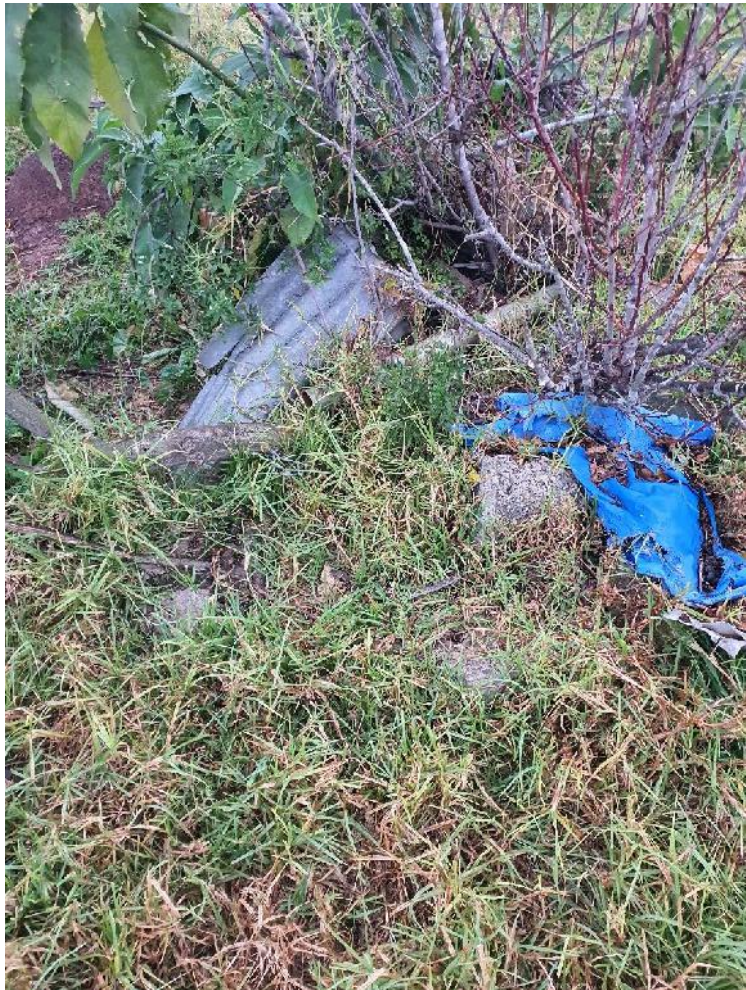
Photo 29 - Building Rubble (MRP24)

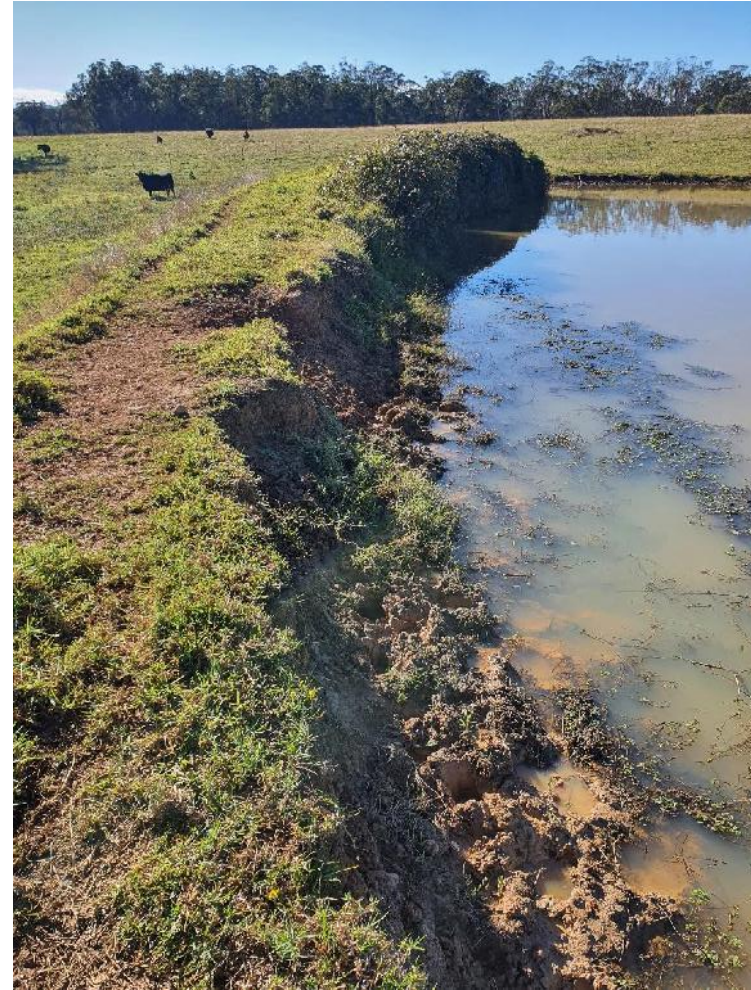
Photo 30 - Dam Wall (MRP25)

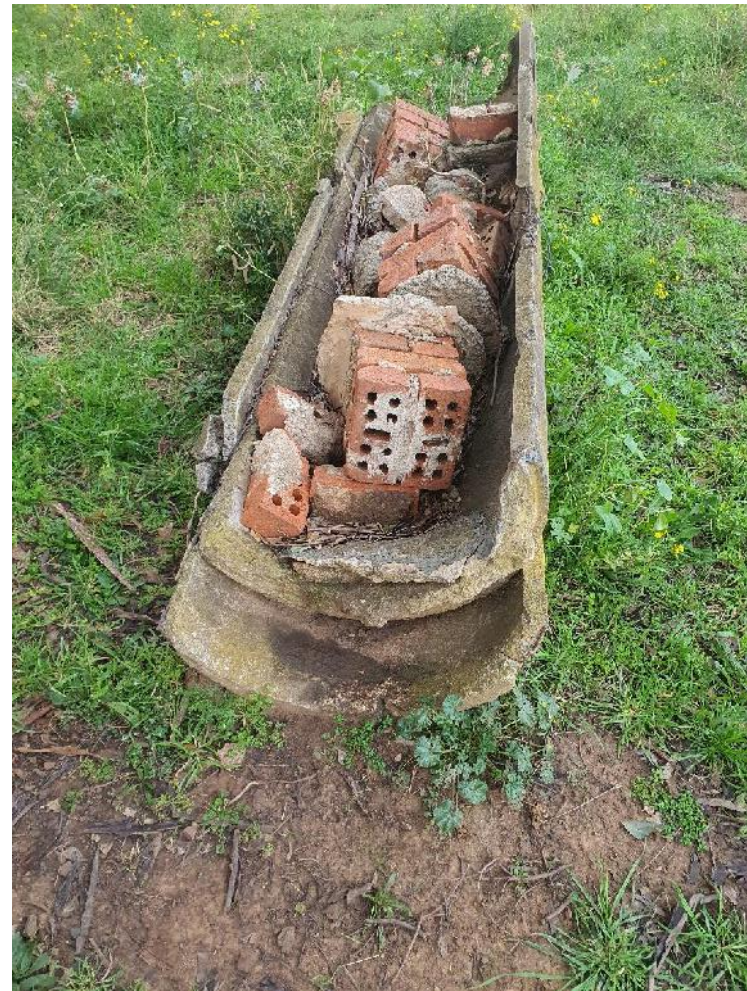
Photo 34 - Pipe and Brick (MRP29)

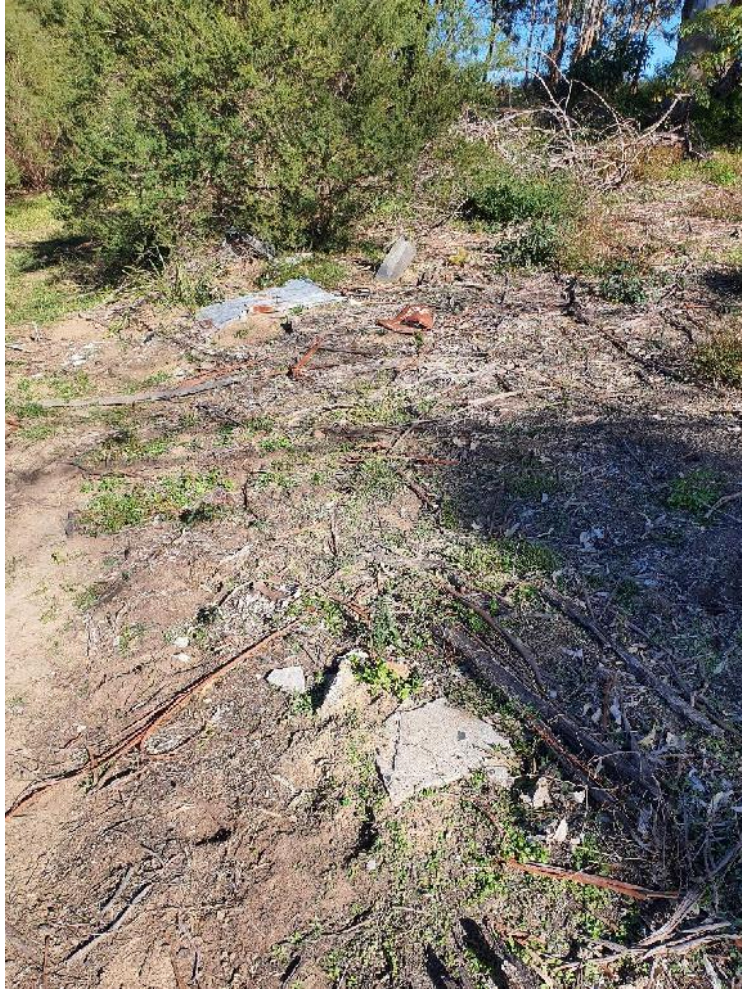
Photo 39 - Minor Building Rubble (MRP33)

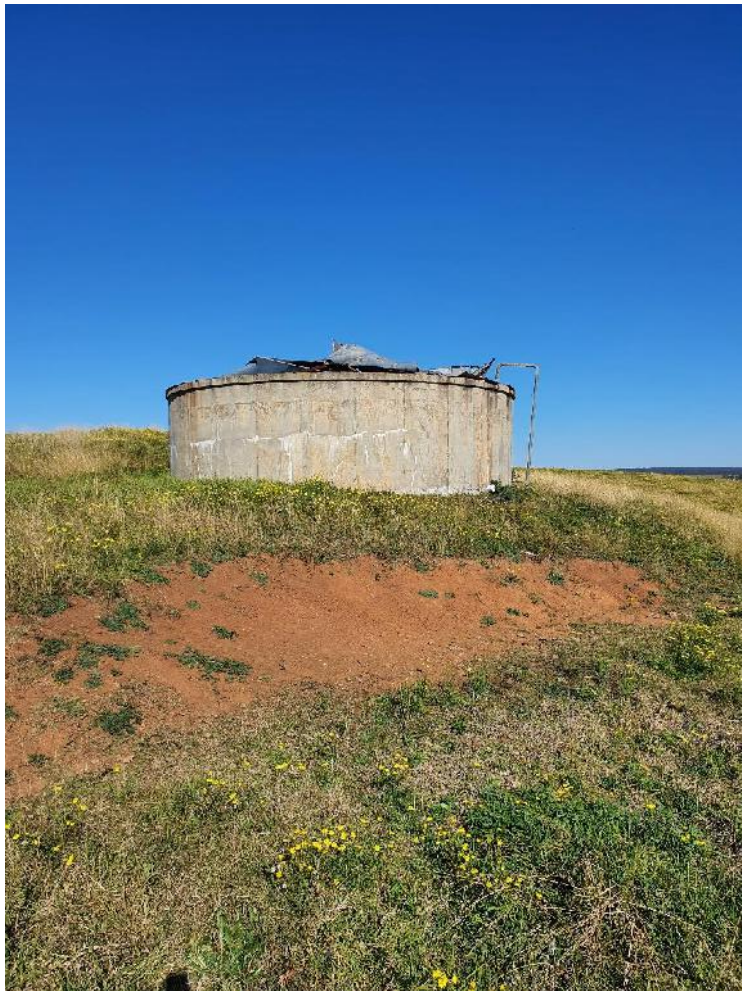
Photo 43 - Water Tank (MRP36)

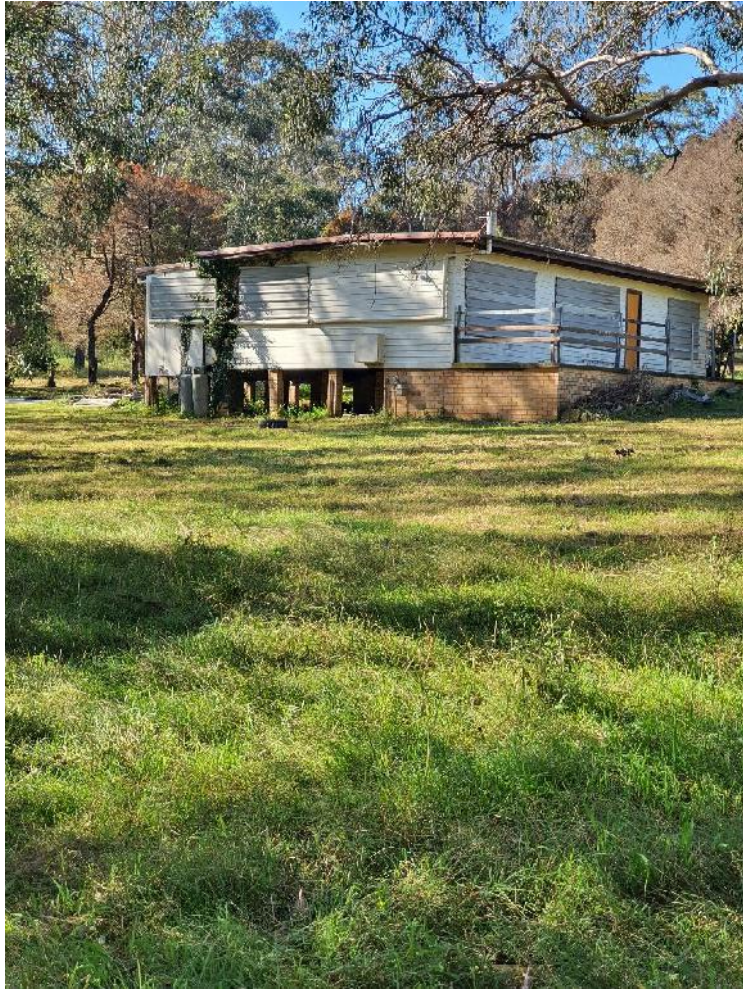
- There were several houses in this area, some of which were derelict (MRP 38; plate 45) and many of which were of the age which would indicate that hazardous building materials may be present.

Photo 45 - Derelict House (MRP38)

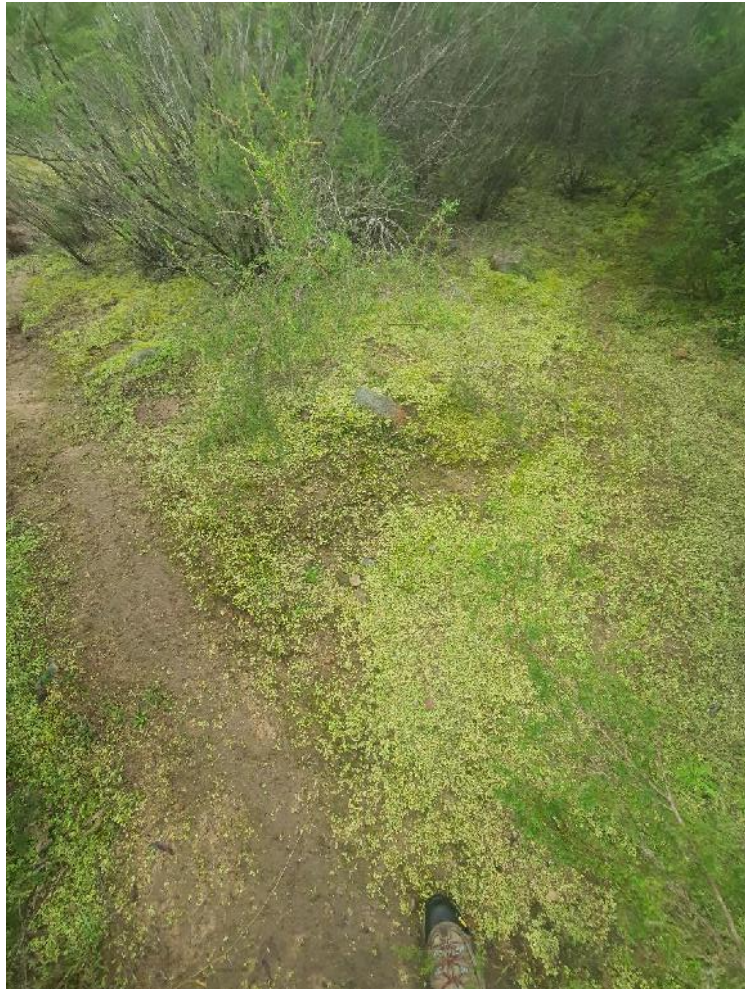
Photo 53 - Filled Ground (MRP46)

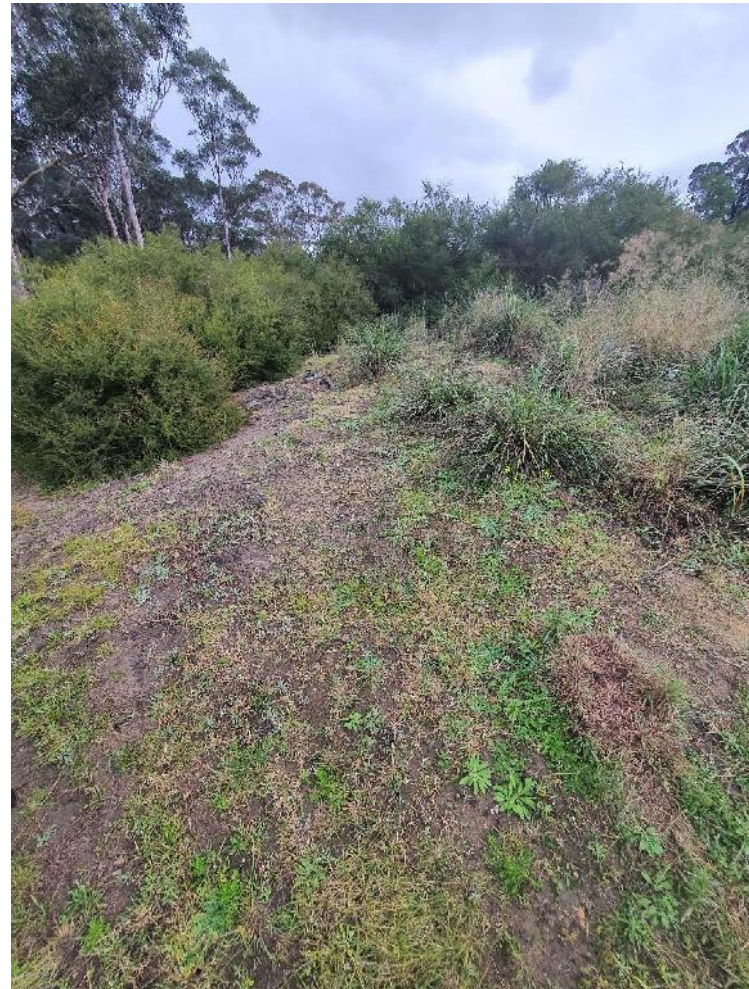
Photo 54 - Filled Ground (MRP47)

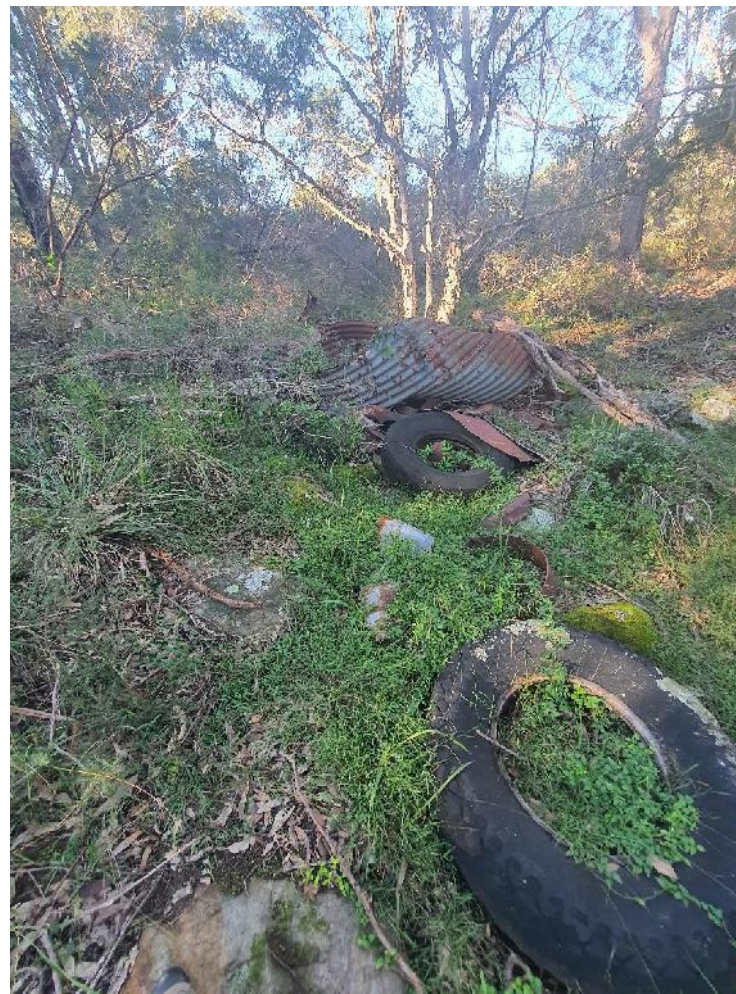
- Localised dumping was observed in some gullies and areas of the site which had not been secured, such as along the western portion near the Nepean River (MRP 5; plate 5, MRP12; plates 13 and 14, MRP 15 and 6; plates 17 to 21, MRP 45; plate 52) and to the rear (southern end) of lots on the eastern side of Macquariedale Road (MRP 51; plate 58, MRP 54; plates 61 and 62, MRP 56; plate 64).

Photo 58 - Dumped Refuse Minor Gully (MRP51)

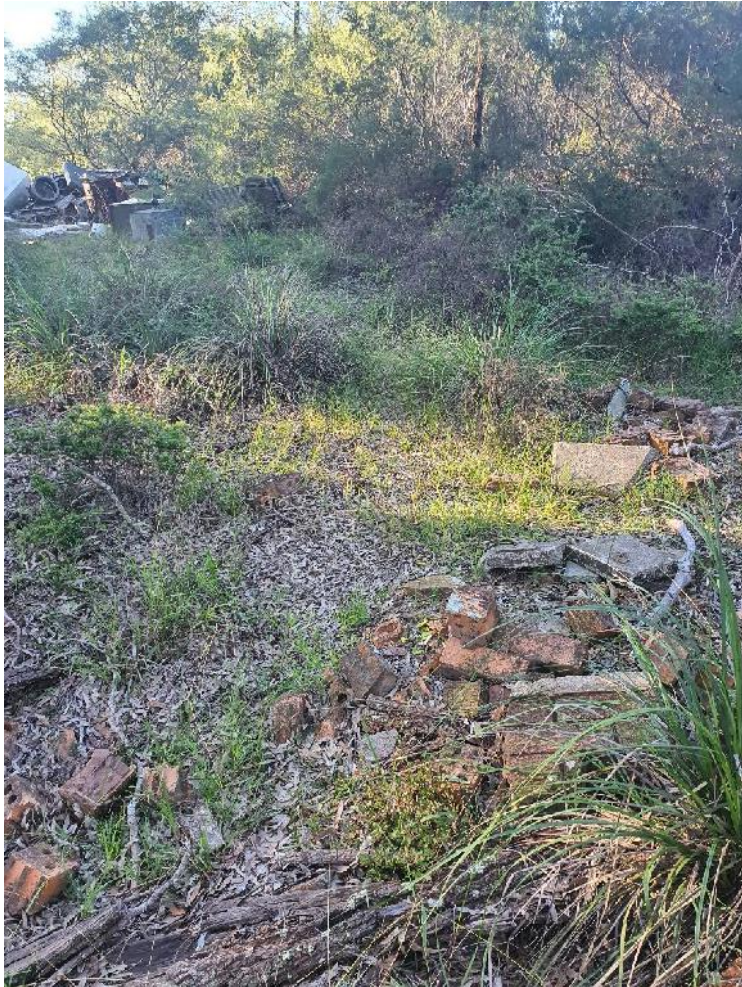
Photo 61 - Dumped Refuse (MRP54)

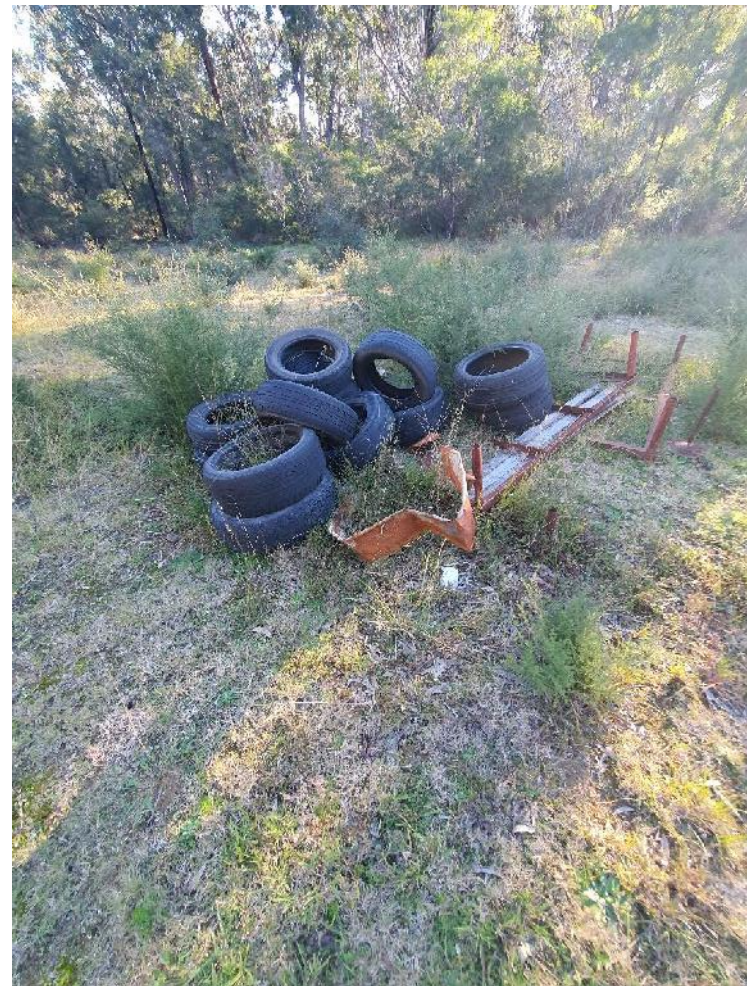
Photo 64 - Minor Dumping (MRP56)

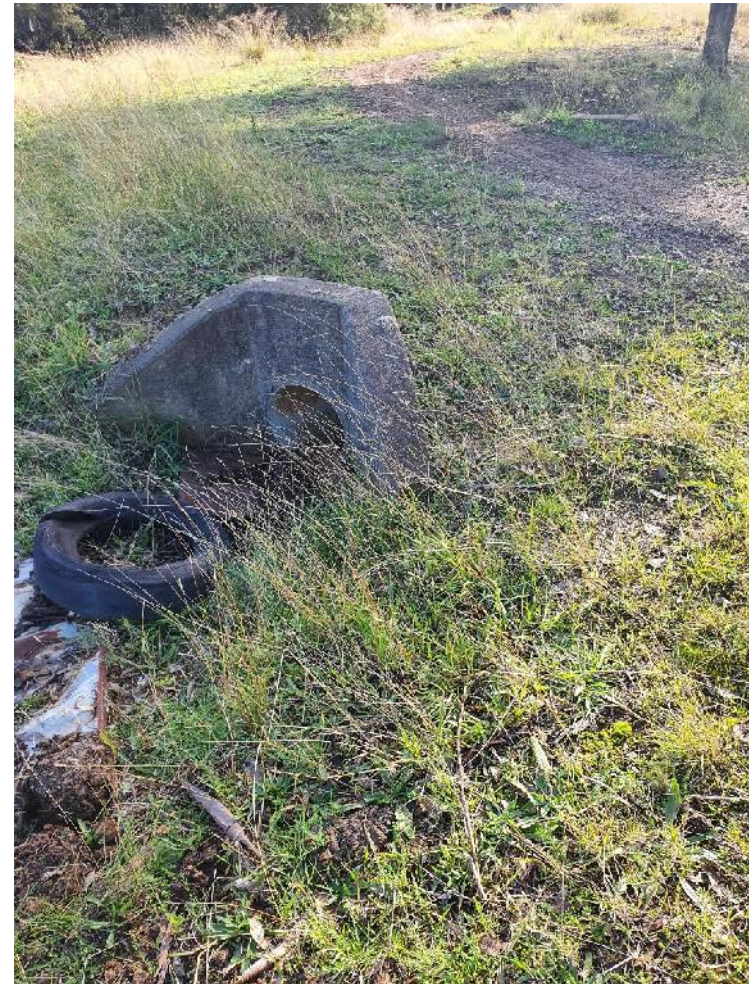
Photo 66 - Concrete Headwalls and Pipes Along Road (MRP58)

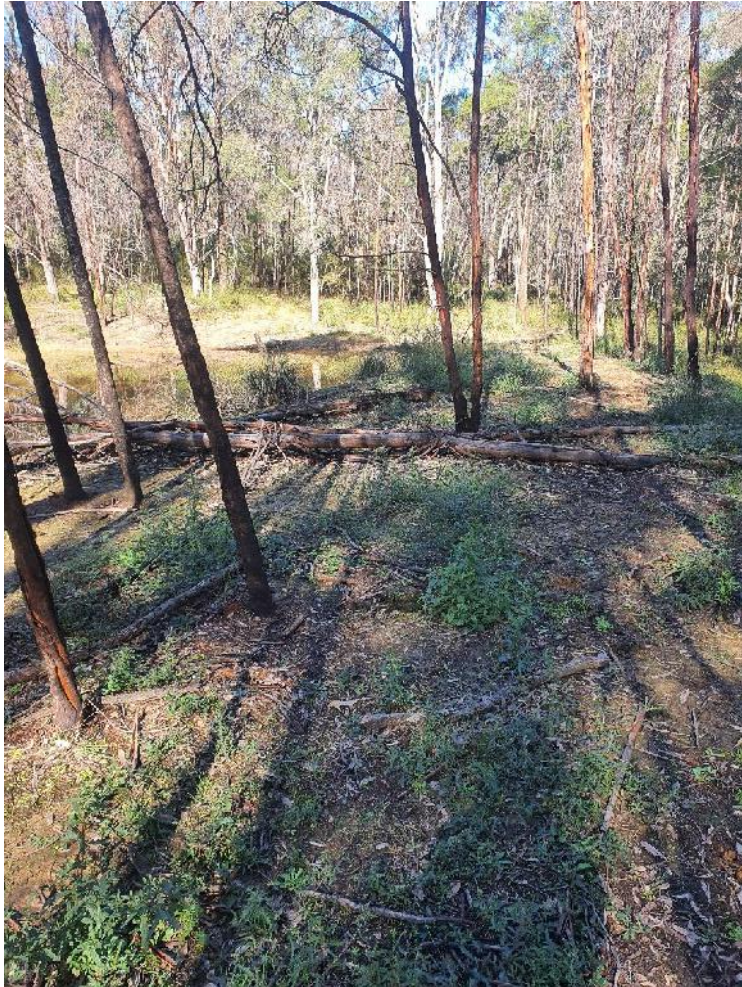
Photo 73 - Dam Wall (MRP64)

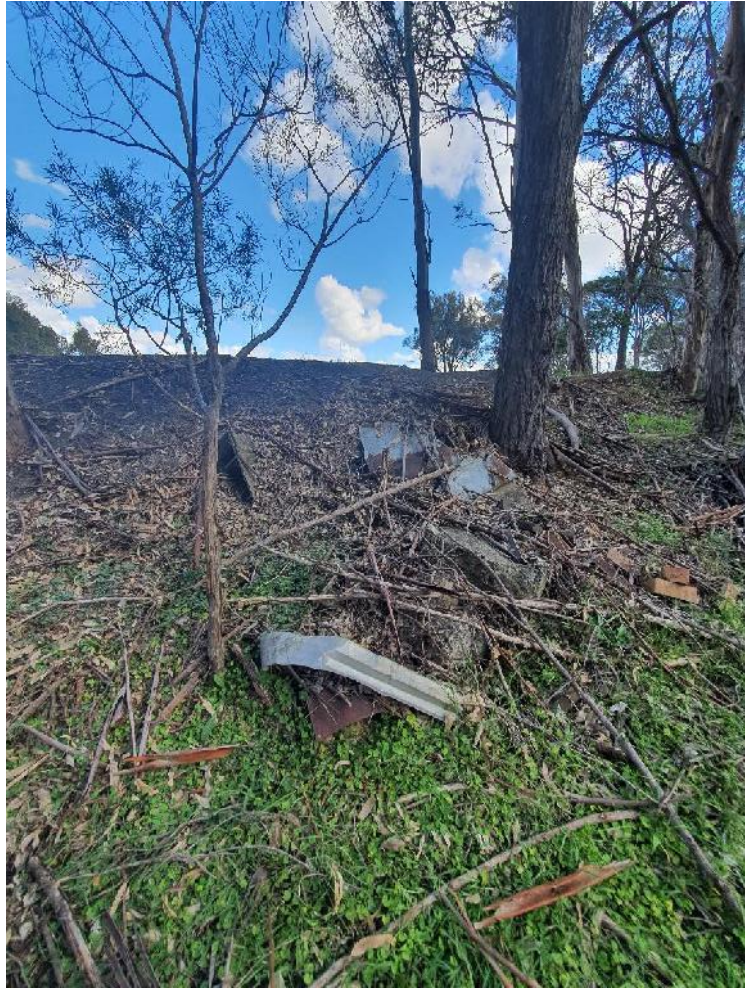
Photo 77 - Rubble in Dam Wall (MRP66)

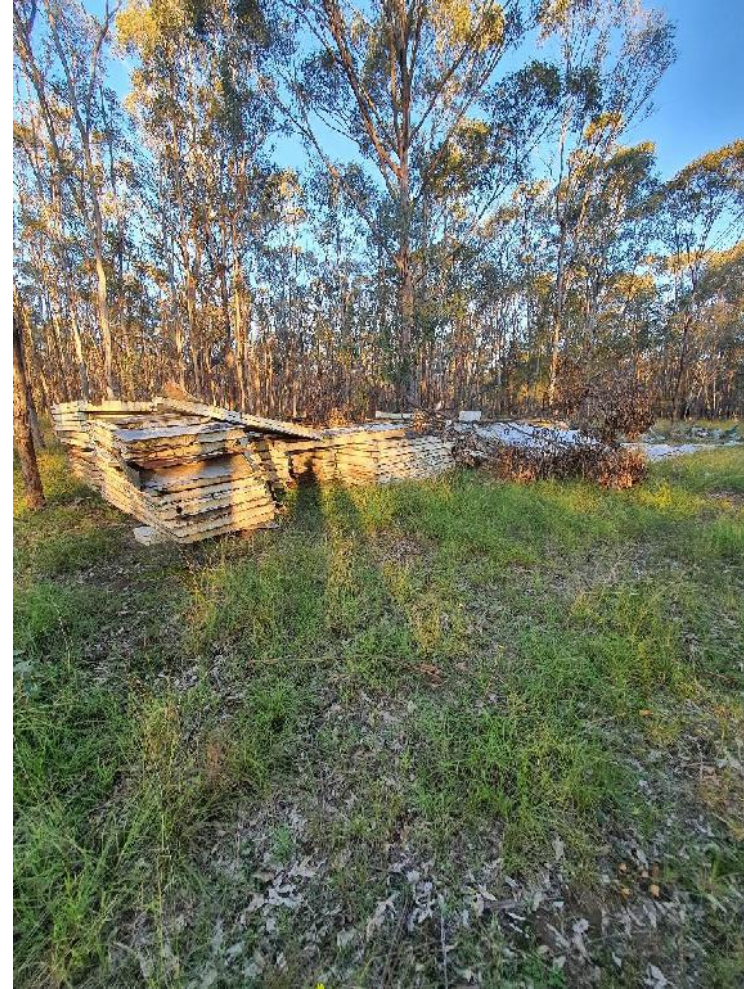
- Systematic dumping was observed along Elladale Road including construction and demolition materials (MRP 65; plates 74 to 76, MRP 67; plate 78, MRP 70; plate 81 and MNP 76; plates 86 to 88).
- Several stockpiles were noted along Elladale Road (MRP 59; plate 67, MRP60; plates 68 and 69, MRP 61 to 63; plates 71 and 72).
- Farm dams were scattered throughout the area, the majority of which were observed to have embankments constructed from locally derived material. One dam embankment was noted to contain building rubble.
- Several timber power pole alignments were encountered.
- There were several houses in this area (i.e. along Brooks Point Road) some of which may be derelict and many of which were of the age which would indicate that hazardous building materials may be present.

Photo 86 - Dumped Cladding and Car (MRP76)

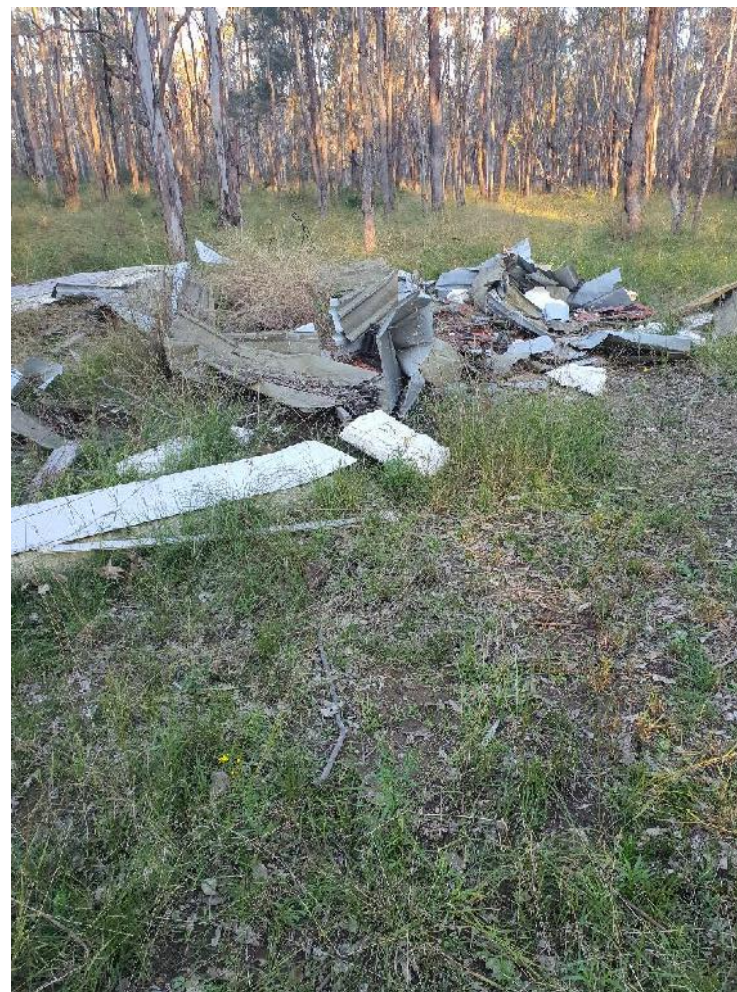
Photo 88 - Dumped Cladding and Car (MRP76)

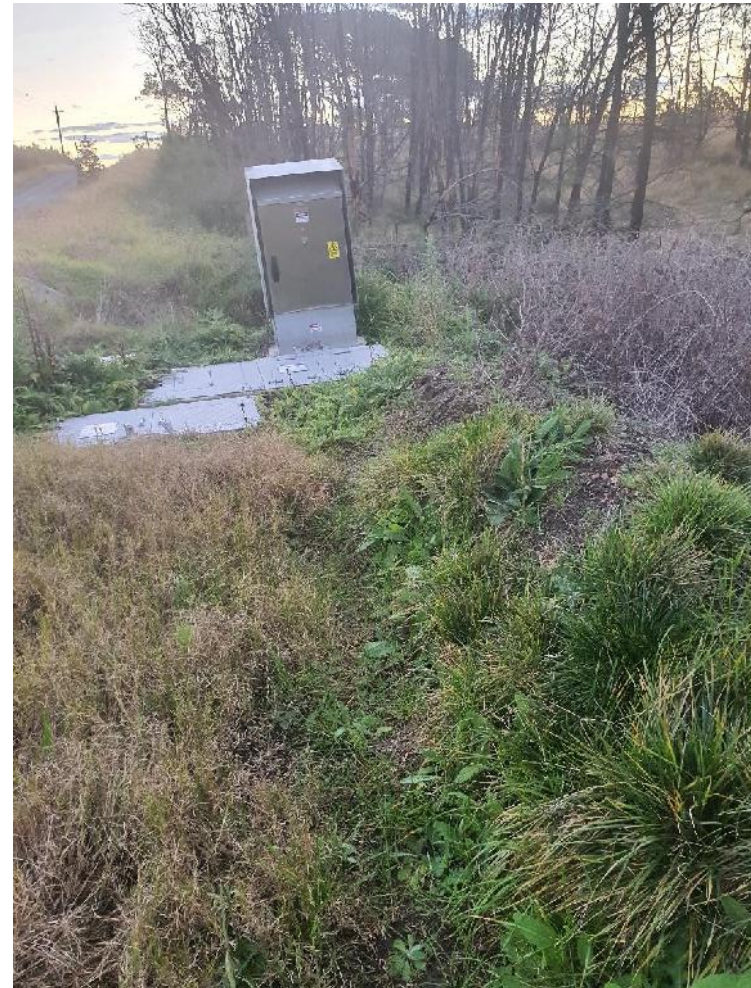
Photo 90 - Pump Station (MRP78)

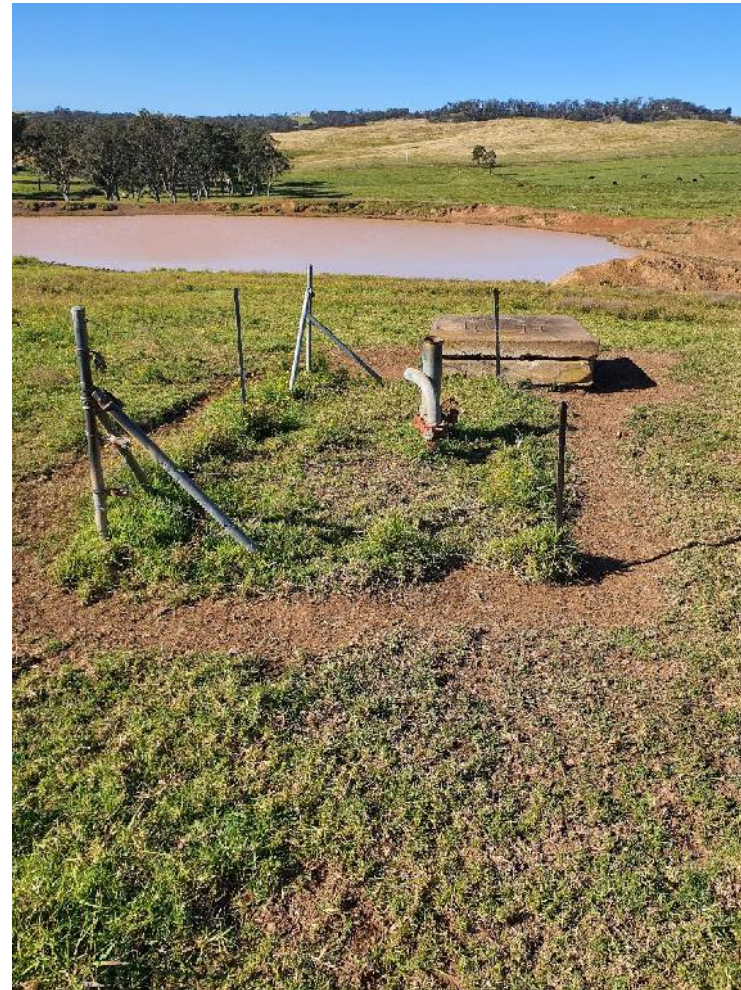
- A coal seam gas well network was observed in the west (MRP 93; plates 103 to 105) near Appin Colliery) centre (MRP 94; plate 106) and south of the site (MRP 98 and 99; plates 113 and 114) and a pipeline extending towards the south west (MRP 101; plate 116, MRP 102; plate 117) adjacent to the creek in the south west portion of the site. A mine communication antenna was also observed (MRP 100; plate 115).
- As with the remainder of the site, several timber power pole alignments were encountered throughout.

Photo 106 - Gas Well and Pipework (MRP94)
