Report on
Preliminary Site Investigation

Proposed Appin (Part) Precinct
Appin, NSW

Prepared for
Walker Corporation Pty Ltd

Project 76589.06
October 2022

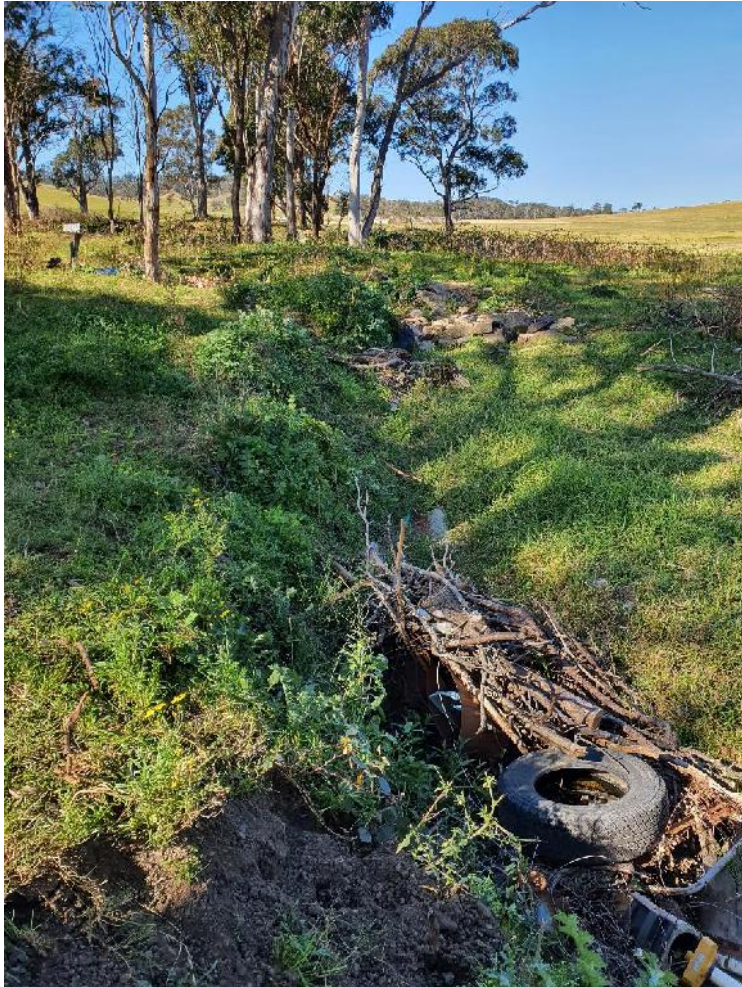
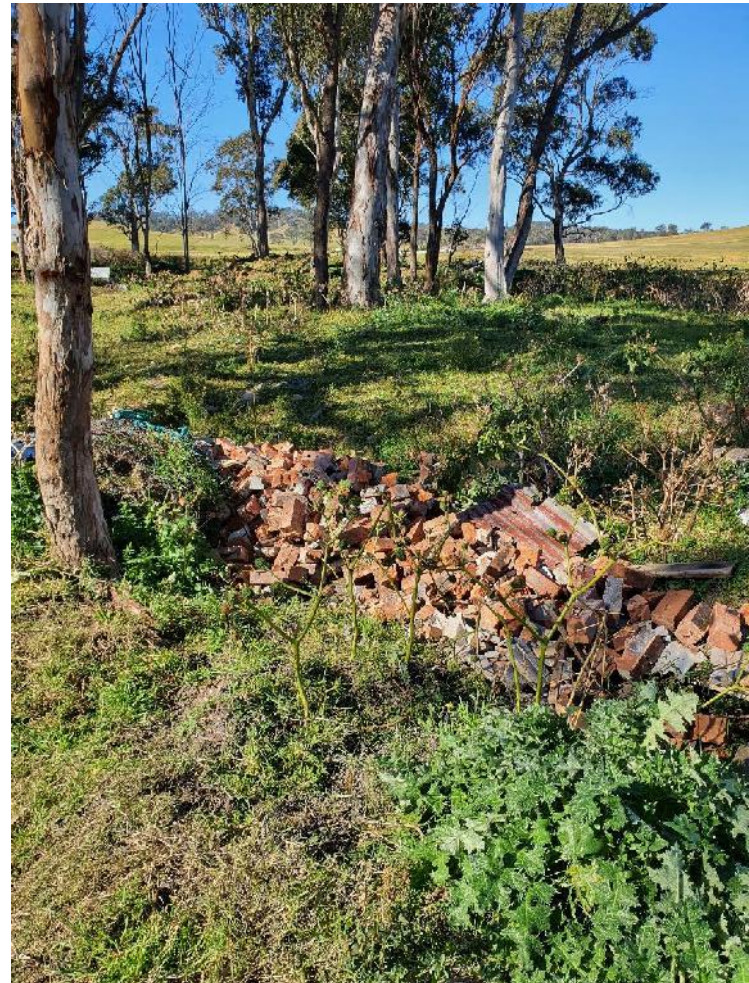
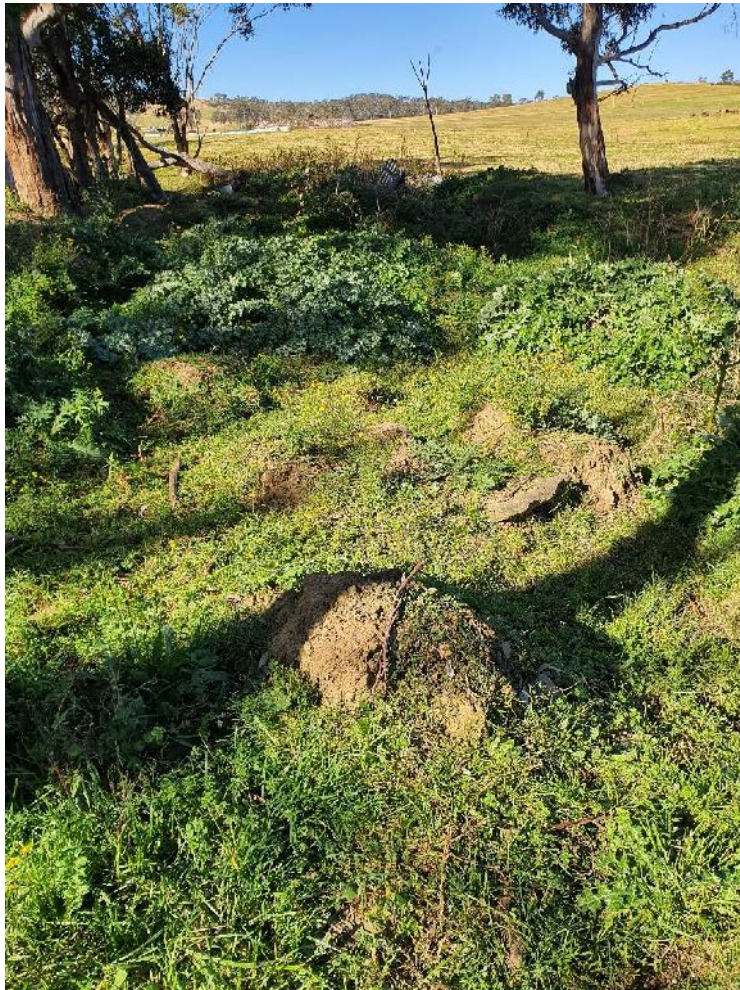
- Localised dumping was observed in some gullies largely minor refuse (MRP 83; plate 93) and cars and machinery (MRP 105; plate 121) with the exception of MRP 96 (plates 108 – 111) and 97 (plate 112) where dumping appeared to be widespread and systematic. An area of waste tyre dumping was noted at MRP 111 (plates 125 to 127).

Site walkover				96	Dumping in creek - white goods, tyre, timber power pole, loose building and demolition rubble	Yes	8-9	Medium	Targeted investigation of area of dumping
	Site walkover				97	Dumping in creek - corrugated metal, timber, rusted metal	Yes	8-10	Medium	Targeted investigation of area of dumping
	Site walkover				105	Dumped cars and machinery (rusted) on either side of the dirt road.	Yes	8-11	Low - Medium	Targeted investigation of area of dumping
	Site walkover				119	dumped refuse	Yes	8-12	Low - Medium	Targeted investigation of area of dumping
PAEC 9										
	Site walkover				9	Power poles in easement next to canal	Yes	9-1	Medium	Targeted investigation of immediate surrounding surface soils
	Site walkover				13	Power poles - old (timber) and new	Yes	9-2	Low - Medium	Targeted investigation of immediate surrounding surface soils
	Site walkover				32	Timber power poles	Yes	9-3	Medium	Targeted investigation of immediate surrounding surface soils

Photo 109 - Dumping in Creek (MRP96)

Photo 110 - Dumping in Creek (MRP96)

Photo 111 - Dumping in Creek (MRP96)

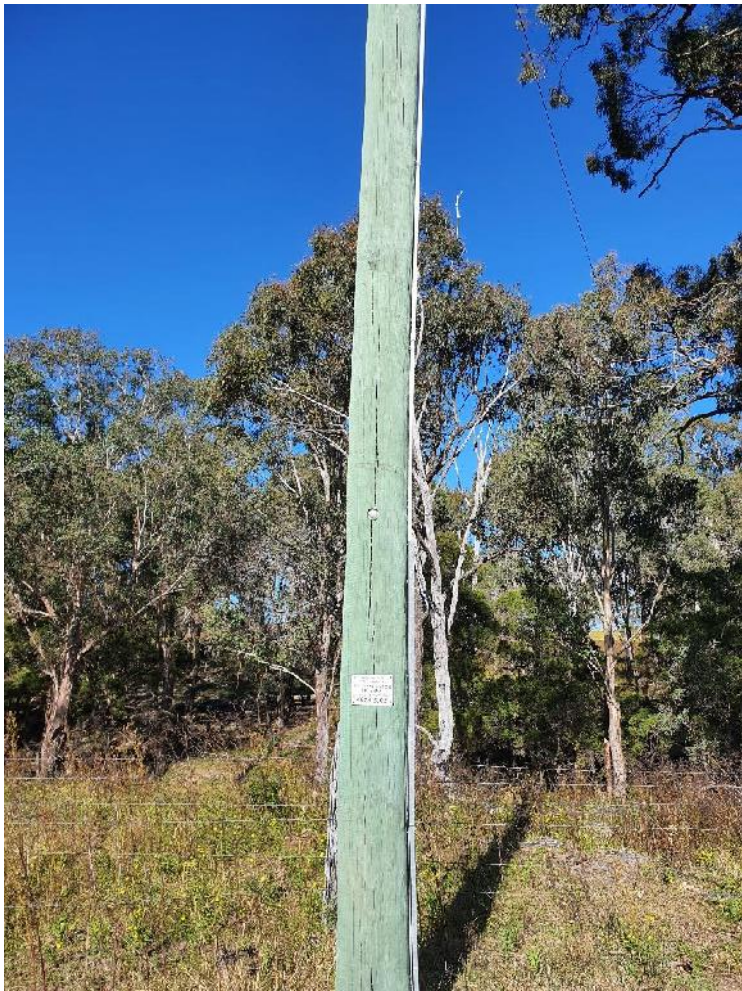
Photo 115 - Mine Communication Antenna (MRP100)

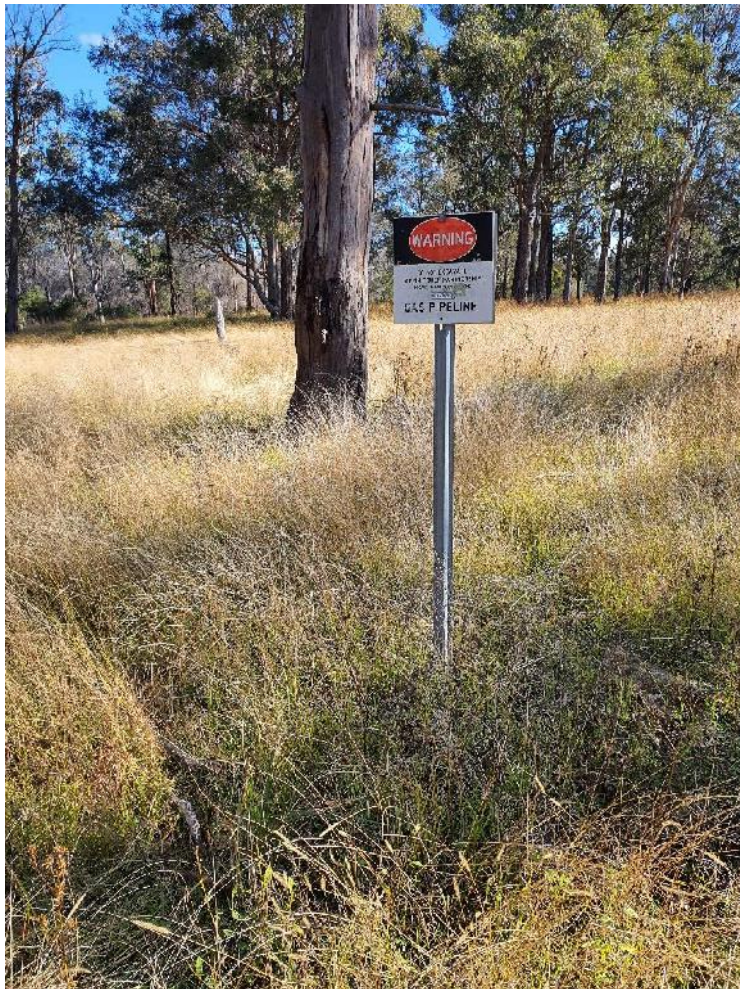
- A coal seam gas well network was observed in the west (MRP 93; plates 103 to 105) near Appin Colliery) centre (MRP 94; plate 106) and south of the site (MRP 98 and 99; plates 113 and 114) and a pipeline extending towards the south west (MRP 101; plate 116, MRP 102; plate 117) adjacent to the creek in the south west portion of the site. A mine communication antenna was also observed (MRP 100; plate 115).
- As with the remainder of the site, several timber power pole alignments were encountered throughout.

Photo 117 - Gas Pipeline (MRP102)

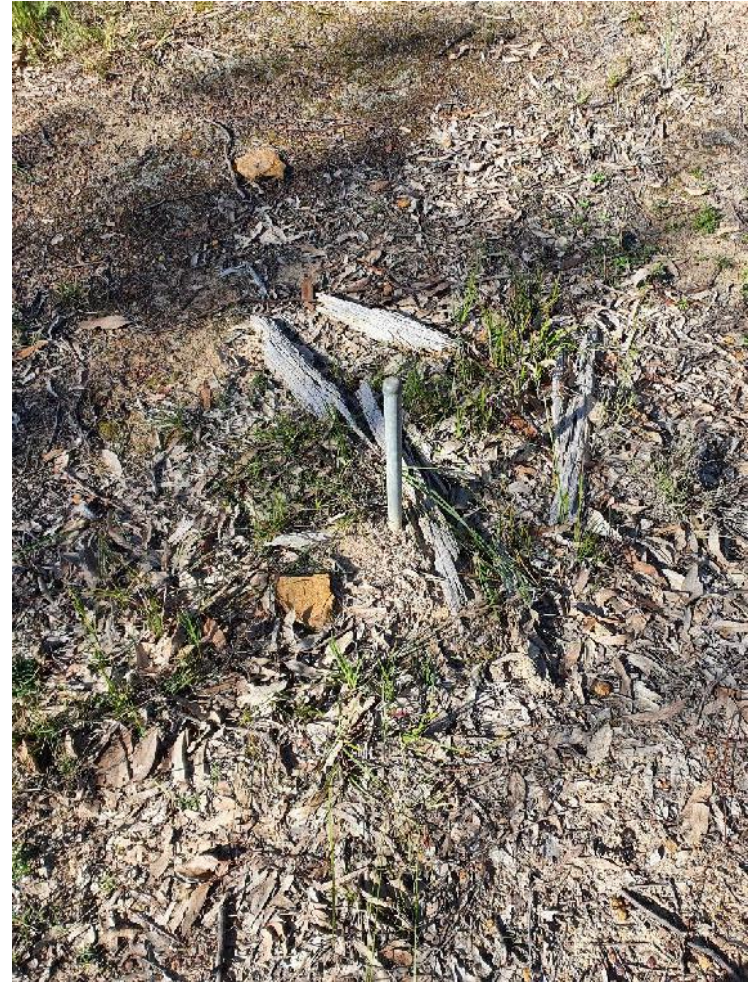
Photo 120 - 25 mm Pipe in Ground (MRP104)

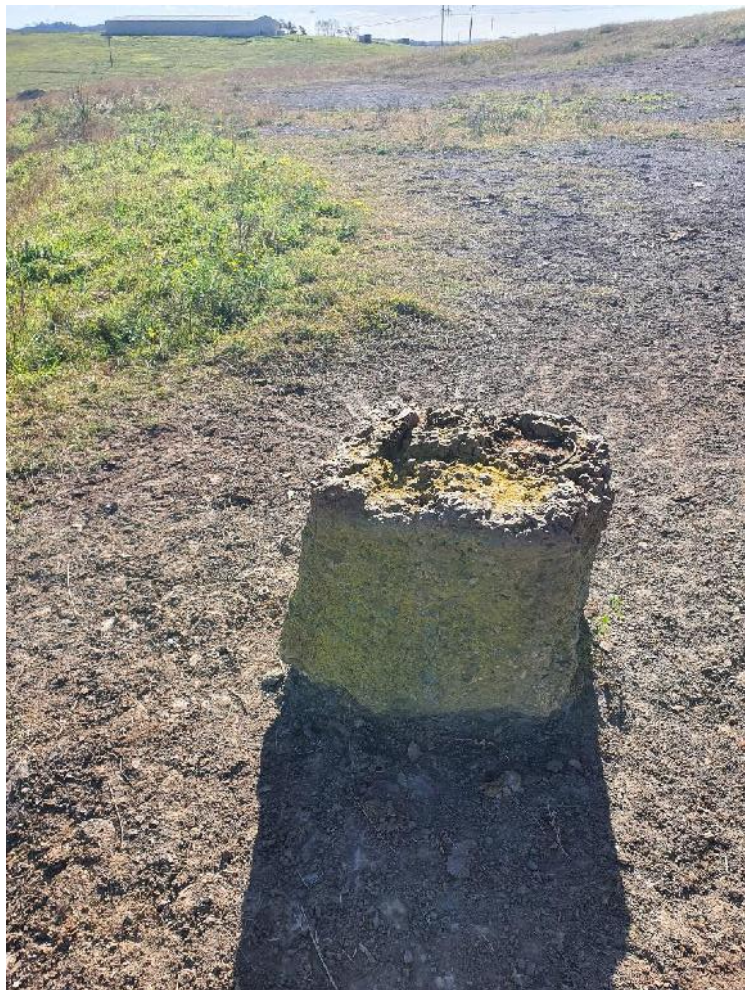
Photo 123 - Footing, Former Structure (MRP109)

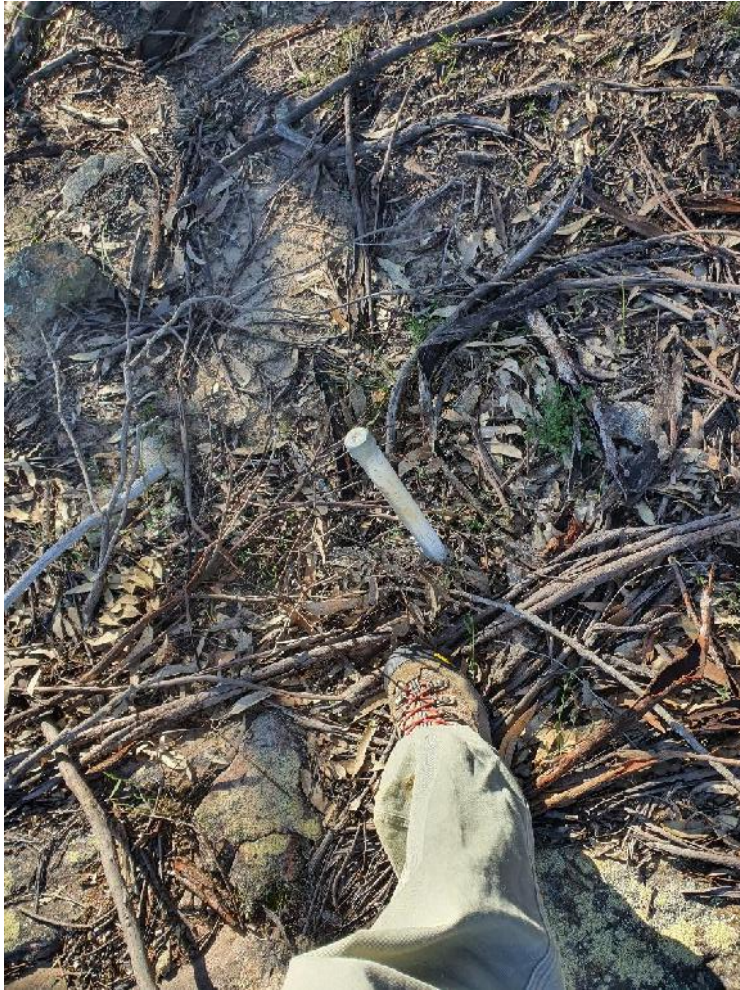
Photo 129 - Galvanised Pipes in Rock (MRP113)

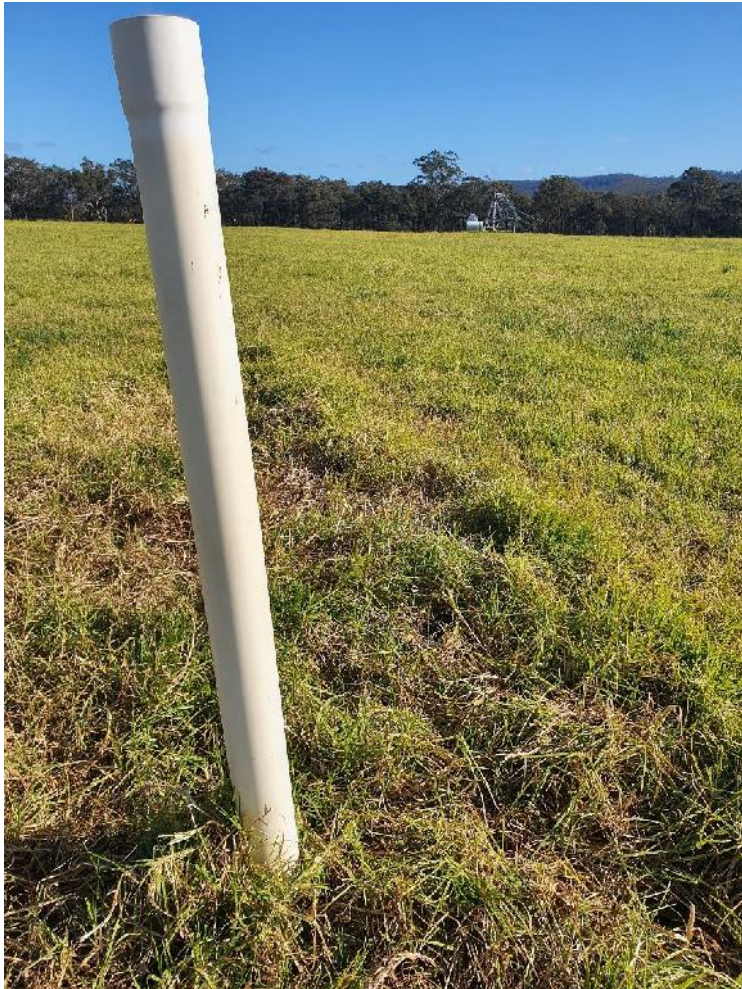
Photo 131 - Pipe Network for Irrigation (MRP115)

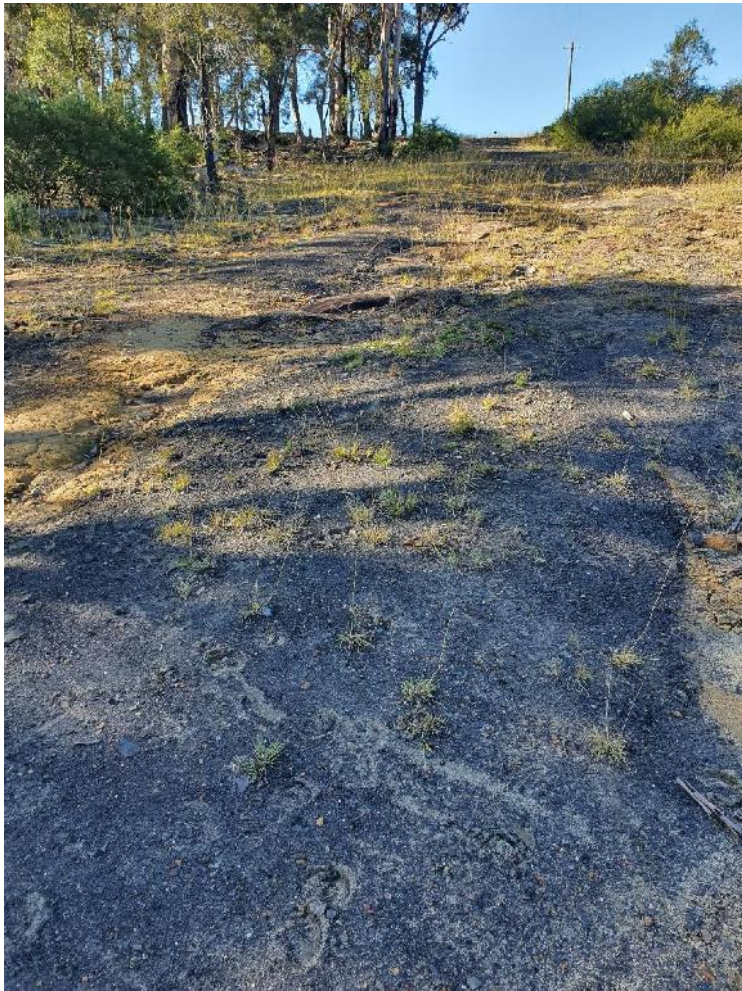
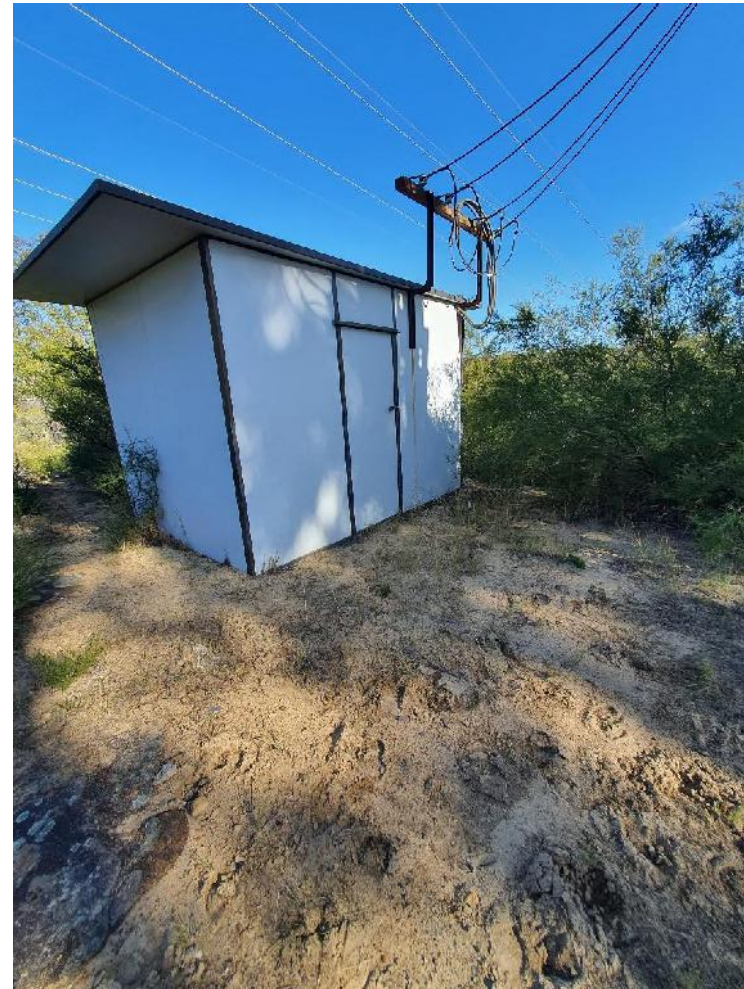
Photo 133 - Shed and Coalwash Road (MRP117)

Photo 134 - Shed and Coalwash Road (MRP117)
