## Peer Review

Document number: H-1019

Review of Comprehensive Heritage Study Proposed

Cumberland Heritage List

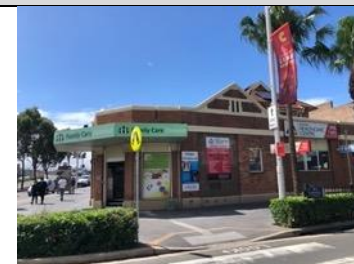
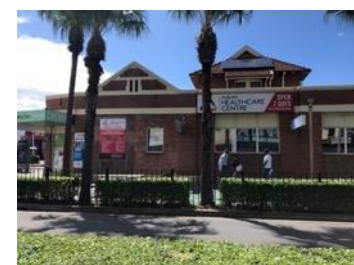
Item	Name	Address	Listing	Comments	Recommendations	Photographic Evidence
HS2	Former Auburn Post Office	4 and 4A Auburn Road and Kerr Parade	Local	<p>The proposed heritage item falls within the boundaries of the proposed South Parade Heritage Conservation Area.</p> <p>Alterations have been made to the ground floor of the Federation style former Post Office (constructed in 1912) that reduces the aesthetic significance of the site.</p> <p>The heritage inventory sheet states that "in its current state, the building cannot be considered a good representative example of its [type] due to the heavily modified façade." Despite this, the parapet roof and upper level retains evidence of the earlier design and the upper storey is highly intact.</p> <p>An investigation of the interior did not take place, therefore the integrity of the interior is not known.</p> <p>The heritage inventory sheet does not note that the site is within a proposed HCA.</p>	The exterior of the former Post Office <b>should be considered for individual listing</b> . While the item is within the proposed HCA, it is a differentiation in architectural form and style in comparison to the other Auburn Road shopfronts, and it has a historical significance that expands on the history of the remainder of the HCA.

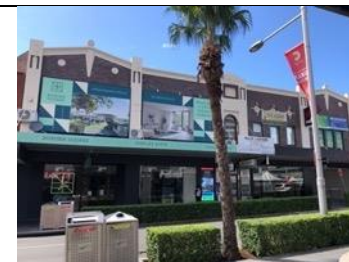
<p>HS141_Auburn Road_6-14</p>

Item	Name	Address	Listing	Comments	Recommendations	Photographic Evidence
				Condition: Good		
				Integrity: Moderate		
HS3	Pritchard's Building	6-14 Auburn Road	Local	<p>The proposed heritage item is located within the proposed South Parade Conservation Area.</p> <p>Pritchard's Building stands as a prominent shopfront on Auburn Road. The scale and architectural detailing contribute to its aesthetic significance. The original form of the upper level is highly intact, despite the alterations to the lower level and replacement of original windows. It is representative of the Inter-War Free Classical style with Art Deco motifs.</p> <p>The heritage inventory sheet does not note that the site is within the potential HCA.</p> <p>Condition: Good</p> <p>Integrity: High</p>	<p>The exterior of Pritchard's Building <b>should be considered for individual listing</b>. While the item is within the proposed HCA, it is a differentiation in architectural form and style from the other shopfronts along Auburn Road, and has a historical significance contributes to the remainder of the HCA.</p>

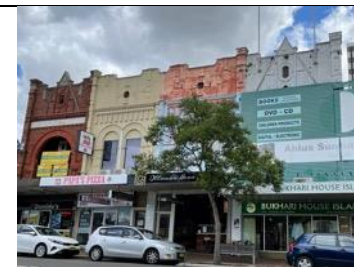
<p>HS6</p>

Item	Name	Address	Listing	Comments	Recommendations	Photographic Evidence
				<p>significance reduced through the demolition of 66 Auburn Road and construction of the neighbouring commercial building, effectively demolishing half of the historical façade.</p> <p>Condition: Good</p> <p>Integrity: Moderate</p>	<p>examples of shopfronts in the LGA that better display the characteristics of the type.</p>	
HS6	'The Towers' – Federation Shopfronts	111-117 Auburn Road	Local	<p>The item is a set of four, Federation Free Style shopfronts that present as a cohesive whole. The two central bays are mirrored, and the outer bay on each side likely match.</p> <p>Despite the alterations to the ground floor, the upper level and parapet (above the awning level) are highly intact. There is intrusive signage and timber screen to No. 111, which obscures the upper level.</p> <p>Alterations including modifications to the ground floor, the addition of air conditioner condenser units to the awning of No. 115 and infilled windows reduces the integrity of the building to an overall moderate degree.</p> <p>Condition: Good</p> <p>Integrity: Moderate</p>	<p>The exterior of the Federation Building <b>should be considered for a group listing.</b></p>

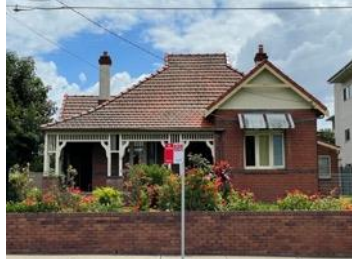
<p>HS7</p>

Item	Name	Address	Listing	Comments	Recommendations	Photographic Evidence
HS7	Federation Queen Anne Residence	151 Auburn Road	Local	<p>The Federation Queen Anne Residence is a good, intact example of the type. It exhibits original details, including timber details to verandah posts, timber windows and entry door, restrained terracotta ridge capping detail to the roof and terracotta chimney pots. The original tiled floor of the verandah remains in place.</p> <p>The low brick fence, hedges and well kept garden contribute to the setting.</p> <p>The side addition is set back from the front and does not detract from the aesthetic appeal of the dwelling.</p> <p>Condition: Good</p> <p>Integrity: High</p>	The Federation Queen Anne Residence <b>should be considered for individual listing at a local level.</b>

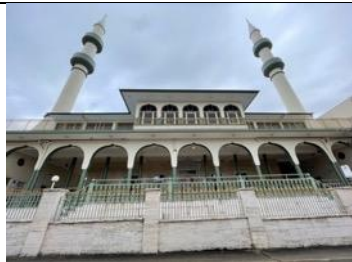
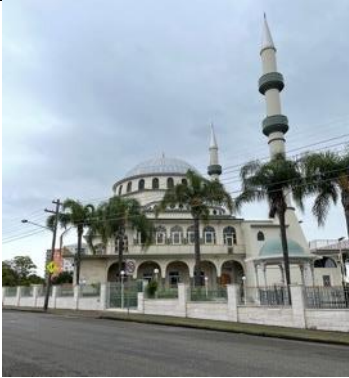
<p>HS10</p>

<p>HS7(1)</p>
HS10	Auburn Gallipoli Mosque	1-3 Dartbrook Road 1-19 Gelibolu Road	Local (potentially State)	<p>The Auburn Gallipoli Mosque presents as a rare example of its type across Sydney and possibly the state.</p> <p>Reflective of Ottoman style Mosques, it features handcrafted and artisanal details, with an arched portico below an elaborate façade and lead clad domed roof.</p>	<p>The Auburn Gallipoli Mosque <b>should be considered for individual listing at a local level.</b></p> <p>The inventory sheet states that the Mosque may be of state heritage significance. To achieve state heritage listed status, the item should first be included in the local heritage list. A full assessment of the site can then be completed to</p>

Item	Name	Address	Listing	Comments	Recommendations	Photographic Evidence
				<p>It is a landmark feature structure is visible from the railway line.</p> <p>Condition: Good</p> <p>Integrity: High</p>	determine its degree of significance, and to inform an application to list the site as a state heritage item.

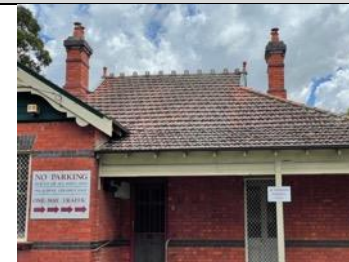
Item	Name	Address	Listing	Comments	Recommendations	Photographic Evidence
				<p>the site, as does the signage on the front facade.</p> <p>The single storey addition at the rear does not contribute to the significance of the site.</p> <p>Condition: Moderate</p> <p>Integrity: Fair</p>

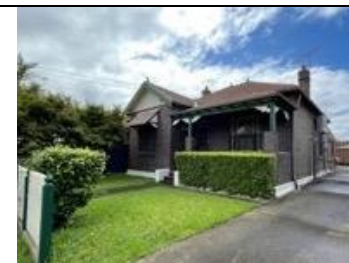
<p>HS12</p>

<p>HS11(2)</p>
HS12	Inter-War Residence	1 Kihilla Road	Local	<p>The Inter-War Residence carries a high degree of integrity and is in a good condition. It displays Federation features, and includes original elements such as terracotta tiled hipped and gabled roof with finials, chimney pots, and timber bracket details to underside of verandah.</p> <p>The tidy garden setting positively contributes to its aesthetic significance.</p> <p>There is a concrete driveway, intrusive metal bars to the front windows and a metal gate to the side with a freestanding garage at the rear. These elements do not contribute to the significance of the site.</p> <p>Condition: Good</p> <p>Integrity: High</p>	The exterior of the Federation Bungalow <b>should be considered for individual listing</b> . It is not known if the interiors are also intact for inclusion in the listing.

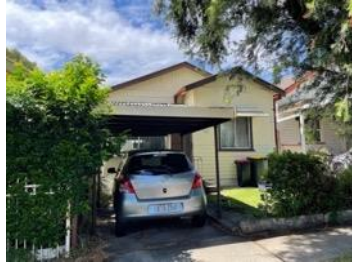
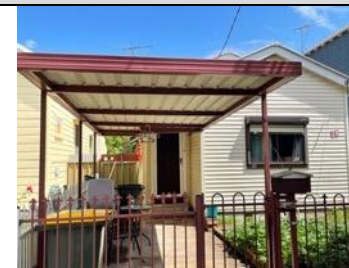
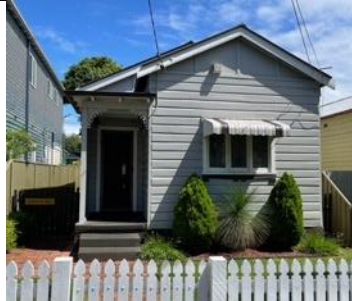
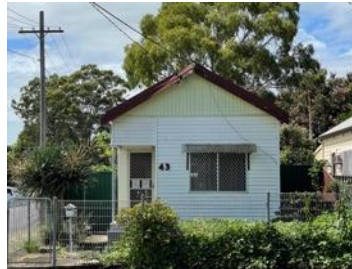
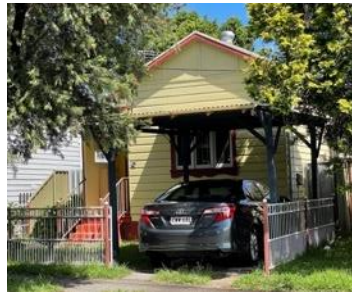
Item	Name	Address	Listing	Comments	Recommendations	Photographic Evidence
HS14	Kihilla Road Workers' Cottages	42-44 and 33-43 Kihilla Road (recommended for listing in original study)  34-40 Kihilla Road (not recommended for listing in original study)	Local	<p>The heritage inventory sheet notes that 42-44 and 33-43 Kihilla Road are recommended for listing and that 34-40 Kihilla Road are not.</p> <p>Collectively, the dwellings represent the residential development of Auburn in the 1920s. The consistency in design and style contributes to the interpretation of the whole.</p> <p>No. 34 – late 20<sup>th</sup> century, two storey construction that does not reflect the scale and design of the other cottages.</p> <p>36-38 – a degree of change has occurred to these two dwellings, although this is not as significant as the change at No. 40. The early design intent is still visible and they contribute to the overall setting.</p> <p>Overall, the group is similar to the architectural style in the proposed Northcote Street Conservation Area. HS14, however, includes a lower degree of intrusive additions to the front of the dwellings and the dwellings are generally of a better condition. Where the HCA has non-contributory dwellings located between, the listing for HS14 includes less non-contributory items. However, this still does not</p>	<p><b>Consider inclusion of Nos. 36-38 in the listing</b> (noted as not recommended for listing in the original study). From a visual inspection and based on the descriptions provided in the heritage inventory sheet, they do not appear significantly reduced in integrity compared to the remainder of the dwellings.</p> <p><b>Nos. 34 and 40 are not recommended for listing</b> (as noted in the original study) owing to the era of construction of No. 34 and the stylistic differences and alterations to No. 40.</p> <p>The exteriors of the Kihilla Road Worker's Cottages at Nos. 42-44 and 33-43 represent contributory items within their setting. <b>The dwellings should only be considered for listing as a group or as contributory items within a Heritage Conservation Area.</b></p> <p>Refer to similar items within the Northcote Heritage Conservation Area of similar architectural style and merit.</p>

Item	Name	Address	Listing	Comments	Recommendations	Photographic Evidence
				<p>elevate the residences to listing as individual heritage items.</p> <p>Condition: Good</p> <p>Integrity: Moderate</p>

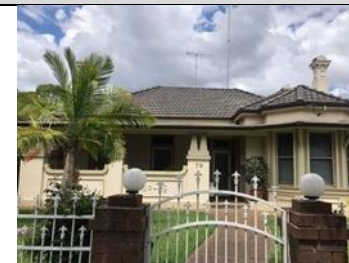
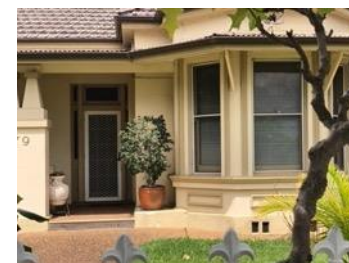
<p>HS15</p>

Item	Name	Address	Listing	Comments	Recommendations	Photographic Evidence
HS15	Federation Residence	79 Macquarie Road	Local	<p>The Federation Residence is an intact, representative example of an early Federation/early Victorian residence.</p> <p>The well-kept garden setting and general maintenance of the dwelling contributes to its significance. It is in an overall good condition, although there is cracking evident to the base of the walls, below the windows.</p> <p>The palisade fence is an intrusive element. A carport shelter is constructed to the side, along the driveway.</p> <p>The surrounding streetscape includes dwellings of Federation era. Although smaller in scale and less prominent, they are largely in a good condition and are reflective of the later subdivision.</p> <p>Condition: Good</p> <p>Integrity: High</p>	<p>The exterior of the Federation Residence <b>should be considered for individual listing</b>. It is not known if the interiors are also intact. Investigation of the interiors could be considered.</p>

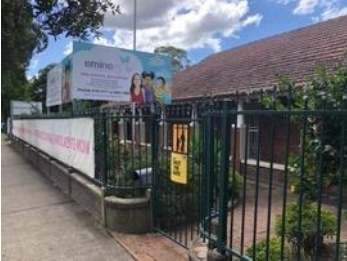
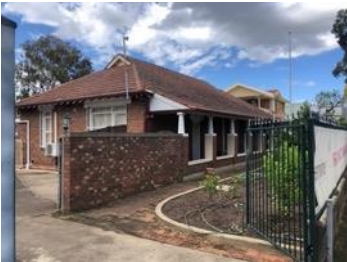
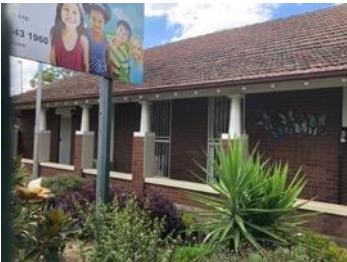
<p>HS18</p>

Item	Name	Address	Listing	Comments	Recommendations	Photographic Evidence
HS18	Federation Bungalow	59 Mary Street	Local	<p>Currently in use as a childcare centre, the Federation Bungalow maintains a moderate degree of integrity despite intrusive alterations. It includes original stained glass windows and timber detailing (obscured by intrusive security bars).</p> <p>A brick fence to the side and the palisade fence to the front are intrusive.</p> <p>The freestanding ca. 1980s garage structure does not contribute to the significance of the site.</p> <p>Condition: Good</p> <p>Integrity: Moderate</p>	The exterior of the Federation Bungalow <b>should be considered for individual listing</b> . It is not known if the interiors are also intact for inclusion in the listing.

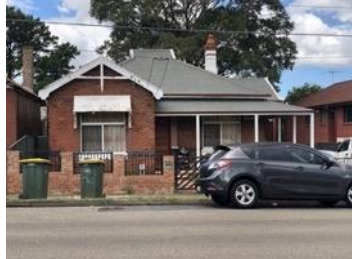
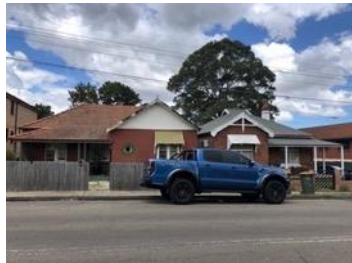
<p>HS19</p>

Item	Name	Address	Listing	Comments	Recommendations	Photographic Evidence
HS19	'Victorian Manor' – Federation Queen Anne Residence	65 Northumberland Road	Local	<p>The Victorian Manor residence is largely intact with minor alterations and additions.</p> <p>The low brick fence is contributory, although the infill metal fencing and gate are intrusive.</p> <p>The neighbouring dwelling is visually similar in architectural style and form. It retains original features, including stained glass panels, round accent window and timber detailing, although the rendered and painted finish of the walls detracts from its aesthetic value.</p> <p>Condition: Good</p> <p>Integrity: High</p>	<p>The exterior of the Victorian Manor <b>should be considered for individual listing</b>. It is not known if the interiors are also intact for inclusion in the listing.</p> <p>In addition to the recommendations, if the opportunity arises, it would be favourable to reinstate round accent window and stained glass details to windows as evident at neighbouring 67 Northumberland Road.</p>

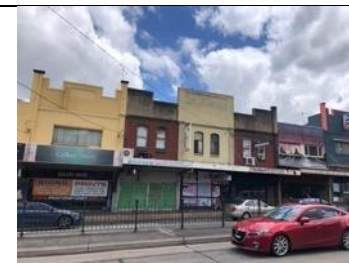
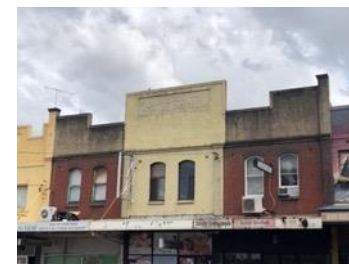
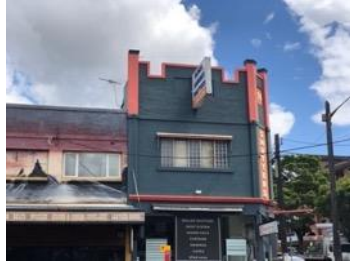
<p>HS23</p>

Item	Name	Address	Listing	Comments	Recommendations	Photographic Evidence
				largely located to the rear of the hotel and are not prominent features when viewed from the public domain.		
				Condition: Good		
				Integrity: High		
HS23	'Auburn Emporium' – Federation Building	160-174 Parramatta Road	Local	<p>The group is a Federation commercial structure with multiple shopfronts.</p> <p>The structure is divided into bays with asymmetrical square topped parapets with a shared design. The central parapet reads 'Auburn Emporium.'</p> <p>The original form is retained to the upper level, although some bays are altered with changes to window frames and forms.</p> <p>The ground floor has been significantly altered, although the aesthetic significance is maintained through the upper level.</p> <p>Condition: Fair</p> <p>Integrity: Moderate</p>	The exterior of the Auburn Emporium <b>should be considered for a group listing.</b>

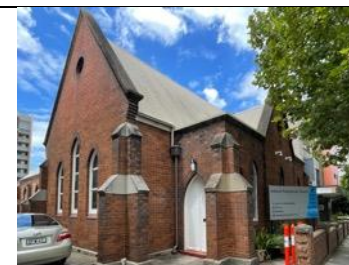
<p>HS26</p>

<p>HS25(2)</p>
HS26	Auburn Presbyterian Church	29 Queen Street		<p>The Auburn Presbyterian Church is an example of Federation ecclesiastical architecture. It features polychromatic brick walls, arched stained glass windows with timber frames, and original timber panelled doors.</p> <p>The site is bound with a brick fence with a bullnose top course. It is</p>	The Auburn Presbyterian Church <b>should be considered for individual listing.</b>

Item	Name	Address	Listing	Comments	Recommendations	Photographic Evidence
				<p>generally in a good condition, with some areas requiring repair.</p> <p>Despite the construction of two additions, the degree of integrity is high due to the retention of most original features.</p> <p>Condition: Good</p> <p>Integrity: High</p>

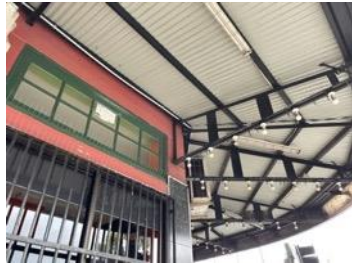
<p>HS30(2)</p>

Item	Name	Address	Listing	Comments	Recommendations	Photographic Evidence
HS30	Federation Commercial Building	73-77 Rawson Street	Local	<p>The Federation Free Style commercial building is located in a prominent position adjacent to the station.</p> <p>It includes original features to the upper level, which contributes to a high degree of integrity externally. The alterations to the ground floor are significant, resulting in a low degree of integrity in this area.</p> <p>The ground floor is considerably altered to facilitate contemporary use, with signage, modified window and door openings and tiled wall finish.</p> <p>The first floor is rendered roughcast and smooth rendered finishes and is largely intact, and features timber arched windows to upper floor.</p> <p>Condition: Good</p> <p>Integrity: Moderate</p>	The exterior of the Federation Commercial Building <b>should be considered for listing.</b>

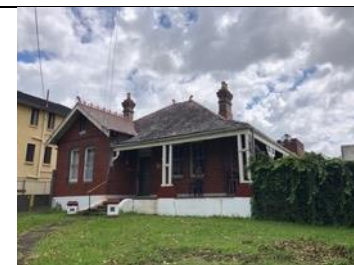
<p>HS33</p>

<p>HS31_117-119</p>
HS33	Federation Residence	96 Station Street	Local	<p>The Federation Residence is an intact example of its type. It includes original slate tiles to the roof, terracotta finials, roughcast chimneys with exposed brick details and chimney pots, and timber windows.</p> <p>Its external condition overall appears to be fair and it has a high degree of integrity, although there are intrusive bars to the windows and a mesh gate to the side of the verandah. Some slate tiles have slipped and there is biological growth across the roof. There is evidence of cracking to the rendered base of the verandah.</p> <p>The statement of significance notes that the site is “well-kept.” This contrasts with the final statement of the physical description, which states that some elements are in a poor</p>	<p>The exterior of the Federation Residence <b>should be considered for individual listing.</b></p> <p>The statement of significance should be altered to remove the statement that the dwelling is “well-kept.”</p>

Item	Name	Address	Listing	Comments	Recommendations	Photographic Evidence
				condition and the building is in a fair condition overall.		
				Condition: Fair		
				Integrity: High		
HS35	Federation Workers' Cottage	106 Vaughan Street	Local	<p>The worker's cottage is an early example of development in the area. The timber clad structure includes original elements, such as decorative wrought iron brackets to the underside of the verandah. The timber cladding to the verandah is likely an infill element.</p> <p>The condition appears to be fair externally, with peeling paint, rusted corrugated roofing over the verandah, and cracks to steps.</p> <p>There is an addition to the side that is likely of an early construction phase, infilling an extension of the verandah.</p> <p>A free-standing garage is set back and to the side of the dwelling.</p> <p>Condition: Fair</p> <p>Integrity: Moderate</p>	The exterior of the Federation Worker's Cottage <b>should be considered for individual listing.</b>

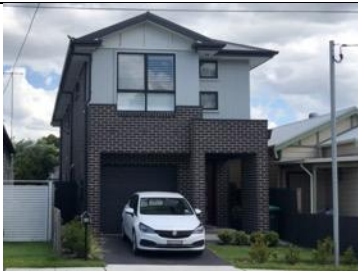
HS140_Northcote_42

HS140_Northcote_40
42	Northcote Street	<input type="checkbox"/>	<input checked="" type="checkbox"/>	N/A	N/A	Dwelling is a large, two storey infill structure from ca. 21 <sup>st</sup> century. It does not reference the scale of the original dwellings. <b>This item does not meet the threshold of contributory.</b>

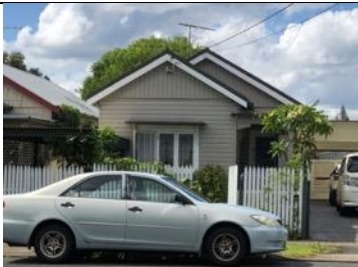
HS140_Northcote_53

53	Northcote Street	<input checked="" type="checkbox"/>	<input type="checkbox"/>	<input type="checkbox"/> Poor <input checked="" type="checkbox"/> Fair <input type="checkbox"/> Good	<input type="checkbox"/> Low <input checked="" type="checkbox"/> Moderate <input type="checkbox"/> High	Dwelling conforms to the general form and description of the proposed HCA as a timber clad structure with a terracotta tiled, gable ended roof. Solar panels have been added to the roof. A security door has been installed in front of a glazed door. Original timber window frames and stained glass are intact. <b>This item contributes to the conservation area.</b>

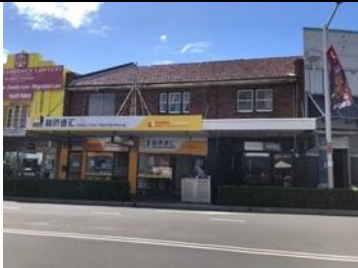
HS141_Auburn Road_2E

HS141_Auburn Road_2-2C
2E	Auburn Road	<input checked="" type="checkbox"/>	<input type="checkbox"/>	<input type="checkbox"/> Poor <input checked="" type="checkbox"/> Fair <input type="checkbox"/> Good	<input type="checkbox"/> Low <input checked="" type="checkbox"/> Moderate <input type="checkbox"/> High	Bay of three shops with terracotta tiled, transverse gabled roof form. Original timber double hung windows remain to two of the three upper level bays, which are exposed brick finish. Aluminium slider windows are in place in the remaining bay. <b>The building contributes to the character of the HCA.</b>

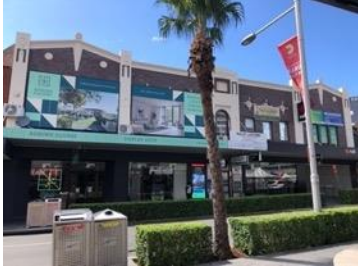
HS141 Auburn Road 6-14(3)

HS141 Auburn Road 7
6-14	Auburn Road	<input checked="" type="checkbox"/>	<input type="checkbox"/>	<input type="checkbox"/> Poor <input type="checkbox"/> Fair <input checked="" type="checkbox"/> Good	<input type="checkbox"/> Low <input type="checkbox"/> Moderate <input checked="" type="checkbox"/> High	Noted as 'Pritchard's Building 1930' in the centre parapet. This item is a proposed heritage item (HS3). It presents as Inter-War Free Classical shops. The ground floor has been significantly altered although the upper level remains intact. <b>The building contributes to the character of the HCA.</b>

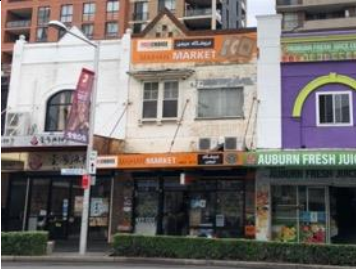
HS141 Auburn Road 11

HS141 Auburn Road 5-9
11	Auburn Road	<input checked="" type="checkbox"/>	<input type="checkbox"/>	<input type="checkbox"/> Poor <input checked="" type="checkbox"/> Fair <input type="checkbox"/> Good	<input type="checkbox"/> Low <input checked="" type="checkbox"/> Moderate <input type="checkbox"/> High	Ground floor has been significantly altered. The upper floor retains an early bay of two double hung windows with decorative awning, although a secondary window has been added/alterd that is intrusive. The concrete lintel above the fixed window is exposed and suggests a later date of installation. <b>The building contributes to the character of the HCA.</b>

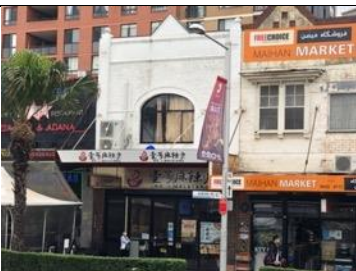
HS141 Auburn Road 13-15

13	Auburn Road	<input checked="" type="checkbox"/>	<input type="checkbox"/>	<input type="checkbox"/> Poor <input checked="" type="checkbox"/> Fair <input type="checkbox"/> Good	<input type="checkbox"/> Low <input checked="" type="checkbox"/> Moderate <input type="checkbox"/> High	Ground floor is significantly altered. The upper floor retains original window form and parapet design, although windows have been replaced with new aluminium frames. <b>The building contributes to the character of the HCA.</b>

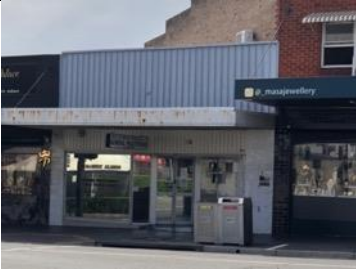
HS141 Auburn Road 16-18

HS141 Auburn Road 13-15
16	Auburn Road	<input type="checkbox"/>	<input checked="" type="checkbox"/>	<input type="checkbox"/> Poor <input checked="" type="checkbox"/> Fair <input type="checkbox"/> Good	<input checked="" type="checkbox"/> Low <input type="checkbox"/> Moderate <input type="checkbox"/> High	The ground floor is considerably altered. The original upper façade treatment has been altered and no longer reflects the original design intent. <b>Due to the loss of fabric and low integrity the building does not contribute to the character of the HCA.</b>

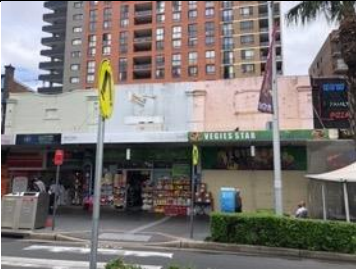
HS141 Auburn Road 17-19

17-19	Auburn Road	<input checked="" type="checkbox"/>	<input type="checkbox"/>	<input type="checkbox"/> Poor <input checked="" type="checkbox"/> Fair <input type="checkbox"/> Good	<input type="checkbox"/> Low <input checked="" type="checkbox"/> Moderate <input type="checkbox"/> High	Two shops with cohesive design across the façade. The ground floor has been significantly altered although the upper level remains intact. The rhythm/pattern of the windows to the upper level is evident, contributing to the original period of development. <b>The building contributes to the character of the HCA.</b>

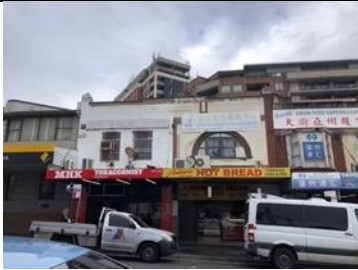
HS141_South Parade_76-78

76-78	South Parade	<input checked="" type="checkbox"/>	<input type="checkbox"/>	<input type="checkbox"/> Poor <input checked="" type="checkbox"/> Fair <input type="checkbox"/> Good	<input type="checkbox"/> Low <input checked="" type="checkbox"/> Moderate <input type="checkbox"/> High	Pair of two shops which may once have mirrored each other. The ground floor of both has been significantly altered. The upper floor of No. 76 has aluminium, rectangular windows while No. 78 has the original timber, fixed windows within an arched form. '1913' is inscribed in the parapet. <b>The building contributes to the character of the HCA.</b>

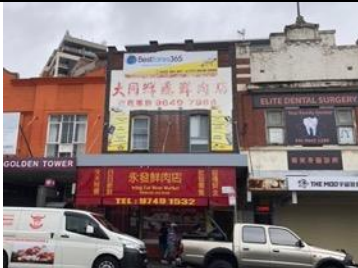
HS141_South Parade_88-90

HS141_South Parade_80-86
88-90	South Parade	<input checked="" type="checkbox"/>	<input type="checkbox"/>	<input type="checkbox"/> Poor <input checked="" type="checkbox"/> Fair <input type="checkbox"/> Good	<input type="checkbox"/> Low <input checked="" type="checkbox"/> Moderate <input type="checkbox"/> High	Presents as a single shop. One double hung timber window remains while the other has been replaced. The ground floor is significant altered although the original design intent remains visible. <b>The building contributes to the character of the HCA.</b>

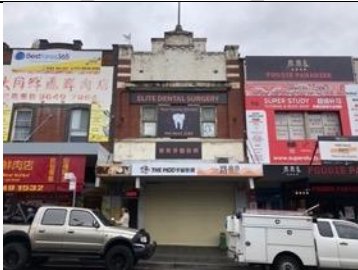
HS141_South Parade_92-94

92-94	South Parade	<input checked="" type="checkbox"/>	<input type="checkbox"/>	<input type="checkbox"/> Poor <input checked="" type="checkbox"/> Fair <input type="checkbox"/> Good	<input type="checkbox"/> Low <input checked="" type="checkbox"/> Moderate <input type="checkbox"/> High	'Harley House' inscribed at the top of the parapet. Original timber windows to the upper level remain, although the ground floor has been significantly altered. <b>The building contributes to the character of the HCA.</b>

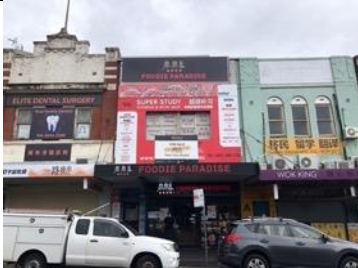
HS141_South Parade_96-98

Number	Street	Contributory	Non-Contributory	Condition	Integrity	Comments	Photograph and reference number
96-98	South Parade	<input type="checkbox"/>	<input checked="" type="checkbox"/>	<input type="checkbox"/> Poor <input checked="" type="checkbox"/> Fair <input type="checkbox"/> Good	<input type="checkbox"/> Low <input checked="" type="checkbox"/> Moderate <input type="checkbox"/> High	Ground floor is significantly altered. original windows replaced with aluminium frames. The upper level façade is not visible due to intrusive, detracting signage covering the entirety. It is not possible to determine whether this item is contributory with the current signage covering the entire front façade, therefore, without any visual evidence of intact fabric that best describes the period of construction, <b>it is recommended that this site be considered as non-contributory to the HCA.</b>

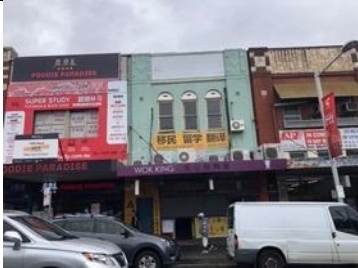
100-102	South Parade	<input checked="" type="checkbox"/>	<input type="checkbox"/>	<input type="checkbox"/> Poor <input checked="" type="checkbox"/> Fair <input type="checkbox"/> Good	<input type="checkbox"/> Low <input checked="" type="checkbox"/> Moderate <input type="checkbox"/> High	The original design intent remains visible, with double hung windows and form retained. The ground floor has been significantly altered. The large number of air conditioner condenser to the awning units is intrusive. <b>The building contributes to the character of the HCA.</b>

Comments	Recommendations
<p>of different design motifs and architectural eras, reflective of the changing needs and aesthetic appeals of society.</p> <p>The awning travels almost uninterrupted throughout the HCA, creating a degree of consistency despite varying heights and minimal retention of the ground floor features and original pressed metal awning ceilings.</p> <p>Generally, the condition is fair, with many items within the HCA requiring minor conservation works. The general integrity of the HCA is moderate, as the HCA consists largely of shopfronts that have been altered significantly at the ground floor level, but have a high degree of original fabric retained above the awning level.</p> <p>A consistent intrusive element across the HCA is the placement of air conditioner condenser units on top of the awnings, which is visually detracting. Likewise, security grills to windows and large signage boards that obscure the façade are intrusive.</p> <p>It is noted that the Heritage Inventory Sheet does not indicate which items are contributory and non-contributory. A map should be provided to illustrate this, as provided in the other proposed HCAs. During the site inspection, it was noted that some items within the proposed HCA should be considered as non-contributory, due to their degree of integrity, intactness and/or age.</p>	<ul style="list-style-type: none"> <li>• 5 Auburn Road</li> <li>• 16-18 Auburn Road</li> <li>• 22A Auburn Road</li> <li>• 31-33 Auburn Road</li> <li>• 96-98 South Parade</li> <li>• 110-112 South Parade</li> <li>• 114-116 South Parade</li> <li>• 124-126 South Parade</li> <li>• 160-164 South Parade</li> </ul> <p>The remainder of the items can be considered as contributory.</p> <p>The NSW Heritage historical themes should be included in the heritage inventory sheet. It is recommended that the following themes are included:</p> <ul style="list-style-type: none"> <li>• 3 Developing local, regional and national economies – commerce</li> <li>• 4 Building settlements, towns and cities – towns, suburbs and villages</li> <li>• 4 Building settlements, towns and cities – land tenure</li> <li>• 4 Building settlements, towns and cities – accommodation</li> <li>• 8 Developing Australia's cultural life – creative endeavour</li> </ul> <p>Additionally, should the opportunity arise, it would be favourable to relocate the air conditioner condenser units to the rear of the shops.</p>

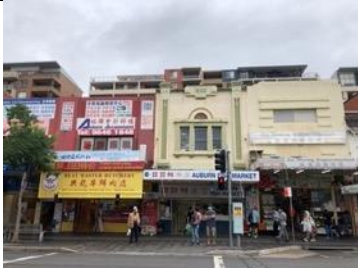
HS141 South Parade 118-120

118-120	South Parade	<input checked="" type="checkbox"/>	<input type="checkbox"/>	<input type="checkbox"/> Poor <input checked="" type="checkbox"/> Fair <input type="checkbox"/> Good	<input type="checkbox"/> Low <input checked="" type="checkbox"/> Moderate <input type="checkbox"/> High	'1929' inscribed to top of parapet. Retains early design features and moulding around windows and to the upper walls, although windows have been replaced with aluminium frames. Ground floor is significantly altered. <b>The building contributes to the character of the HCA.</b>

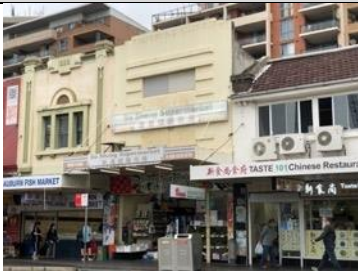
Number	Street	Contributory	Non-Contributory	Condition	Integrity	Comments	Photograph and reference number
122	South Parade	<input checked="" type="checkbox"/>	<input type="checkbox"/>	<input type="checkbox"/> Poor <input checked="" type="checkbox"/> Fair <input type="checkbox"/> Good	<input type="checkbox"/> Low <input checked="" type="checkbox"/> Moderate <input type="checkbox"/> High	Windows to upper level appear to be boarded up, although the original shape and design of the facade remains evident. Ground floor has been significantly altered. <b>The building contributes to the character of the HCA.</b>

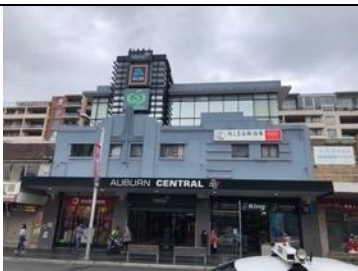
HS141_South Parade_128-136

128-136	South Parade	<input checked="" type="checkbox"/>	<input type="checkbox"/>	<input type="checkbox"/> Poor <input checked="" type="checkbox"/> Fair <input type="checkbox"/> Good	<input type="checkbox"/> Low <input checked="" type="checkbox"/> Moderate <input type="checkbox"/> High	Three shops with three matching bays at 128-132 and a differing design to 134-136. A contemporary, glazed addition has been constructed to create additional levels although is set behind the parapet. <b>The original building contributes to the character of the HCA. The rear addition does not contribute to the character of the HCA.</b>

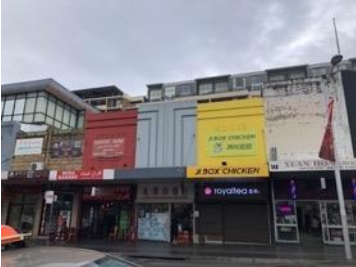
HS141 South Parade 142-146

HS141 South Parade 138-140
142-146	South Parade	<input checked="" type="checkbox"/>	<input type="checkbox"/>	<input type="checkbox"/> Poor <input checked="" type="checkbox"/> Fair <input type="checkbox"/> Good	<input type="checkbox"/> Low <input checked="" type="checkbox"/> Moderate <input type="checkbox"/> High	Presents as three shops with a consistent design across the parapet. Inscribed with 'Stuart House' across the façade. Ground floor has been altered although the upper level façade remains intact. <b>The building contributes to the character of the HCA.</b>

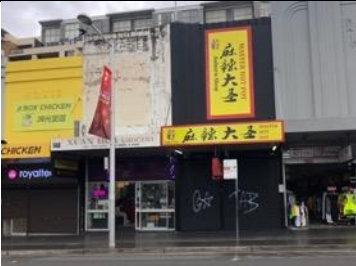
148-150	South Parade	<input checked="" type="checkbox"/>	<input type="checkbox"/>	<input type="checkbox"/> Poor <input checked="" type="checkbox"/> Fair <input type="checkbox"/> Good	<input type="checkbox"/> Low <input checked="" type="checkbox"/> Moderate <input type="checkbox"/> High	Pair of shops with mirrored design. No. 148 is in a poorer condition than No. 150. Original design intent to upper level remains visible despite alterations to the ground floor. <b>The building contributes to the character of the HCA.</b>

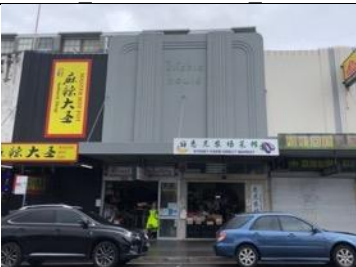
HS141 South Parade 152-154

HS141 South Parade 148-150
152-154	South Parade	<input checked="" type="checkbox"/>	<input type="checkbox"/>	<input type="checkbox"/> Poor <input type="checkbox"/> Fair <input checked="" type="checkbox"/> Good	<input type="checkbox"/> Low <input checked="" type="checkbox"/> Moderate <input type="checkbox"/> High	Inscribed with 'Ritchie House' to upper level façade. Original detailing to the façade remains, despite alterations to ground floor. <b>The building contributes to the character of the HCA.</b>

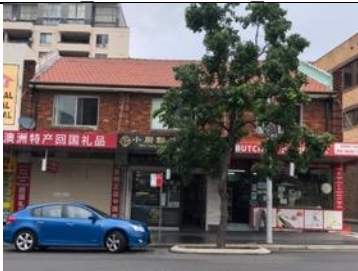
HS141_South Parade_160-164

HS141_South Parade_156-158
160-164	South Parade	<input type="checkbox"/>	<input checked="" type="checkbox"/>	<input type="checkbox"/> Poor <input checked="" type="checkbox"/> Fair <input type="checkbox"/> Good	<input type="checkbox"/> Low <input checked="" type="checkbox"/> Moderate <input type="checkbox"/> High	Three shops that present as one building, with consistent terracotta tiled, transverse gabled roof front and exposed brick upper level. No original windows remain and the ground floor has been significantly altered, although the original design intent is visible. The group of shops illustrates a later phase of construction, however they are simplistic in their design approach with little or no architectural merit for the period and style. <b>They are therefore not considered as contributory to the HCA.</b>

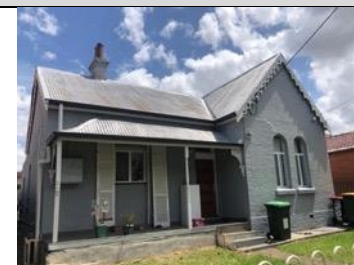
<p>HS38</p>

Item	Name	Address	Listing	Comments	Recommendations	Photographic Evidence
HS38	Victorian Cottage	32 Woodburn Road	Local	<p>The cottage is reflective of Victorian era residential architecture, despite alterations reducing the original fabric.</p> <p>It features a transverse gable roof and projecting gable with lace detail to timber bargeboards.</p> <p>The projecting gable end includes two slim, arched window forms with contemporary aluminium casement windows in place of the original timber windows. The other window to the side of the front door is also an aluminium frame and is an infill of an earlier door opening.</p> <p>There is an intrusive metal looptop fence to the front boundary and minimal landscaping.</p> <p>Condition: Fair</p> <p>Integrity: Moderate</p>	<p>The exterior of the Victorian Cottage <b>should be considered for individual listing.</b></p> <p>The secondary dwelling at the rear should be noted as an item that does not contribute to the significance of the site.</p>

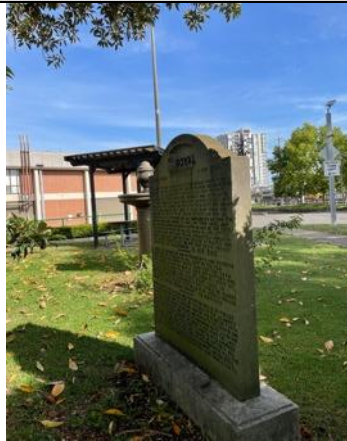
<p>HS41</p>

Item	Name	Address	Listing	Comments	Recommendations	Photographic Evidence
HS41	Headstone and Memorials	Factory Street, western side, near Clyde Railway Station	Local	<p>The Headstone and Memorials are located behind a palisade fence and close to the property boundary. It was not possible to enter the site at the time of inspection, although the items were visible from the street.</p> <p>The wider setting has been impacted upon by the construction of the industrial buildings on the site, although a curtilage has been retained.</p> <p>It is a unique combination of memorials, including a plaque commemorating Thomas Brunton (founder of the Australian Flour Mills), a memorial fountain to John Spencer Bruton (Thomas Brunton's grandson and prominent miller), and a headstone dedicated to John Spencer Brunton's dog.</p> <p>Condition: Good</p> <p>Integrity: High</p>	The Headstone and Memorials should be considered for listing.

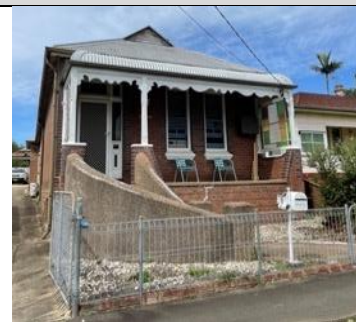
<p>HS44</p>

Item	Name	Address	Listing	Comments	Recommendations	Photographic Evidence
HS44	Federation Cottage	8 Hewlett Street	Local	<p>The Federation Cottage is within the existing Granville HCA – Residential Precinct.</p> <p>The cottage is a good example of its type. It has a high degree of integrity and appears to be in a good condition externally.</p> <p>It has a hipped, corrugated roof, moulded timber valance detail to the verandah, face brick, timber double hung windows and stained glass windows to the sides of the verandah.</p> <p>There is a cement faced, curved stairway that leads to the verandah and a metal fence marking the boundary.</p> <p>There is contradicting information in the Statement of Significance and the historical information provided in the heritage inventory sheet. The Statement of Significance notes a construction date of ca, 1895, while the history notes 1910 as the construction date.</p> <p>Condition: Good</p> <p>Integrity: High</p>	<p>The Federation Cottage <b>should be considered for listing.</b></p> <p>Historical information should be revised to determine the date of construction; and update the Statement of Significance and/or historical information accordingly.</p>

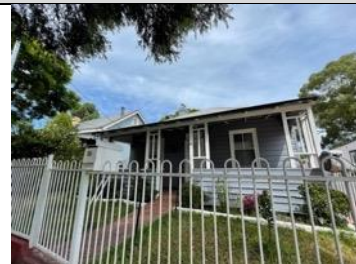
Item	Name	Address	Listing	Comments	Recommendations	Photographic Evidence
HS46	Victorian Cottage	32 The Avenue	Local	<p>The Victorian Cottage is located within the existing Granville HCA – Residential Precinct.</p> <p>The cottage is a good example of its type. It carries a moderate degree of integrity and appears to be in a good condition externally.</p> <p>It is a weatherboard clad, single storey structure with hipped roof and corrugated sheeting. It retains original multi-paned double hung window, although some have security screens. The metal loop fence, painted driveway and security screens detract from the significance of the site.</p> <p>The exterior of the cottage has been repainted since the assessment was completed for the heritage inventory sheet.</p> <p>Condition: Good</p> <p>Integrity: Moderate</p>	The Victorian Cottage <b>should be considered for listing.</b>

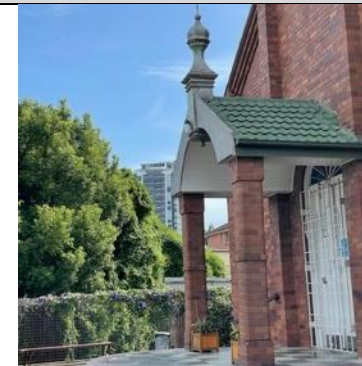
<p>HS48(1)</p>

Item	Name	Address	Listing	Comments	Recommendations	Photographic Evidence
				<p>polychromatic brickwork and a lower ridge height. The Church is the dominant form on the site, owing to the ornate details and increased height of the domed spires.</p> <p>The Church and Hall hold a high degree of integrity and appear to be in a good condition externally.</p> <p>Condition: Good</p> <p>Integrity: High</p>

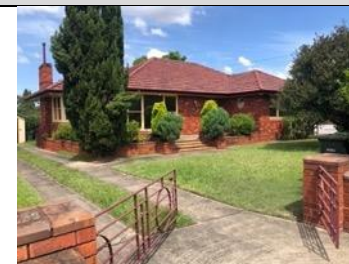
<p>HS51</p>

Item	Name	Address	Listing	Comments	Recommendations	Photographic Evidence
HS51	Post-War Austerity Style House	38 Bolton Street	Local	<p>The dwelling is highly intact and well maintained, displaying a good example of restrained architectural features, including the triple fronted façade, reflective of the Post-War Austerity style residential developments.</p> <p>It has Marseilles tiles to the hipped roof and one large brick chimney. There is a circular window under the projecting hipped roof, near the front entrance. The other windows are timber double hung frames. The dwelling is accessed via the recessed verandah, which has a geometric metal balustrade.</p> <p>The front boundary is marked with a low brick fence and established hedge, and includes an original metal gate that matches the fencing to the verandah. An established conifer tree to the northern corner is beside two dwarf conifers that frame the stairs.</p> <p>Free-standing garage at rear is visually separate and does not</p>	The exterior of the Post-War Austerity Style House <b>should be considered for individual listing.</b>

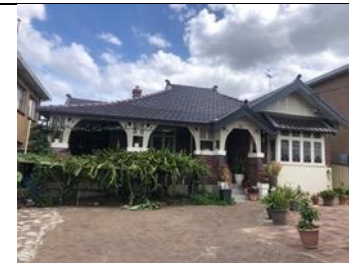
<p>HS52</p>

Item	Name	Address	Listing	Comments	Recommendations	Photographic Evidence
				detract from or contribute to the aesthetic significance of the site.		
				Condition: Good		
				Integrity: High		
HS52	Federation Bungalow	214 Guildford Road	Local	<p>The Federation Bungalow is a good example of its type. It has a moderate degree of integrity and appears to be in a good condition externally.</p> <p>It has a terracotta, hipped and projecting gable roof to roof proper with finials and chimney pot to the chimney, and a terracotta roof to the verandah. The verandah is supported by polychromatic brick piers and timber brackets with Art Nouveaux carved details. The projecting gable end to the roof proper and the verandah are roughcast.</p> <p>Below the projecting gable end is a bay window with four stained glass casement windows with transoms. Windows to the front façade, under the verandah, include three timber framed stained glass casement window.</p> <p>The front yard is paved and includes mature planting that is not</p>	<p>The exterior of the Federation Bungalow <b>should be considered for individual listing</b>.</p> <p>Consideration should be given to also include Recommendations 12 and 13, in the future event that the recent addition be demolished and a new addition constructed.</p>

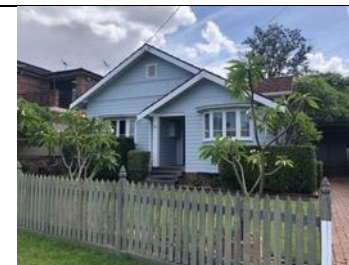
<p>HS53</p>

Item	Name	Address	Listing	Comments	Recommendations	Photographic Evidence
				likely to be from the original landscaping.  Condition: Good  Integrity: Moderate		
HS53	Californian Bungalow	59 Rosebery Road	Local	<p>The Californian Bungalow is a good example of its type. It has a high degree of integrity and is in a good condition.</p> <p>It is an asymmetrical form with a double gabled frontage. The gable ends are clad with timber weatherboards and there is a timber louvered vent to the recessed, larger gable end. A bay window with four timber casement windows is located under both gable ends.</p> <p>The front boundary is defined with a timber picket fence. The garden is well maintained, with non-significant plantings.</p> <p>An awning has been added to the side elevation and a freestanding garage has been constructed beyond.</p> <p>Condition: Good</p> <p>Integrity: High</p>	The exterior of the Californian Bungalow <b>should be considered for individual listing.</b>

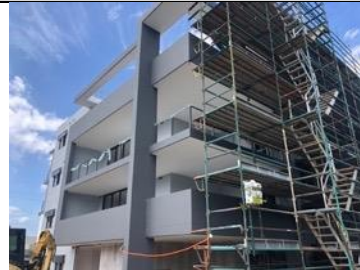
Number	Street	Contributory	Non-Contributory	Condition	Integrity	Comments	Photograph and reference number
84	Bursill Street	<input type="checkbox"/>	<input checked="" type="checkbox"/>	N/A	N/A	Heritage Inventory Sheet notes this item as non-contributory and not recommended for listing within the HCA boundaries. A multistorey development is under construction and <b>does not contribute to the character of the HCA.</b>

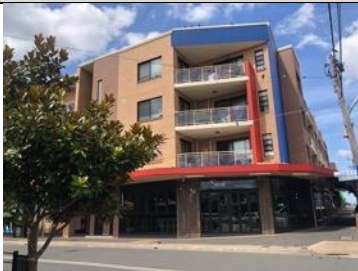
Number	Street	Contributory	Non-Contributory	Condition	Integrity	Comments	Photograph and reference number
265	Guildford Road	<input type="checkbox"/>	<input checked="" type="checkbox"/>	N/A	N/A	Heritage Inventory Sheet notes this item as non-contributory and not recommended for listing within the HCA boundaries. It is a contemporary development that <b>does not contribute to the character of the HCA.</b>

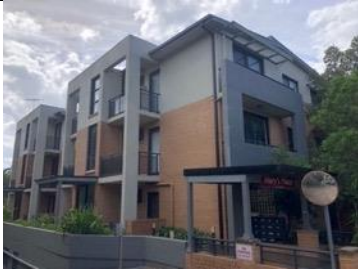
Number	Street	Contributory	Non-Contributory	Condition	Integrity	Comments	Photograph and reference number
3-5	Talbot Road	<input type="checkbox"/>	<input checked="" type="checkbox"/>	N/A	N/A	Heritage Inventory Sheet notes this item as non-contributory and not recommended for listing within the HCA boundaries.  It is a multistorey residential development that <b>does not contribute towards the character of the HCA.</b>

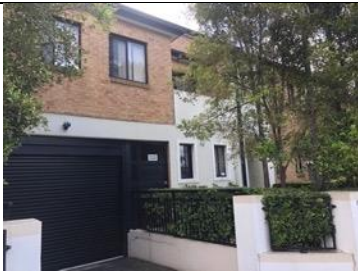
Number	Street	Contributory	Non-Contributory	Condition	Integrity	Comments	Photograph and reference number
<p><b>No. 6 Talbot Road contributes to the character of the HCA.</b> It makes a positive contribution to the streetscape character, owing to its degree of integrity and condition.</p>							
7	Talbot Road	<input type="checkbox"/>	<input checked="" type="checkbox"/>	N/A	N/A	Heritage Inventory Sheet notes this item as non-contributory and not recommended for listing within the HCA boundaries. It is a large, two storey development of recent construction that <b>does not contribute to the character of the HCA.</b>

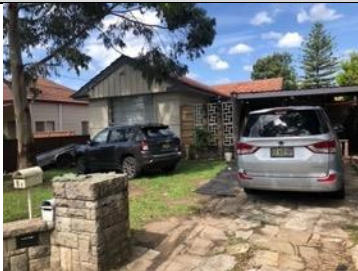
Number	Street	Contributory	Non-Contributory	Condition	Integrity	Comments	Photograph and reference number
8A	Talbot Road	<input type="checkbox"/>	<input checked="" type="checkbox"/>	<input type="checkbox"/> Poor <input checked="" type="checkbox"/> Fair <input type="checkbox"/> Good	<input checked="" type="checkbox"/> Low <input type="checkbox"/> Moderate <input type="checkbox"/> High	Heritage Inventory Sheet notes this item as non-contributory and not recommended for listing within the HCA boundaries. It has been significantly altered and does not reflect the characteristics of the HCA and <b>does not contribute to the character of the HCA.</b>

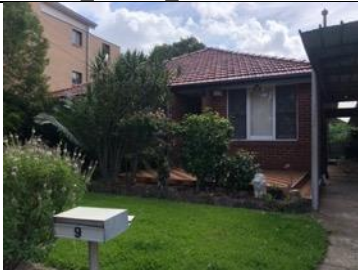
HS144 Talbot 9

HS144 Talbot 8A
9	Talbot Road	<input type="checkbox"/>	<input checked="" type="checkbox"/>	<input type="checkbox"/> Poor <input checked="" type="checkbox"/> Fair <input type="checkbox"/> Good	<input checked="" type="checkbox"/> Low <input type="checkbox"/> Moderate <input type="checkbox"/> High	Heritage Inventory Sheet notes this item as non-contributory and not recommended for listing within the HCA boundaries. It has been significantly altered and <b>does not contribute to the character of the HCA.</b>

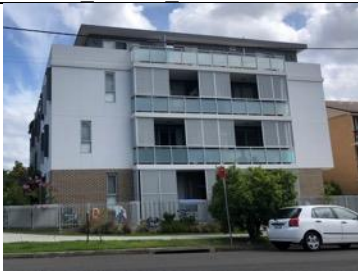
HS144 Talbot 9A

9A	Talbot Road	<input type="checkbox"/>	<input checked="" type="checkbox"/>	N/A	N/A	Heritage Inventory Sheet notes this item as non-contributory and not recommended for listing within the HCA boundaries. It is a multistorey residential development that <b>does not contribute to the characteristics of the HCA.</b>

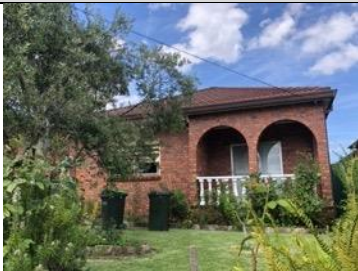
Number	Street	Contributory	Non-Contributory	Condition	Integrity	Comments	Photograph and reference number
10	Talbot Road	<input type="checkbox"/>	<input checked="" type="checkbox"/>	N/A	N/A	Heritage Inventory Sheet notes this item as non-contributory and not recommended for listing within the HCA boundaries. It is a ca. mid-late 20 <sup>th</sup> century dwelling that <b>does not reflect the form and character of the HCA.</b>

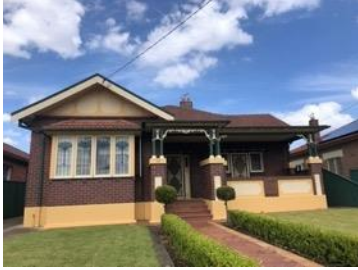
HS144_Talbot_12

12	Talbot Road	<input checked="" type="checkbox"/>	<input type="checkbox"/>	<input type="checkbox"/> Poor <input type="checkbox"/> Fair <input checked="" type="checkbox"/> Good	<input type="checkbox"/> Low <input type="checkbox"/> Moderate <input checked="" type="checkbox"/> High	Heritage Inventory Sheet notes this item as a listed heritage item. It is part of the existing listing, item I164. It is a red brick, single storey dwelling that retains original features such as stained glass window details, rough cast portions to the gable end and verandah wall and timber detailing to the verandah. <b>The garden setting positively contributes to the item, which is contributory to the</b>

Number	Street	Contributory	Non-Contributory	Condition	Integrity	Comments	Photograph and reference number
						HCA. The dwelling should be considered for Individual heritage listing as it provides a good example of its type.	
13	Talbot Road	<input checked="" type="checkbox"/>	<input type="checkbox"/>	<input type="checkbox"/> Poor <input type="checkbox"/> Fair <input checked="" type="checkbox"/> Good	<input type="checkbox"/> Low <input type="checkbox"/> Moderate <input checked="" type="checkbox"/> High	Heritage Inventory Sheet notes this item as a listed heritage item. It is part of the existing listing, item I164. It is a rendered brick, single storey dwelling that retains original features such as shingles to the gable end and below the window, lattice windows to the front bay of three casement windows. <b>It is contributory to the HCA.</b>

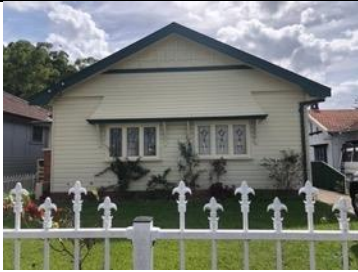
HS144_Talbot_15

15	Talbot Road	<input checked="" type="checkbox"/>	<input type="checkbox"/>	<input type="checkbox"/> Poor <input type="checkbox"/> Fair <input checked="" type="checkbox"/> Good	<input type="checkbox"/> Low <input checked="" type="checkbox"/> Moderate <input type="checkbox"/> High	Heritage Inventory Sheet notes this item as a listed heritage item. It is part of the existing listing, item I164. It is a timber clad, single storey dwelling with one large, timber clad gable end. It retains two bays of early stained glass windows, with an entrance to the side of the dwelling. <b>It contributes to the character of the HCA.</b>

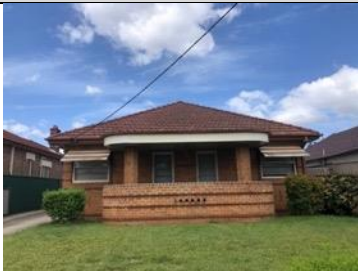
Number	Street	Contributory	Non-Contributory	Condition	Integrity	Comments	Photograph and reference number
16	Talbot Road	<input checked="" type="checkbox"/>	<input type="checkbox"/>	<input type="checkbox"/> Poor <input type="checkbox"/> Fair <input checked="" type="checkbox"/> Good	<input type="checkbox"/> Low <input type="checkbox"/> Moderate <input checked="" type="checkbox"/> High	Heritage Inventory Sheet notes this item as a listed heritage item. It is part of the existing listing, item I164. It is a single storey, blonde brick dwelling with contrasting brick details. It features a curved verandah wall and roof, and retains timber double hung window frames. <b>It contributes to the character of the HCA.</b>

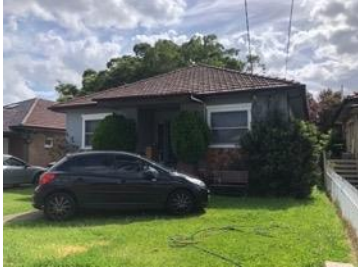
HS144_Talbot_17

HS144_Talbot_16
17	Talbot Road	<input checked="" type="checkbox"/>	<input type="checkbox"/>	<input type="checkbox"/> Poor <input checked="" type="checkbox"/> Fair <input type="checkbox"/> Good	<input type="checkbox"/> Low <input checked="" type="checkbox"/> Moderate <input type="checkbox"/> High	Heritage Inventory Sheet notes this item as a listed heritage item. It is part of the existing listing, item I164. It is a single storey, fibro clad dwelling consistent with the form and scale of the HCA. <b>It contributes to the character of the HCA.</b>

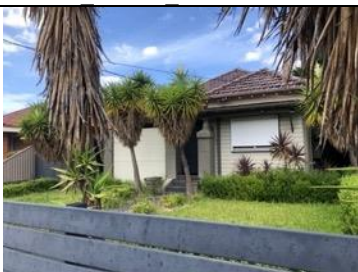
HS144_Talbot_18

18	Talbot Road	<input type="checkbox"/>	<input checked="" type="checkbox"/>	<input type="checkbox"/> Poor <input checked="" type="checkbox"/> Fair <input type="checkbox"/> Good	<input checked="" type="checkbox"/> Low <input type="checkbox"/> Moderate <input type="checkbox"/> High	Heritage Inventory Sheet notes this item as non-contributory. It falls within the existing heritage listing for Item I164. While the form of the original dwelling is still visible, it has been altered with a high brick wall to infill the verandah, a timber screen fence to the side and mechanical shutters, such that these works limit the visibility of any remaining original features. This item <b>does not significantly contribute to the HCA.</b>

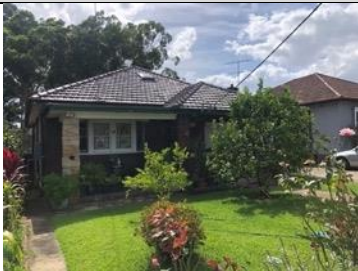
Number	Street	Contributory	Non-Contributory	Condition	Integrity	Comments	Photograph and reference number
19	Talbot Road	<input checked="" type="checkbox"/>	<input type="checkbox"/>	<input type="checkbox"/> Poor <input checked="" type="checkbox"/> Fair <input type="checkbox"/> Good	<input type="checkbox"/> Low <input checked="" type="checkbox"/> Moderate <input type="checkbox"/> High	Heritage Inventory Sheet notes this item as a listed heritage item. It is part of the existing listing, item I164. It is a painted brick, single storey dwelling with hipped terracotta roof form. The verandah has been altered to include a sandstone post, although retains original double hung timber stained glass windows. <b>It contributes to the character of the HCA.</b>

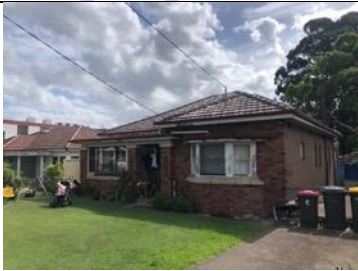
HS144_Talbot_21

21	Talbot Road	<input checked="" type="checkbox"/>	<input type="checkbox"/>	<input type="checkbox"/> Poor <input checked="" type="checkbox"/> Fair <input type="checkbox"/> Good	<input type="checkbox"/> Low <input checked="" type="checkbox"/> Moderate <input type="checkbox"/> High	Heritage Inventory Sheet notes this item as a listed heritage item. It is part of the existing listing, item I164. It is a single storey, dwelling with polychromatic brickwork creating detail to the verandah. There is peeling paint to the timber windows and fascia, and the verandah has been infilled with glazing, although it appears to be in a relatively sound and intact condition. <b>It contributes to the character of the HCA.</b>

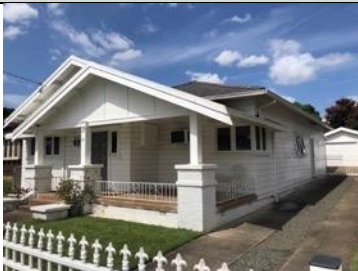
Number	Street	Contributory	Non-Contributory	Condition	Integrity	Comments	Photograph and reference number
22	Talbot Road	<input checked="" type="checkbox"/>	<input type="checkbox"/>	<input type="checkbox"/> Poor <input type="checkbox"/> Fair <input checked="" type="checkbox"/> Good	<input type="checkbox"/> Low <input checked="" type="checkbox"/> Moderate <input type="checkbox"/> High	Heritage Inventory Sheet notes this item as a listed heritage item. It is part of the existing listing, item I164. It is a weatherboard clad, single storey dwelling with two gable ends. It is consistent with the form and scale of the HCA, and <b>positively contributes to the character of the HCA and should be considered for Individual heritage listing.</b>

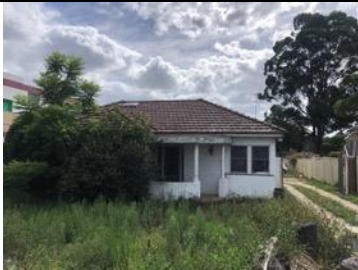
HS144_Talbot_23

HS144_Talbot_22
23	Talbot Road	<input type="checkbox"/>	<input checked="" type="checkbox"/>	<input type="checkbox"/> Poor <input checked="" type="checkbox"/> Fair <input type="checkbox"/> Good	<input type="checkbox"/> Low <input checked="" type="checkbox"/> Moderate <input type="checkbox"/> High	<p>Heritage Inventory Sheet notes this item as a listed heritage item. It is part of the existing listing, item I164. It is a single storey, rendered dwelling. The garden is overgrown and there is peeling paint to the timber elements, although it retains the original form, timber windows and a rounded verandah setting.</p> <p>The proposed heritage inventory sheet identifies the dwellings within the HCA as constructed between ca. 1915-1930, including 23 Talbot Road, which is noted for heritage listing under item I164. Upon further research, the SIXMaps 1943 aerial image indicates that the current structure was not on the site prior to 1943. <b>Further research is required</b> to establish date of construction and possibility of removal from the Heritage Inventory Sheet.</p>

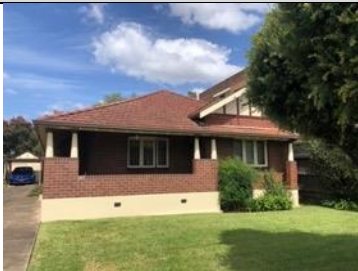
Number	Street	Contributory	Non-Contributory	Condition	Integrity	Comments	Photograph and reference number
24	Talbot Road	<input checked="" type="checkbox"/>	<input type="checkbox"/>	<input type="checkbox"/> Poor <input type="checkbox"/> Fair <input checked="" type="checkbox"/> Good	<input type="checkbox"/> Low <input type="checkbox"/> Moderate <input checked="" type="checkbox"/> High	Heritage Inventory Sheet notes this item as a listed heritage item. It is part of the existing listing, item I164. It is a good example of the type, being a single storey, brick dwelling with rendered base, timber windows and well maintained setting. The item <b>contributes to the character of the HCA and should be considered for Individual heritage listing</b> as it provides a good example of its type.
